Report addendum

Timber condition survey of The Smithy, No. 23 Denmark Place

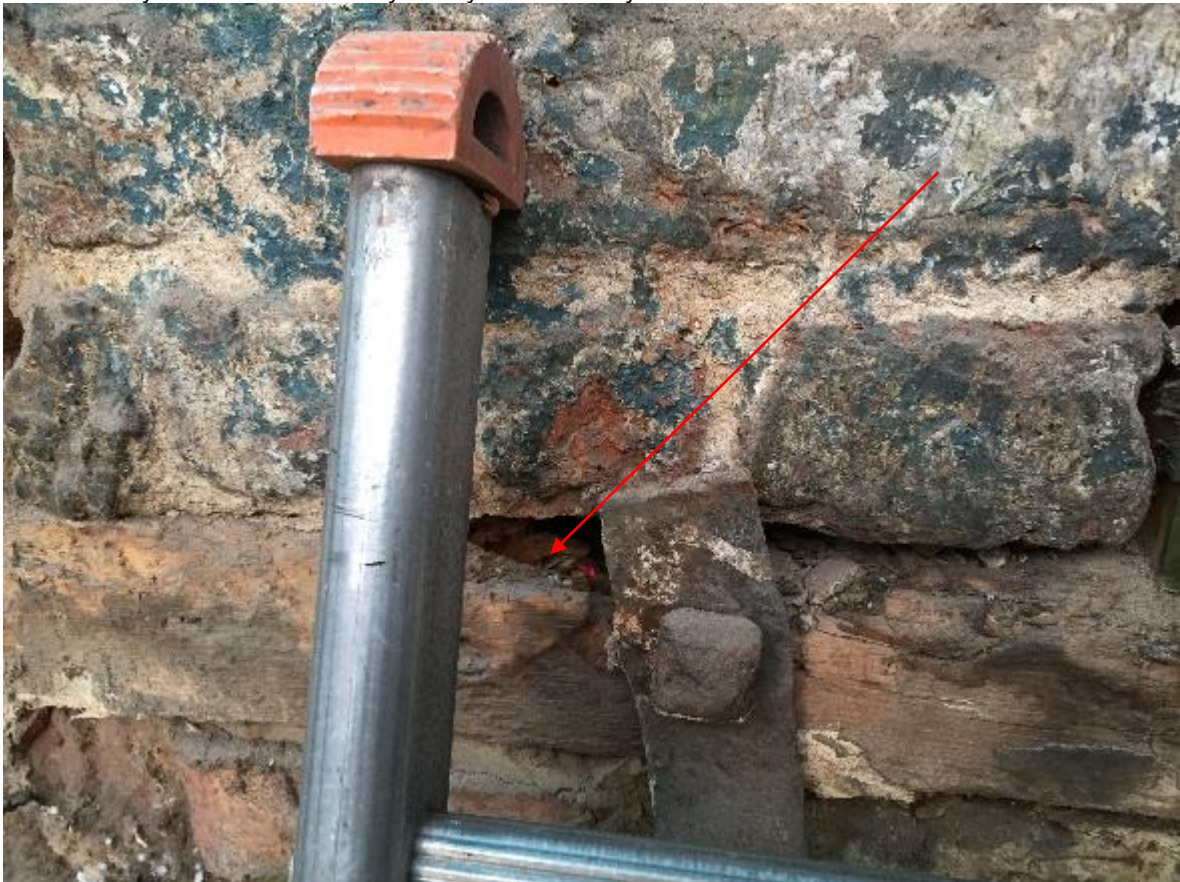
Photograph 2: Bonding timbers observed along the south and east elevations. Significant softening associated with action of decay fungi was detected in the bonding timbers.

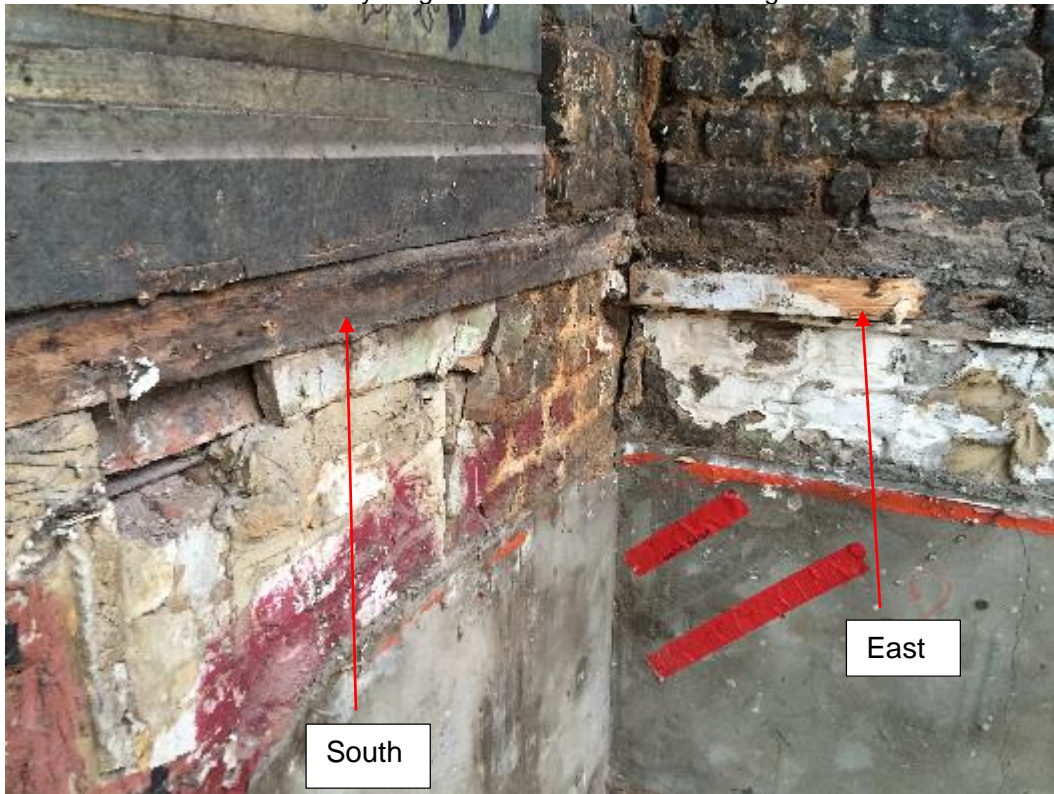
Photograph 3: Severe decay detected in a bonding timber located along the south elevation and adjacent to the west elevation. The decay is marked by the red arrow.

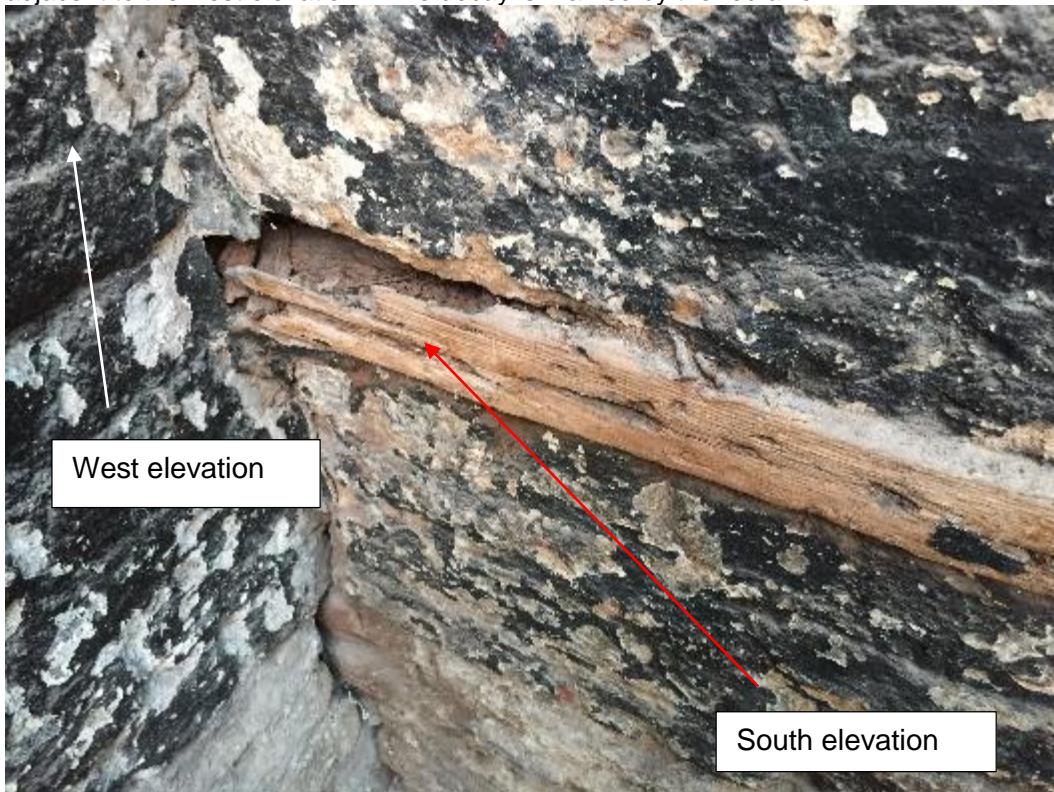
Photograph 4: Poor condition of the lintel observed over the doorway located on the east elevation. The photograph shows that the lintel has failed in service as illustrated by the fracture (arrowed).

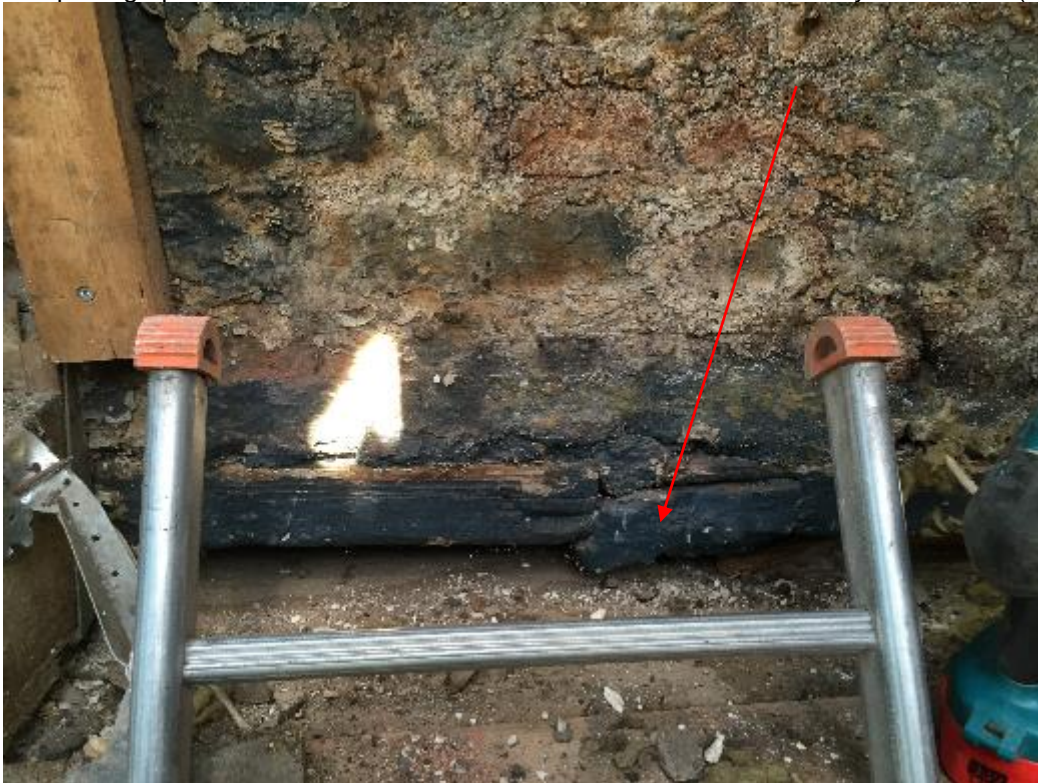
Photograph 5: Bonding timber present along the east elevation. The bonding timber positioned to the right of the light (yellow arrow) was in good condition and free from any softening associated with decay. The sound section extended from the wall light to the door opening on the east elevation (out of camera shot) and is marked by the green arrow.

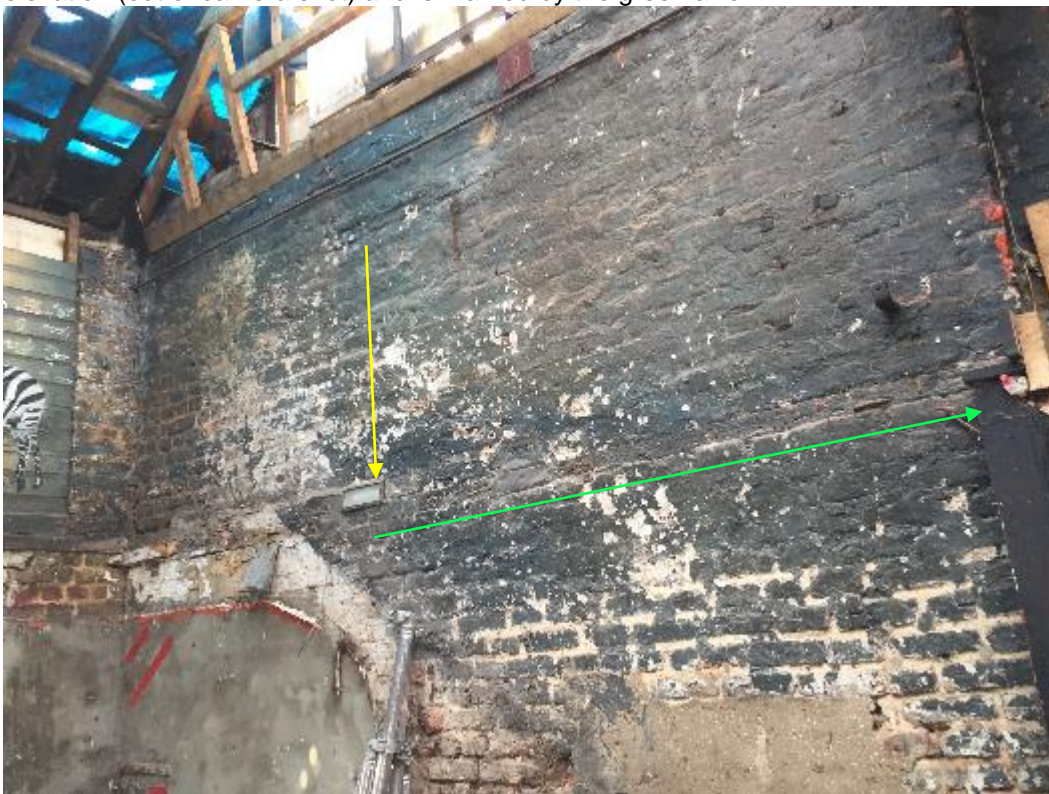
Photograph 6: General erosion caused by surface decay and loss of cross section (arrowed) observed on the common rafters at high level when viewed from a scaffold tower.

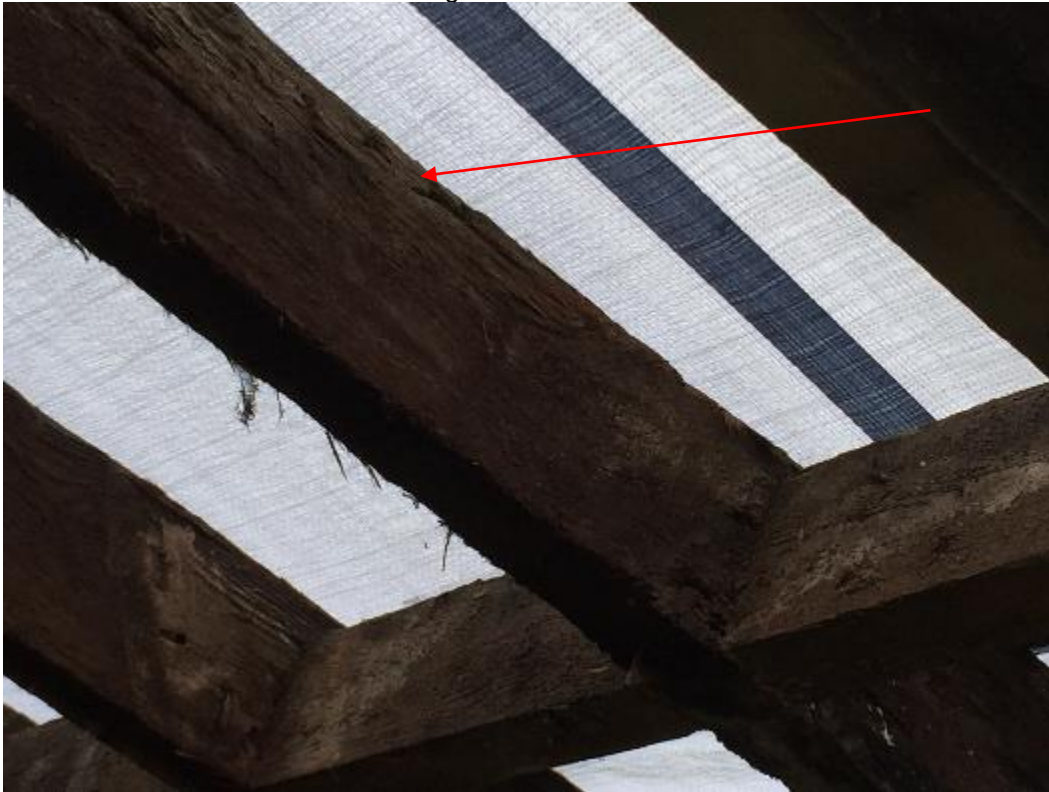
Photograph 7: Mechanical damage resulting in significant loss of section (arrowed) to this common rafter. This loss of section would prevent a strength grade from being assigned.

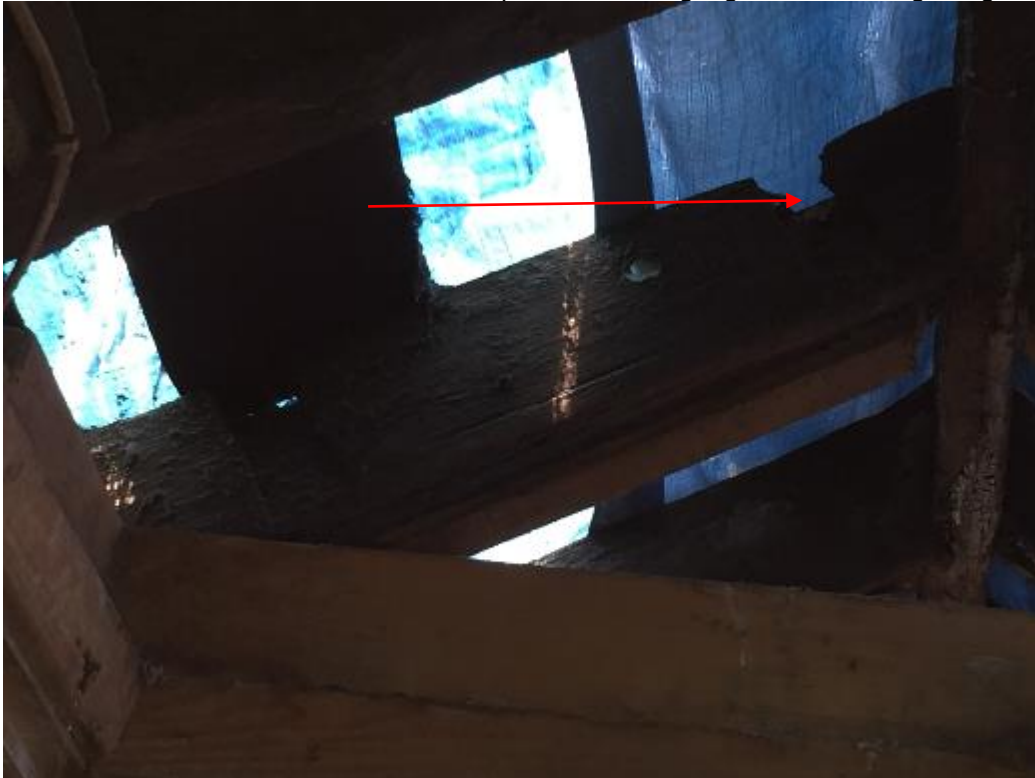
Photograph 8: Significant void resulting in loss of cross section (arrowed) to this common rafter. This loss of cross section may prevent a strength grade from being assigned.

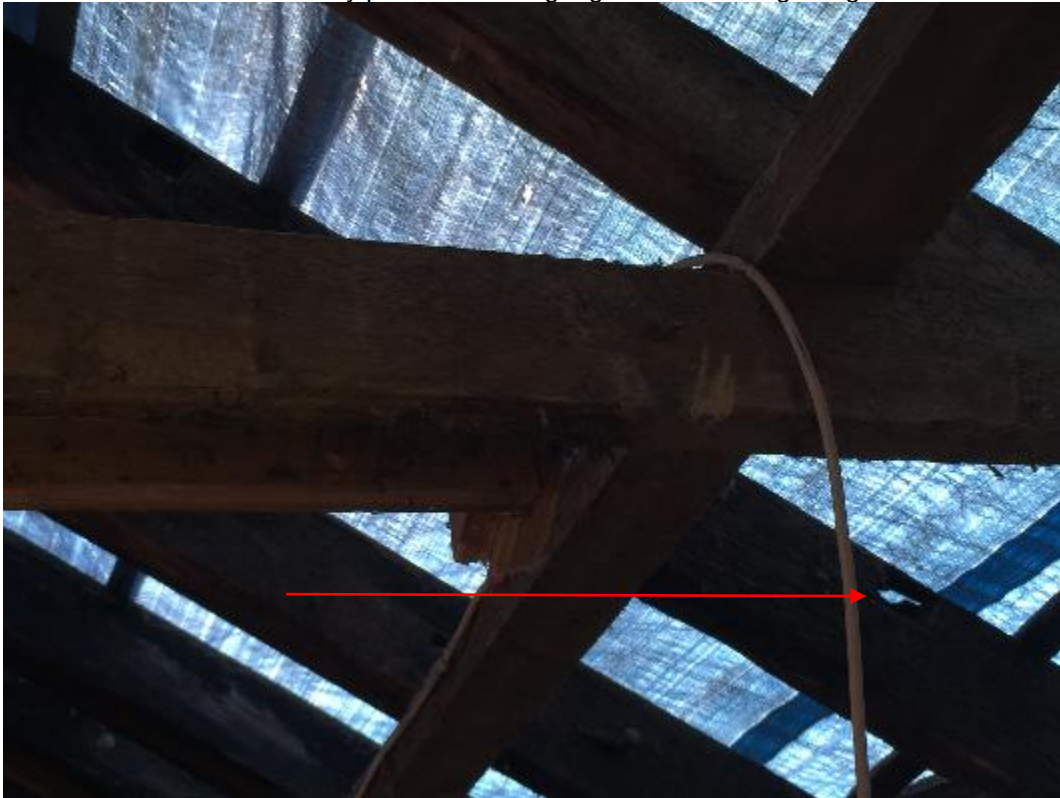
Photograph 9: Possible compression failure observed in the common rafter (arrowed) which would prevent the timber from being assigned to a visual strength grade. The timber batten fixed to the underside suggests that this is an ad-hoc structural repair.

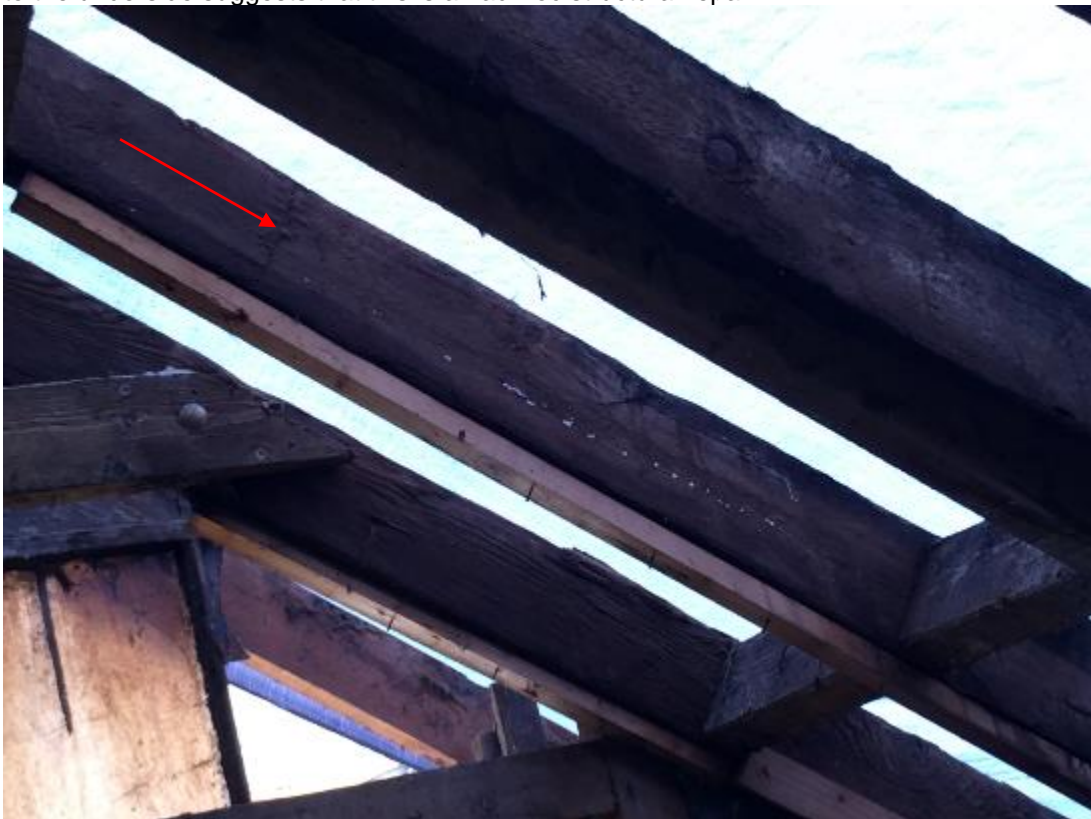
Photograph 10: Evidence of movement and dislocation of common rafters from the ridge as marked by the arrows.

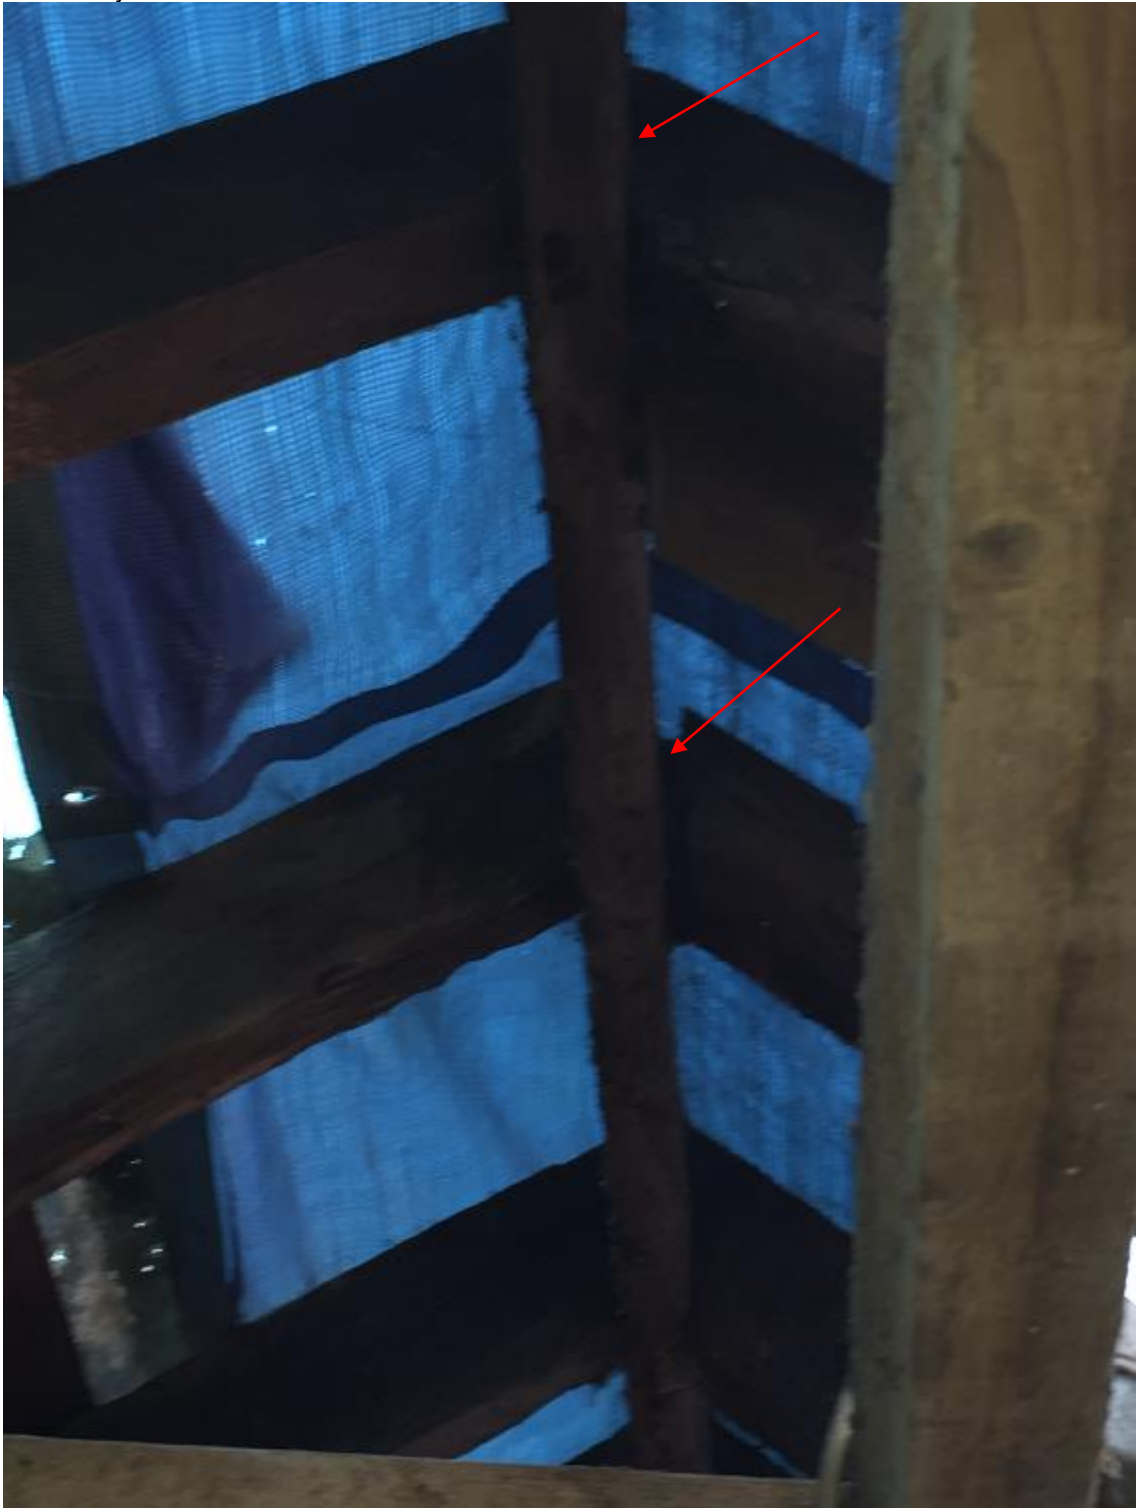
Photograph 11: Large knot area observed on the common rafter and evidence of failure in service as marked by the arrow.

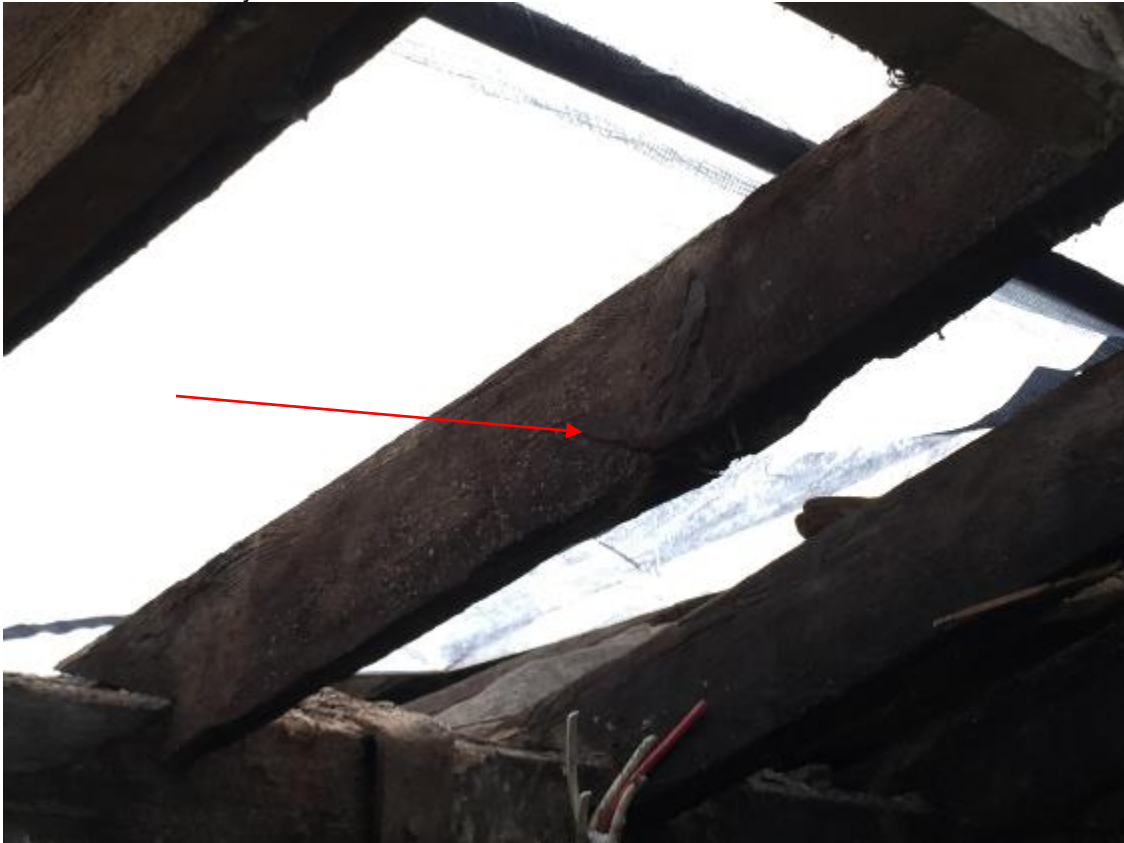
Photograph 12: An example of erosion caused by surface decay and loss in cross section observed on a common rafter as marked by the arrow.

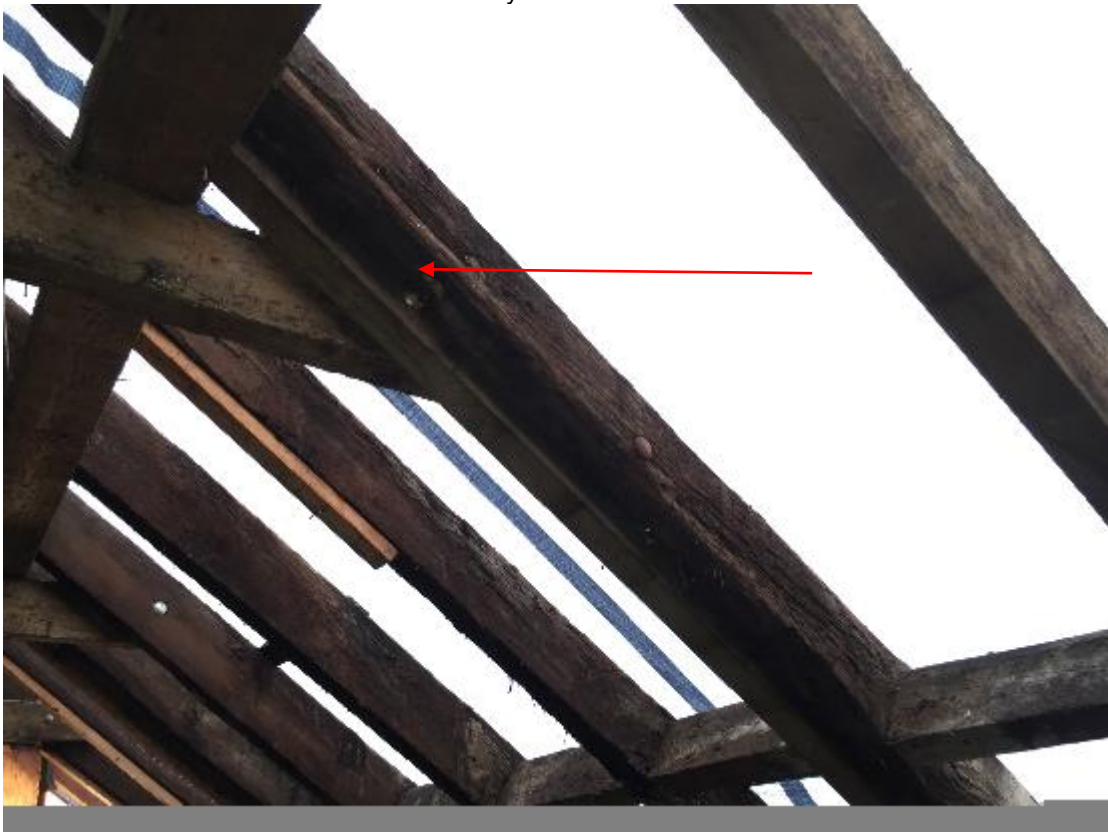
Photograph 13: Evidence of mechanical failure in a common rafter as marked by the arrow.

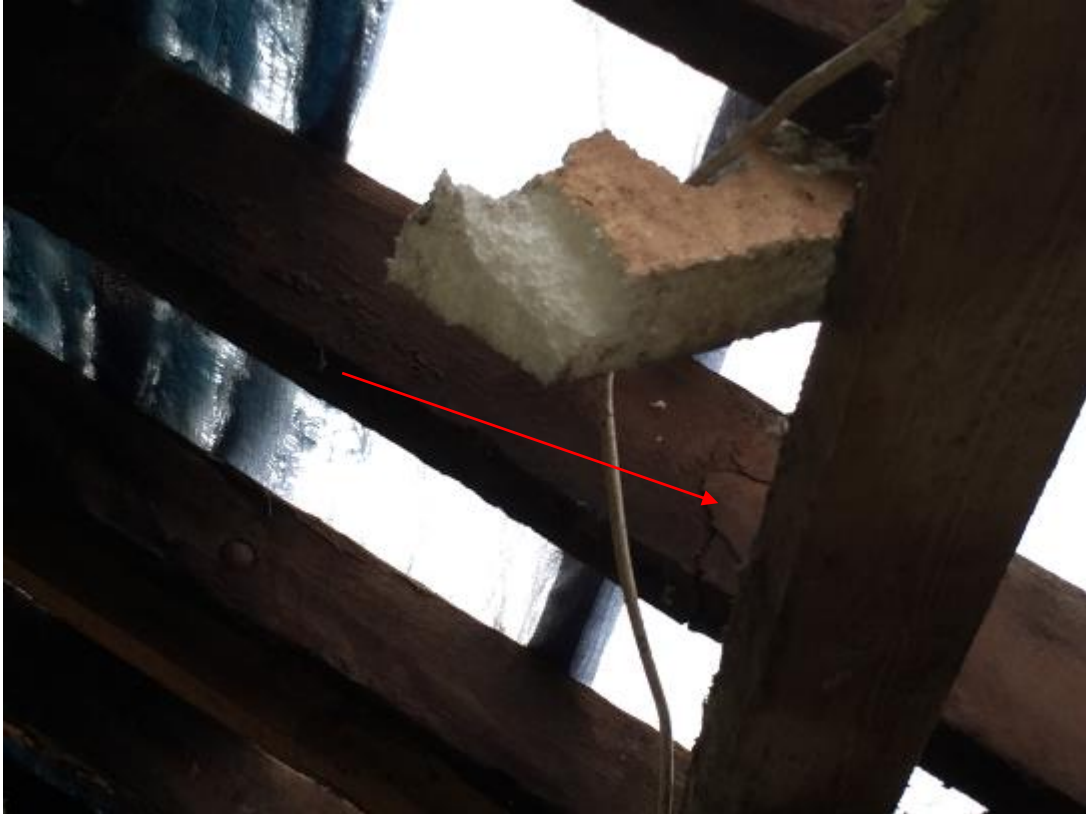
Photograph 14: Significant void resulting in significant loss of cross section (arrowed). This loss in cross section may prevent a strength grade from being assigned to this common rafter.

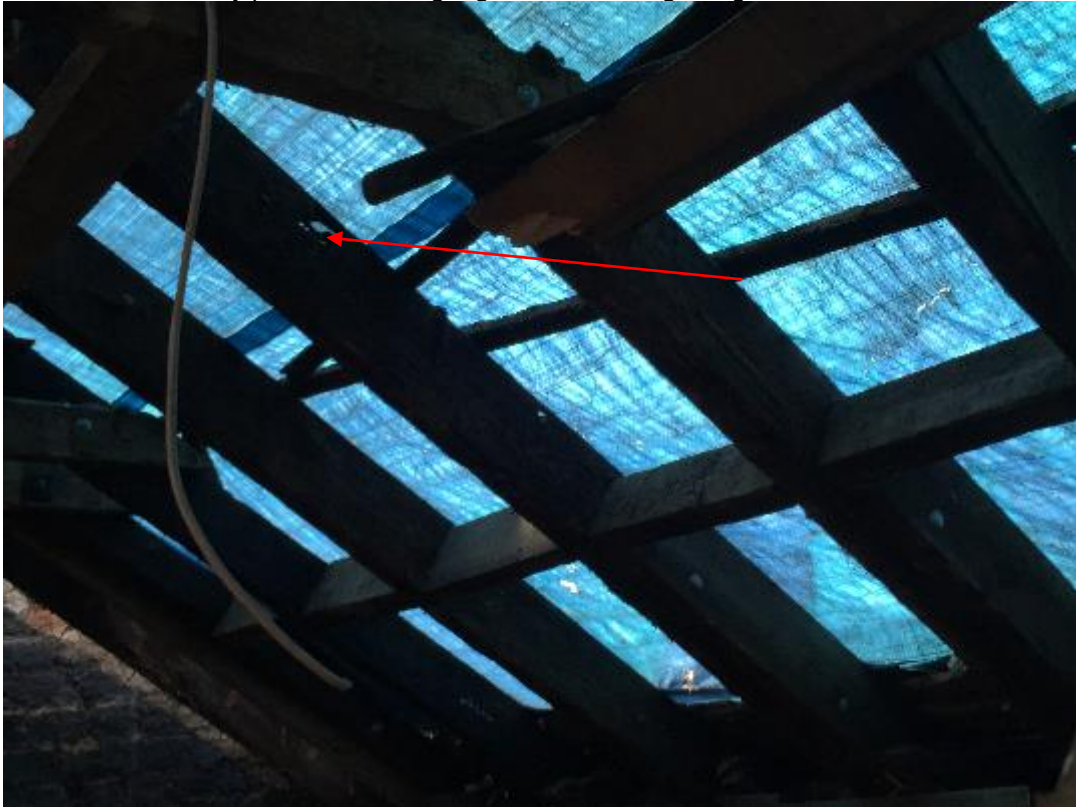
Photograph 15: Evidence of mechanical failure expressed as a fissure through the thickness of a common rafter as marked by the arrow.

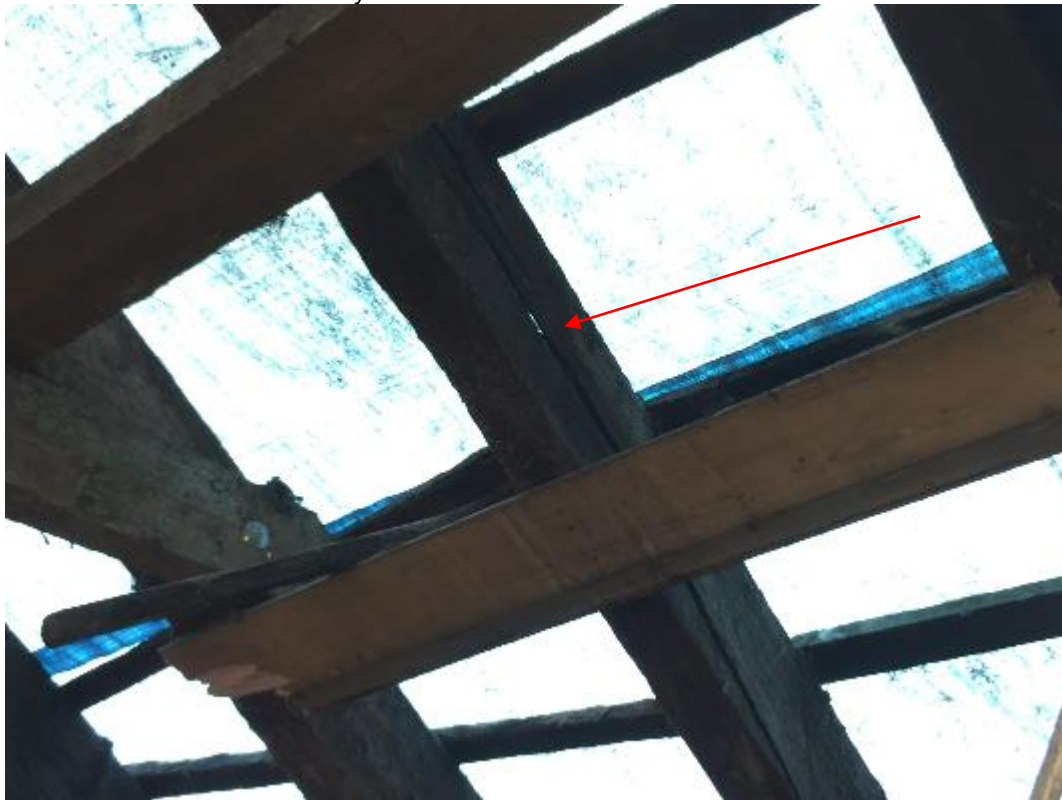
Photograph 16: Erosion caused by surface decay and loss of cross section observed on a common rafter.

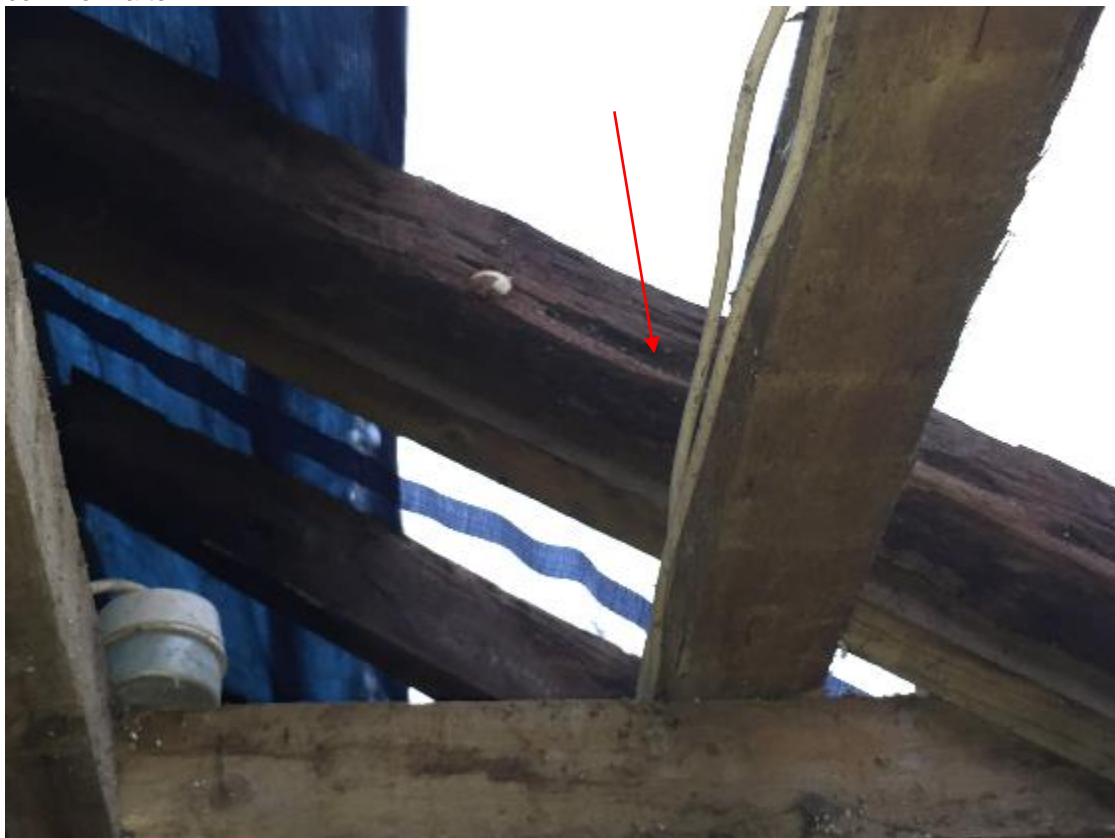
Photograph 17: Significant loss of cross section (arrowed) to this common rafter. This loss of cross section could prevent a strength grade from being assigned.

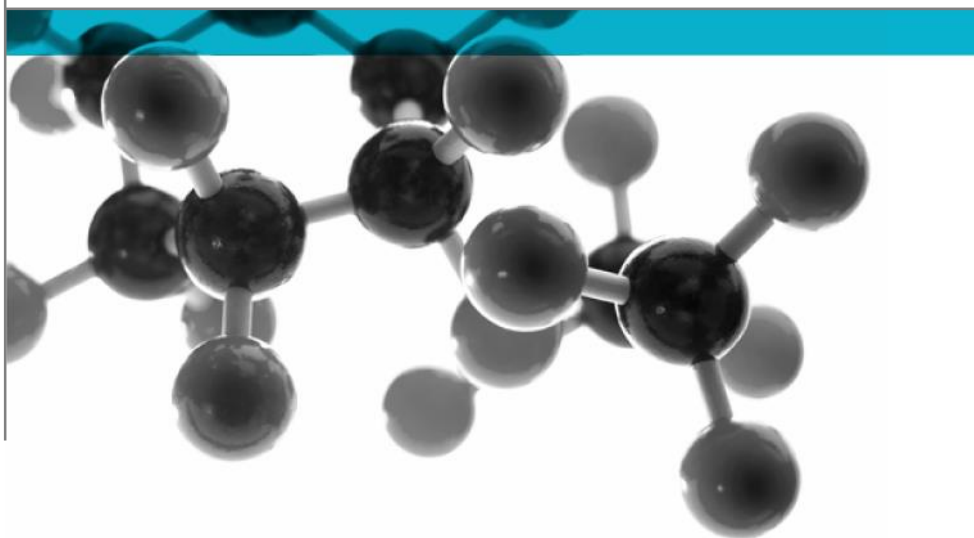
Timber condition survey of the smithy, No. 23 Denmark Place

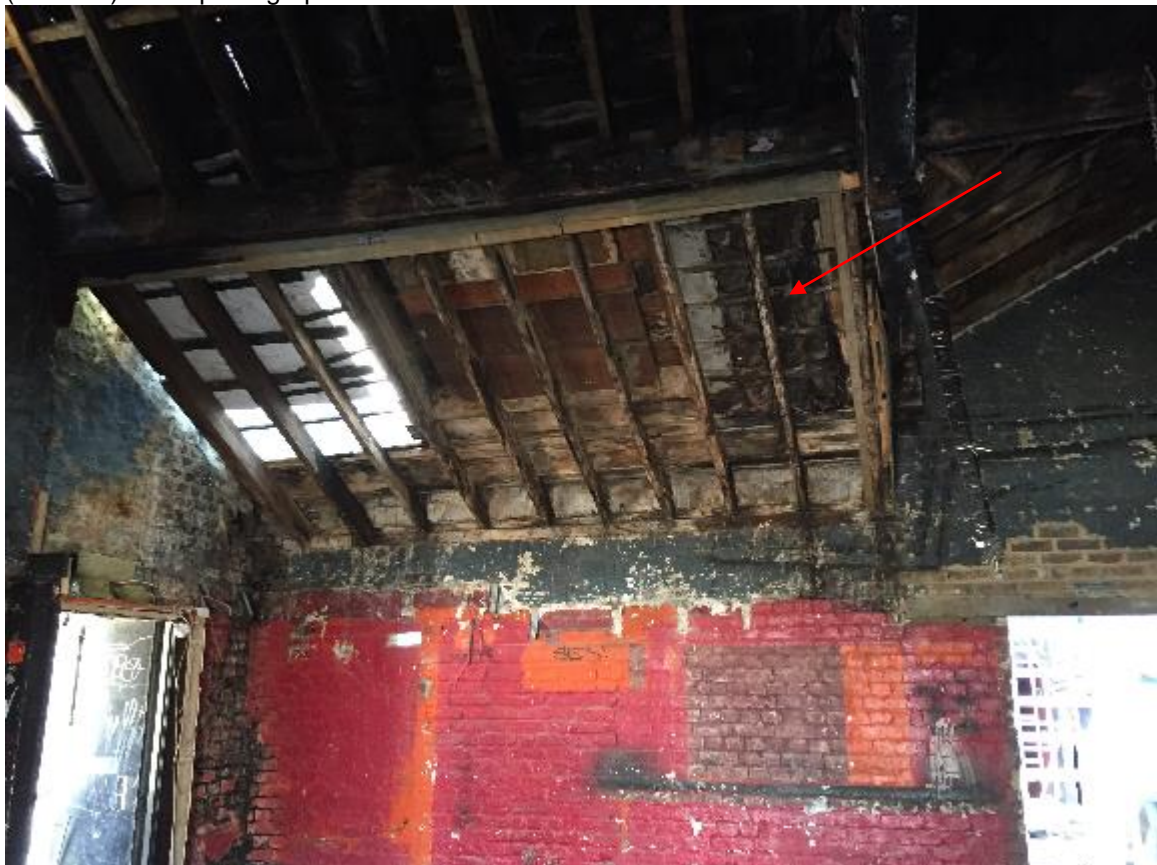
Photograph 2: General view of the roof at the rear of the smithy looking towards the Denmark Place elevation. The photograph clearly shows that the roof has undergone many interventions with some comparatively recent as can be seen from the paler coloured timber frame just below the ridge (arrowed). This has been installed to support a lighting rig when the smithy was the former 12 Bar music venue.

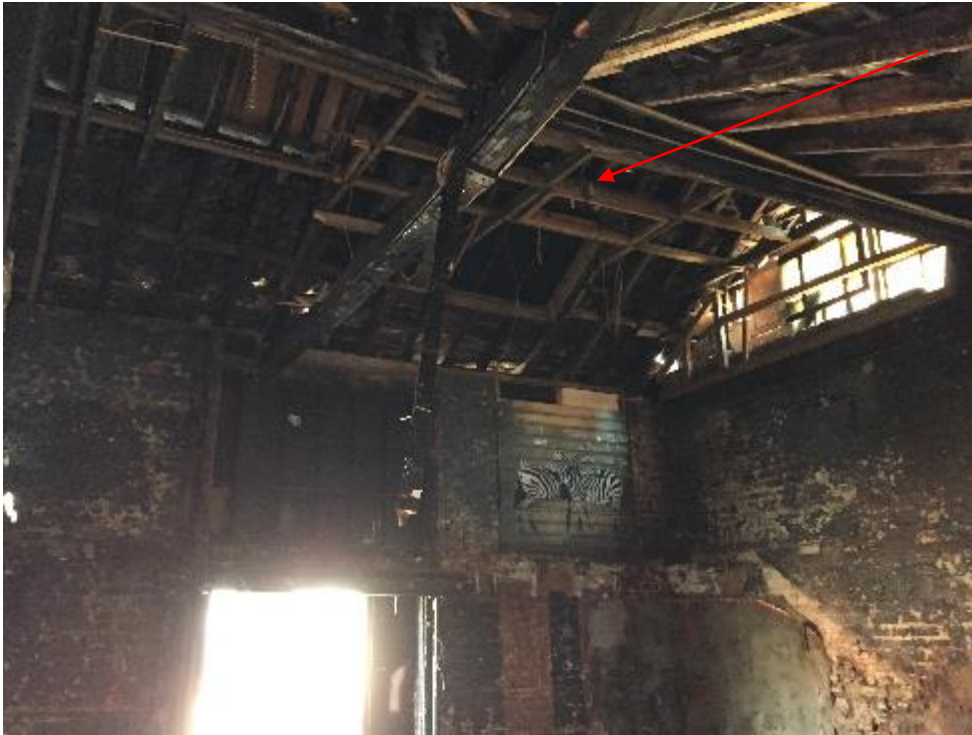
Photograph 3: General appearance of the roof facing the west elevation. The common rafters were in good condition although there was evidence of superficial chemical attack resulting in surface softening.

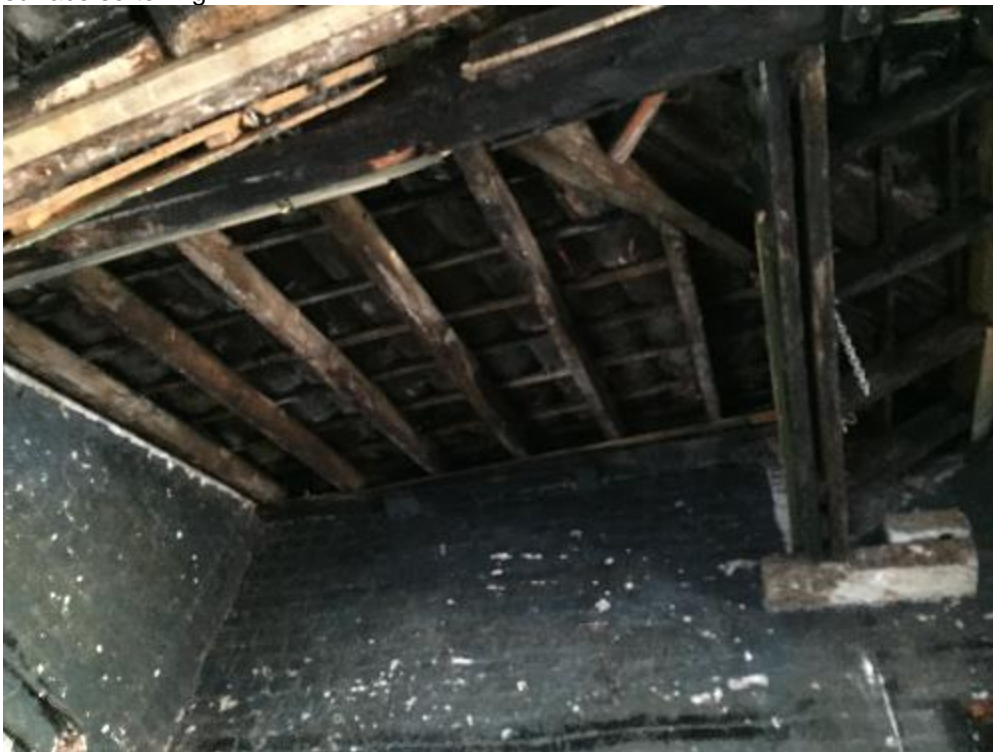
Photograph 4: General view of the ridge of the roof. The photograph clearly shows that the roof has undergone many interventions with some comparatively recent as can be seen from the paler coloured timber frame intervention just below the ridge. This has been installed to support a rig when the smithy was the former 12 Bar music venue. Also note the use of plastic sheet materials as a roofing material (arrowed).

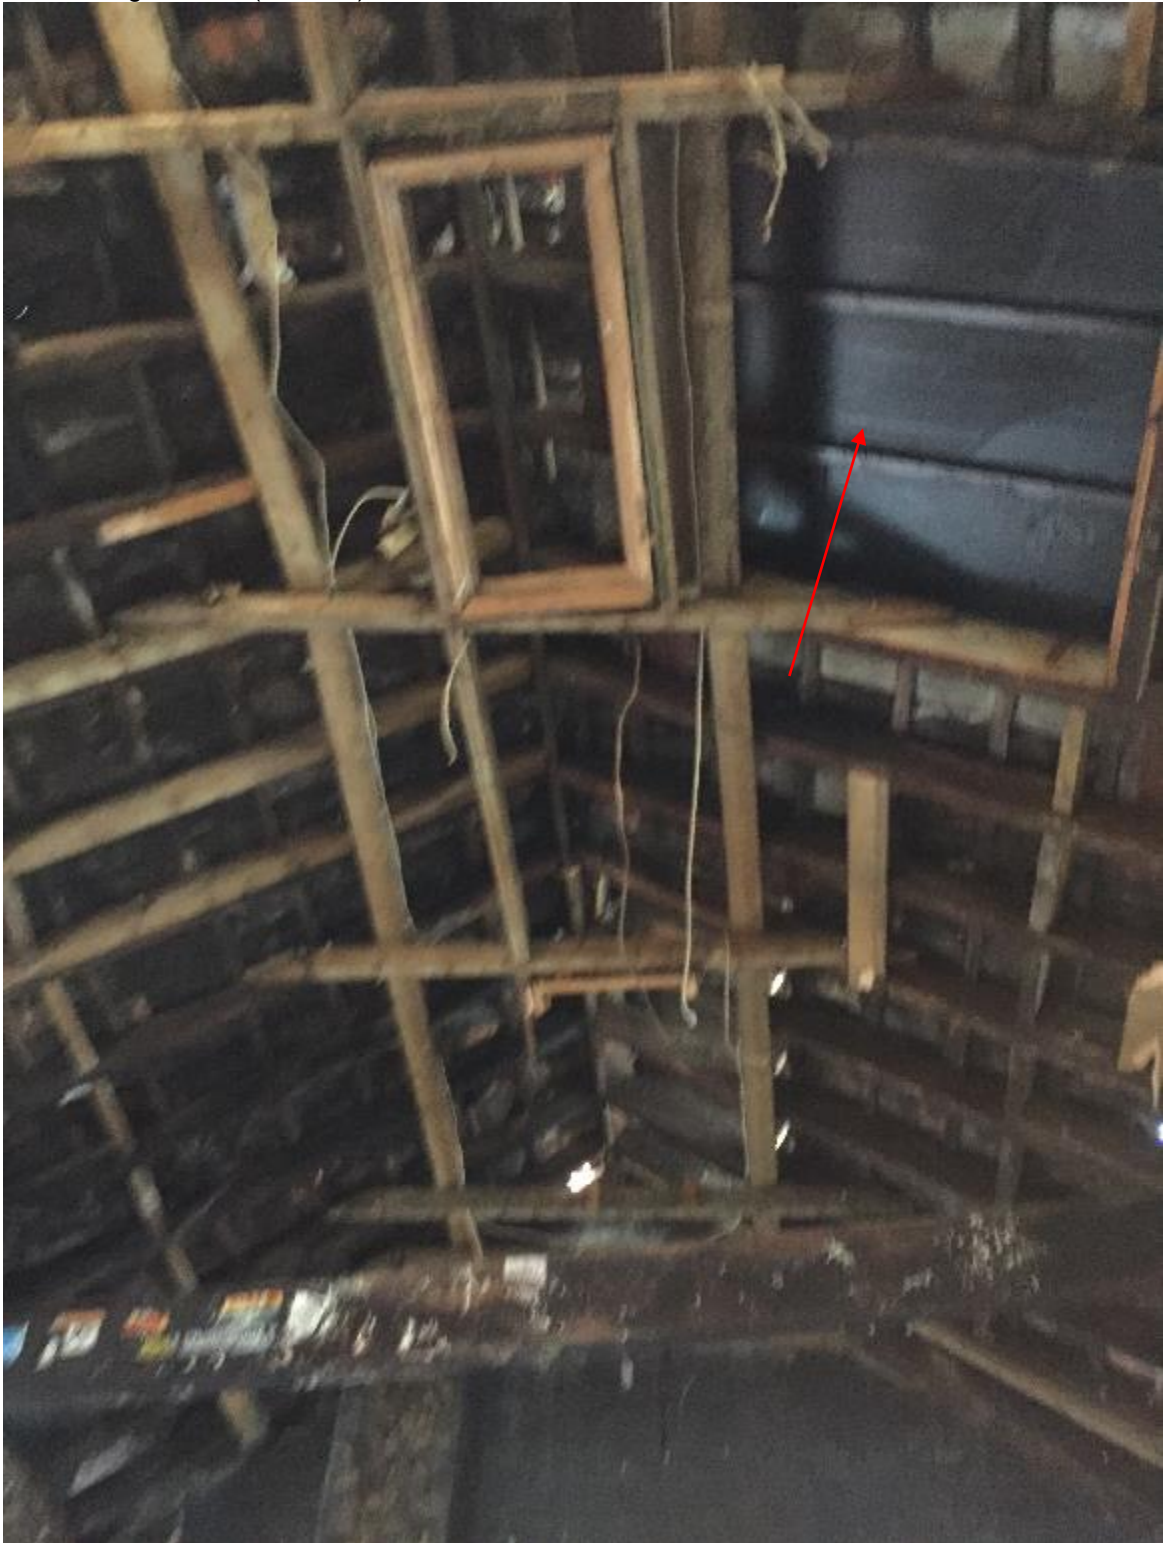
Photograph 5: General example of localised repair to a common rafter. Note the addition of new, pressure treated green colour timber – yellow arrow) alongside the original common rafter. The photograph also shows the extent of deterioration of the sarking boards. This surface softening was consistent with defibrillation of the outer timber layers (arrowed), probably as a consequence of exposure to atmospheric pollutants from the smith forge.

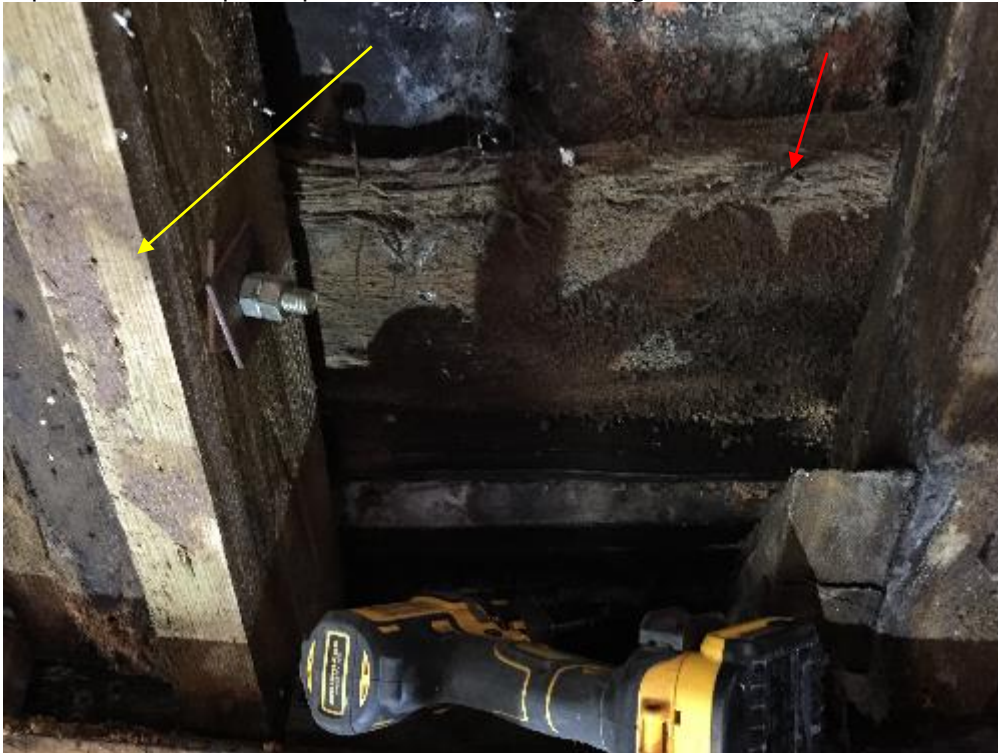
Photograph 6: General appearance of the common rafters along the rear elevation (facing Denmark Place) of the smithy. The rafters are supported by a timber wall plate. This photograph illustrate typical surface erosion of the common rafters (arrowed).

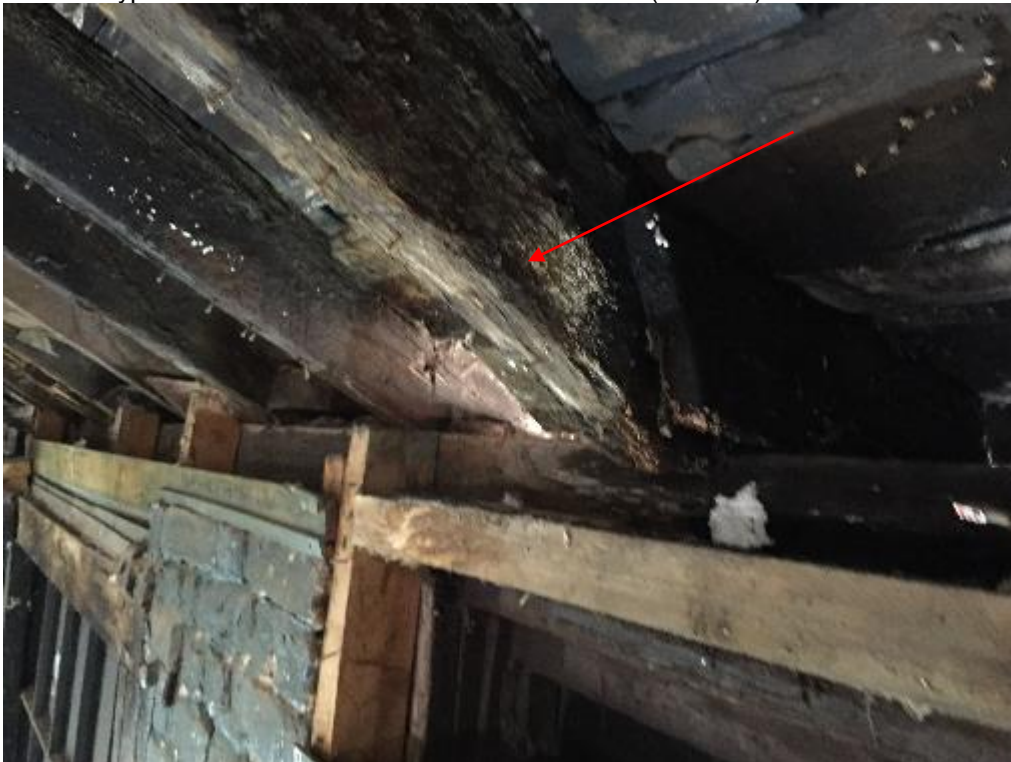
Photograph 7: Example of excessive notching (arrowed) observed on a number of the common rafters which affected indicative visual strength grade. Also note the chemical attack in the surface of the common rafter resulting in a woolly appearance caused by defibrillation of the outer layer of timber (arrowed).
