Report addendum

Timber condition survey of The Smithy, No. 23 Denmark Place

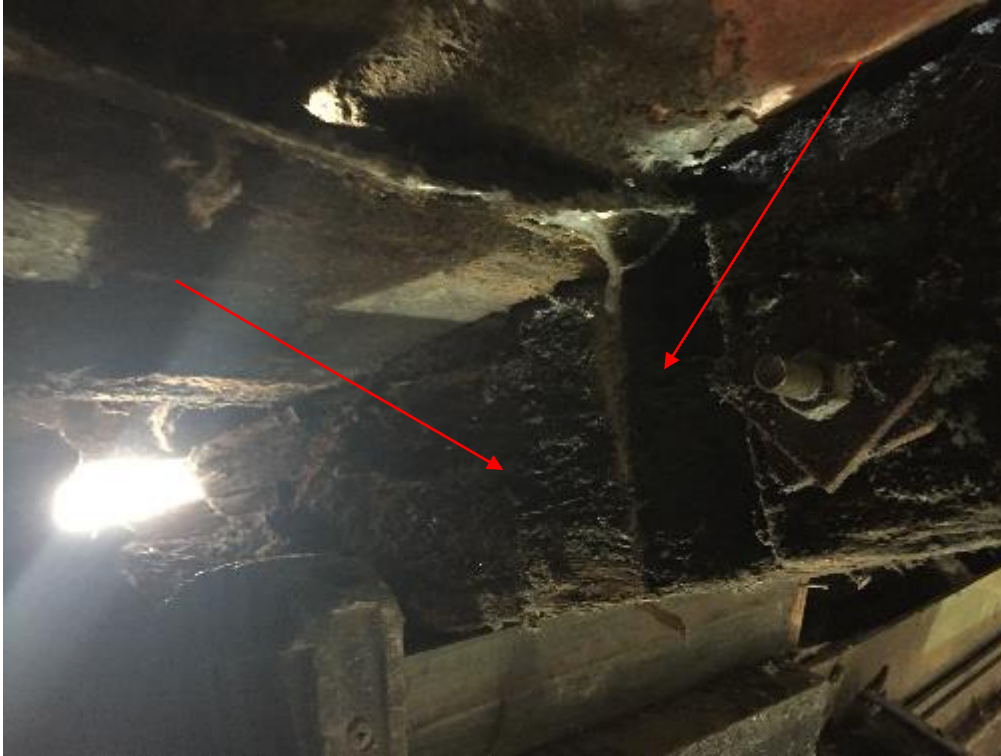
Photograph 8: Close up view of the front elevation of the smithy (Denmark Street) illustrating the common rafters bearing onto a timber wall plate. Also note the severe decay in the roofing battens (arrowed) and evidence of localised repair to a decayed rafter (arrowed).

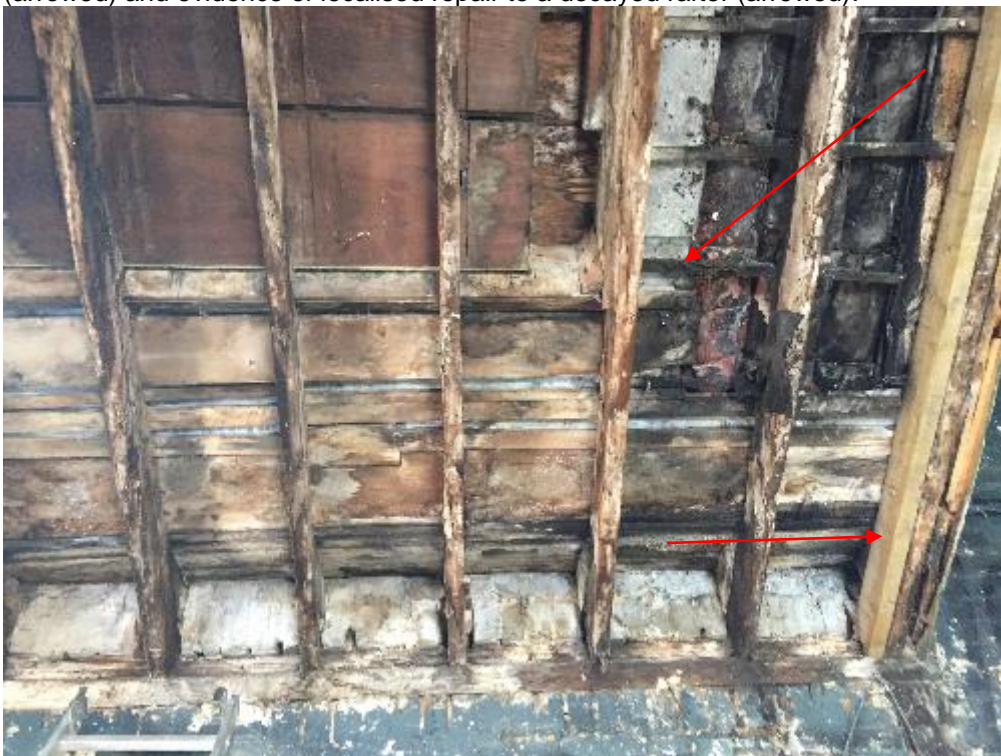
Photograph 9: Construction of the roof along the east elevation of the smithy. Also note the rooflight has been subject to many interventions and is in poor condition.

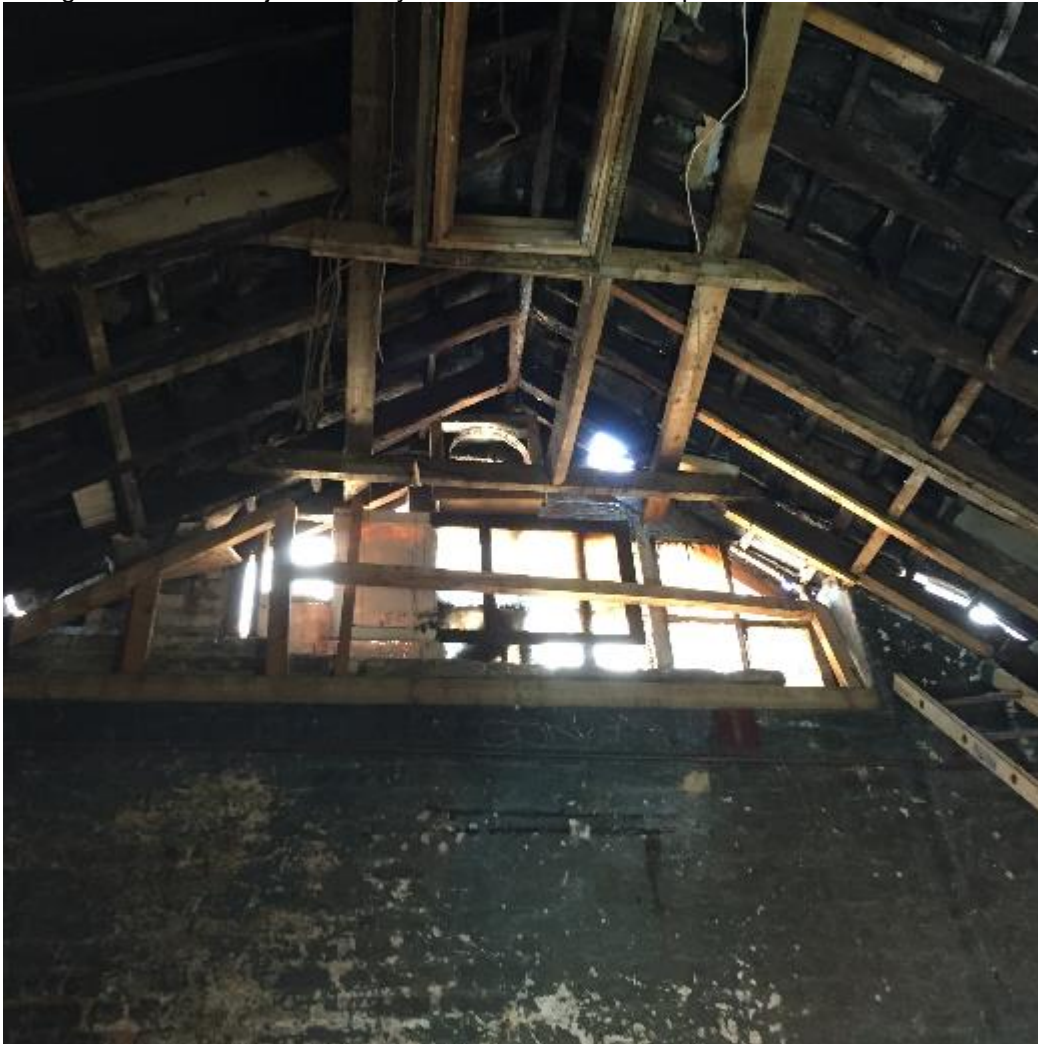
6.2 Detailed observations
