CONSULTING STRUCTURAL ENGINEERS

**Basement Impact Assessment  
Stages 1 and 2  
15 Park Village West  
London**

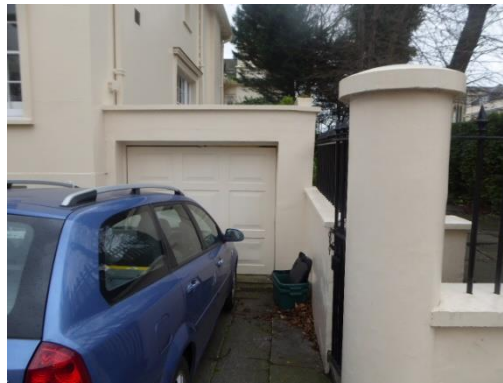
Photograph No.1

The garage is situated on the western side of the property with the front access being off Park Village West with the garage slab level being 0.3m below the road level which results in a very gentle slope on the driveway as shown on photograph No.1

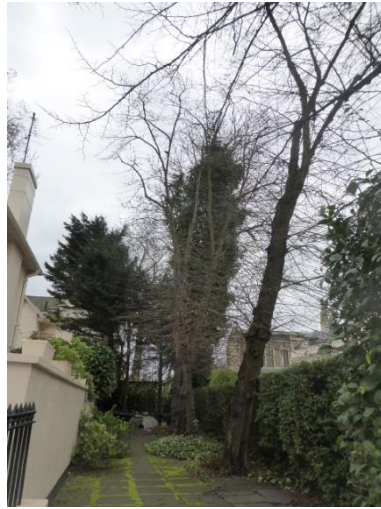
Photograph No.2

On the western side there is a raised terrace area where the level of the terrace is 0.84m above the garage floor level and at the rear southern side the terrace steps up so that it is 1.29m above. It should also be noted that the lower ground floor level of the main house is 1.0m below the garage floor and there is a set of internal steps to gain access. The cross section below, taken from the Cadplan survey drawing 8454-08, shows the relevant levels. A view of the raised terrace is shown on photograph No. 2

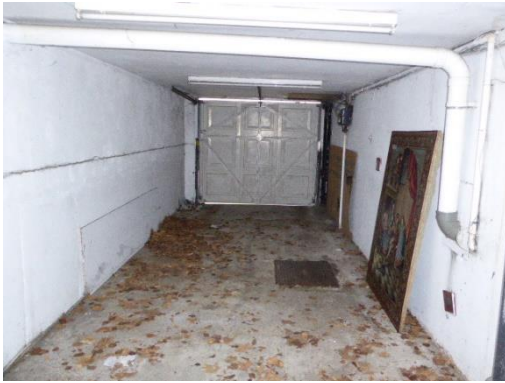
Photograph No.3

The lower part of the wall on the western side is cast instiu reinforced concrete and then there is a masonry wall above on the no retaining section. There is clear evidence internally that there has been displacement at the junction between the two forms of construction. This can be seen from the step in the wall as shown in general on photograph no. 3, in detail on photograph 4 and the pulling of the flat roof joists in photograph No 5. Externally there is evidence of cracking at the junction with the front wall as shown on photograph No. 6

The garage works involve taking down the existing western wall, which has evidence of previous structural movement, and rebuilding it 0.6m to the west. The proposal is shown below on an extract from the architects drawing PL07 Section AA

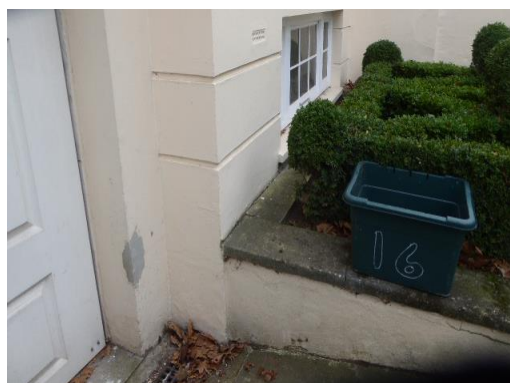
Photograph No.7

These are to be located in the area outside the northern front windows as shown on photograph No. 7

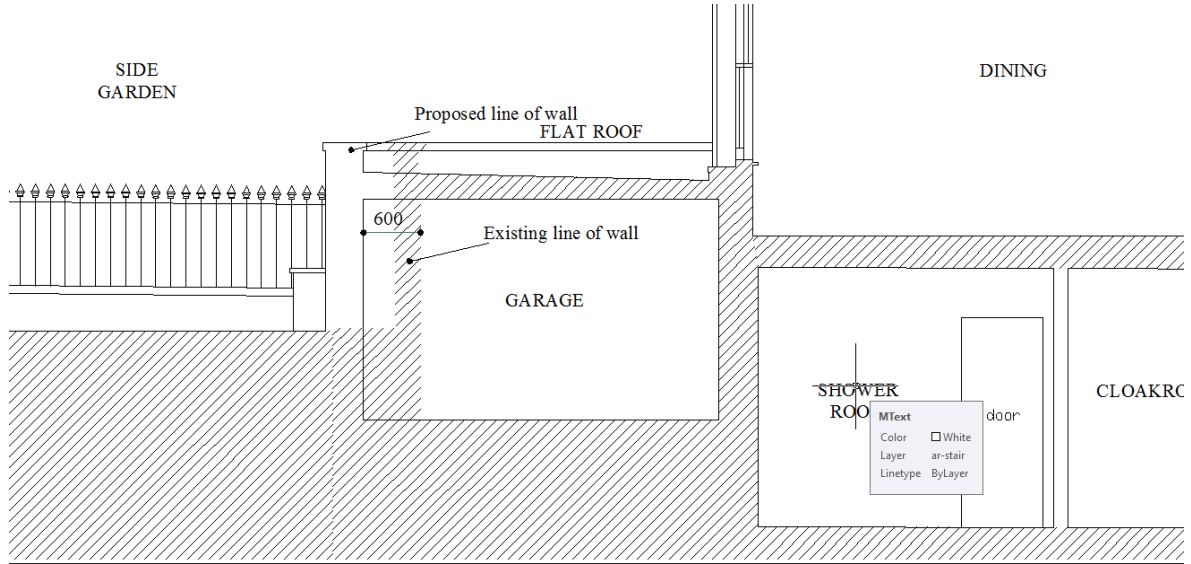
Trial holes have shown that this extension is within the zone of previously excavated material for both the original construction and a later land drain. The level of the garage floor slab is not being altered and is 1.0m above the lower ground floor of the existing house and therefore will have no influence on the existing foundations. The level of the garage is only 0.3m below the road level and it is considered the terrace to the west has been built up and therefore the garage is not a significant subterranean structure.

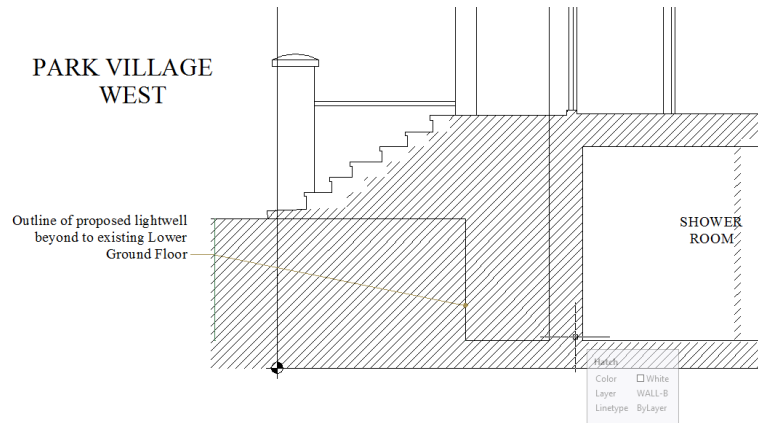
The light wells are immediately adjacent to the existing property and do not extend below the existing level of the lower ground floor as shown below on the extract from the architects proposed section.

The construction will be through previously disturbed ground due to the fact that it will have been excavated and backfilled to construct the original building. As the level of the existing building is not being altered then there will no impact on the existing and neighbouring structures. The increase in hard surfacing is only 2% which will have no significant impact on the existing drainage system and can be accommodated by use of a local soakaway or a small reduction in the existing hard landscaping to provide compensation.
