2016061/RT/
6th June 2016

10 ROCHESTER SQUARE, LONDON NW1 – EXISTING TREE

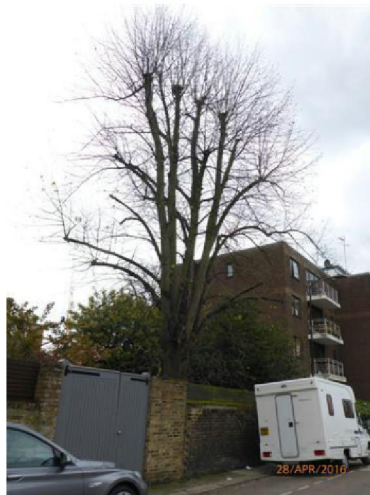
The tree in question is a lime tree, approximately 12m tall, directly adjacent to the eastern boundary of the site, close to the north east corner. We also understand the tree is under a Tree Protection Order. Crown Consultants, the arboreacultural consultants, have stated in their email report of 31st May 2016 that the tree is diseased at present and has also been previously pollarded severely in its upper reaches. Please see photograph below.

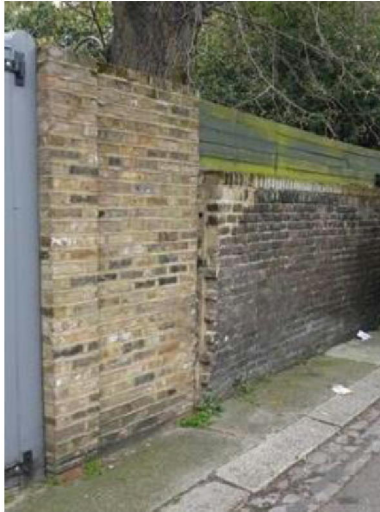
The principal structural issue is the proximity of the tree to the boundary wall of the site and its effect on that wall. The existing wall is Victorian stock brickwork, most probably in lime mortar with a shallow brick corbelled foundation on the local bearing strata, which is likely to be clay. The existing wall is now significantly out of plumb, as shown below.

It appears the existing foundation has rotated and moved eastwards such that the wall above ground has moved approximately 100mm to the east at ground level then approximately 200mm to the east at the top of the wall. We believe this distortion is due to the growth of the lime tree, both in its roots and the increased volume of the trunk above ground. There is a horizontal force the growing tree would have applied to the wall and foundation but additionally the water demand of the tree would have caused volume changes in any clay bearing strata. This would cause additional movement of the foundation which has exacerbated the above ground movement.

The existing wall is typically 225mm thick so the degree of horizontal movement that has occurred means the wall is structurally unstable. There is therefore a tangible risk the existing wall could collapse due to the actions of the tree. That collapse would occur to the east, onto the public pavement along that boundary of the site. The existing wall could be rebuilt on new foundations but the volume and proximity of the lime tree would make this work unfeasibly extensive. In order to minimise the risk of collapse of the wall into public space, we suggest the tree should be removed for structural reasons. Once removed a new boundary wall could be rebuilt if required. Additionally, until the removal of the tree, we recommend the wall is either taken down or horizontally propped to prevent collapse.
