**Flat 2, 32 Lambs Conduit Street, London WC1N 3LE.**

**Design and Access Statement to support listed building consent  
Application ref: PP-05232063**

**Proposal:** Repair five sash windows and frames.

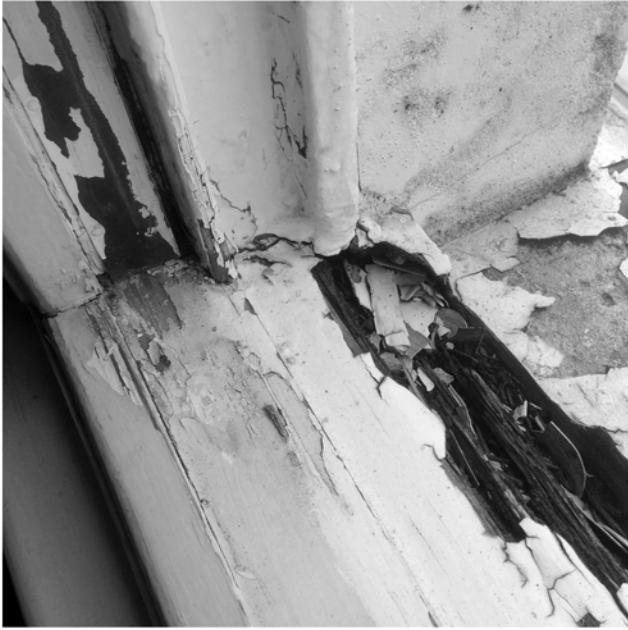
The lower parts of the windows have significant areas of rotten timber due to the long term effect of rainwater. The lower edges are completely rotten in some places and the wood has separated from the frame leaving gaps between glass and frame. Exterior paintwork is significantly peeling and cracking. (Please see reference photos below.) The connection between sash windows and frames is quite loose everywhere thus creating significant heat loss.

3rd Floor bedroom 1 window damage / rotten timber

Repair where possible damaged timber, beading, cords and weights. Replace damaged timber with new wood and complete frames if necessary. Repaint all windows and frames, interior and exterior. Add 'brush' strips where possible and improve any other features that might reduce heat loss.

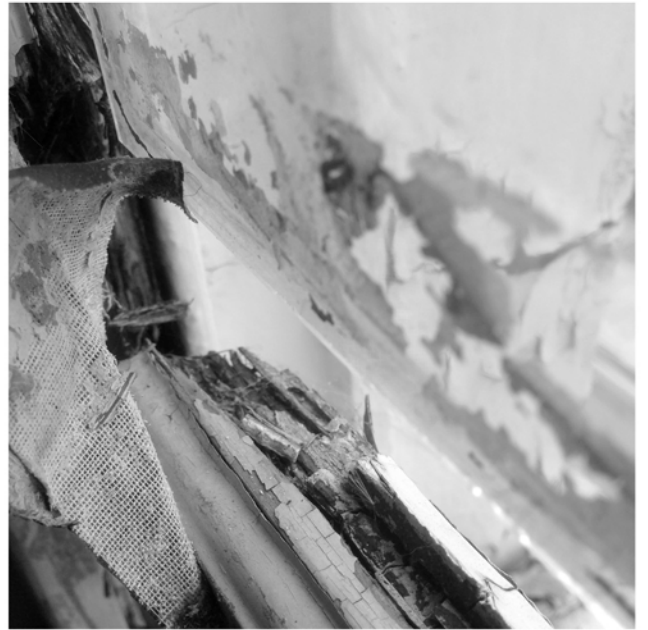
3rd Floor bedroom 2 window damage / rotten timber

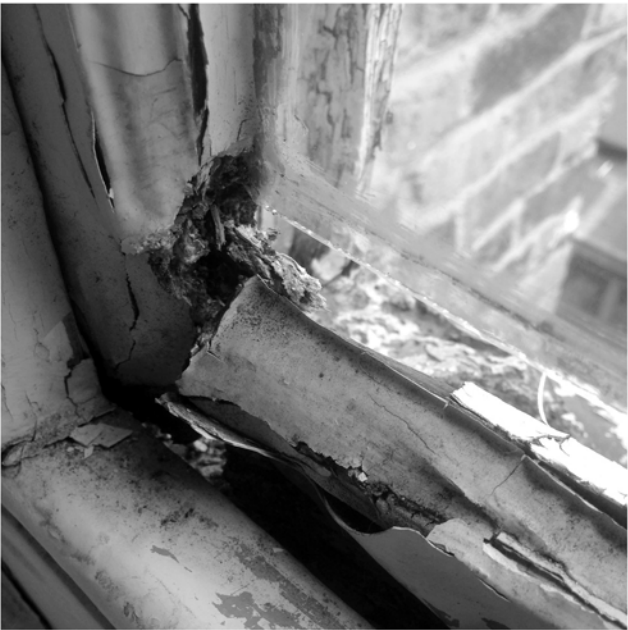
Stairs / Landing Window damage / rotten timber

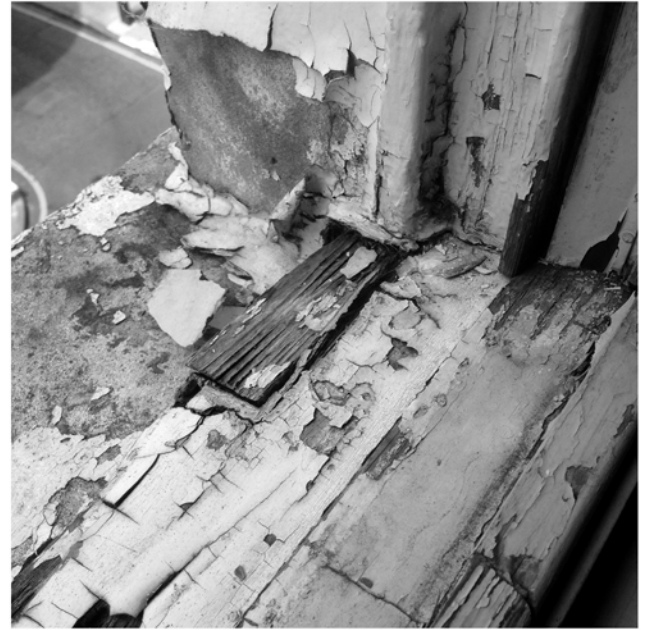
2nd Floor lounge window damage / rotten timber
