9.1 Demolition Asbestos Survey, Vezey Wing (2015)

Demolition Asbestos Survey

National Temperance Hospital (Vezey-Strong Wing)
London NW1

RSK Report Number: 415000-2 (00)

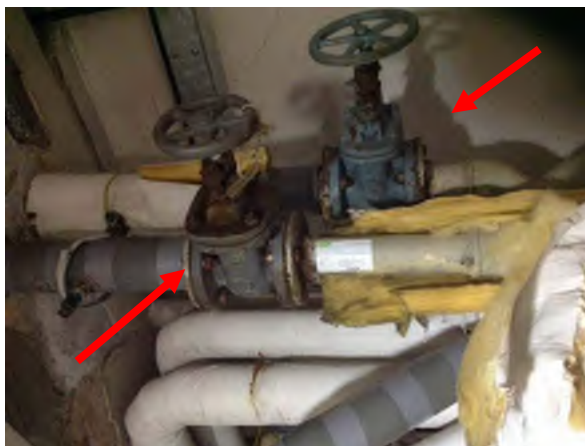
Building	Vezey-Strong wing
Floor	Basement
Room	306
Item Description	Gasket to pipework
Material Type	Gaskets/Washers
Sample Number	27076
Asbestos Type	Chrysotile

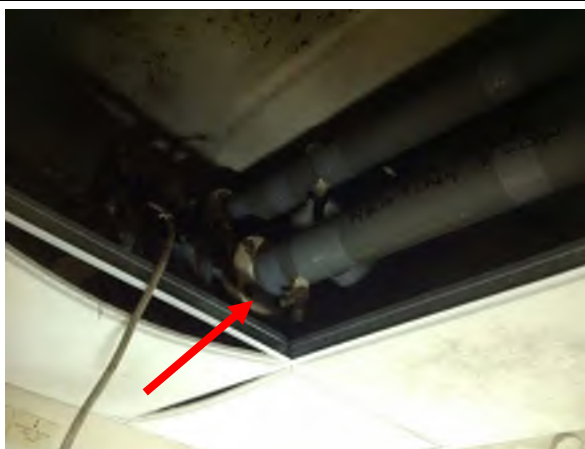
Building	Vezey-Strong wing
Floor	Basement
Room	307
Item Description	Gasket to pipework
Material Type	Gaskets/Washers
Sample Number	Similar to 27076
Asbestos Type	Sp Chrysotile

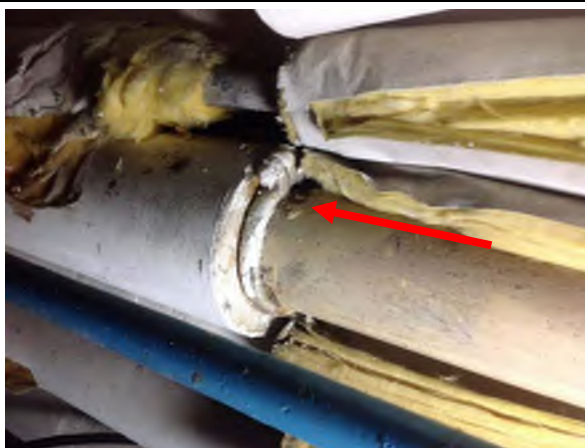
Building	Vezey-Strong wing
Floor	Basement
Room	314
Item Description	Residue to pipework
Material Type	Dust/Debris
Sample Number	27110
Asbestos Type	Chrysotile / Amosite

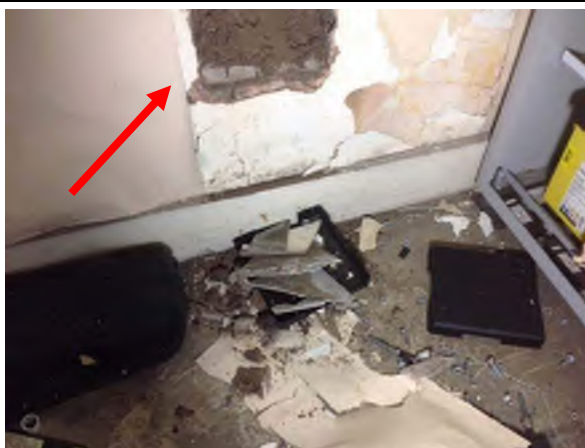
Building	Vezey-Strong wing
Floor	Basement
Room	330
Item Description	Cement vent panel
Material Type	Cement
Sample Number	27087
Asbestos Type	Chrysotile / Crocidolite

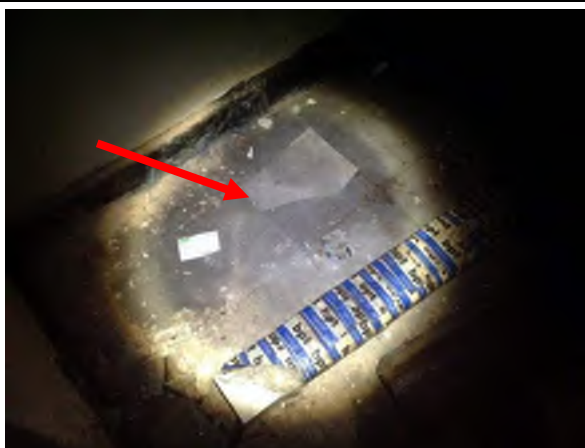
Building	Vezey-Strong wing
Floor	Basement
Room	341
Item Description	Grey vinyl floor tile
Material Type	Floor Tile & Mastic
Sample Number	27091
Asbestos Type	Chrysotile (Floor Tile Only)

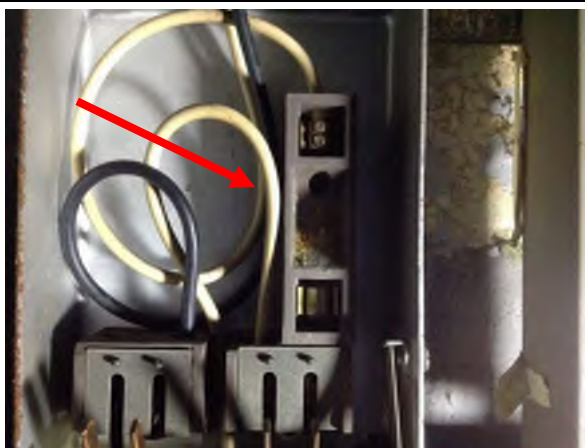
Building	Vezey-Strong wing
Floor	Basement
Room	342
Item Description	Flash guard debris
Material Type	Dust/Debris
Sample Number	27095
Asbestos Type	Chrysotile

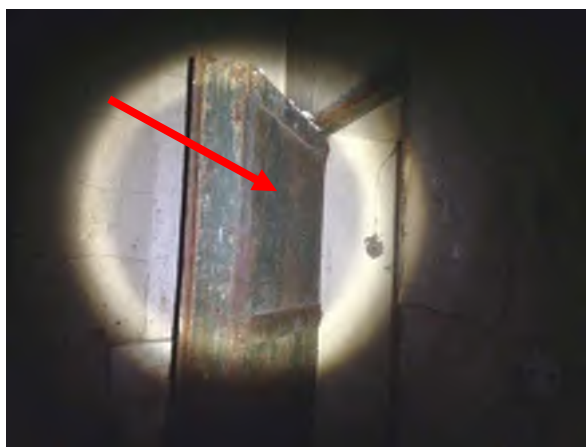
Building	Vezey-Strong wing
Floor	Basement
Room	376
Item Description	Safe
Material Type	-
Sample Number	-
Asbestos Type	Default Presumption

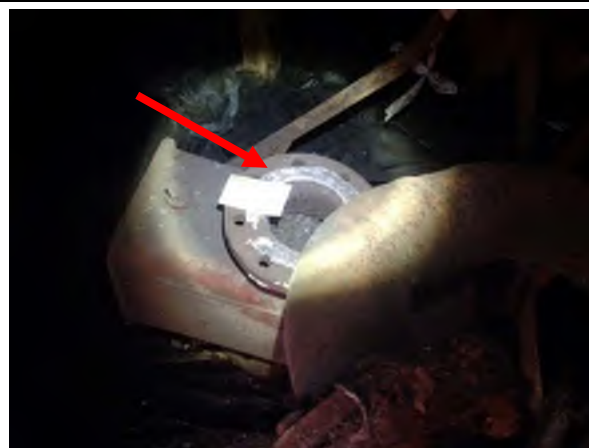
Building	Vezey-Strong wing
Floor	Basement
Room	382
Item Description	Gasket to pipe flanges
Material Type	Gaskets/Washers
Sample Number	27102
Asbestos Type	Chrysotile

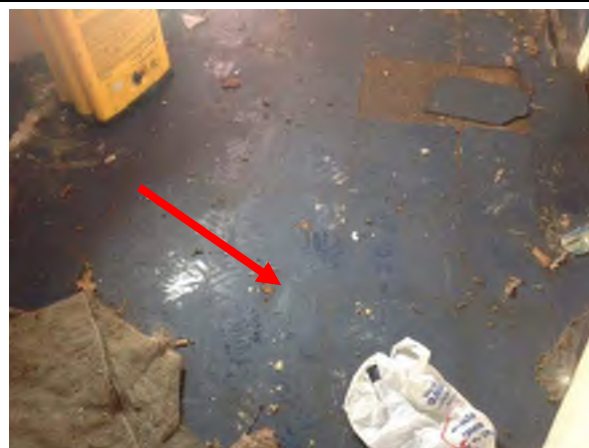
Building	Vezey-Strong wing
Floor	Basement
Room	387
Item Description	Blue vinyl floor tile
Material Type	Floor Tile / Vinyl
Sample Number	Similar to 27105
Asbestos Type	Sp Chrysotile

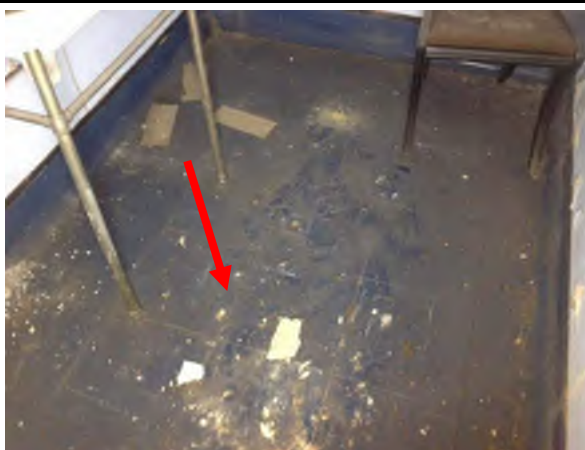
Building	Vezey-Strong wing
Floor	Basement
Room	389
Item Description	Blue vinyl floor tile
Material Type	Floor Tile / Vinyl
Sample Number	Similar to 27105
Asbestos Type	Sp Chrysotile

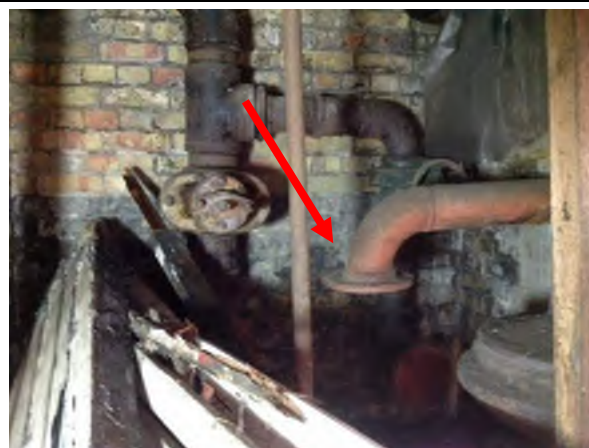
Building	Vezey-Strong wing
Floor	Basement
Room	Exterior
Item Description	Gasket to pipe flanges
Material Type	Gaskets/Washers
Sample Number	Similar to 27102
Asbestos Type	Sp Chrysotile

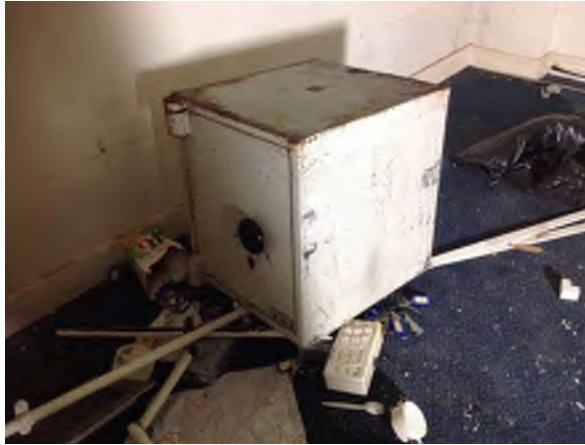
Building	Vezey-Strong wing
Floor	Ground
Room	245
Item Description	Security Safe
Material Type	-
Sample Number	-
Asbestos Type	Default Presumption

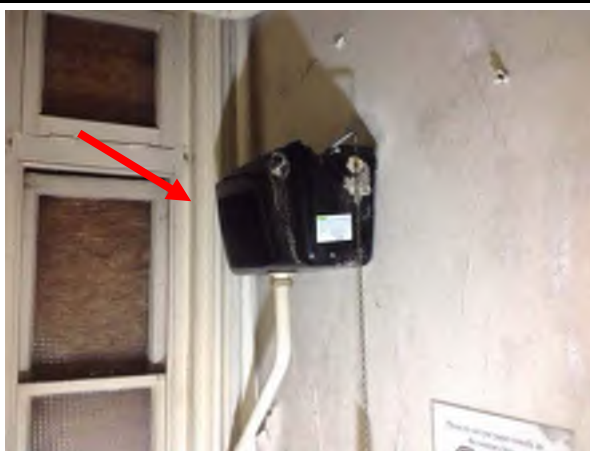
Building	Vezey-Strong wing
Floor	Ground
Room	262
Item Description	Toilet cistern
Material Type	Composite
Sample Number	27068
Asbestos Type	Amosite

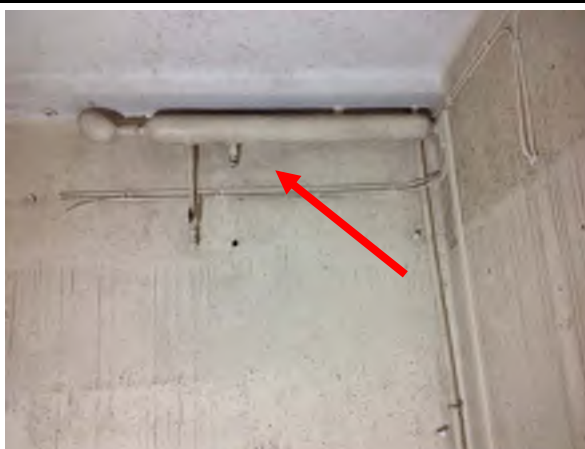
Building	Vezey-Strong wing
Floor	First
Room	175
Item Description	Pipe insulation
Material Type	Thermal Insulation/Lagging
Sample Number	Similar to 27057
Asbestos Type	Sp Chrysotile

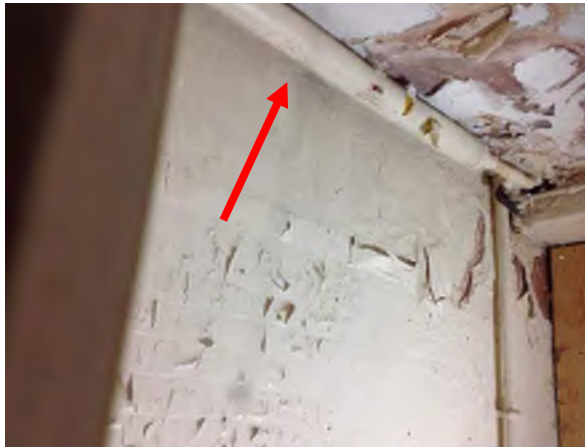
Building	Vezey-Strong wing
Floor	First
Room	178
Item Description	Pipe insulation
Material Type	Thermal Insulation/Lagging
Sample Number	Similar to 27057
Asbestos Type	Sp Chrysotile

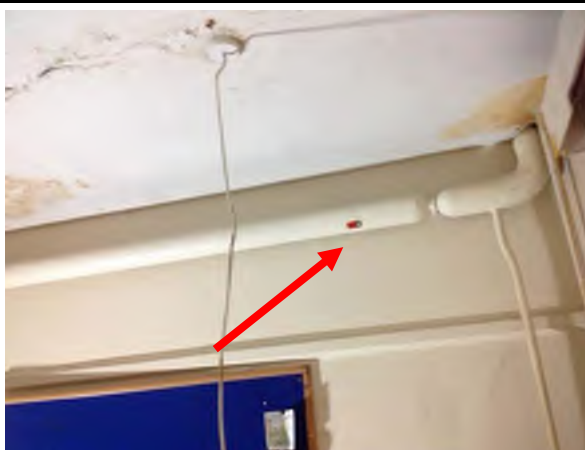
Building	Vezey-Strong wing
Floor	First
Room	185
Item Description	Pipe insulation
Material Type	Thermal Insulation/Lagging
Sample Number	Similar to 27057
Asbestos Type	Sp Chrysotile

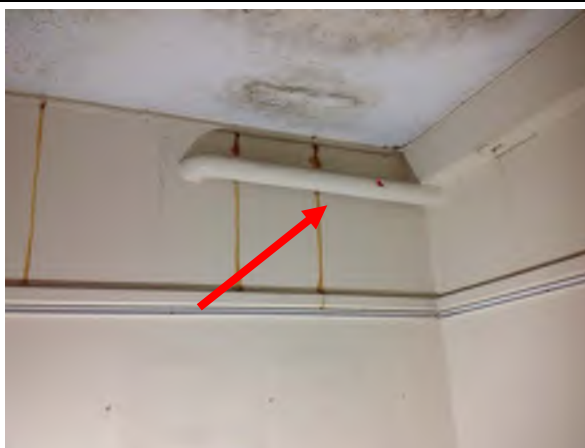
Building	Vezey-Strong wing
Floor	First
Room	186
Item Description	Pipe insulation
Material Type	Thermal Insulation/Lagging
Sample Number	Similar to 27057
Asbestos Type	Sp Chrysotile

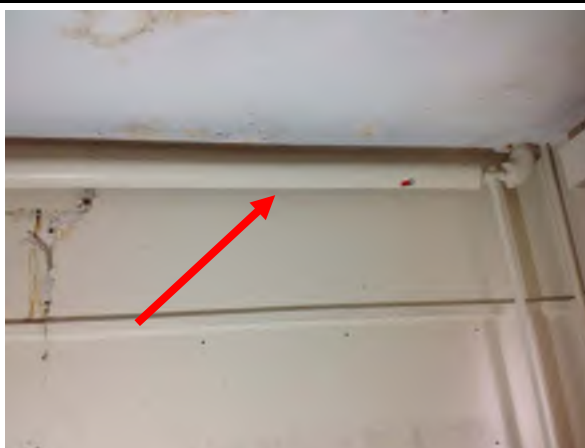
Building	Vezey-Strong wing
Floor	First
Room	187
Item Description	Pipe insulation
Material Type	Thermal Insulation/Lagging
Sample Number	Similar to 27057
Asbestos Type	Sp Chrysotile

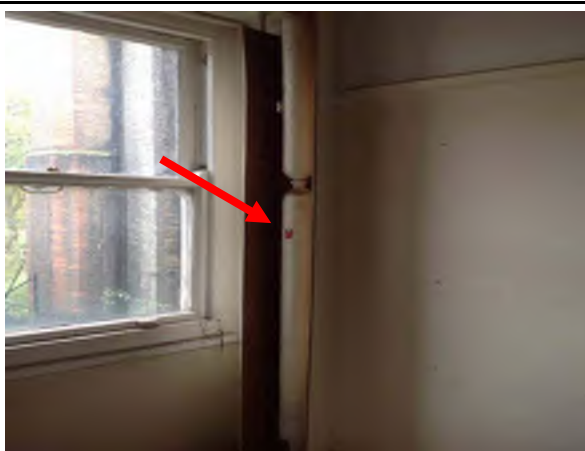
Building	Vezey-Strong wing
Floor	2 nd floor Mezzanine
Room	216
Item Description	Pipe insulation
Material Type	Thermal Insulation/Lagging
Sample Number	Similar to 27063
Asbestos Type	SpChrysotile

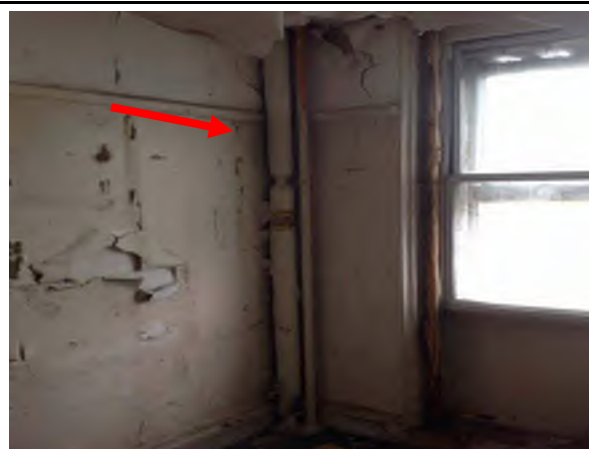
Building	Vezey-Strong wing
Floor	2 nd floor Mezzanine
Room	222
Item Description	Pipe insulation
Material Type	Thermal Insulation/Lagging
Sample Number	Similar to 27063
Asbestos Type	Sp Chrysotile

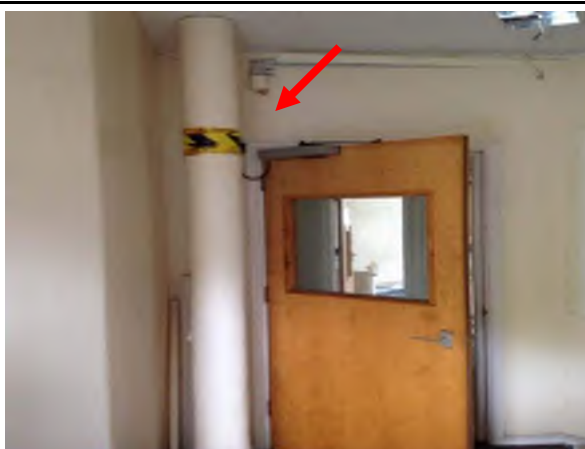
Building	Vezey-Strong wing
Floor	2 nd floor Mezzanine
Room	227
Item Description	Pipe insulation
Material Type	Thermal Insulation/Lagging
Sample Number	Similar to 27063
Asbestos Type	Sp Chrysotile

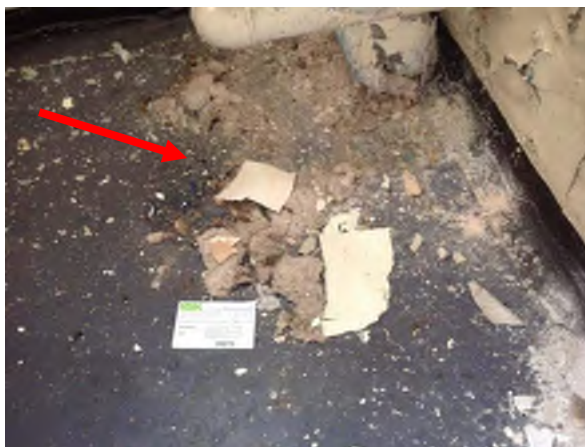
Vezey-Strong wing	Second	074	Pipe lagging debris	Loose Insulation	Chrysotile	25273	Easily disturbed	<1	3	3	3	1	10	Remove Prior to Demolition.	
Vezey-Strong wing	Second	074	Pipe lagging	Thermal Insulation/Lagging	Sp Chrysotile	Similar to 25273	Occasionally disturbed	3 lm	3	3	3	1	10	Remove Prior to Demolition.	
Vezey-Strong wing	Second	074	Pipe lagging	Thermal Insulation/Lagging	Sp Chrysotile	Similar to 25273	Easily disturbed	4.5 lm	3	3	3	1	10	Remove Prior to Demolition.	
Vezey-Strong wing	Second	079	Pipe lagging	Thermal Insulation/Lagging	Sp Chrysotile	Similar to 25273	Easily disturbed	4.5 lm	3	3	3	1	10	Remove Prior to Demolition.	
Vezey-Strong wing	Second	085	Pipe lagging	Thermal Insulation/Lagging	Sp Chrysotile	Similar to 25273	Easily disturbed	10 lm	3	3	3	1	10	Remove Prior to Demolition.	
Vezey-Strong wing	Second	087	Pipe insulation	Thermal Insulation/Lagging	Chrysotile	25277	Easily disturbed	4 lm	3	3	3	1	10	Remove Prior to Demolition.

Building	Vezey-Strong wing
Floor	Second
Room	074
Item Description	Pipe lagging debris
Material Type	Loose Insulation
Sample Number	25273
Asbestos Type	Chrysotile

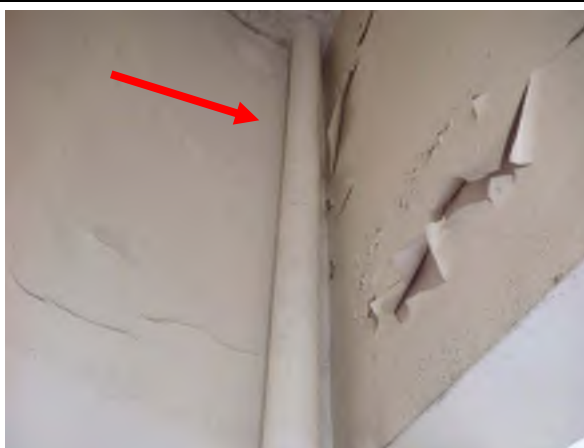
Building	Vezey-Strong wing
Floor	Second
Room	074
Item Description	Pipe lagging
Material Type	Thermal Insulation/Lagging
Sample Number	Similar to 25273
Asbestos Type	Sp Chrysotile

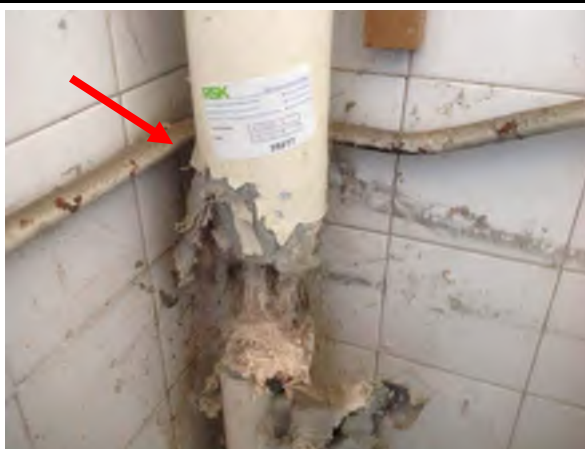
Building	Vezey-Strong wing
Floor	Second
Room	087
Item Description	Pipe insulation
Material Type	Thermal Insulation/Lagging
Sample Number	25277
Asbestos Type	Chrysotile

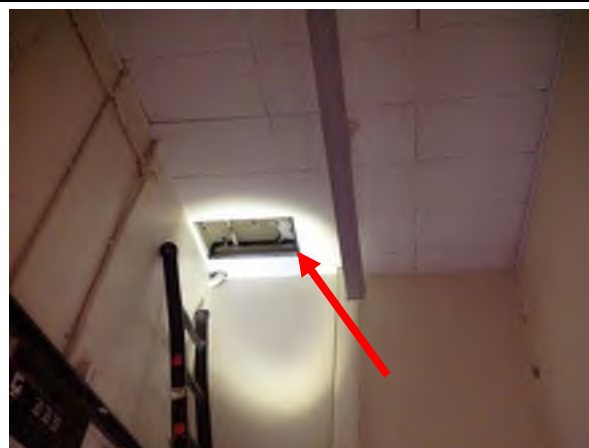
Building	Vezey-Strong wing
Floor	Second
Room	124
Item Description	Pipe insulation
Material Type	Thermal Insulation/Lagging
Sample Number	Similar to 25277
Asbestos Type	Sp Chrysotile

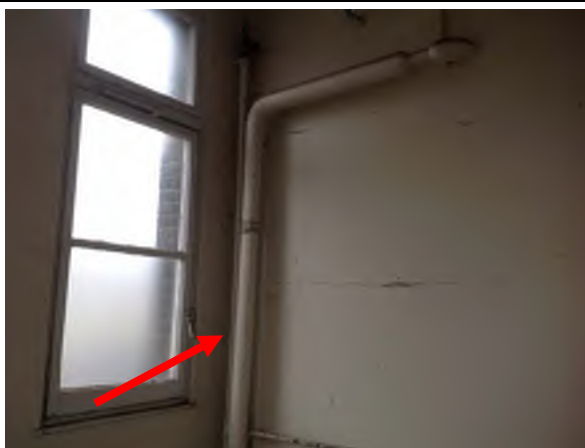
Building	Vezey-Strong wing
Floor	Third
Room	006
Item Description	Pipe insulation
Material Type	Thermal Insulation/Lagging
Sample Number	Similar to 25227
Asbestos Type	Sp Chrysotile

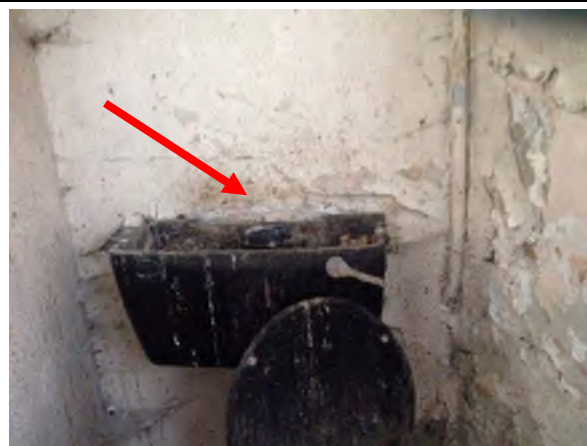
Building	Vezey-Strong wing
Floor	Third
Room	038
Item Description	Toilet cistern
Material Type	Composite
Sample Number	Similar to 25247
Asbestos Type	Sp Amosite

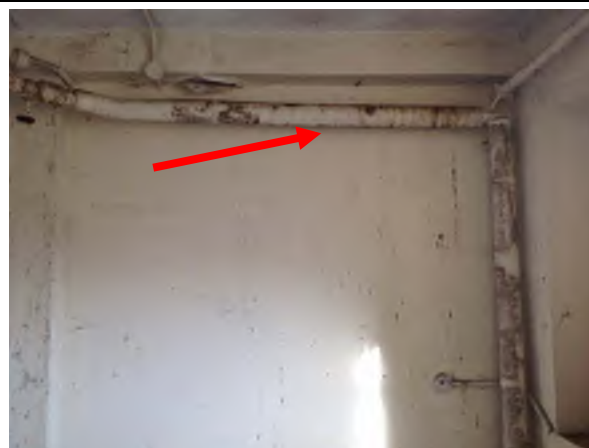
Building	Vezey-Strong wing
Floor	Third
Room	044
Item Description	Pipe insulation
Material Type	Thermal Insulation/Lagging
Sample Number	Similar to 25250
Asbestos Type	Sp Chrysotile

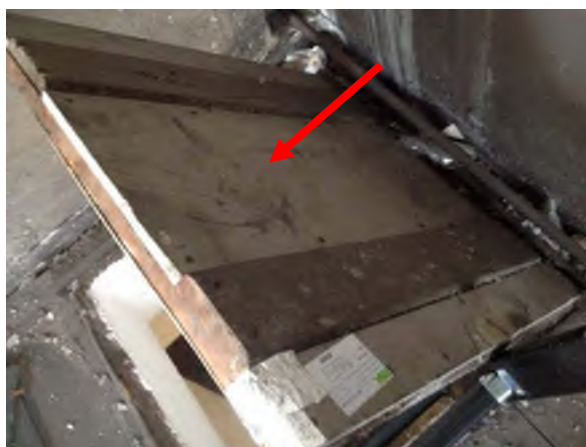
Building	Vezey-Strong wing
Floor	Third
Room	Loft area 9
Item Description	Insulating board panel
Material Type	Insulating Board
Sample Number	25265
Asbestos Type	Chrysotile / Amosite

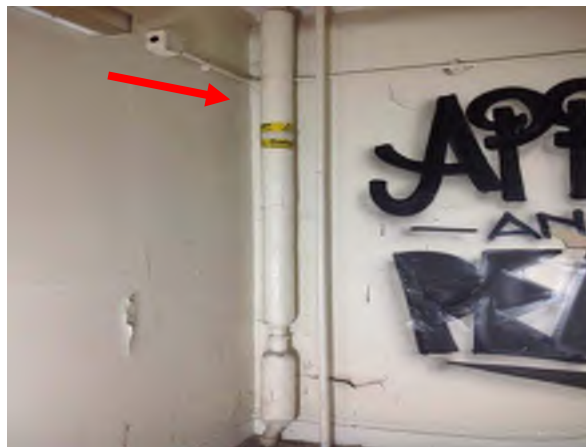
Building	Vezey-Strong wing
Floor	Stairwell
Room	Stairwell 2
Item Description	Pipe insulation
Material Type	Thermal Insulation/Lagging
Sample Number	Similar to 25260
Asbestos Type	Sp Chrysotile

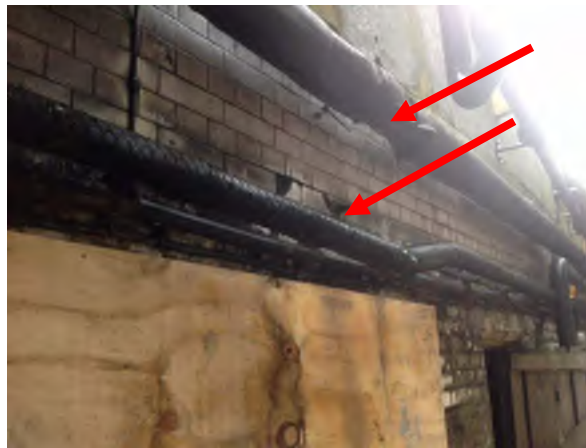
Building	Vezey-Strong wing
Floor	External
Room	Exterior
Item Description	Paper insulation to exterior pipework
Material Type	Thermal Insulation/Lagging
Sample Number	27103
Asbestos Type	Chrysotile

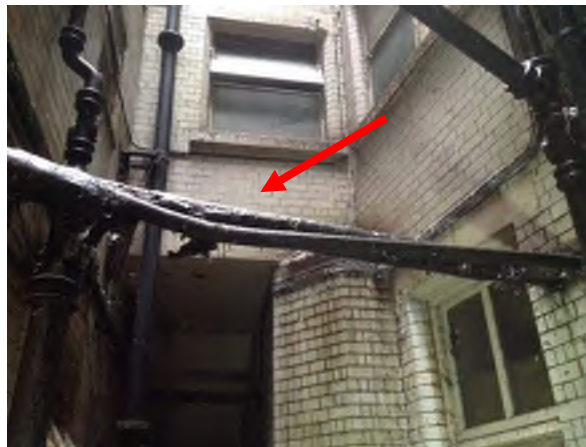
Building	Vezey-Strong wing
Floor	External
Room	Exterior
Item Description	Paper insulation to exterior pipework
Material Type	Thermal Insulation/Lagging
Sample Number	Similar to 27103
Asbestos Type	Sp Chrysotile
