Demolition Asbestos Survey

National Temperance Hospital
Insull Wing

RSK Report Number: 415000-1(00)

16 March 2015

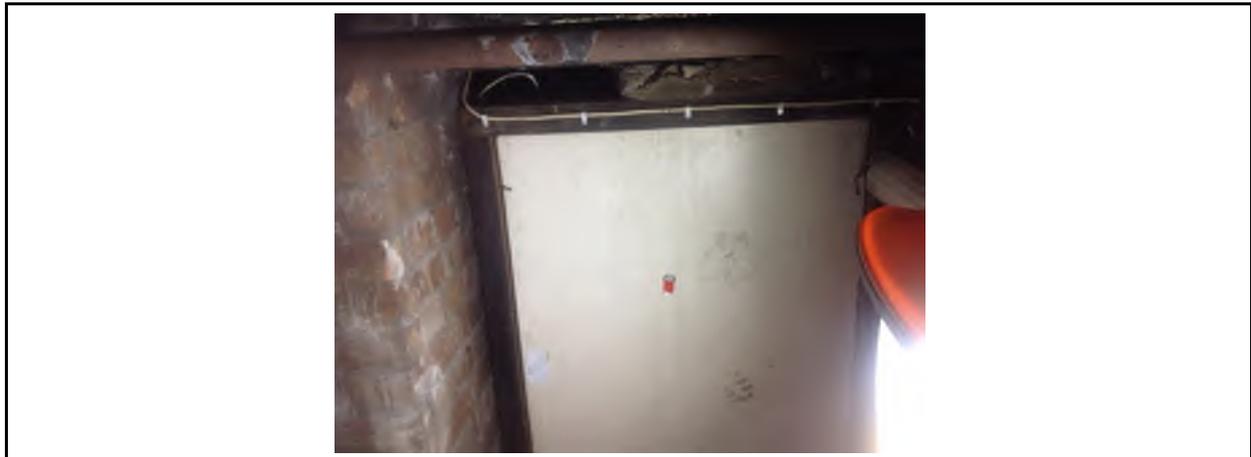
Building	Insull Wing
Floor	Basement
Room	Underground duct
Item Description	Door panel
Material Type	Insulating Board
Sample Number	21763
Asbestos Type	Chrysotile / Amosite

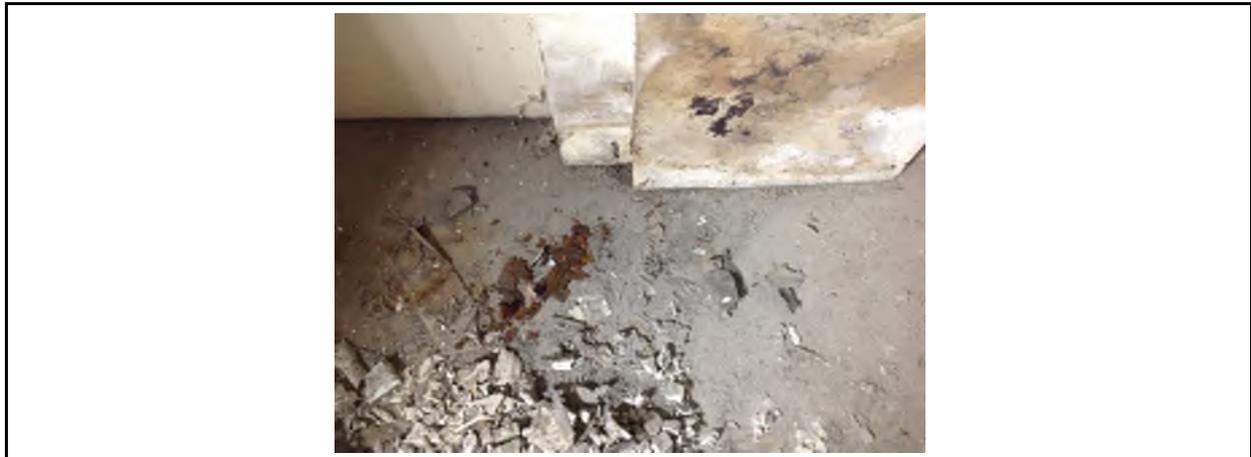
Building	Insull wing
Floor	Basement
Room	022
Item Description	Panel debris to floor
Material Type	Insulation Board
Sample Number	Similar to 21760
Asbestos Type	Chrysotile / Amosite

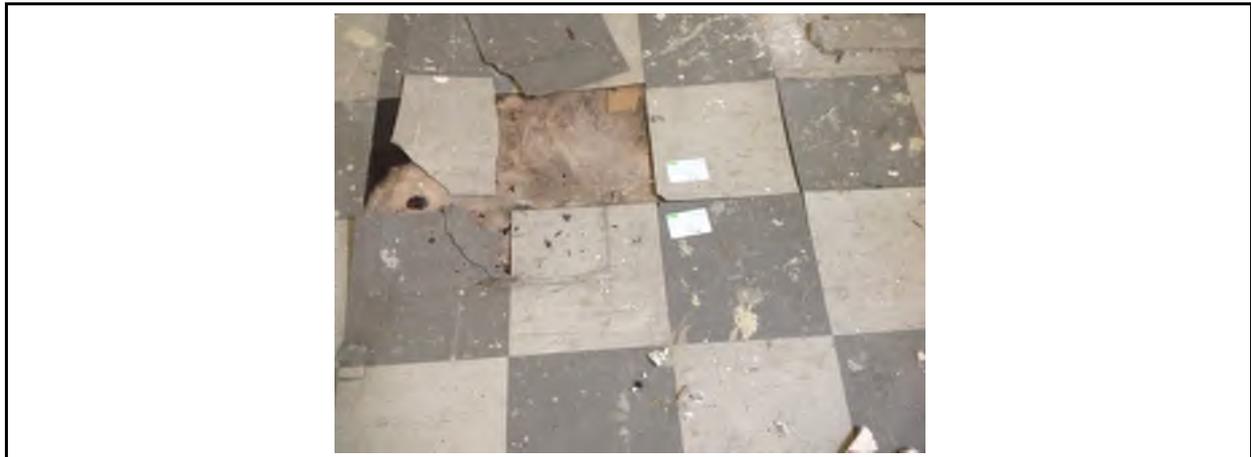
Building	Insull wing
Floor	Basement
Room	011
Item Description	White vinyl floor tile (grey fleck)
Material Type	Floor Tile & Mastic
Sample Number	21747
Asbestos Type	Chrysotile (Floor Tile & Mastic)

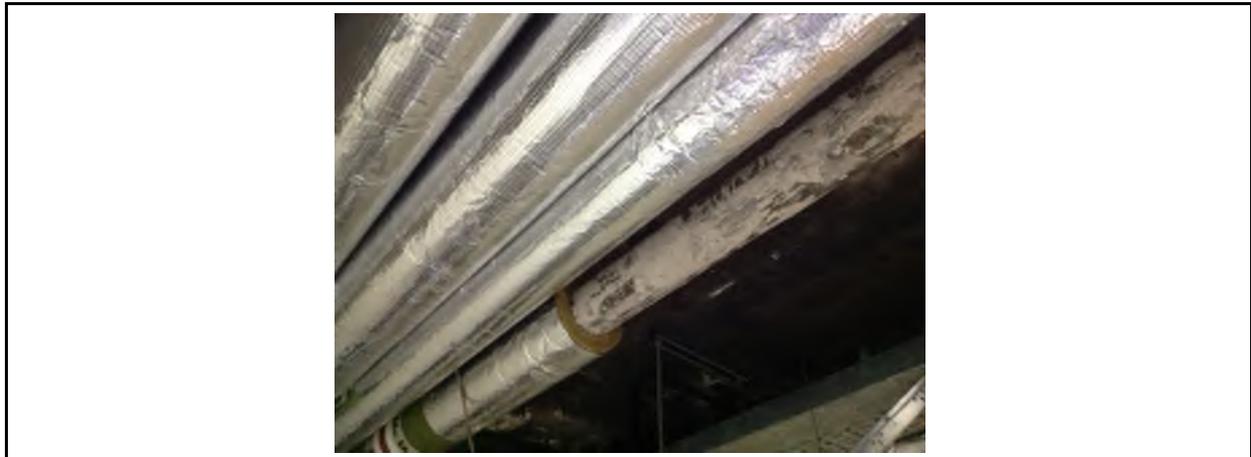
Building	Insull wing
Floor	Basement
Room	015
Item Description	Pipe lagging to entrance corridor to basement
Material Type	Thermal Insulation/Lagging
Sample Number	21751
Asbestos Type	Chrysotile

Access to Basement Room 015 and associated areas should be restricted until the area (including floor) has been fully environmentally cleaned by a licensed asbestos removal contractor (see recommendations for further details)

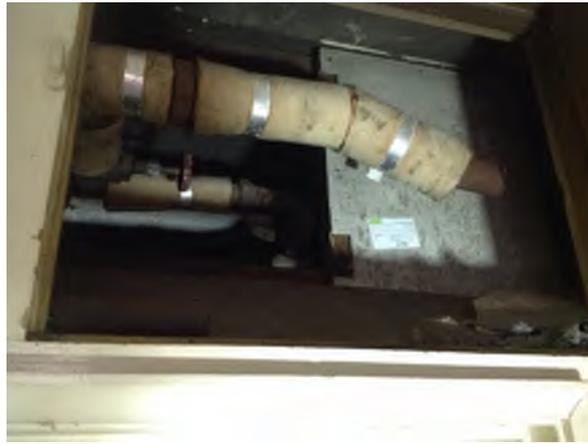
Building	Insull wing
Floor	Basement
Room	021
Item Description	Cement panel in ceiling void
Material Type	Cement
Sample Number	21759
Asbestos Type	Chrysotile

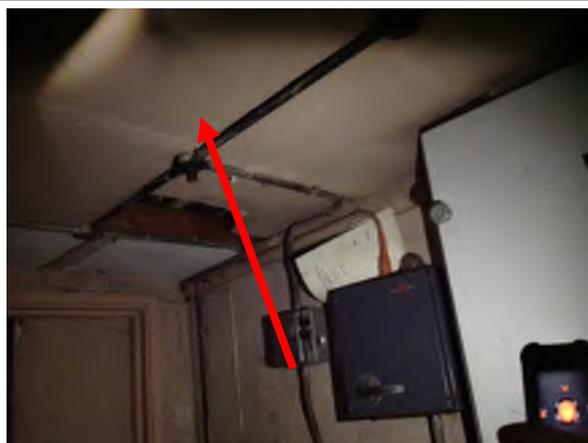
Building	Insull wing
Floor	Basement
Room	Open space 3
Item Description	Board ceiling
Material Type	Insulating Board
Sample Number	21799
Asbestos Type	Chrysotile / Amosite

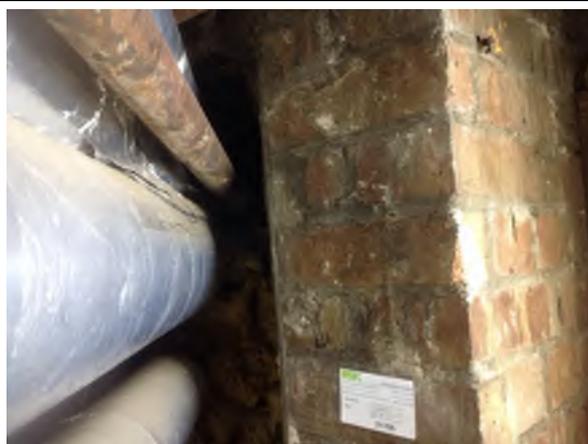
Building	Insull Wing
Floor	Basement
Room	Underground duct
Item Description	Wall residue to brick column
Material Type	Dust/Debris
Sample Number	21765
Asbestos Type	Chrysotile

Access to the duct tunnel should be prohibited until the duct has been fully environmentally cleaned by a licensed asbestos removal contractor (see recommendations for further details)

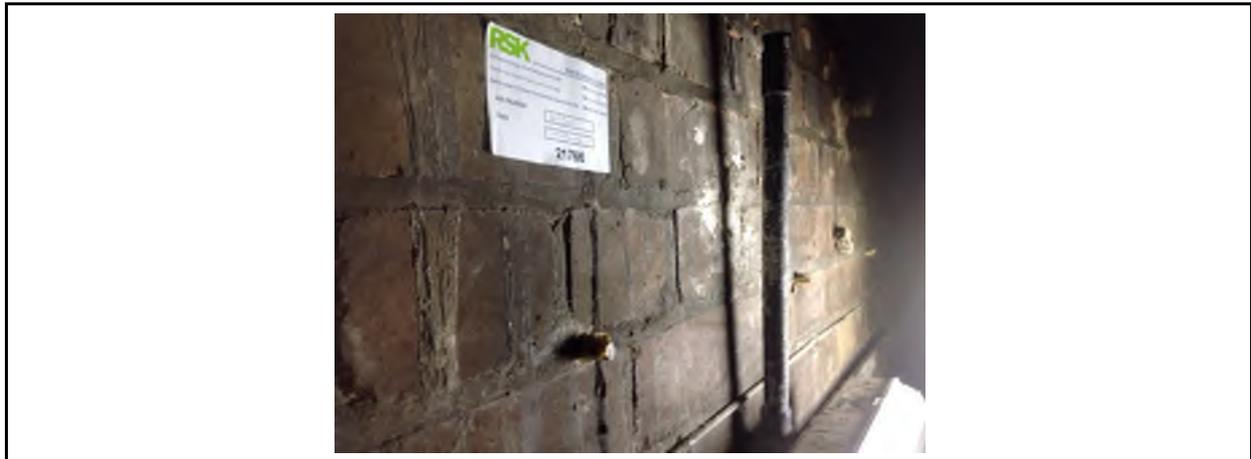
Building	Insull Wing
Floor	Basement
Room	Underground duct
Item Description	Wall residue
Material Type	Dust/Debris
Sample Number	21766
Asbestos Type	Chrysotile

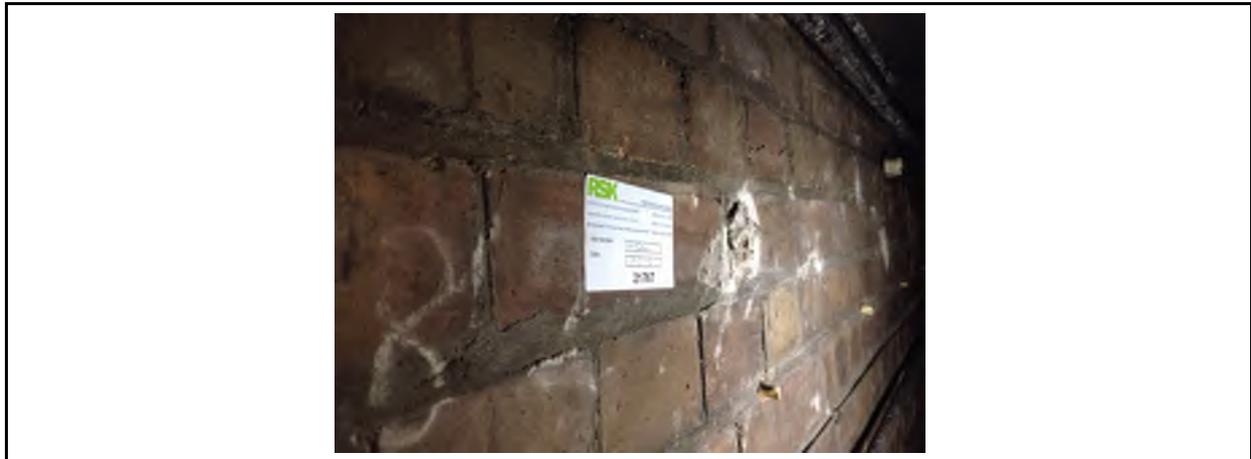
Building	Insull Wing
Floor	Basement
Room	Underground duct
Item Description	Wall residue
Material Type	Dust/Debris
Sample Number	21767
Asbestos Type	Chrysotile

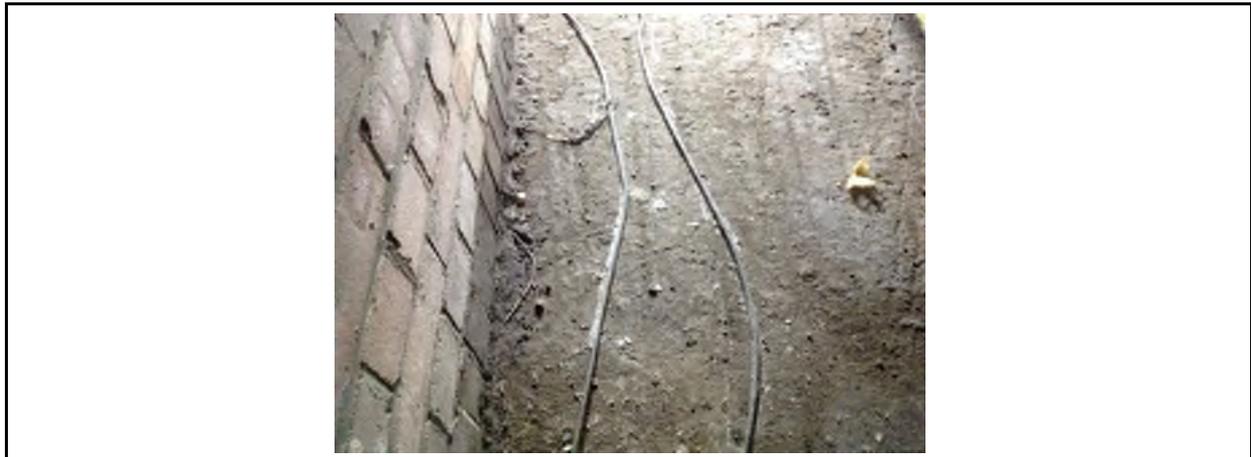
Building	Insull Wing
Floor	Basement
Room	Underground duct
Item Description	Floor debris throughout duct
Material Type	Dust/Debris
Sample Number	21771
Asbestos Type	Chrysotile

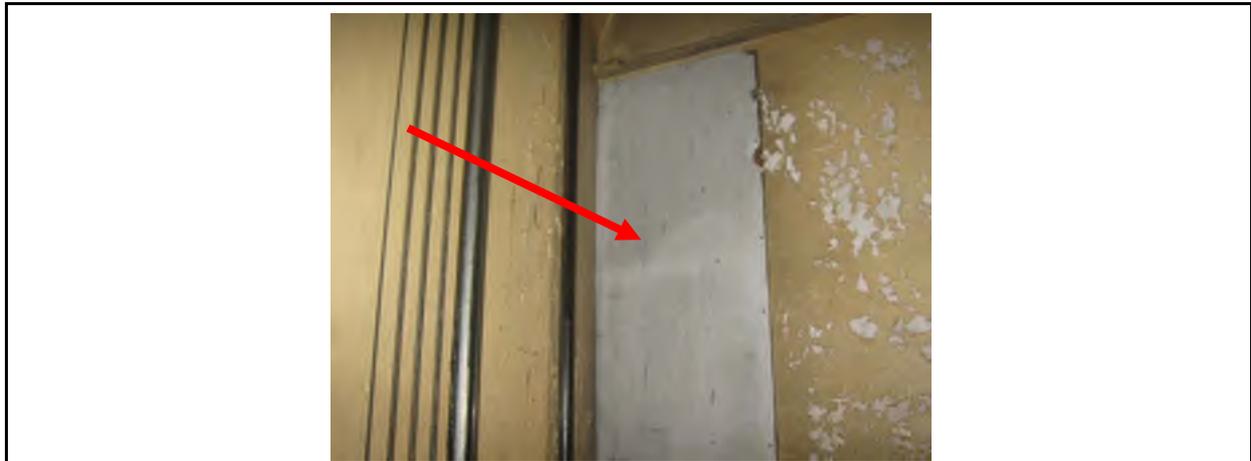
Building	Insull Wing
Floor	First
Room	Lift shaft
Item Description	Panel to rear wall of lift shaft (infill to existing window)
Material Type	Insulating Board
Sample Number	Presumed
Asbestos Type	Presume Chrysotile & Amosite

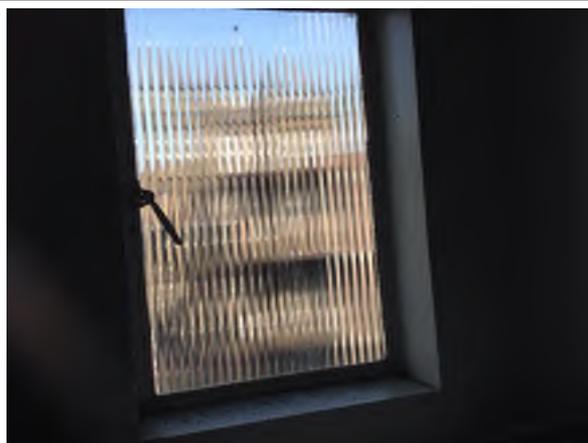
Building	Insull Wing
Floor	Second
Room	Second floor (see Plan)
Item Description	Bitumen lining to windows in wall cavity second floor (see plan)
Material Type	Bitumen
Sample Number	Similar to 21776
Asbestos Type	Pr Chrysotile

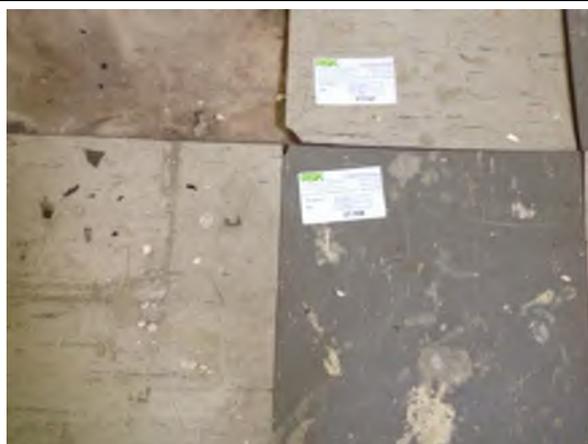
Building	Insull wing basement
Floor	Basement
Room	011
Item Description	Dark grey floor tile (flecked white)
Material Type	Floor Tile & Mastic
Sample Number	21748
Asbestos Type	Chrysotile (Floor Tile & Mastic)

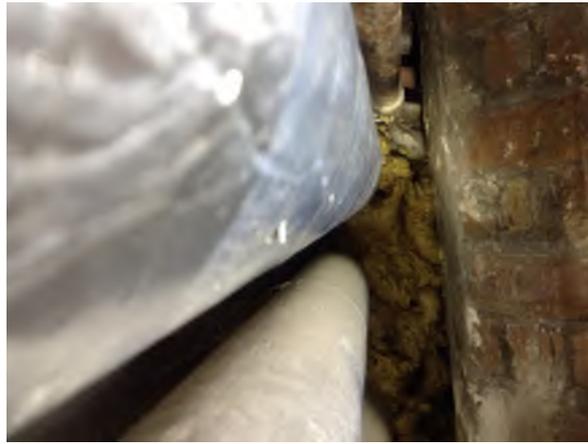
Building	Insull Wing
Floor	Basement
Room	Underground duct
Item Description	Pipe insulation near foam
Material Type	Thermal Insulation/Lagging
Sample Number	21764
Asbestos Type	Chrysotile

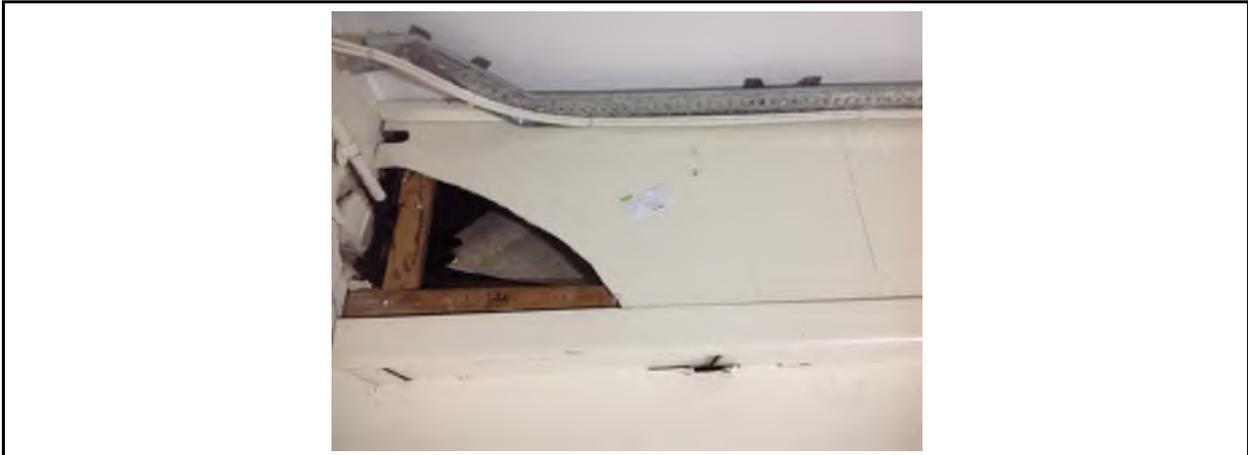
Building	Insull wing basement
Floor	Basement
Room	004
Item Description	Cement sheeting to boxing
Material Type	Cement
Sample Number	21745
Asbestos Type	Chrysotile
