Flat 1, 37 Gascony Ave, London, NW6 4NB

Structural Survey report

June 2016

Project No. 2198

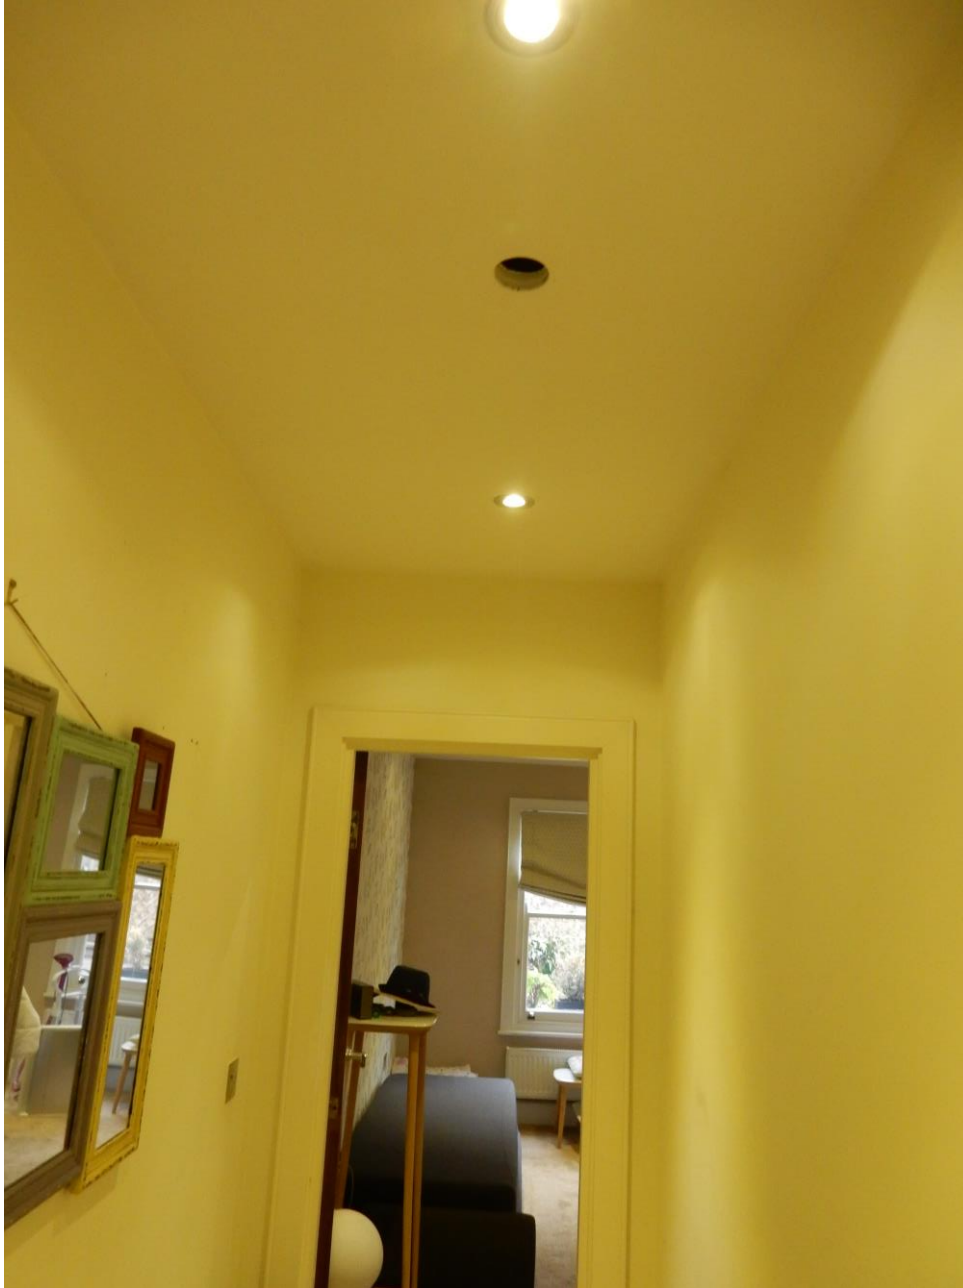
Photograph 1 – Hallway

3.9. Internal Walls and Partitions - Internal walls and partitions are of mixed solid and lightweight construction, with a plastered finish. Minor hairline cracks were noted to wall in the hallway, bathroom and front bedroom but these were not considered structural and should be raked out, taped and jointed as part of the renovation works.

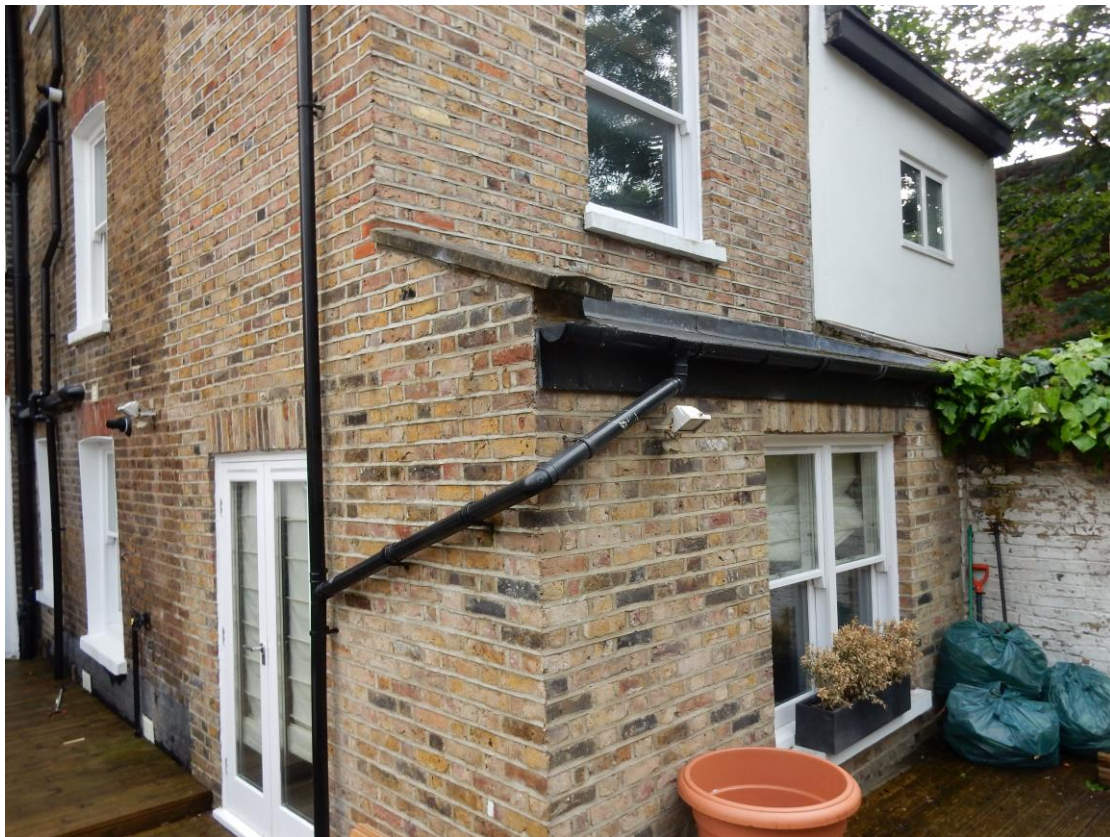
Photograph 3 – Existing Rear Extension

3.4. External Walls and Elevation - No DPC was noted to the external elevations. It was noted that the pointing to the rear extension was recent and likely consistent with the time of construction. No cracks were noted to the external masonry around the rear extension.

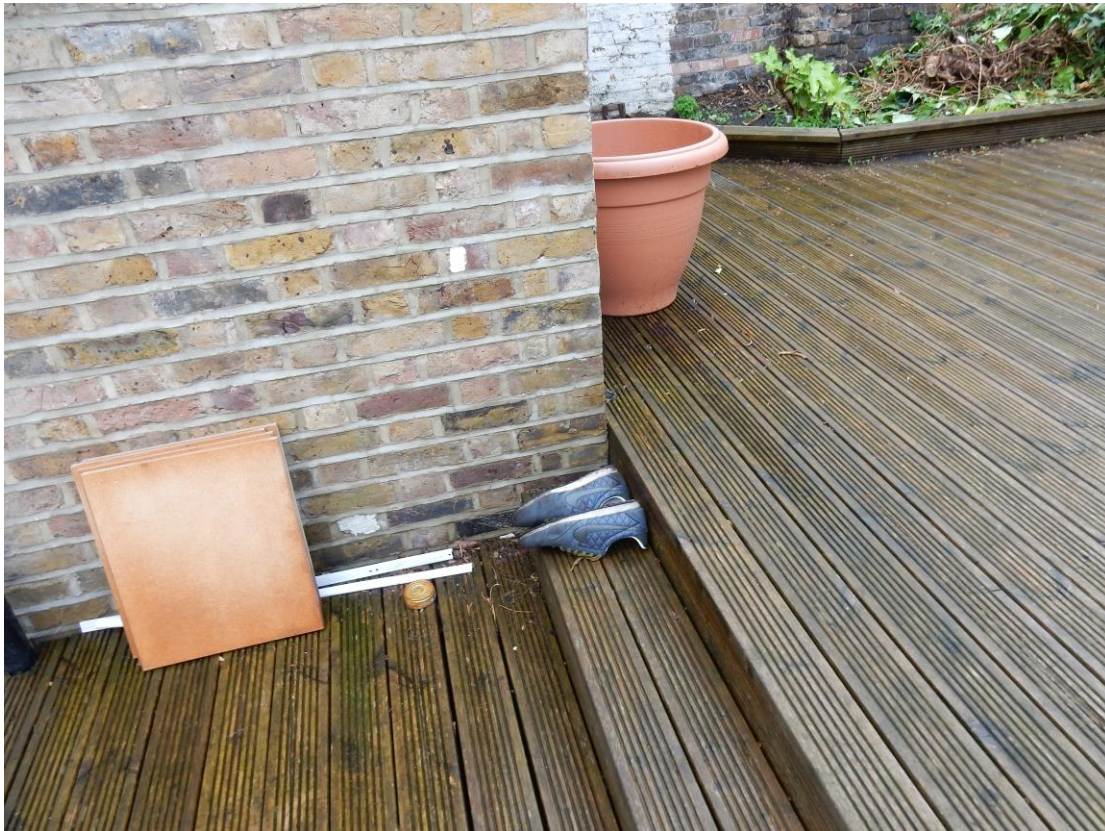
It was noted that the decking to the rear was raised approximately 3 brick courses above the internal ground level. It is advised that a gap should be maintained between the decking and the brick face to prevent saturation of the brickwork which could cause damp internally. This gap would also ensure any vents from the building are not blocked.

- 6.5. It was noted that the external decking is approximately 3 masonry courses above the internal floor level. It is advised that either the level is dropped or a gap is maintained between the external masonry and the decking.

Photograph 4 – Raised decking above internal floor level

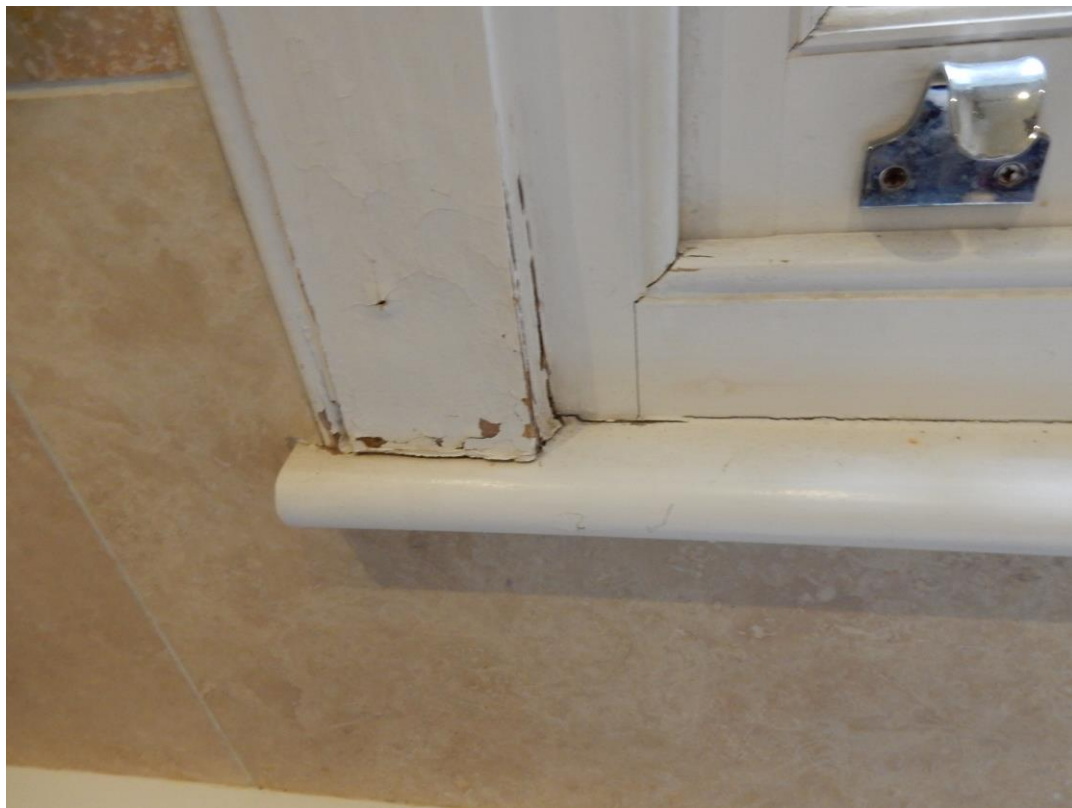
Windows and doors at ground floor are painted timber. Paint peeling and blistering was noted to the bathroom window and the front bedroom external door. It is advised that some rubbing down and redecorating of the timber doors and windows will be required on a periodic basis. It was noted that paint peeling and blistering was evident internally to the window in the bathroom. This is likely due to the high levels of moisture found in bathrooms. It is advised that this window

Photograph 6 – Main bathroom – Window above bath – Paint peeling and blistering.

is rubbed down and repainted. An extractor fan should also be installed to minimise the moisture exposure of the window.

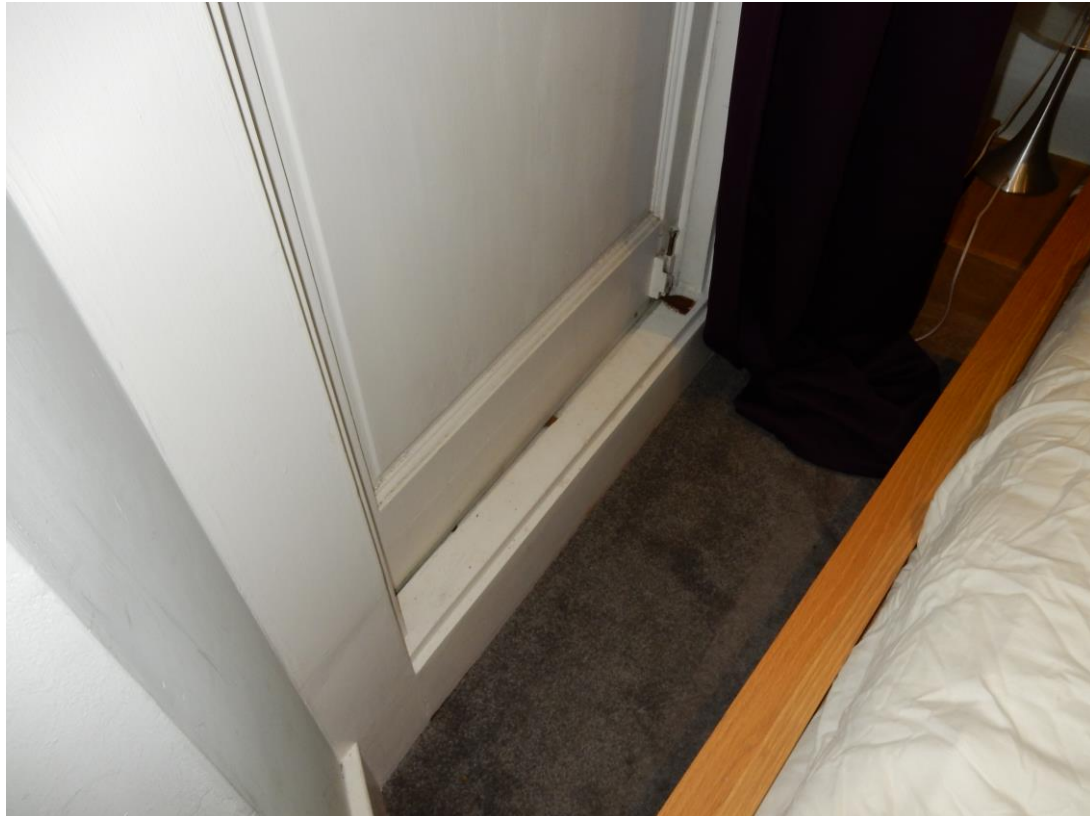
3.11. Internal Joinery - Windows and doors were generally in a good condition. The bathroom window requires rubbing down and painting. It was also noted that the window lock was broken. The external door to the front bedroom was also not closing correctly and requires some adjustment to the bottom lock.

Photograph 7 – Front bedroom – External door not shutting properly. Adjustment required.

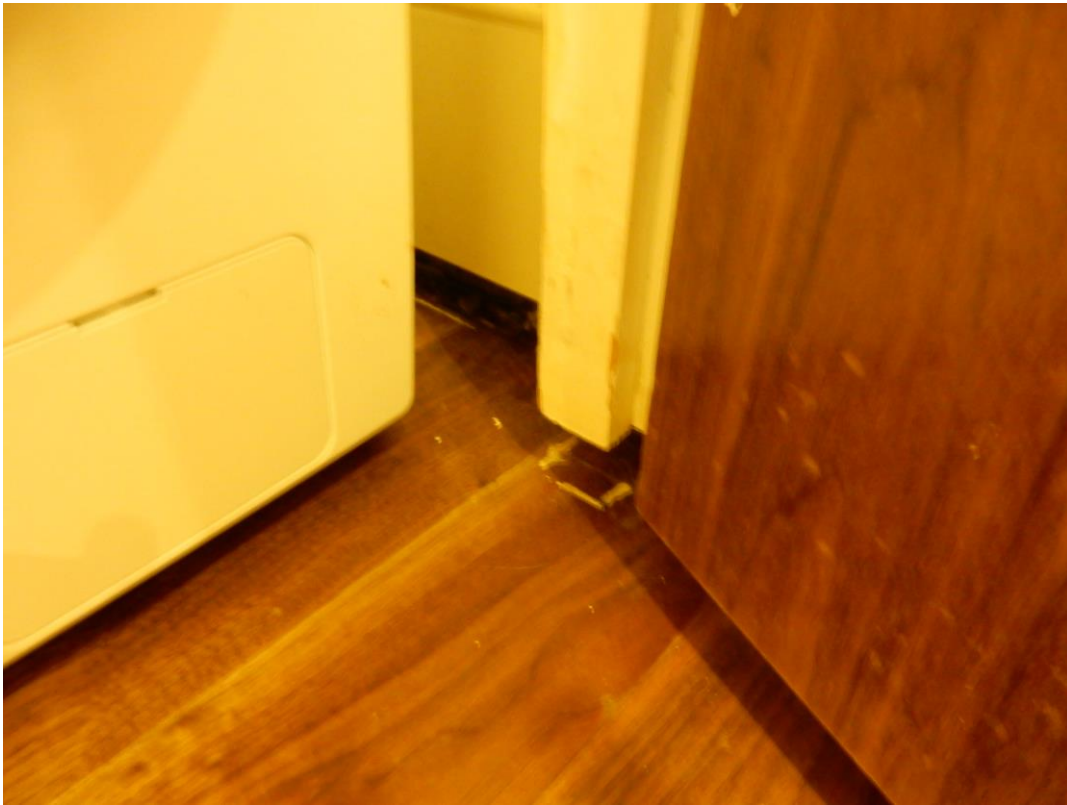
A drop in floor level of 40-50mm was noted into the cupboard below the stairs. It was noted that section of timber had been installed below the skirting board to fill the gap. It is not thought the movement is recent but it is advised that the floor in this area is inspected once the floor finishes have been lifted to determine the likely cause.

Photograph 8 – Gap between skirting board and floor in cupboard under stairs.

- 6.2. To form the large opening at the rear of the property a Catnic CX90/100 lintel is proposed. Refer to Appendix B for details.
- 6.3. A drop in floor level is noted in the cupboard below the stairs. The movement is not considered recent but it is recommended that the floor in this area is inspected during the works.

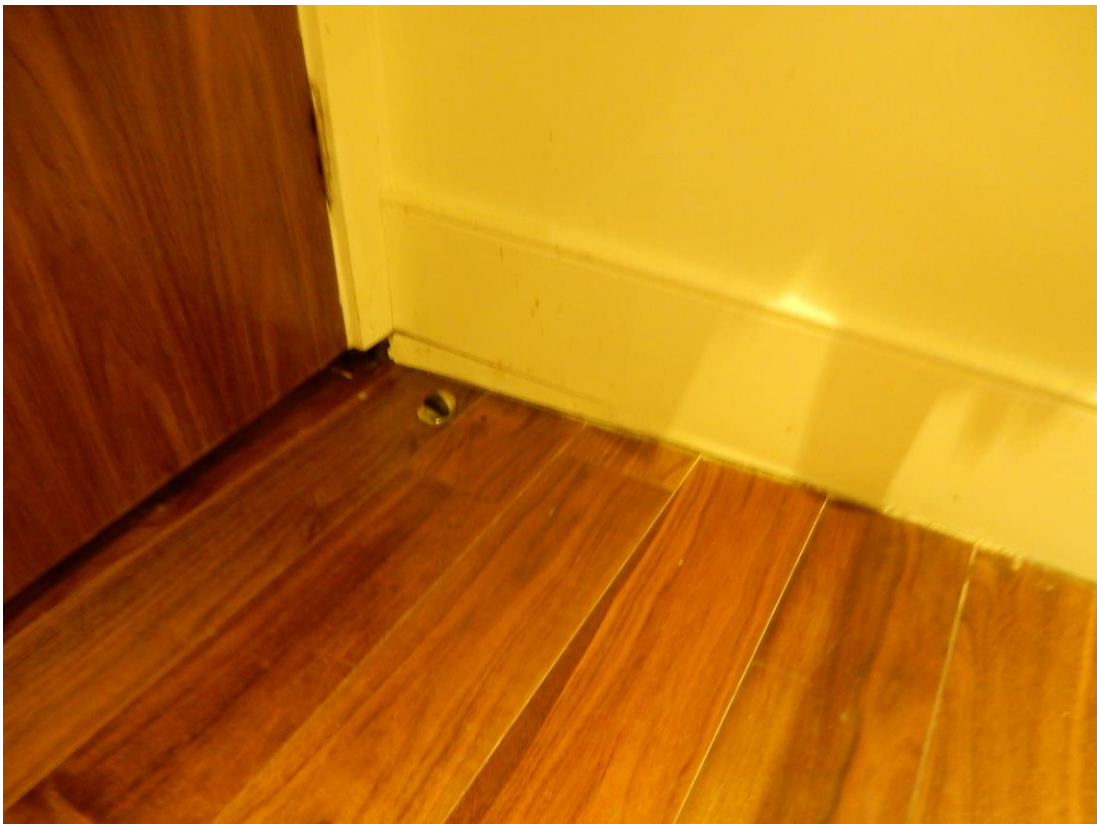
Photograph 9 – Previous repairs to dropped floor to cupboard under stairs. Infill installed to skirting.

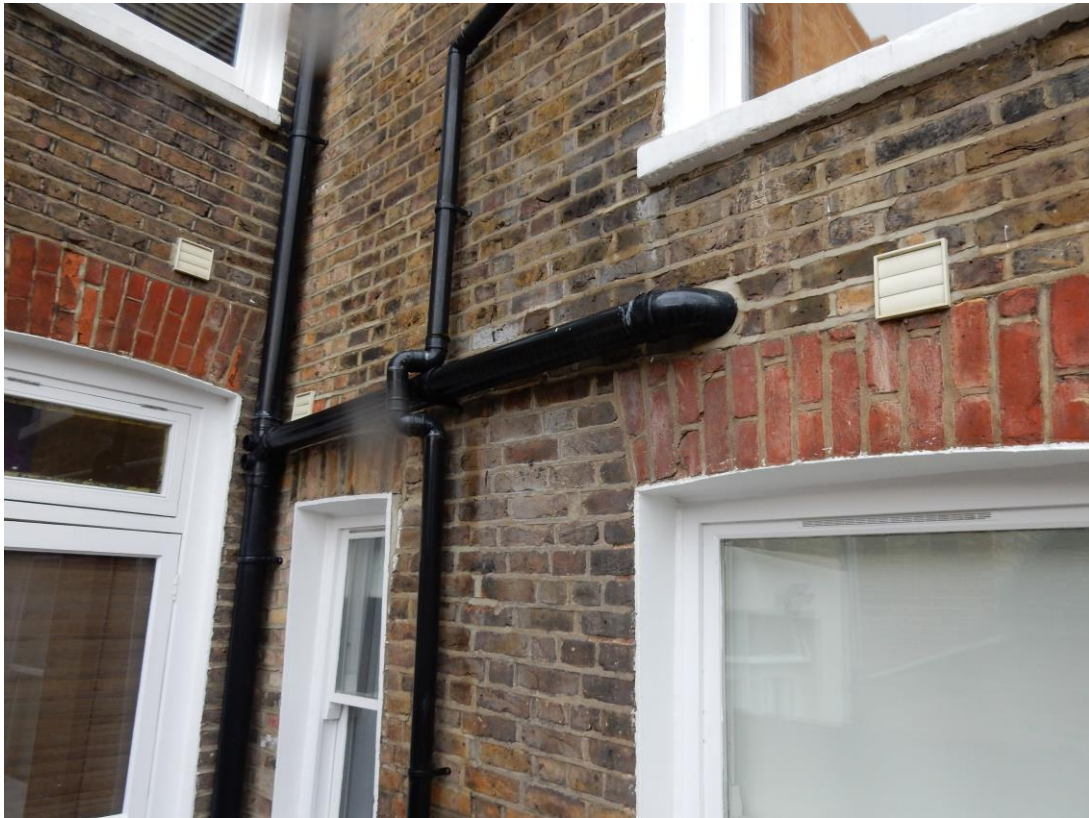
Evidence of previous repairs was noted to the side elevation in the rear garden around the window to the ensuite bathroom. Evidence of repointing to the side elevation was noted but these were not considered significant.

Brick spalling was noted to the brickwork forming the arch over the door into the front bedroom. It is advised that these bricks will require replacing in time.

Photograph 10 – Rear and side elevation with brick spalling noted and evidence of previous repairs.
