ARBORICULTURAL IMPACT ASSESSMENT REPORT:

Maryon House
115 - 119 Goldhurst Terrace
London
NW6 3EY

Ref: HV1/1MRN/AIA/01c

Date: 21st June 2016

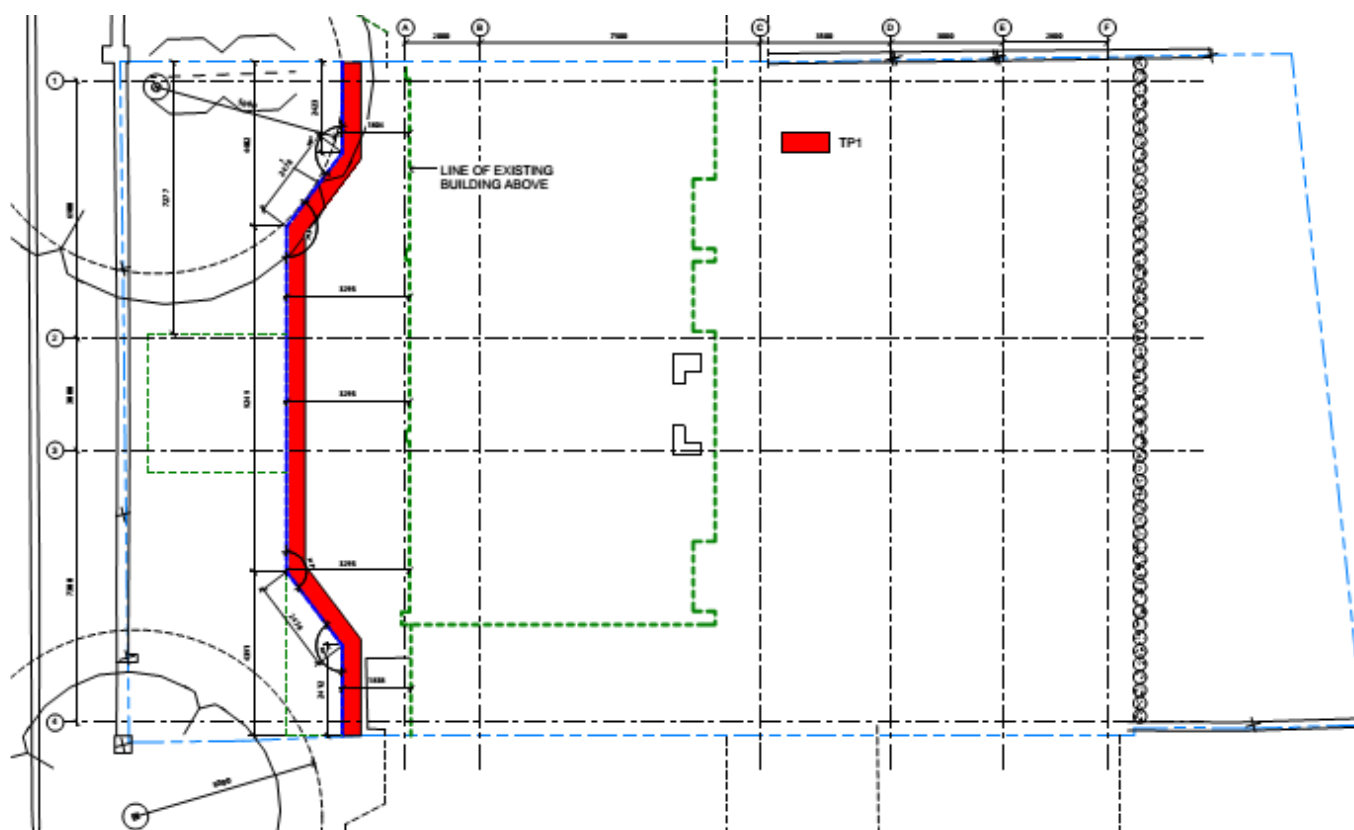
Plan Extract 1: Extent of trial trench excavated

- 4.1.4 Such assumptions cannot be proved without prior site investigations / trial pits. In this instance, five trial pits were excavated by Arboraeration. These showed that there were no roots present from T1 in that area of its notional RPA but some significant roots were discovered from T2. These roots appeared to be in a discrete packet going towards the building / along the side of the corner path with no evidence that they are spearing laterally across the lawn.

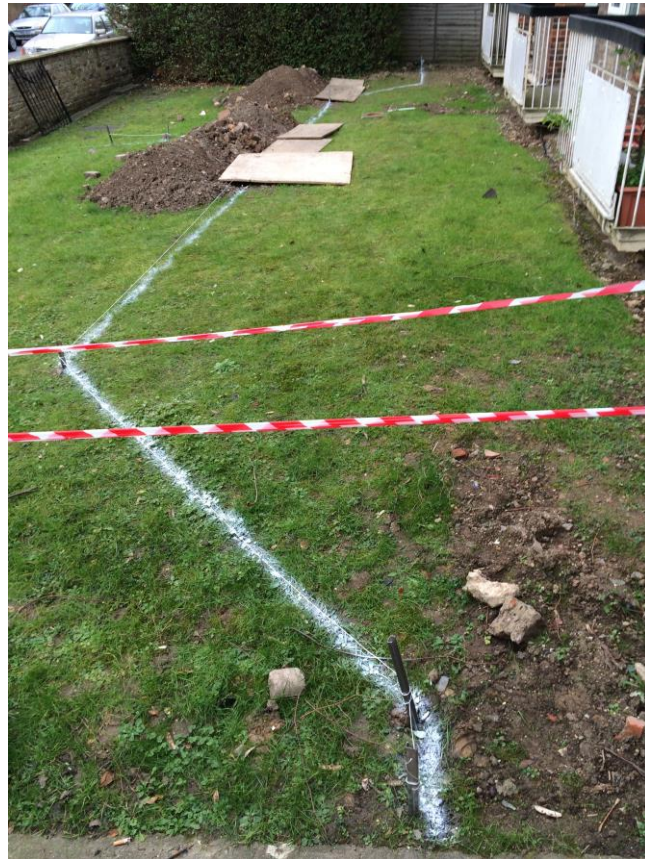
Photograph 2: Line of trial pit

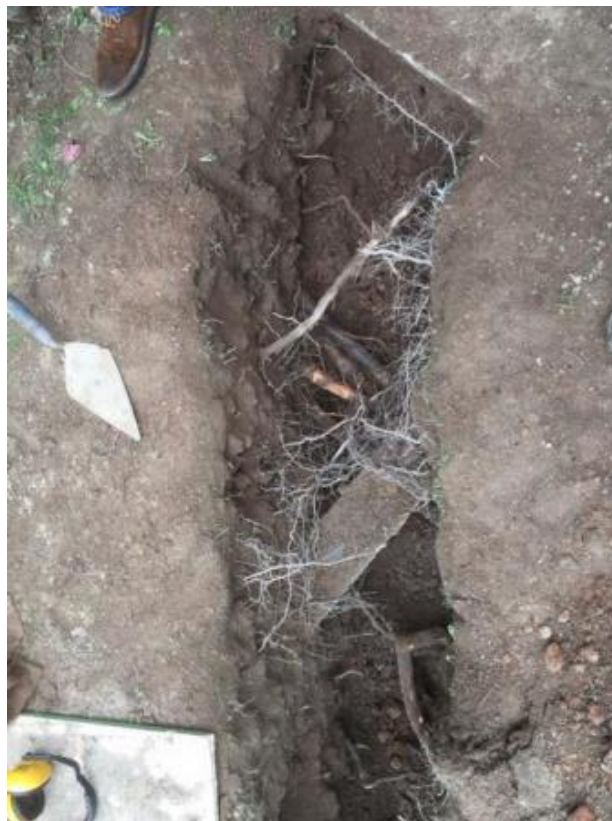
Photograph 3: Packet of significant roots found (2 x 45mm, 1 x 40mm diameter)

- 6.3.2 The path of foundations through RPAs will be manually excavated to 750mm depth under arboricultural supervision; any roots encountered within the trenches / pits will be cleanly pruned back to an appropriate junction with a sharp pruning saw or secateurs back to a junction. Roots larger than 25mm diameter may only be cut in consultation with an arboriculturalist.

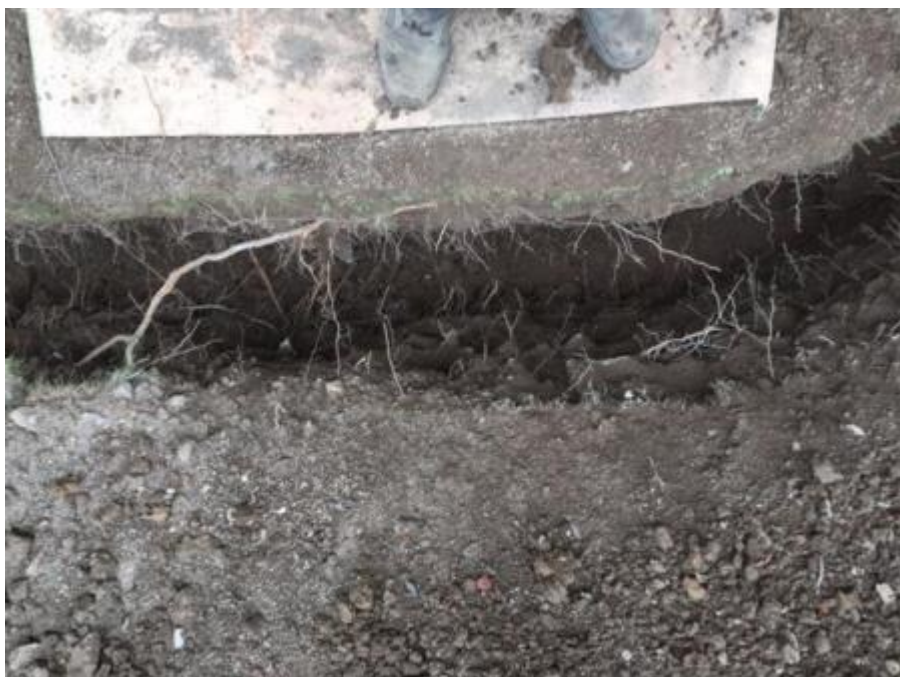
Photograph 4: Fibrous roots present in remainder of trench 1

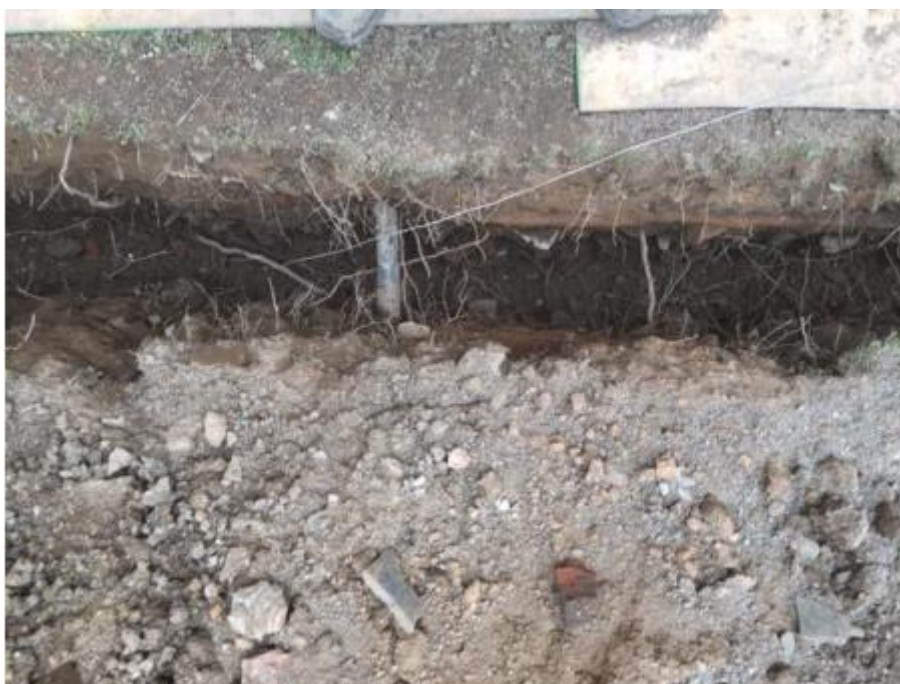
Photograph 5: Further fibrous roots present in trial trench 1
