Condition of: Gordon Square -
UCL

UCL - Wilkins Building, Bernard Katz Building, Archaeology Building and associated outdoor space

Date of Audit

04/02/2016

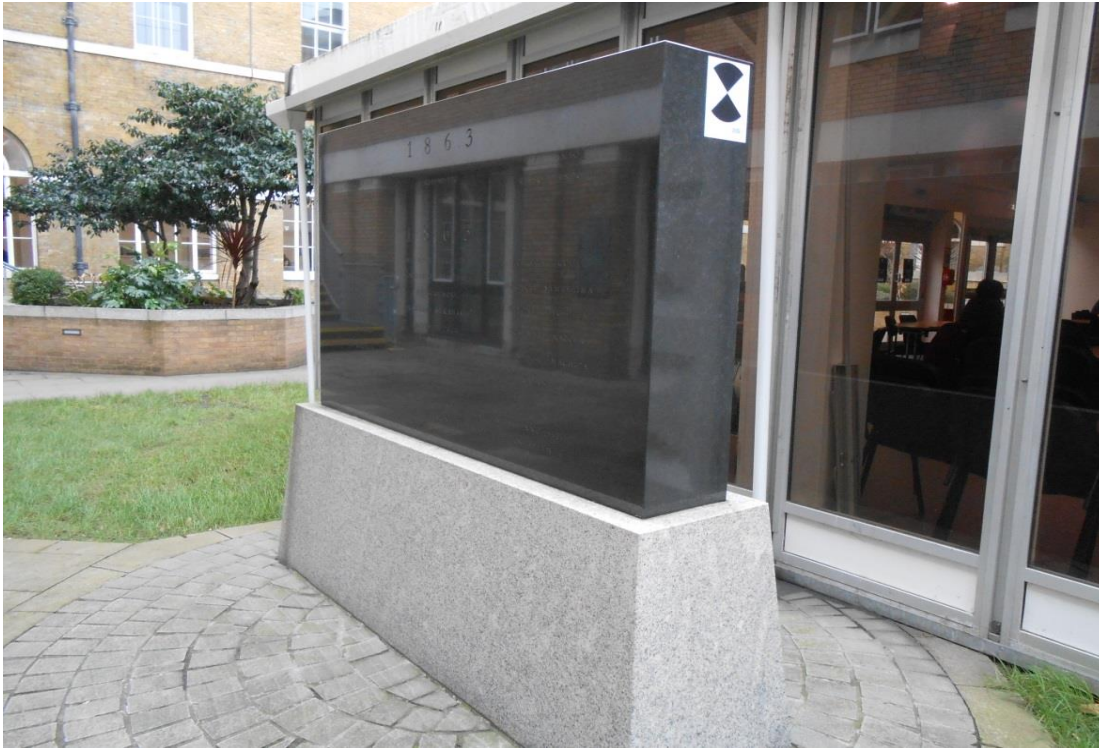
1418, Japanese Memorial

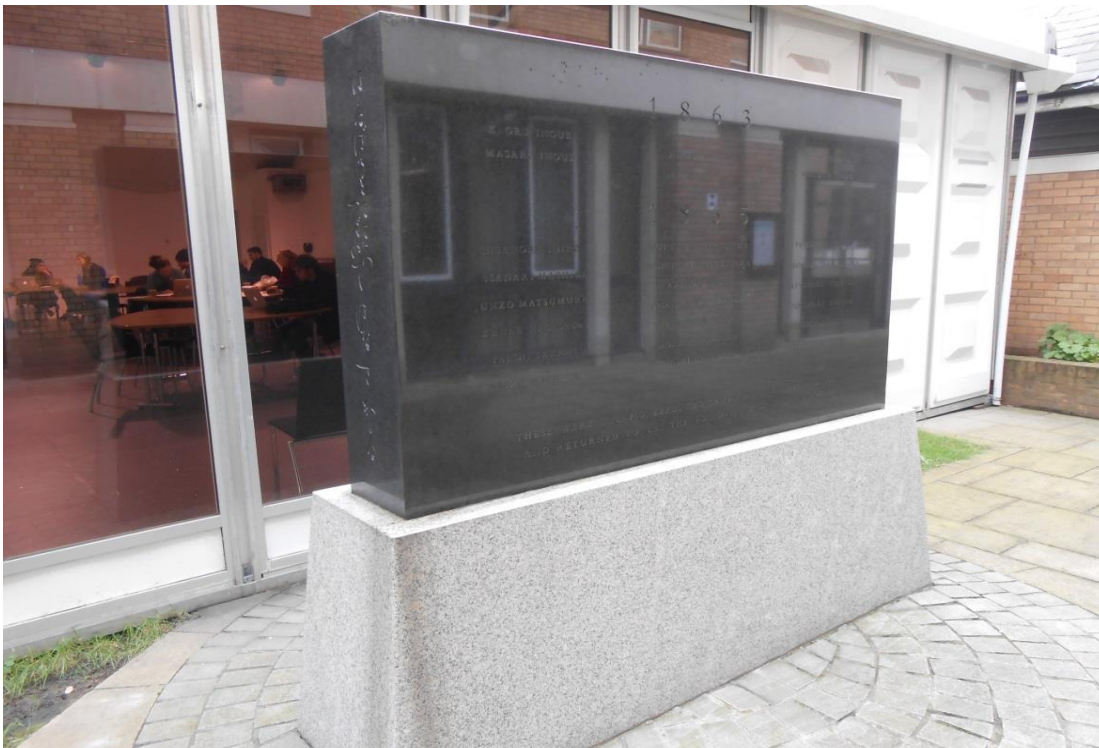
1421 Japanese Memorial

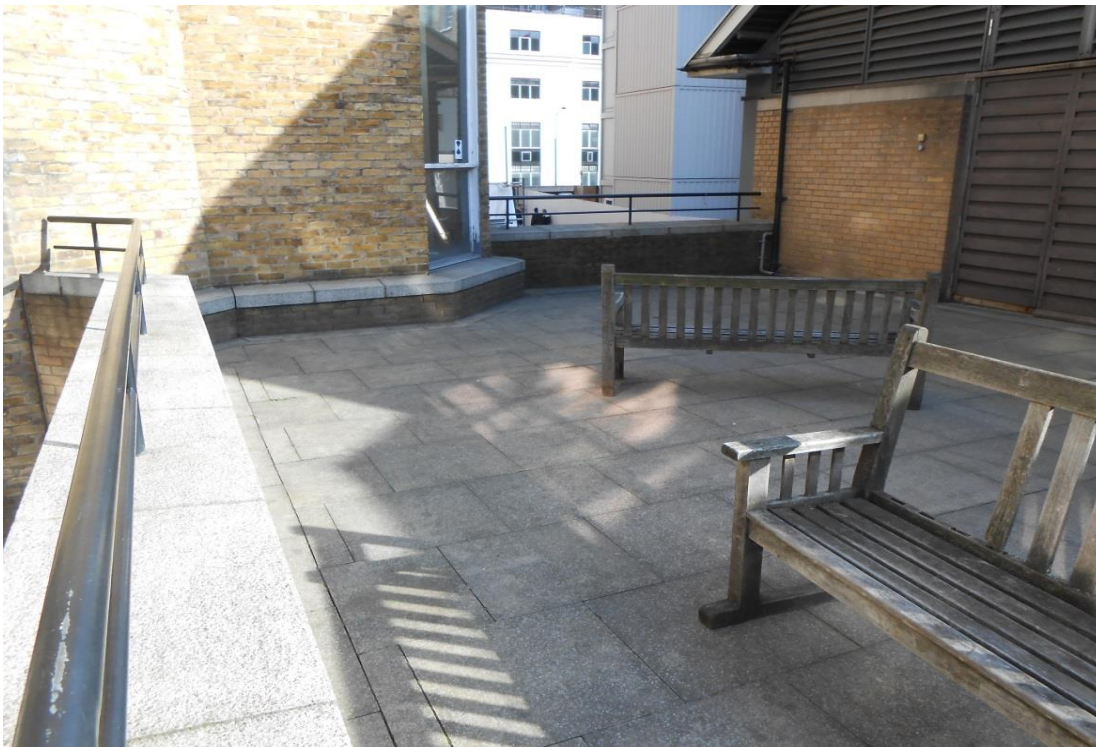
1906 Looking towards Gordon Square - vestible to be demolished

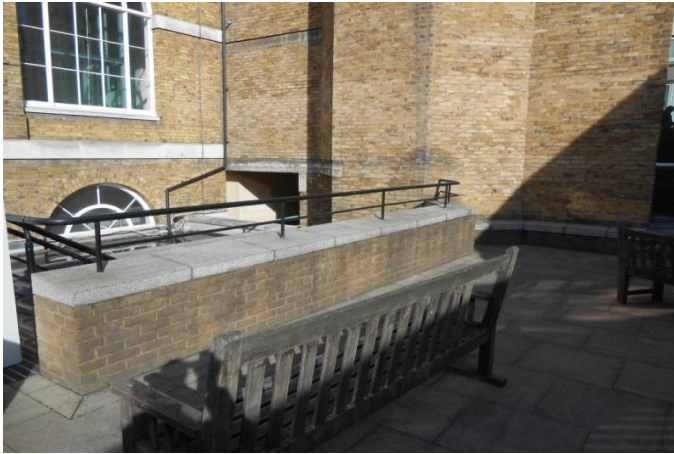
1907 Wilkins Building - vestible to be demolished

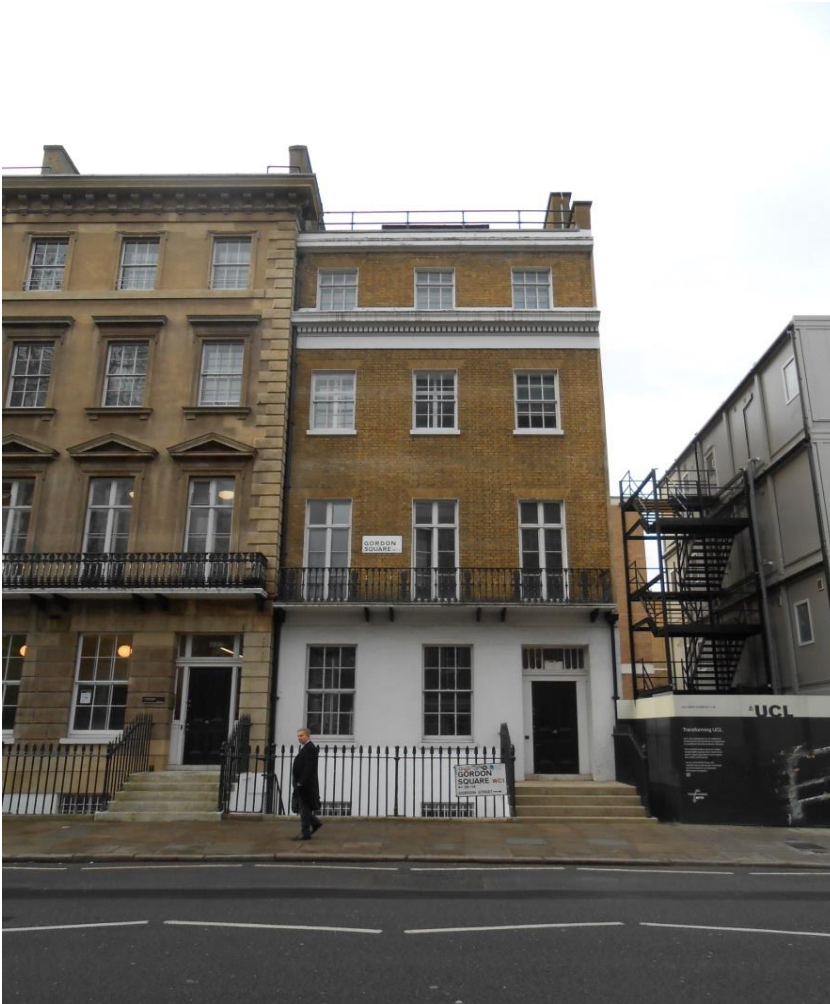
<p>Within the basement void was evidence of any defects or movement. The cracking above the ground floor window head and door head appear to be historic due to discolouration and is running up to the underside of the balcony (maximum of 1 – 3mm wide). There is damage paint work to the door surrounds and the masonry surrounding the door and various nicks and chips and wear and tear. As typical for a construction of this period there is a flying landing and four number steps to the pavement. The steps and paving slabs are in good condition though they are reconstituted stone rather than original stone work. There are a few numerous open joints between the stone work. Surrounding the light well/basement and the landing to the front door are cast iron balustrades and these appear to be in good condition though require touching up of paint work. The front elevation on the side, there are two tie rods which indicate that the building has suffered from movement in the past and this has been remedied with tying the front & rear elevations together. There are indications on the front elevation to the right hand side and the side elevation of the left hand side of survey points which would indicate that there has been or there is monitoring in place.</p>

Front elevation

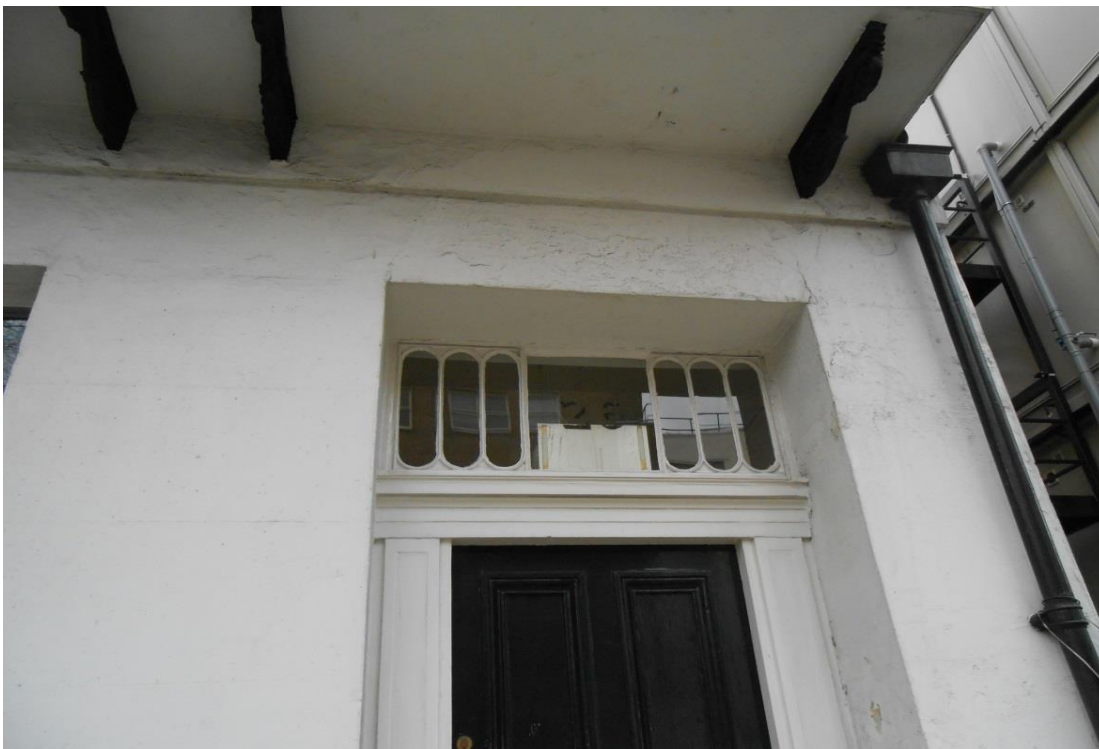
Front entrance door and cantilever detail under balcony

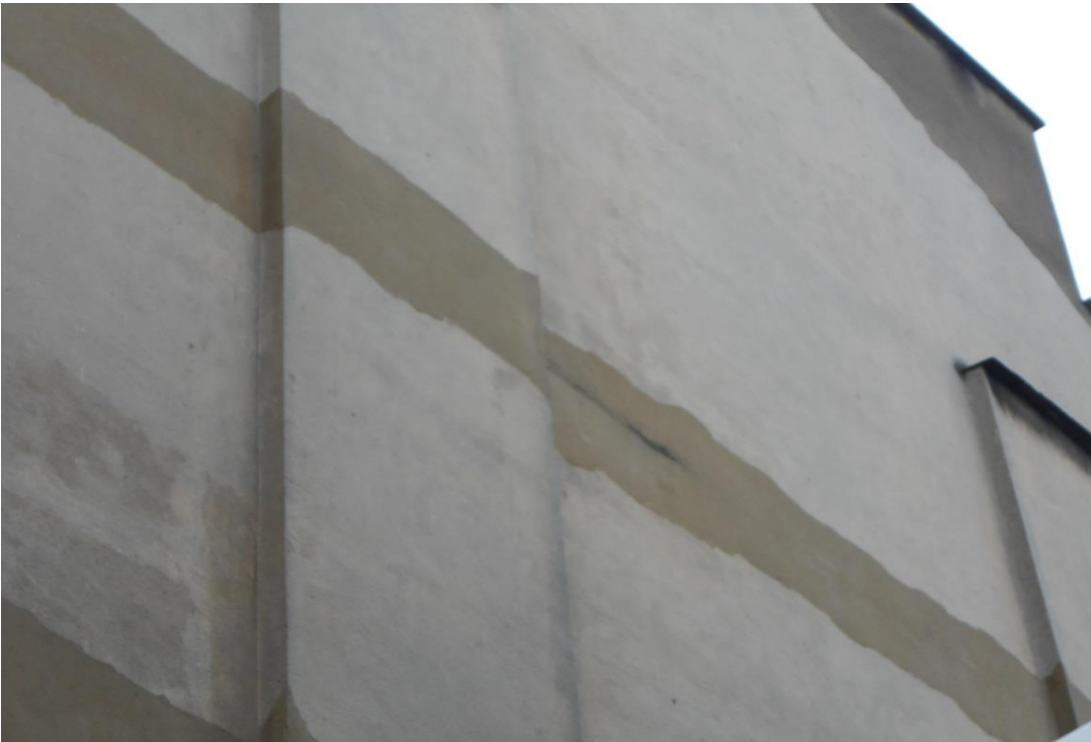
3. External Walls, Windows and Doors			
<u>Walls</u>		Fair condition / B	
	The side elevation was not fully accessible at the time of the survey due to it being partly covered by temporary portacabins and hoardings surrounding the property. The side elevation has been rendered with a cement render finish and has numerous crack repairs at floor levels. Between 2 nd and 3 rd floor level there is a small horizontal fracture between the chimney stacks within the new repair works. To the right hand side of the side elevation of 26 there is a fracture to the new render between 3rd and 4th floor in a similar location to the fracture between the two chimney breasts.		
Structure			
<u>Windows and doors</u>			
Framing	none

Side elevation, with previous patch repairs and further cracks

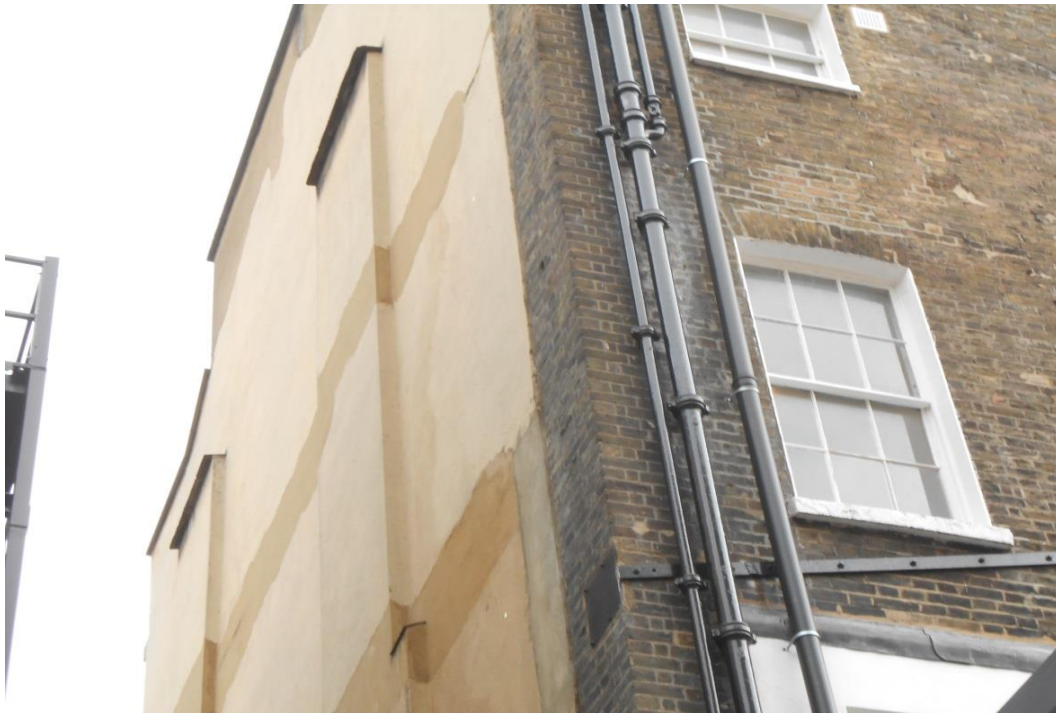
<p>On the rear elevation there is an external tie running diagonally underneath the first window and the presumed landing window. There has been numerous patch repairs to the rear elevation, particularly above the window on the right hand elevation and repointing underneath it. At the time of the survey there is hoarding that has been buttied up the existing rear outshot of the building. The rear outshot of the building is to the ground floor and basement only - this has a render finish with a flat roof detail. There are outlets from the flat roof detail and limited electrical fixings to the property. Abutting the building there is a tarmac entrance. Towards the rear entry door there is a gully detail for the down pipe, this down pipe has got a rust staining, indicating a long term historical leak which is reflected on those stainings on the wall. Around the gully detail there has been damage undertaken to the upstand. It should be noted that the adjoining building has a rear extension of 3 storeys including basement and this has rough render finish but no sign of cracking. The rear area between the two buildings has a conditioning unit and a service run and that is also a substantial trunking system which runs between basement level and ground floor – photo 346. There is also metal strapping between the 1st and 2nd floor which appears to run behind the extensions.</p>

Side and rear elevation showing further patch repairs and tie bars

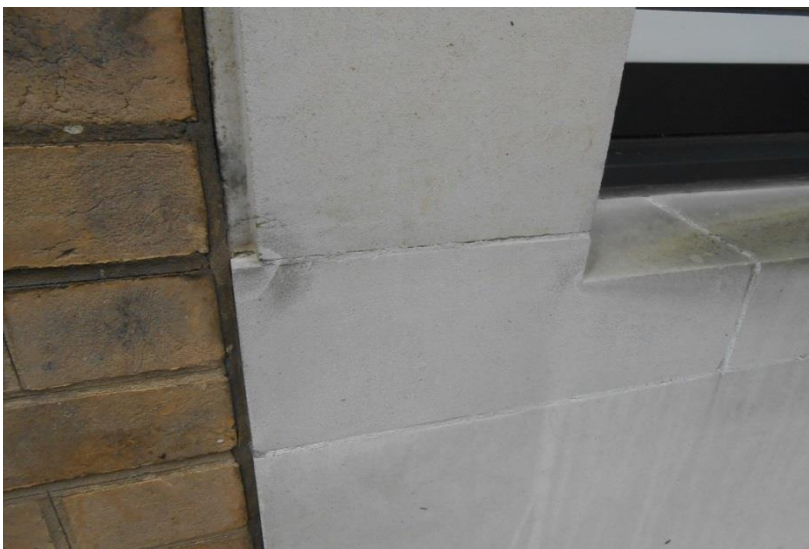
Damage and staining to stone surrounds

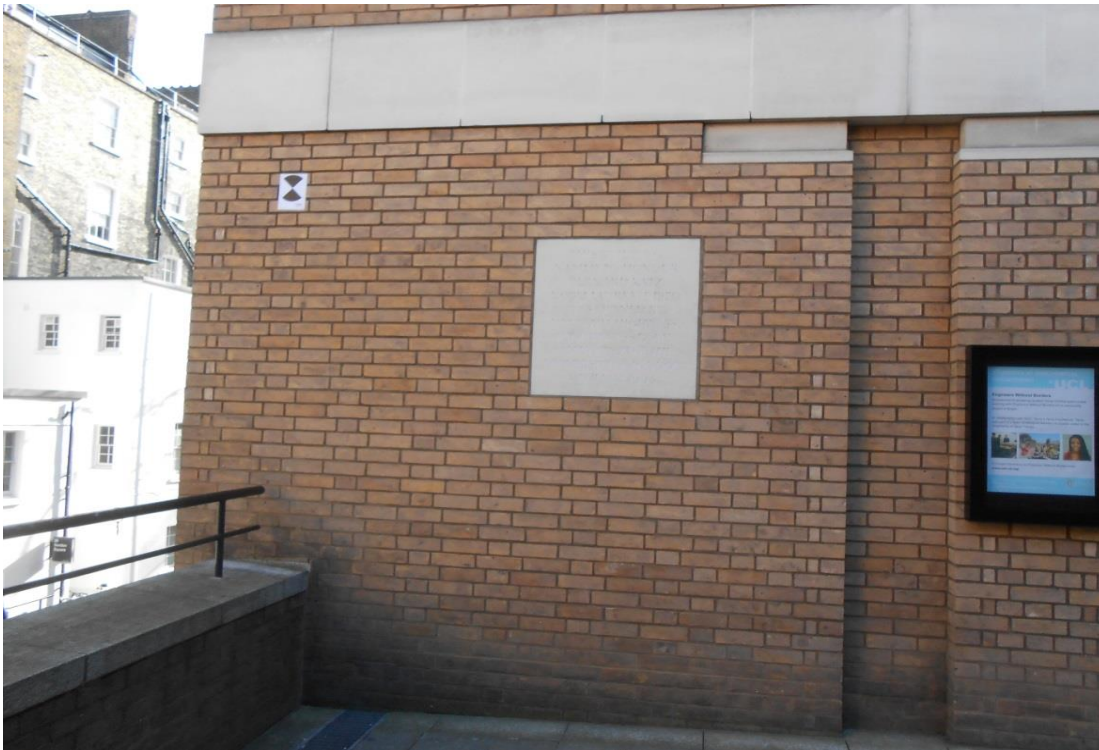
2. External Walls, Windows and Doors <u>Walls</u>	Rear elevation of the Katz building, is predominantly glazed at ground floor level (to the Japanese Garden) which has a stone string course above it followed by individual windows with stone sill and head details, and a stone coping detail to the top. There is a design detail in the stone cladding to the string course which leaves the bottom 50mm and the underside of the joint exposed. This is on all of joints along this stone detail apart from where there are expansion joints to the building which have a silicone finish. Along this elevation there is a carved stone plaque which designates the building to being opened in May 1993. From the visual inspection there appears to be no damage to any other corners of the brick work, to the stone detail along this elevation or to the corner that joins the main/ formal elevation. The stone parapet returning towards the Bloomsbury Theatre there is slight cracking to the mortar bed joint between the two materials of the brick work and the stone parapet detail.	Good condition / A

Japanese Garden elevation showing staining to brick work at low level and inset stone plaqu

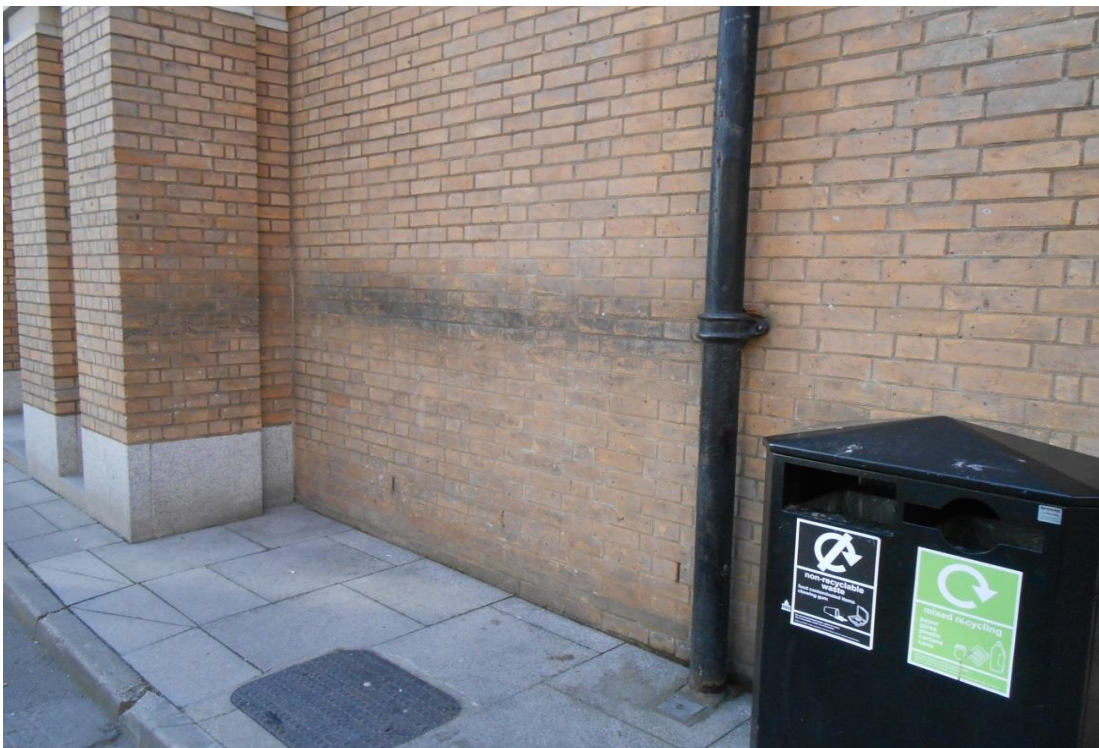
1. Roof	Not surveyed - however, no major defects or undulations were noted.		
2. External Walls, Windows and Doors			
<u>Walls</u>	The Katz building is a modern 1980s/1990s construction appearing to be of concrete frame with brick infill panels. There is a small cantilever balcony detail to 1st floor windows which is of concrete with a stone clad and there are stone surrounds to window frames on the ground and 1st floor level and then stone lintels and a stone parapet detail to the roof. The court yard elevation has the main access to the building through aluminium and glazed doors, the building looks to be in good condition with no evidence of cracks or movement. Behind the parapet there is an additional storey which is set back from this elevation.		
Structure	To the right hand side of this elevation on the stone detail there has been damage to the top and bottom arrases of the stone work string course. On the right hand side there is at approximately 1 ½ metres height there is dark staining to the return of colonnased section and the wall which is not clear where this is from.

Staining to brick work on formal entrance

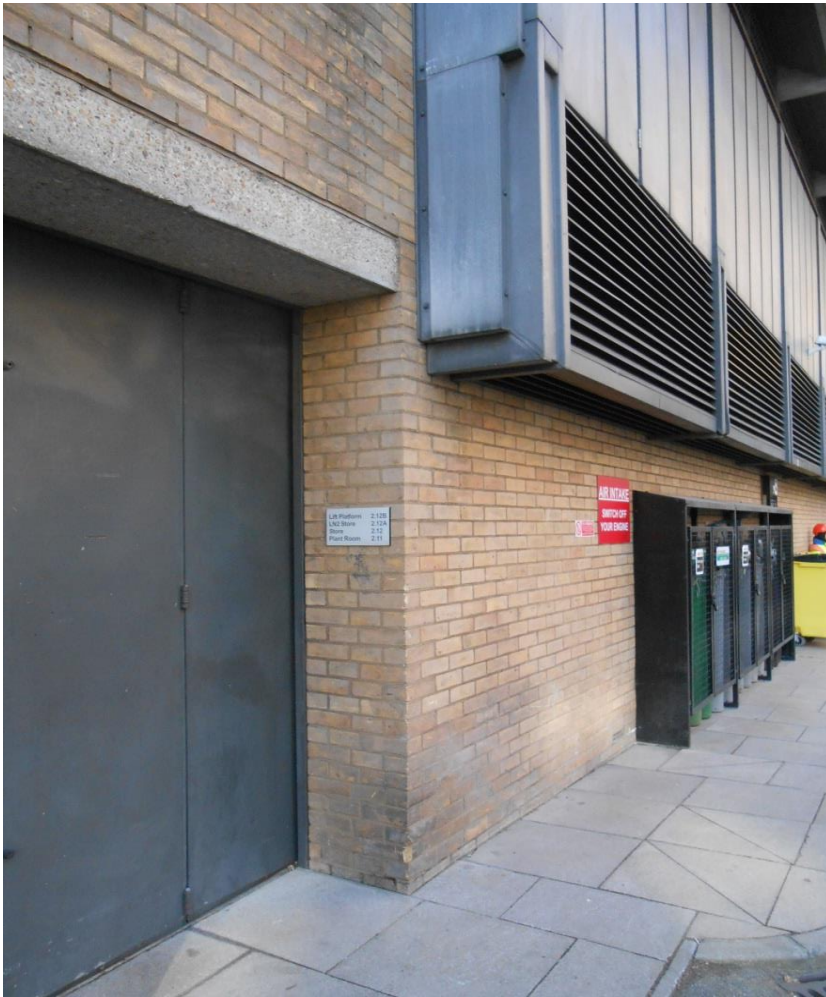
External linings/finishes			
	The cladding is to the 1st floor level with brick work detail beneath it. Brick work detail is in good condition with low level staining caused by splash back. Part of the wall is obstructed by gas bottles, a sign and two bins.	Fair condition / A	
Plant Room

Brick work under Plant Room

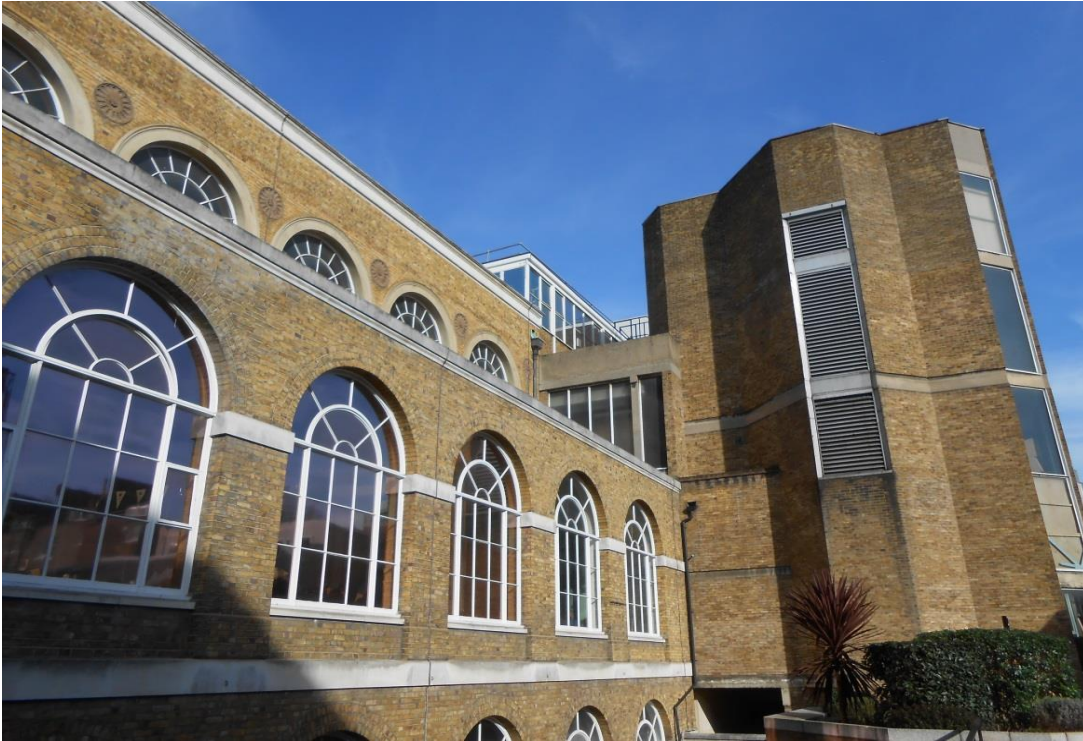
Wilkins Building (Library) with vestibule to be demolished

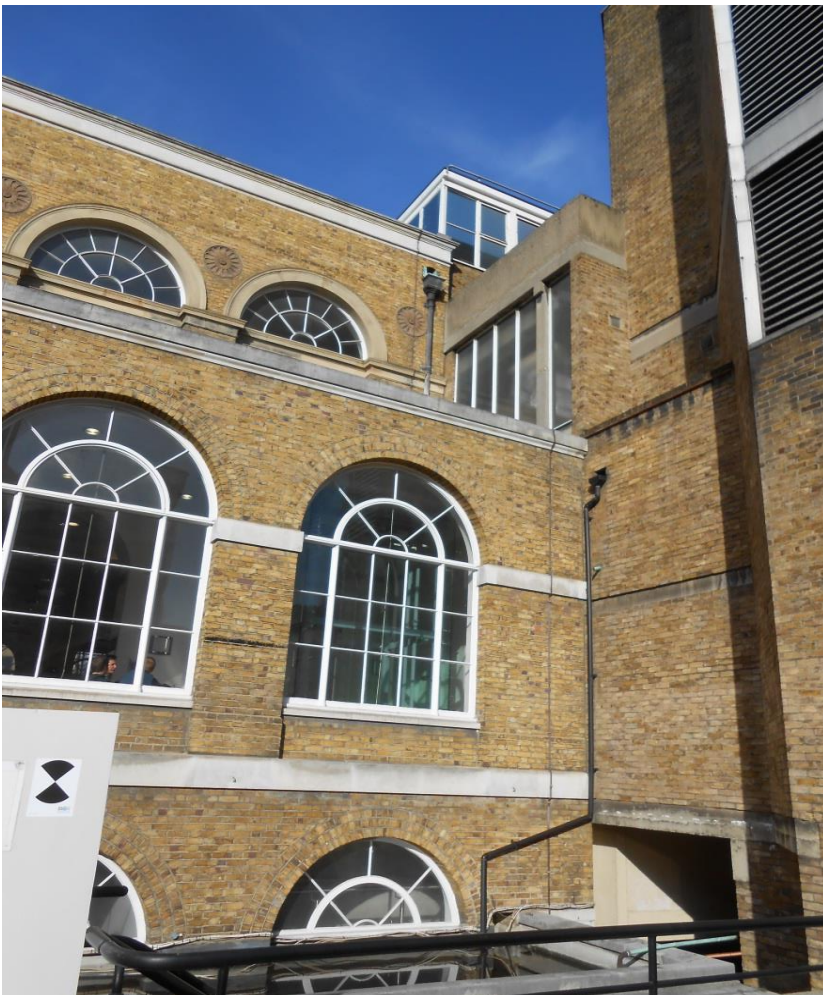
Mark on brickwork between 1st and 2nd window

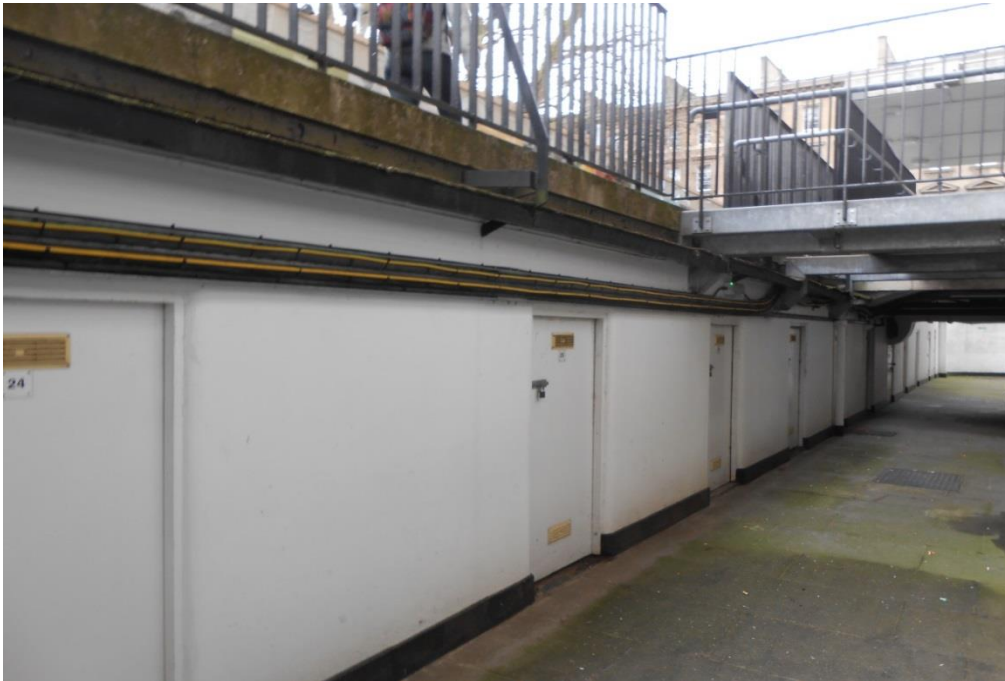
Access to the light well is via a gated entrance in Gordon Square, down concrete clad steps with galvanised metal hand rail. Within the light well there is concrete paving slabs which appear to be in fair condition, although have mould growth underneath the main pavement there is vaults (12 number) and numerous plant runs. (These vaults will be picked up separately.) Within the light well there are the galvanised metal fixings to the hand rail, between these are numerous minor fractures within the rendered finish, particularly above door B34 and B33. The gate leading down to the stair well has moved and expanded and has caused numerous cracking to the decorative stone work	Minor defects / B	
Light Well			
Roads and car parks	The small turning area has numerous patch repairs undertaken	Minor defects / B	
Paths and pedestrian walkways	The pavement outside the building is public footpath, which has numerous broken slabs to it.	Minor defects / B

Vaults under public pavement
