Condition of: Wilkins Building
UCL

Wilkins

04/02/2016

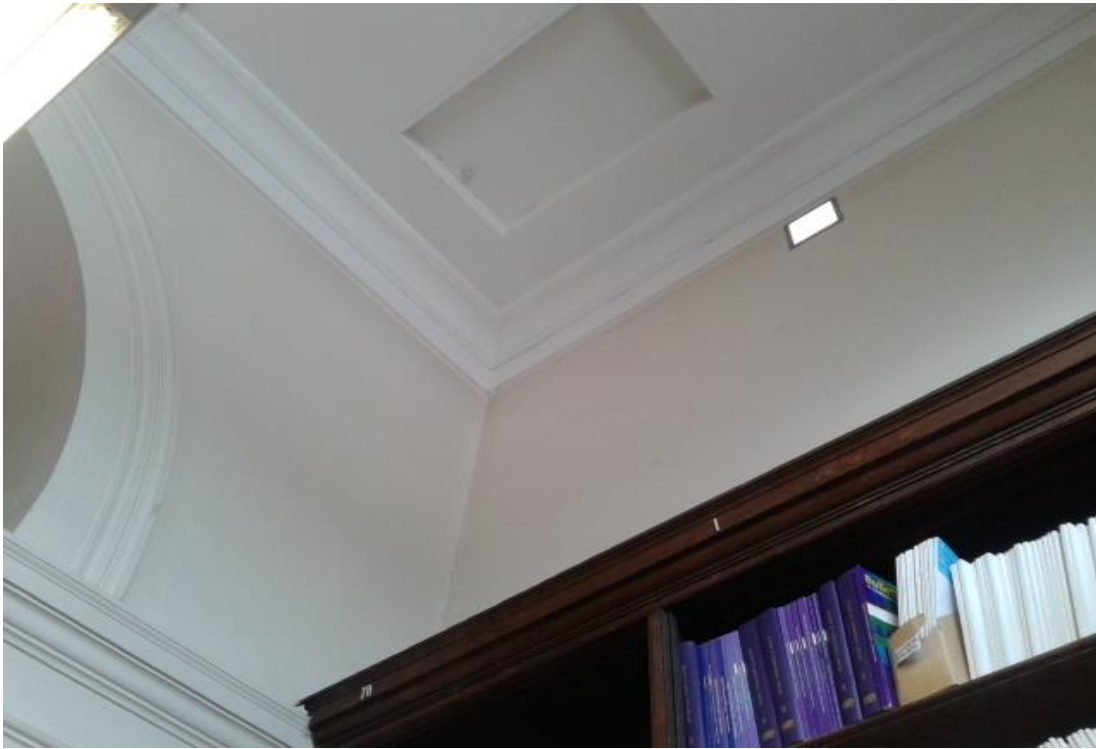
<p>there are numerous hairline fractures throughout the ceiling which are a typical for a building of this age but consideration should careful with any vibration works that are currently being undertaken as these cracks may extend even further. I am not sure if the ceiling in this is a lime plaster or a papier-mâché finish but care should be taken for this historic ceiling as it has indications that show signs of stress already. It should be noted that also on both elevations of this library that there are external construction works being undertaken at this time. It is recommended that a photographic survey to be taken of the ceiling and rear external walls should be taken prior to any further construction works are undertaken by Mace.</p>	Poor condition / C

124126 Library - hairline fractures

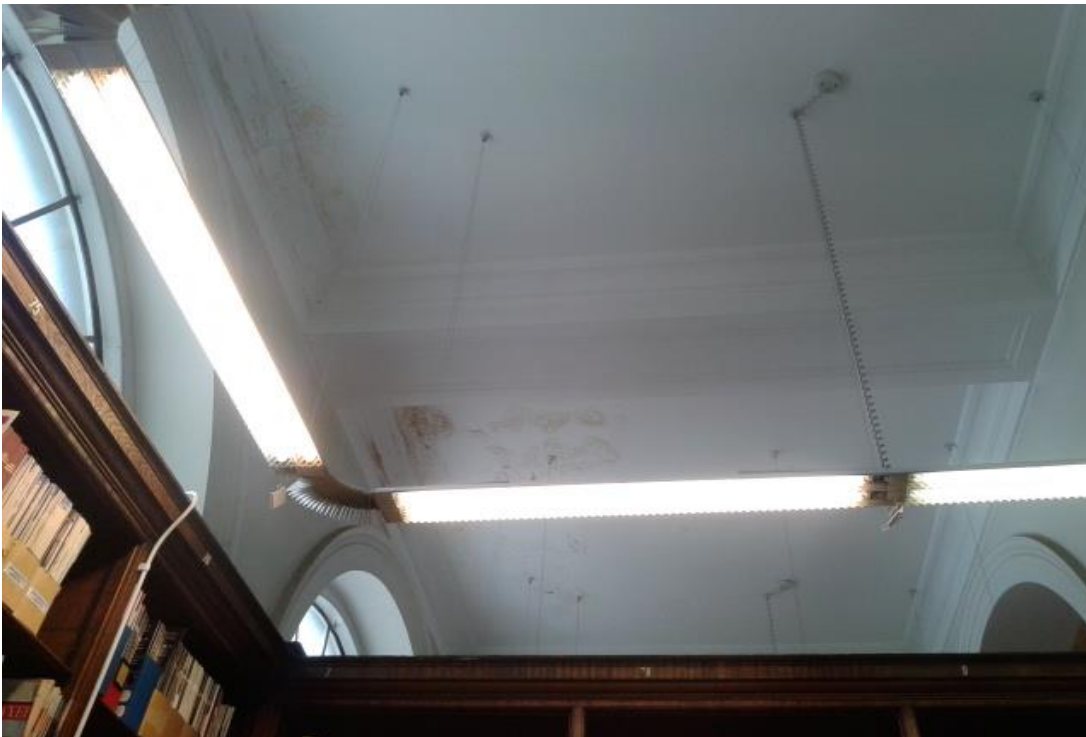
124148 Water ingress to library

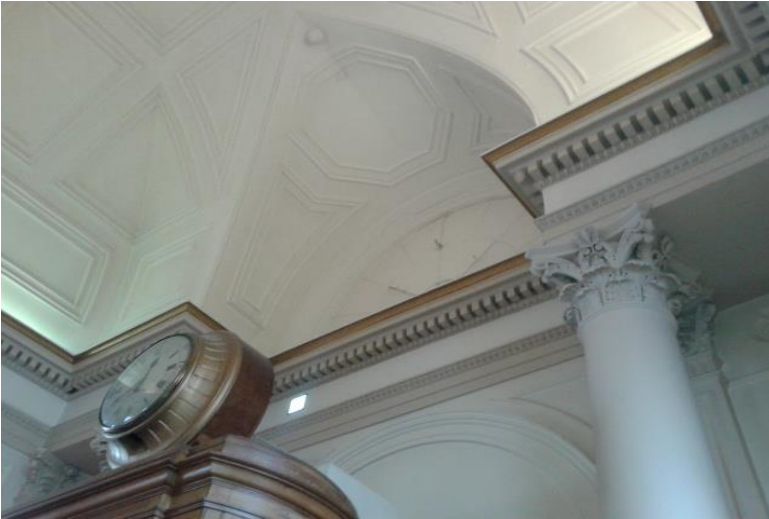
124355 Hairline fractures in library ceiling

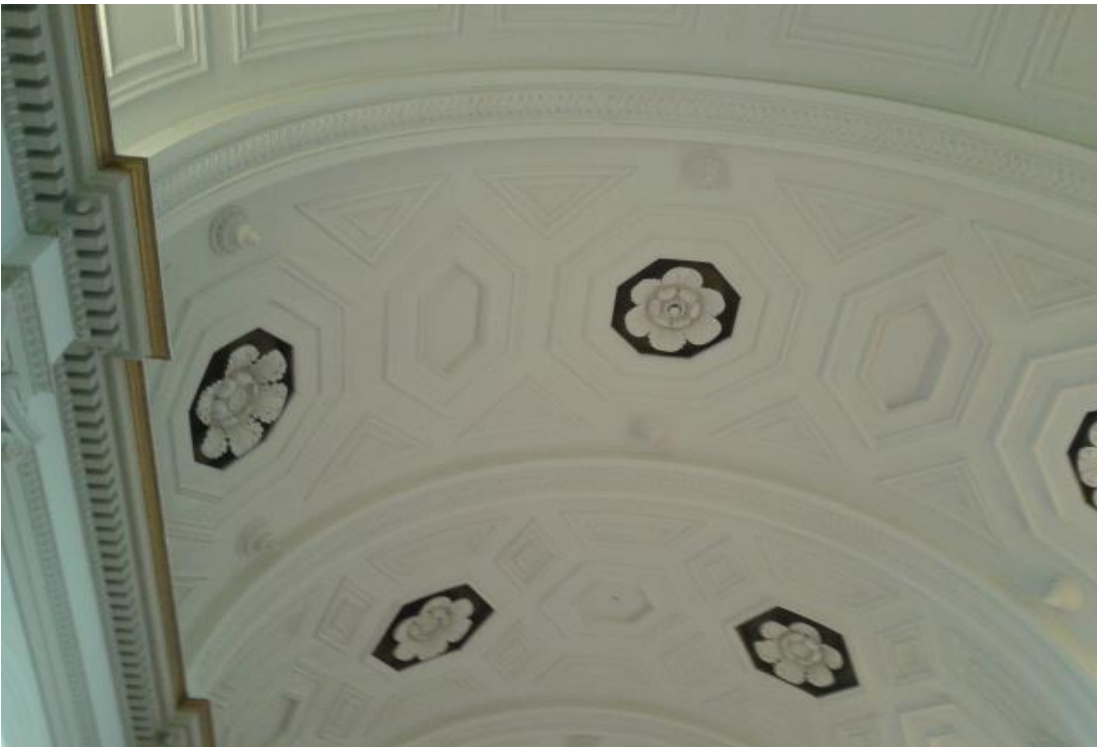
124429 Hairline fractures to plaster ceiling

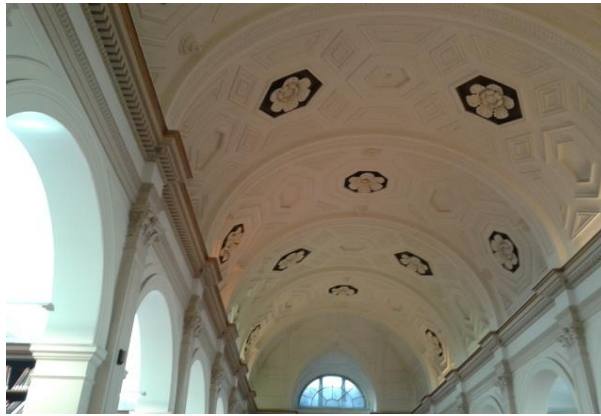
124442 plaster ceiling with ribs

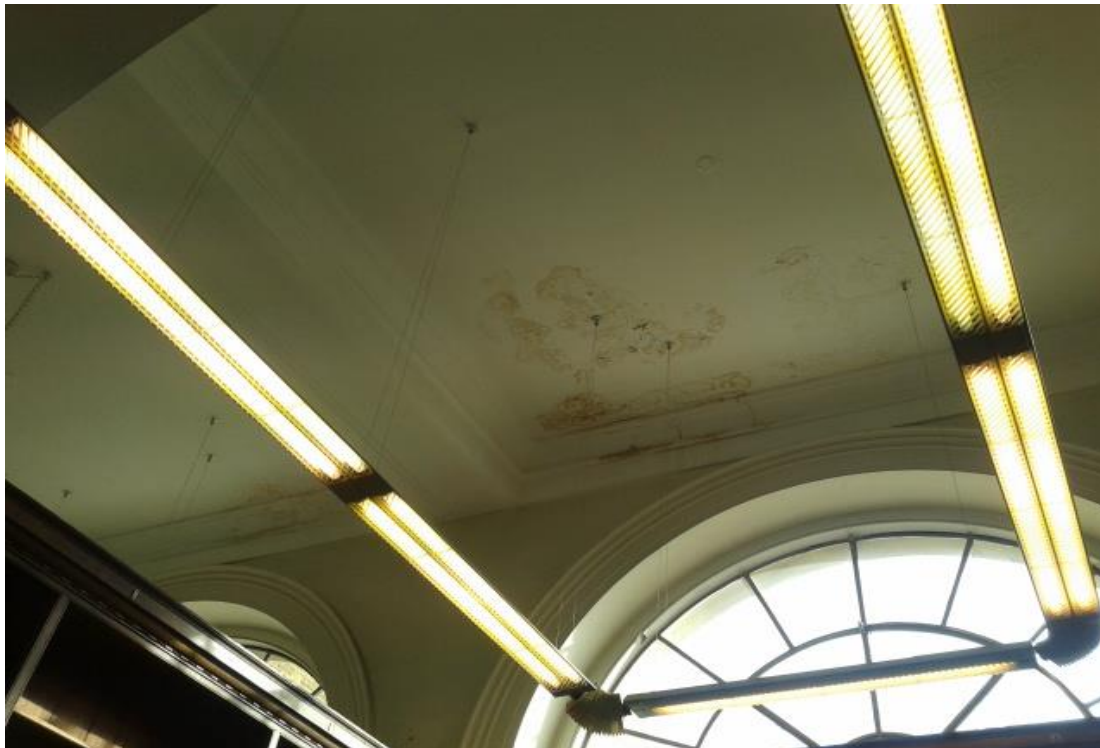
124509 water ingress to ceiling

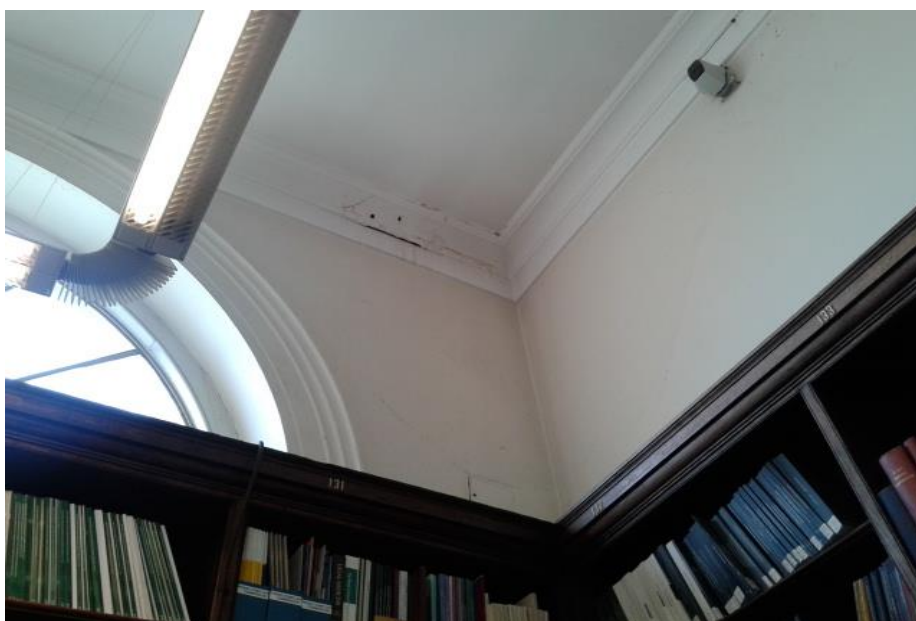
125322 Further water damage

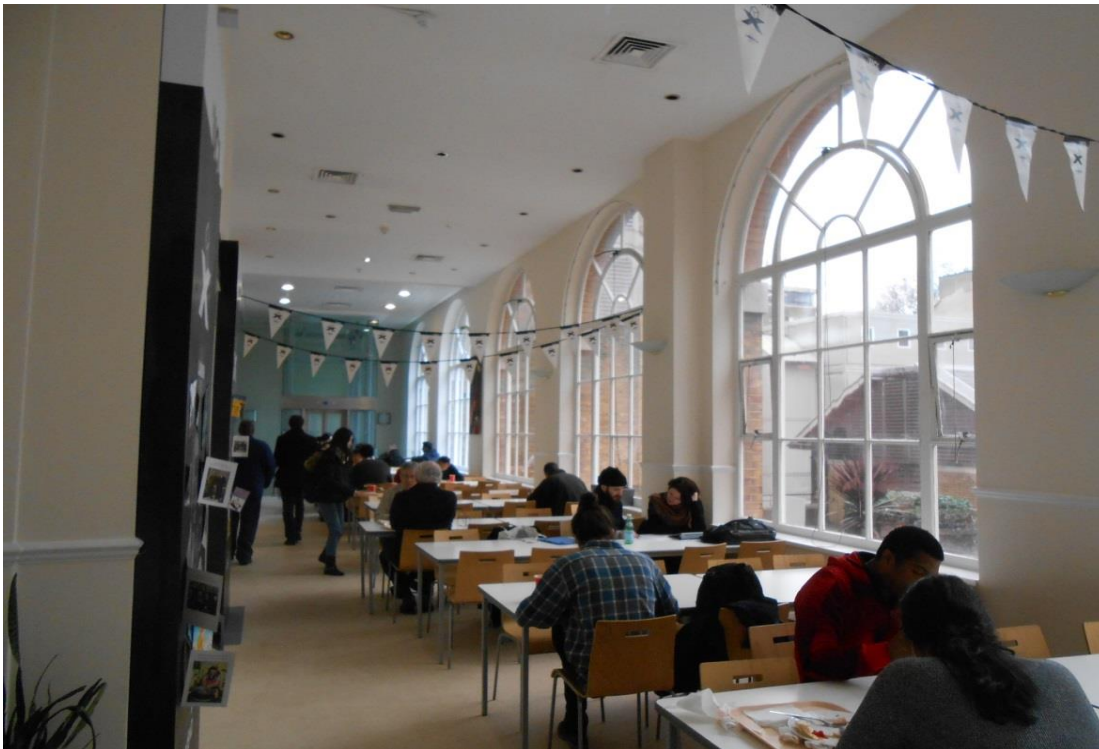
1444 Refectory

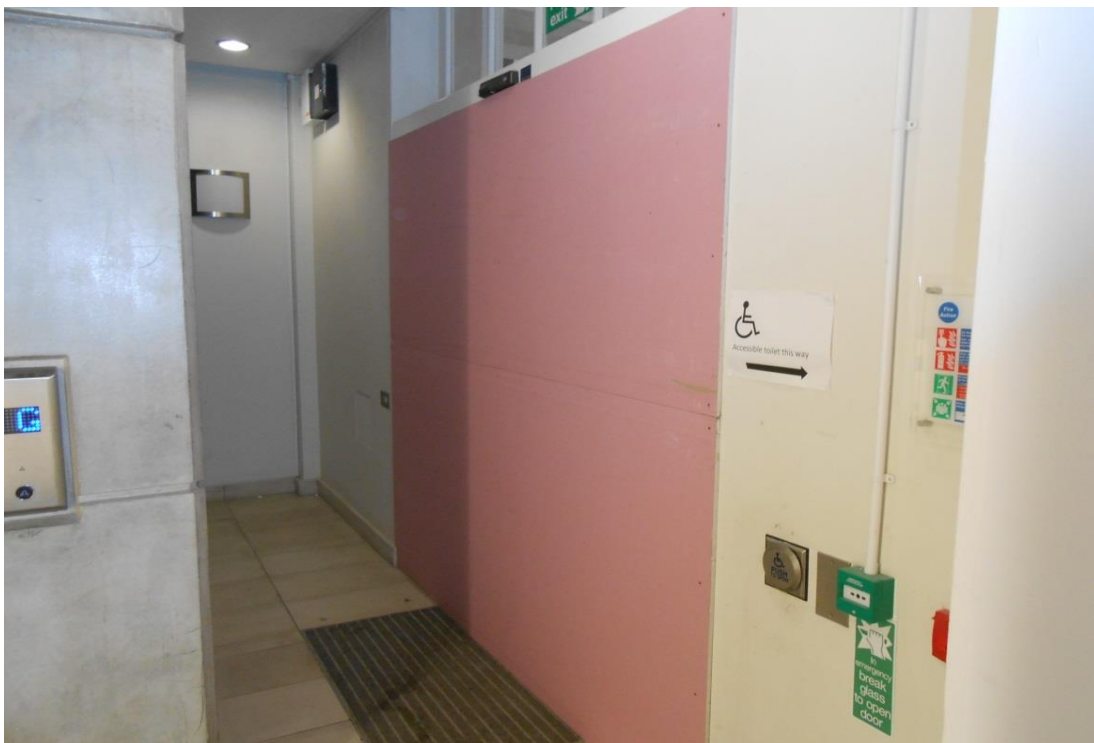
1425 Lower Ground floor - area sectioned off for construction site

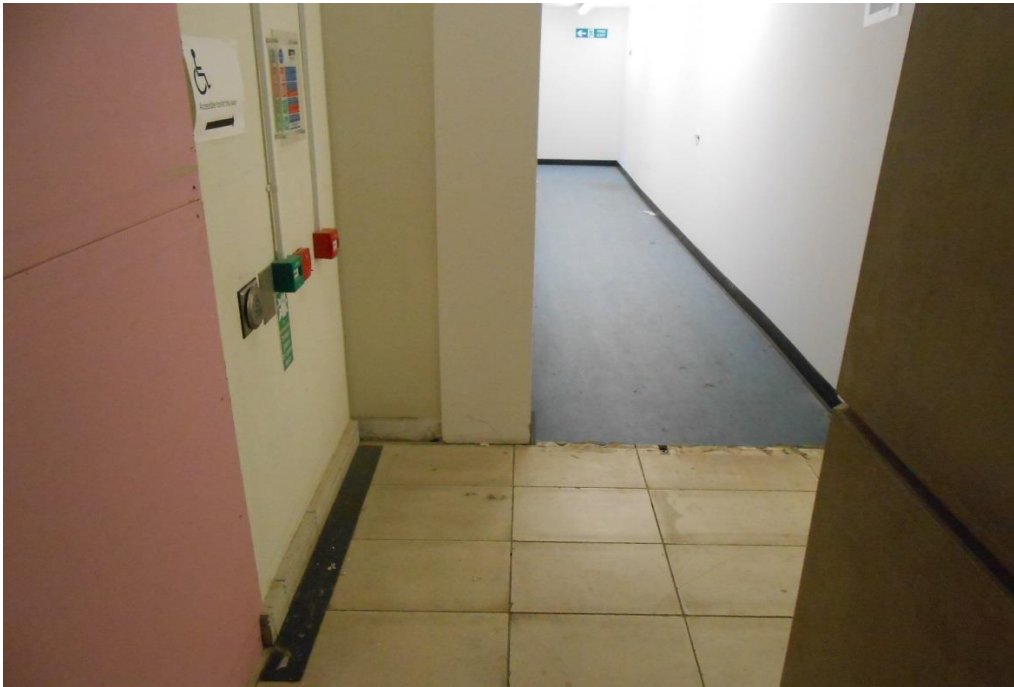
1423 temporary corridor to Japanese Garden

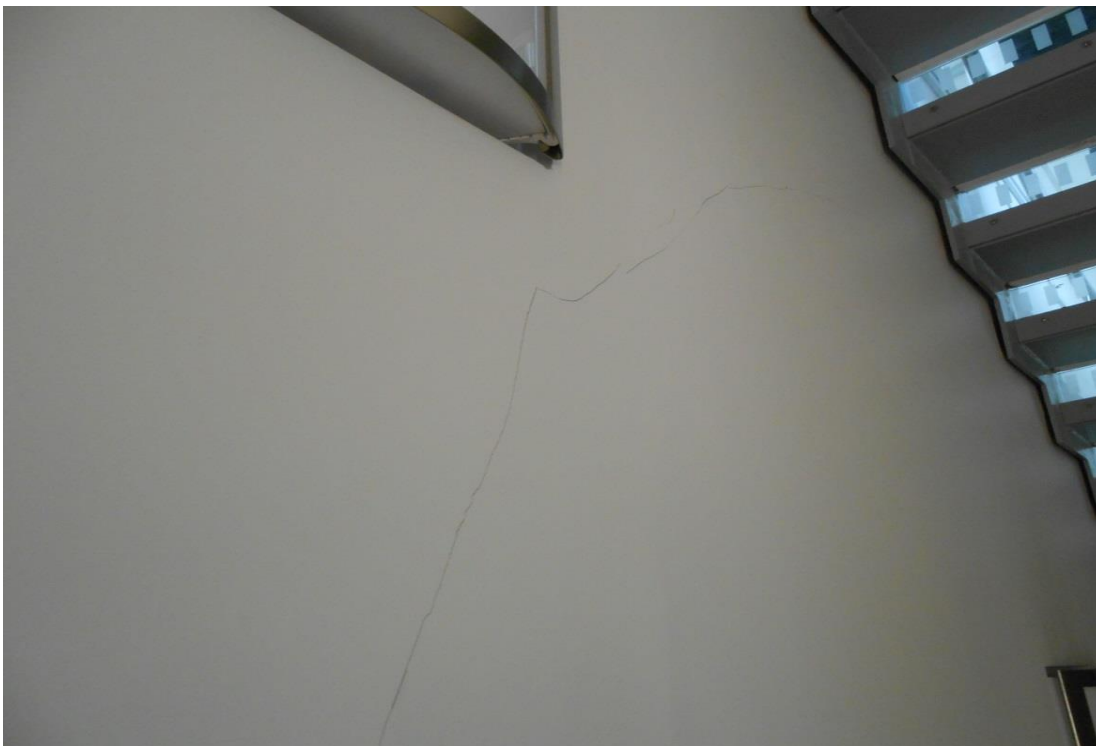
<p><u>Doors</u></p> <p>Framings</p> <p>Doors</p> <p><u>Windows</u></p>	<p>Bloomsbury Theatre. This appears to be expansion damage. The fracture starts on basement level on the second trend and runs up approximately 1.5 meters and then it hairline fracture diagonally off to the right hand side. There is also a hairline fracture above the centre light fitting running across the bottom of the stairs – photographs have been taken but due to the fracture being hairline it is not very clear to see. On the half landing opposite the window there is further diagonal fracture which appears to be fresh, this approximately 1 to 2mm at its worse point and runs underneath the light on the half landing. Over towards the right hand side to the sort of flight of stairs leading up. It should be noted that the temporary site lighting has been secured to the wall loosely with plugs. Moving on to the half landing by the large window, there is slight marking above the light fittings, possibly due to heat marks. Above the window on this half landing there is a minor fracture to the left hand side of the arch. This runs from the open unit of the arch to the return of the floor support, this is hairline fractures and has minor short 10 to 20mm hairline fractures coming off of it. Along this wall there is hairline fractures to the wall which would turn to the corner elevation of the building. However it should be noted that there is construction works including ground removal on the external wall of this area. It is recommended that a further survey once those works have been undertaken is carried out to ensure that the extent to the cracking movement prior to further construction works. To the wall internally abutting the refectory there is minor hairline fractures to the plaster work. These run from the skirting board detail to the timber sill detail and are of</p> <p>The external door is currently boarded over with temporary boarding for access onto the construction site.</p>

1428 Fracture to wall within stairwell

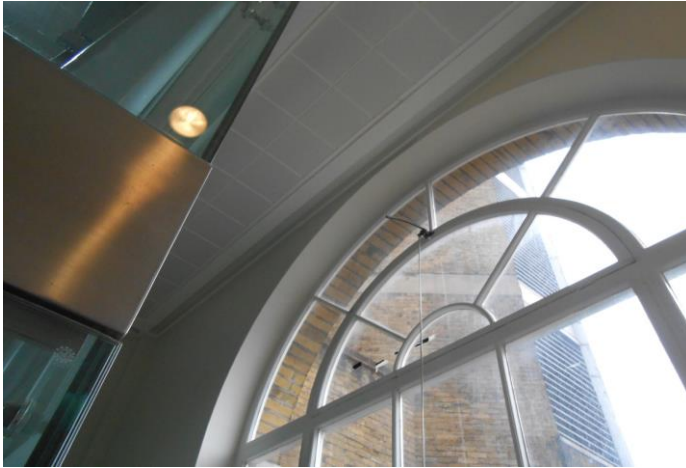
<p>Framings Glazed screens</p> <p>5. Mechanical services</p> <p>6. Electrical services</p> <p>8. Decorations Internal</p> <p>9. Fixed furniture and fittings</p>	<p>The window is a timber framed window, this window overlooks onto the colonnade with the ponding on the flat roof picked up externally</p> <p>Lift not tested</p> <p>site light fittings installed</p> <p>The staircase is a free standing metal stair case with polished reconstituted stones treads and half landings with a galvenised steel hand rail with glass balustrades where required.The first flight of stairs coming down from the ground floor or the refectory the bottom tread has some damage to the corner and this has been repaired with poor glue/resing fix.</p>		
--	--	--	--

1434 Stairwell window

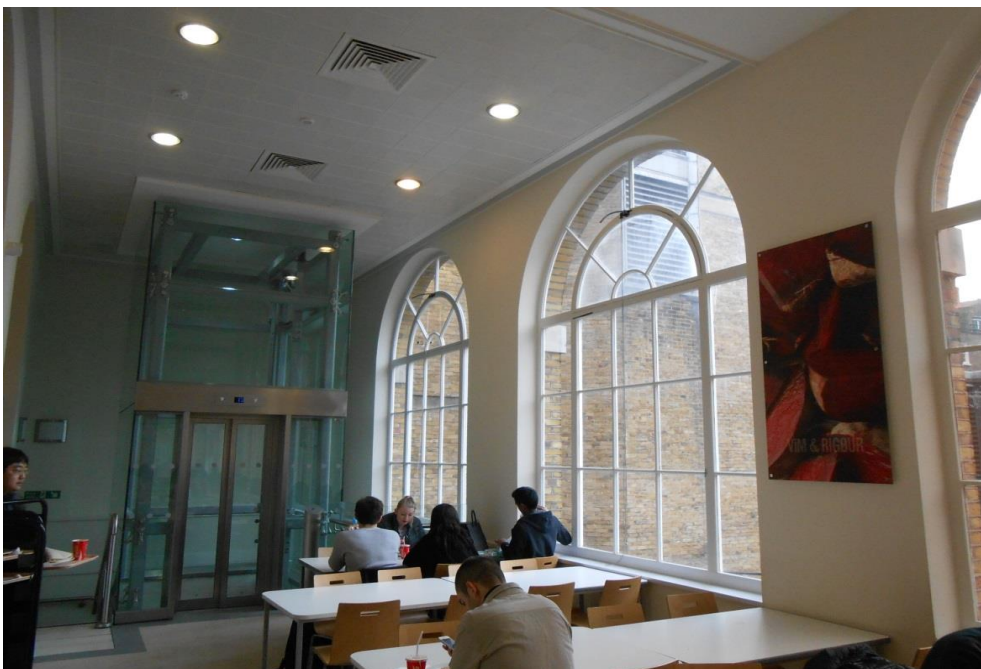
1440 Refractory

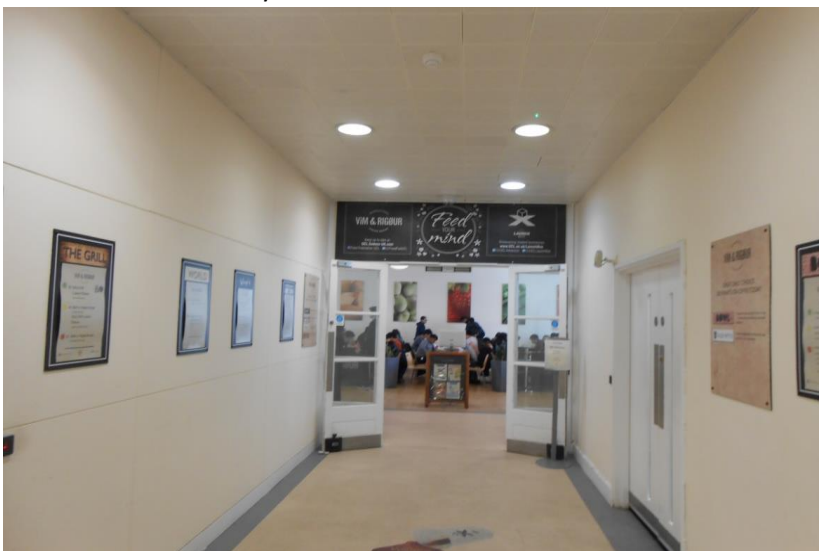
Floor: Ground Floor Room: G93B - Lobby			
Element	Description	Condition / Condition Rating	Photo Reference
1. Floors and stairs <u>Floor</u> Screed and floor finish Structure	Vinyl floor finish Solid concrete floor	Good condition - A Good condition - A	1932
2. Ceilings Structure	ceiling is a low suspended grid system, complete with inset lights and smoke and fire detectors and CCTV camera.	Good condition - A Good condition - A	
3. Internal walls, doors and windows <u>Walls and Partitions</u> Structure	Solid built walls On one side the walls are painted plaster finish and in good condition with general scuff marks.	Good condition - A Good condition - A	
Linings/finishes	wall has been clad with plaster board to give it a decorative finish. This plaster board has a painted finish and has numerous scuffs and greasy stains along the walls from general usage.		
<u>Doors</u>

1932 Entrance lobby to Refractory

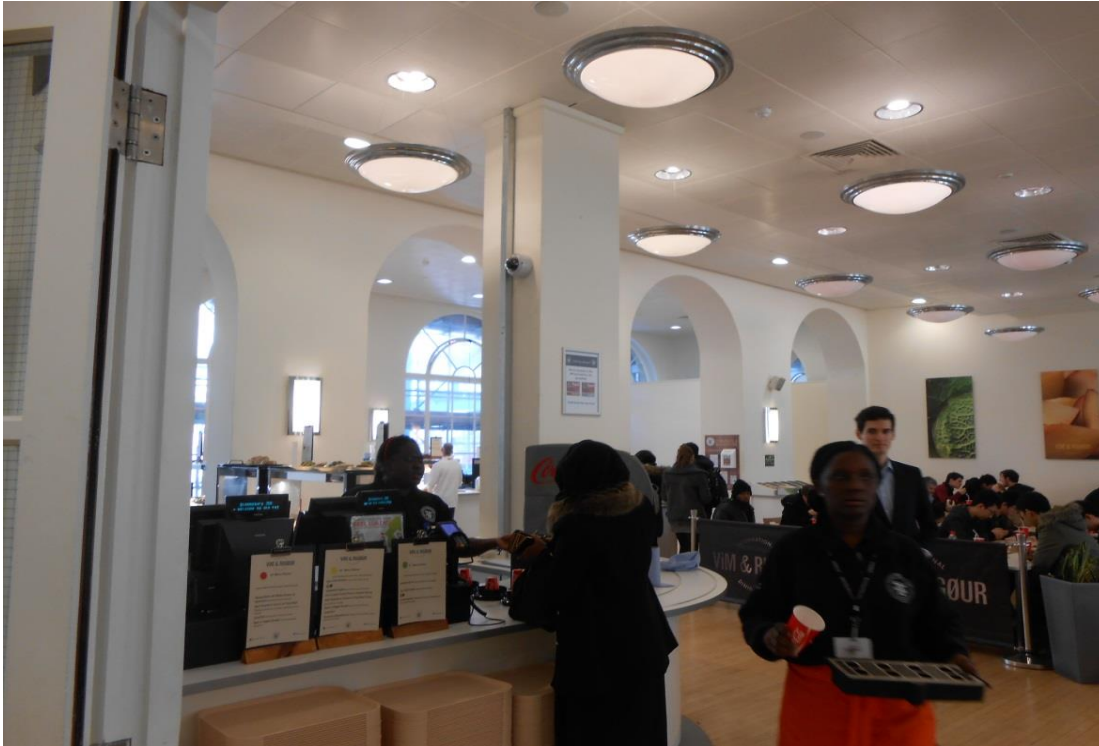
1933 Overview of Refractory

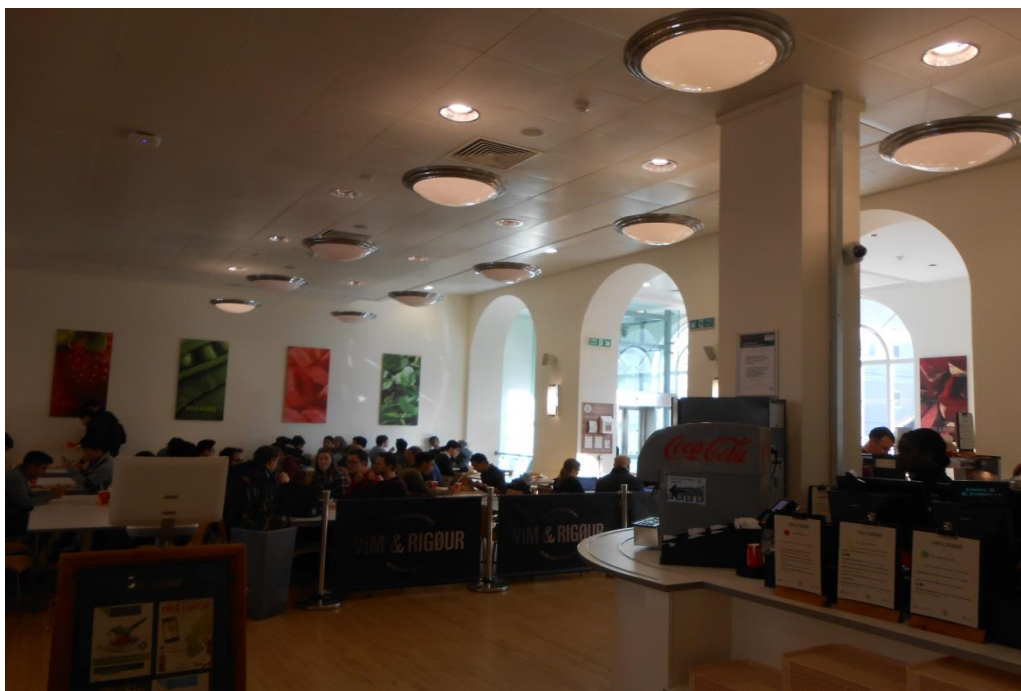
1934 Refractory
