Condition of: Bloomsbury Theatre Internals
UCL, London
WC1E 6BT

Chartered Building Surveying and Consultancy Services

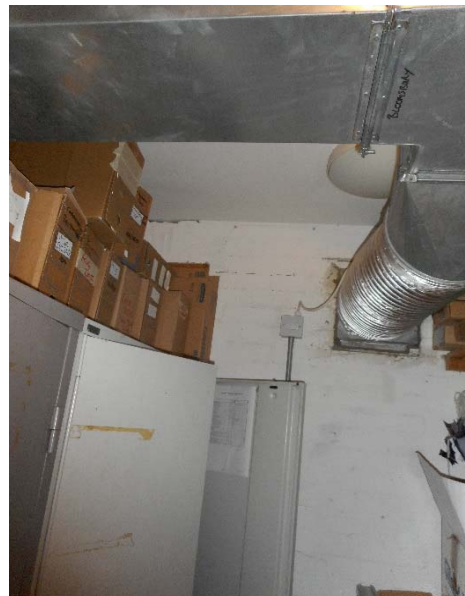
Floor: Third Floor Room: B.F.C Store (56)			
Element	Description	Condition / Condition Rating	Photo Reference
1. Floors and stairs <u>Floor</u> Screed and floor finish Structure	Solid concrete floor, no issues noted.	A	BLI024
2. Ceilings Structure Decoration	Painted plaster ceilings, this has been done to a relatively poor standard and could do with further decoration works.	B	
3. Internal walls, doors and windows <u>Walls and Partitions</u> Structure Linings/finishes	Walls here are formed of painted brickwork, these decorative works here have been completed to a poor standard. Some minor movement cracks noted to the mortar joints but this is not of any significance, no issues other than poor decoration noted.	B	
<u>Doors</u> Framings	Flat panelled door and softwood surrounds, was in good condition, no issues noted.	A	
<u>Windows</u> Framings Glazed screens			
4. Sanitary services

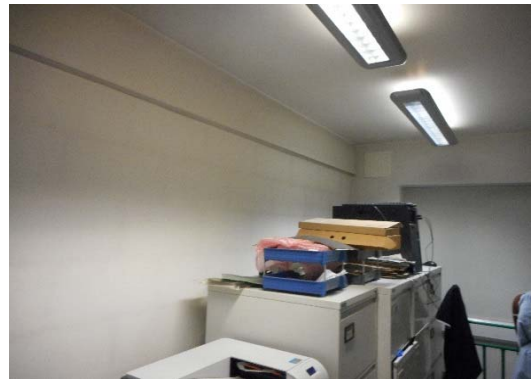
Floor: Third Floor Room: 308A Machine Room (60)			
Element	Description	Condition / Condition Rating	Photo Reference
1. Floors and stairs <u>Floor</u> Screed and floor finish Structure 2. Ceilings Structure Decoration 3. Internal walls, doors and windows <u>Walls and Partitions</u> Structure Linings/finishes <u>Doors</u> Framings <u>Windows</u> Framings Glazed screens 4. Sanitary services 5. Mechanical services	Carpeted floor covering in good condition. Solid concrete floor. Painted plaster ceiling, good condition, no issues noted. Painted plaster walls and painted blockwork, there is a prominent vertical crack noted here which runs from floor to ceiling, this should investigated further to determine the cause. Softwood door surrounds in good conditions, doors were in good working order, not issues noted.	A A C A	BLI029 to BLI031

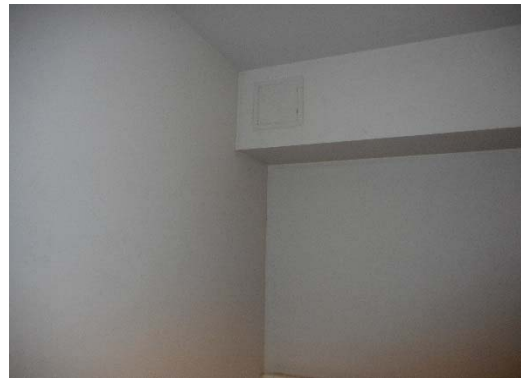
Floor: Third Floor Room: 308 Reception (51, 50)			
Element	Description	Condition / Condition Rating	Photo Reference
1. Floors and stairs <u>Floor</u> Screed and floor finish Structure	Laminate floor covering in good condition, this appears to be a relatively new installation. Solid concrete flooring.	A	BLI031 to BLI032

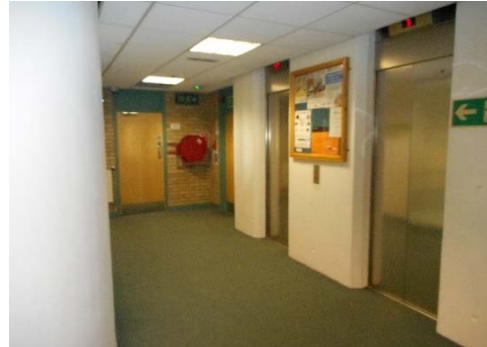
Floor: Second Floor Room: Lobby284 (45)			
Element	Description	Condition / Condition Rating	Photo Reference
1. Floors and stairs <u>Floor</u>	Solid concrete slab flooring with a carpeted finish, the carpet was slightly worn in areas but was relatively good condition. This is a high traffic area therefore carpets should be maintained to ensure they maximise their usable life.	B	BLI035 to BLI037
Screed and floor finish Structure

2. Ceilings Structure			
Decoration	Suspended roof tiles, good condition, some tiles would benefit from being replaced to keep the high aesthetics in the building.	B

3. Internal walls, doors and windows <u>Walls and Partitions</u>	The walls were a mixture of painted plaster, exposed brickwork and painted concrete. No cracking noted, painted areas would benefit from redecoration.	B	
Structure Linings/finishes			
<u>Doors</u>			
Framings	Softwood door frames with flat panelled doors. Good working order, no issues noted.	A	
<u>Windows</u>			
Framings			
Glazed screens

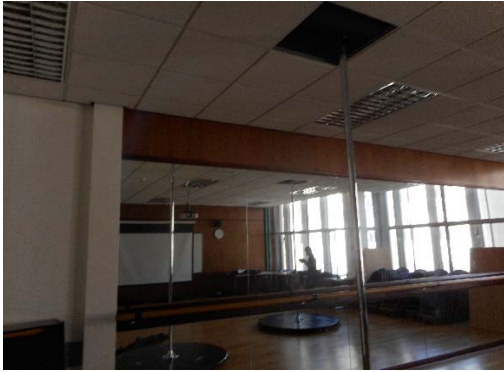
Floor: First Floor Room: Meeting Room 106 (33)			
Element	Description	Condition / Condition Rating	Photo Reference
1. Floors and stairs			
<u>Floor</u>			
Screed and floor finish	Solid concrete floor with a laid laminate flooring. Good condition, no issues noted.	A	BLI042 to BLI044
Structure

2. Ceilings			
	Suspended ceiling tiles, these are in relatively good condition, some minor damages in areas. These would benefit from being replaced to keep the high aesthetics to the building.	B	
Structure			
Decoration

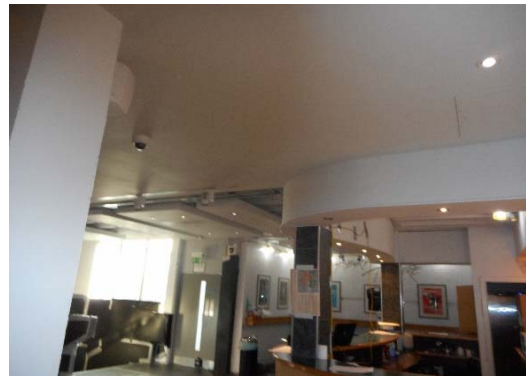
Floor: Upper Ground Floor Room: Lobby / Theatre Reception (17 / 16 / 15)			
Element	Description	Condition / Condition Rating	Photo Reference
1. Floors and stairs			
<u>Floor</u>			
Screed and floor finish	Solid concrete floor, this could not be inspected due to a protective covering for the construction works.	No Rating	BLI045 to BLI049
Structure

2. Ceilings			
	Painted exposed concrete beams with suspended lighting features. Good condition at the time of the inspection, no issues noted.	A	
Structure			
Decoration

3. Internal walls, doors and windows			
<u>Walls and Partitions</u>			
	This was a mixture of painted brickwork, painted plaster and painted concrete finish with some walls covered with protective coverings, all was in relatively good condition. Some minor decoration works needed, although I assume this will be completed after the construction works.	B	
Structure			
Linings/finishes			
<u>Doors</u>			
	Softwood door frames with flat panel door frames. Good working order, redecoration needed but again I assume this will be completed after the construction works.	B	
Framings			
<u>Windows</u>

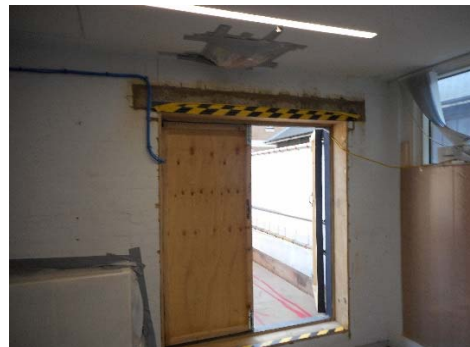
Floor: Upper Ground Floor Room: Theatre Office (19)			
Element	Description	Condition / Condition Rating	Photo Reference
1. Floors and stairs <u>Floor</u> Screed and floor finish	Solid concrete floor with protective coverings, no inspection could be completed.	No Rating	BLI054 to BLI056
Structure

2. Ceilings Structure Decoration	Painted exposed concrete and beam ceiling, this was in good condition no issues noted.	A	
3. Internal walls, doors and windows <u>Walls and Partitions</u> Structure Linings/finishes	This area had a mix of painted brickwork, painted concrete and painted plaster, the walls here are in need of a thorough redecoration although I assume this will be done after the construction works.	No Rating	
<u>Doors</u> Framings			
<u>Windows</u> Framings Glazed screens	Door here was a timber framed double door opening to the exterior, I assume this door was installed for the construction works only as this is not shown on the plan.	No Rating
