Private client

Tree quality survey for  
Athlone House,  
Hampstead Lane, London N6

June 2016

**Catherine Bickmore Associates Ltd**

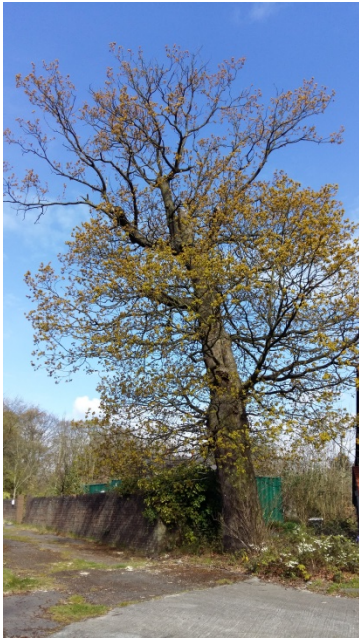
- 3.5 Oak 905 is located to the immediate south side of the Gatehouse with a foot path to its north and hard standing to its south. The oak included decay in the lower trunk recorded as part of an investigation in 2004. Die back (photo P1) that was recorded in the crown in 2007 still persisted in 2012 and 2016. A comparison of photographs from that time also showed a thinner canopy cover in this part of the tree suggesting on going decline in vigour.

- 3.6 The tree leans to the west (photo P1 & P7). Previous recommendations to reduce sail area of the tree through reducing its height by not less than 30 per cent to a minimum of 4.5m have not been undertaken. This tree continues to provide a significant risk to the adjacent Gatehouse building, and the entrance drive to Athlone House. The tree was classed as grade B quality on account of its current condition and life expectancy of over 20 years assuming recommended tree works were undertaken.

P1: Oak no. 905 with lost leader, die back in the crown and slight lean

- 3.7 Prior to the start of works tree protection barriers should be erected to delineate the root protection area outside existing hard standing. The position of the fencing would need to be adjusted to accommodate the works to the Gatehouse and wall, with the reduced secondary protected area to remain in place for the duration of the construction works for Athlone House. Sections of the tree barrier could be incorporated as a part of the fencing to define the construction area for the contractors Drawing 725/05).The barriers would need to be removed to enable the landscape works to be undertaken.

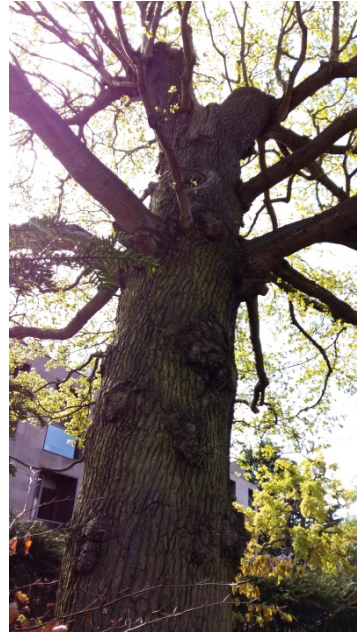
- 3.4 Oak 905 and 906 were located either side of the entrance, off Hampstead Lane. However, previous poor maintenance and possibly their location close to previous buildings/hard standing (associated with the former Hospital use) may have affected their condition. Both these oaks were severely lopped over 10 years ago resulting in a poor form, in particular oak 906 with regrowth now forming a pollard (photo P2).

- 3.12 The dense canopy of the tree provided some containment of views of the north western part of Caenwood Court and Athlone House (photo P5). The regrowth from previous lopping appeared vigorous however there were significant cavities and decay in both the upper trunk and close to ground level with at least part of the trunk hollow (photo P3). The condition of the tree needs to be monitored annually on account of the internal decay. Re pollarding is recommended on account of likely weak union of branch regrowth. In the absence of re pollarding the continued re growth could result in future structural instability and failure close to vulnerable locations of the entrances of Caenwood Court and Athlone House. This tree merited a category B retention classification mainly for landscape qualities.

P2: Oak no. 906 with former lopping, pollarded branches with a relatively vigorous re-growth, and internal cavities.

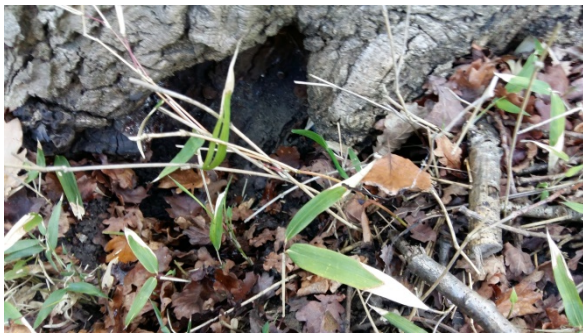
P3: Oak no. 906 with cavity at base of trunk

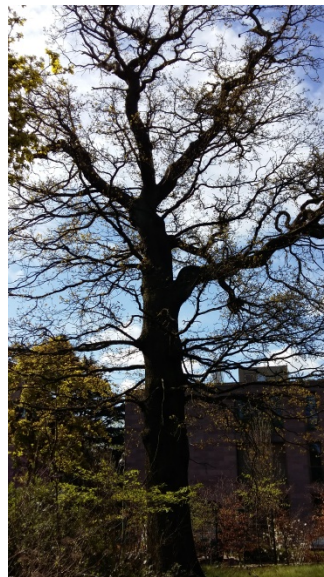
- 3.13 Oak 912 on the eastern boundary with Caenwood Court retained a reasonable form although the crown was slightly unbalanced (photo P4 & 5). At c18m height it was significant in certain restricted views in the immediate vicinity along Hampstead Lane and between Athlone House and the north western side of Caenwood Court. A road was previously located along the western side of the trunk and has since been grassed over and a line of laurel bushes established within the canopy spread. Some hard standing also remained within the vicinity. There were areas of hard standing on its western side.

- 3.14 Minor die back on the eastern side of the crown was been removed recently on account the potential risk to occupants of Caenwood Court, however minor die back in the upper crown has developed since. Wet brown slime mould was previously recorded in a cavity at the base of the trunk with a further cavity recorded at a higher level. The recommendations of 2004 survey to lighten the three main branches by about 2m and to re balance the crown have still to be implemented. Regular inspection of the tree should be undertaken on account of its proximity including overhang to the central drive way of Caenwood Court. The tree provides a significant landscape feature between the two properties with a Category B retention classification.

P4: Oak 912 by eastern boundary

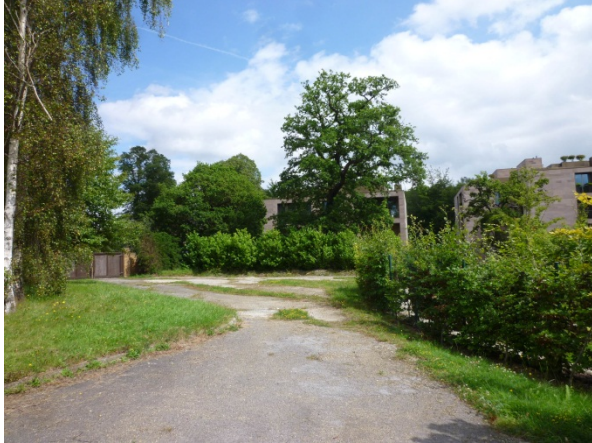
P5: Dense low canopy of oak no. 905 next to taller oak no. 912 showing slight lopsided crown

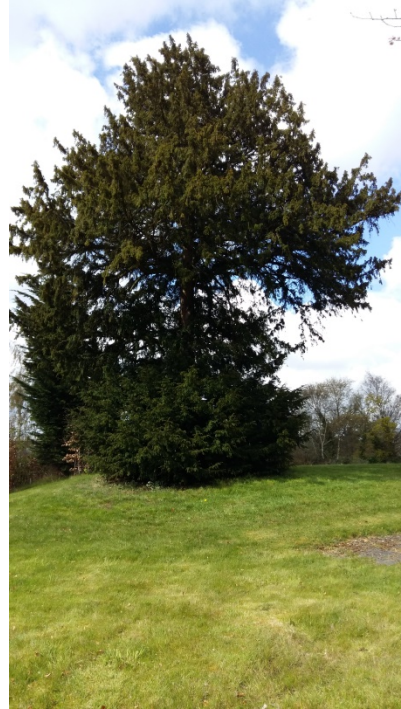
- 3.18 Yew 955 was a mature tree located on slightly sloping ground with a reasonable form and condition (photo P6). It is classed as category B retention quality. Yew 955 was previously adjacent to the southern side of the single storey accommodation block extension to Athlone House and had the majority of the lower branches removed exposing the lower trunk. These branches have re-grown to provide an indented lower canopy to the ground unsynchronised with the main canopy. Removal of the lower canopy back to expose the main trunk is recommended and included as part of the landscape proposals. The north eastern part of the root protection area has been affected by changes in ground levels as a result of landscape works within Caenwood Court.

P6: Yew no. 955 with epicormic re growth on the lower trunk creating a lower canopy,

- 3.20 Prior to the start of works tree protection barriers (Drawing 725/05) should be erected to incorporate the root protection area, and areas for planting to the north and south. Preparation of the ground for tree and shrub planting and areas of grassland within the root protection area should be undertaken by hand so as not to result in severance of larger roots. As far as possible the planting should avoid areas with a high density of roots.

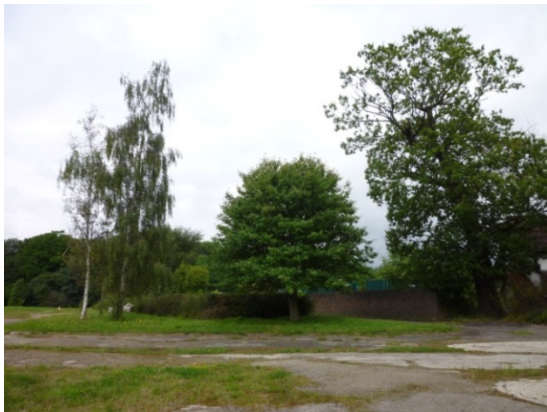
- 3.23 To the south west of the existing entrance, group no 902-904 comprised two semi mature birch and a Swedish whitebeam (photo P7) in an area of open grass adjacent to hard standing. The whitebeam no 904, in particular had developed into a reasonable tree although still relatively small in height it formed a local feature by the entrance and was allocated a category B retention class. It would be affected by the realignment of the drives and therefore would be removed.

- 3.24 Of the silver birch, no. 902 had died and should be removed at any rate. No. 903 was allocated a category C retention class-it included a minor cavity with decay and was of no particular merit and would be removed as part of the proposals.

P7: Swedish whitebeam no. 904 near the entrance between birch no. 901-902 and oak no. 905, also showing existing hard standing

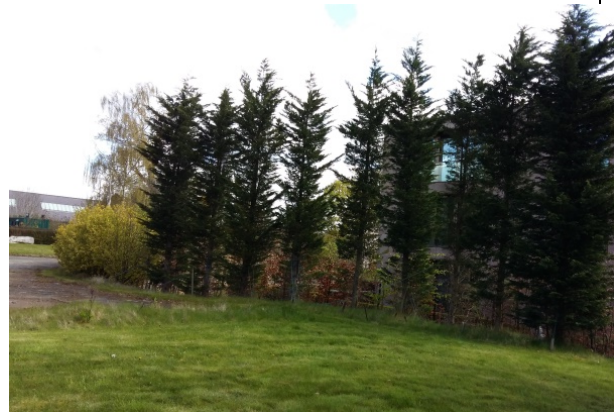
- 3.22 A row of nine semi mature Leyland cypress were planted sometime in 2009 along the boundary with Caenwood Court to provide immediate screening (photo P 9). Most retained the tree planting guys, but establishment has been slow. In 2016 the tree canopies were beginning to join suggesting that they were becoming more established. Their slow rate of establishment may be attributed to localized the poor ground conditions including the possible remains of a foundation slab (pers. com). The landscape proposals include for the replacement of the cypress with holm oak and pine planted as semi mature nursery stock (Dwing 9135/01). The alleviation of compacted ground and removal/breaking- up of any remaining underlying hard standing is recommended to improve growing conditions for the proposed planting along this section of the boundary.

P8: Row of nine Leyland cypress along eastern boundary planted as a temporary screen

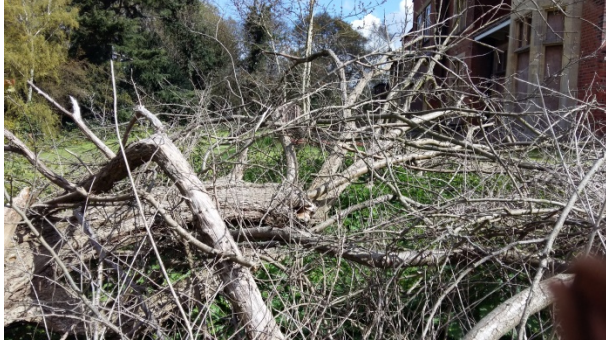
- 3.26 Two trees of no special merit were located to the south side of the house. At the southern end of the terrace by the corner of Athlone House no. 958 was a multi stemmed moribund hawthorn (photo P9). The majority of the trunk was dead with parts split off although the western part of the canopy was regenerating. It was allocated a U category as unsuitable for retention and would be removed as part of plans for the restoration of Athlone House including the extension of the terrace.

P9: Moribund hawthorn no. 958 with much dead wood on south western corner of the terrace of Athlone House

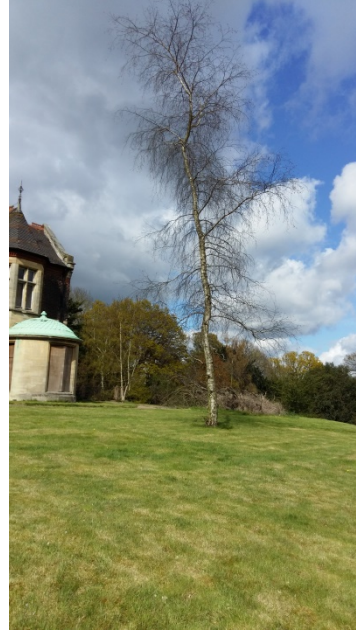
- 3.27 Tree no.957, a semi mature purple leaved birch (photo P10), was located in the lawn on the south side of Athlone House. It was a straggly specimen with a poor growth rate and was allocated a Category C retention class, of no particular merit to the immediate or wider landscape. Although it would be possible to retain, it is included for removal within the landscape proposals.

P10: Purple leaved birch no. 957 to the south of Athlone House

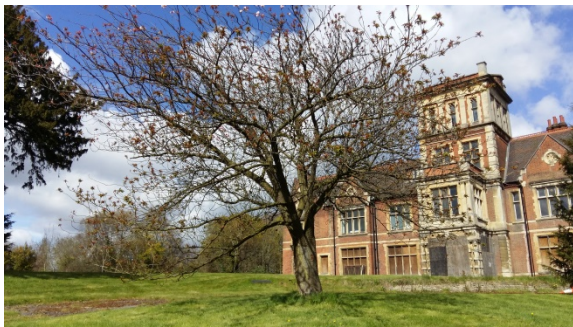
- 3.21 This mature cherry was located in open grass to the south of the yew. It was showing significant signs of decline including extensive die back in the crown (photo P11) and should be removed Category U class. This tree would be replaced by new tree planting including two *Catalpa bignoides* 'Aurea' and yew hedging as part of the landscape proposals. On its eastern side such planting of trees and shrubs would enable the establishment and long term development of trees along the eastern garden boundary.

P 11: Cherry no. 956 near eastern boundary with sparse canopy

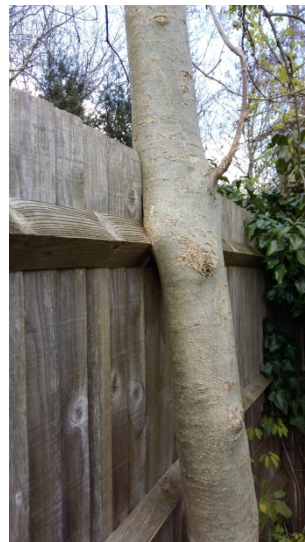
P12: Ash no. 21 ingrowing into garden fence near cottage

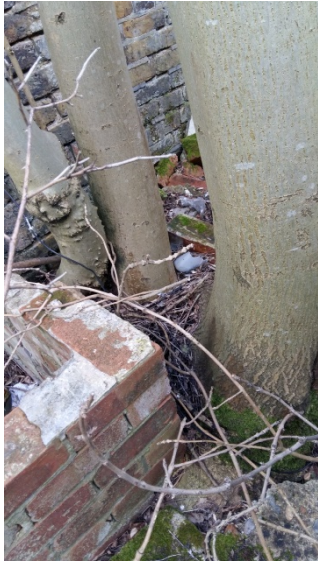
P13: Ash no. 17 growing from base of a drain.

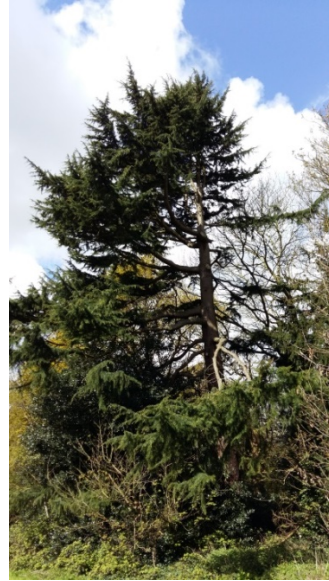
- 3.30 Trees nos 11 cedar, 959 cherry, and 965 false acacia, were located on the eastern edge of the woodland to the north west side of the main building. Cedar no 11 was the tallest tree on the eastern edge of the wooded area (photo 14), however significant branch drop in 2011 has resulted in a lopsided crown and impaired condition. It has been allocated a Category C retention class.

P14: Cedar no. 11 on northern eastern edge of woodland belt showing lopsided canopy on account of previous branch drop.

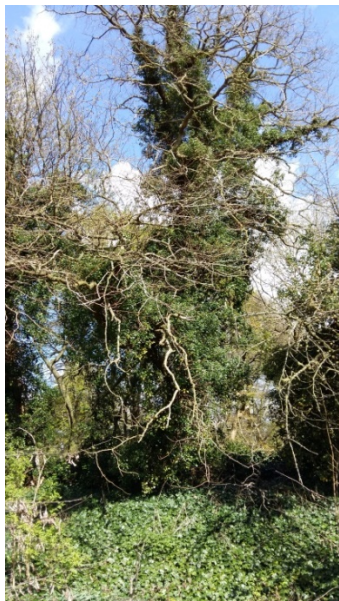
- 3.31 A leaning cherry no 959 on a banked area had a low fork at 1.5 m and leaned. Growth was suffering from being suppressed by neighbouring trees, in addition to heavy ivy cover. There was die back in the crown. It had a relatively low life expectancy and was of little merit, allocated a category U unsuitable class. On account of its woodland location it should be removed to provide more space for adjacent trees.

- 3.32 The adjacent false acacia no 965 (photo P15) at some 12m in height at the eastern edge of the wooded area was growing on a bank from the edge of a wall. It had a slight lean, with a significant ivy cover (which should be removed from the trunk on account of the weight). It was allocated a Category C retention class. It would benefit from the removal of the adjacent cherry no 959 which could be undertaken as part of the conservation management plan for the grounds. The acacia would be retained as part of the development proposals.

P15: False acacia and cherry nos. 959/965 along northern boundary bank with dense ivy cover
