Existing condition images:

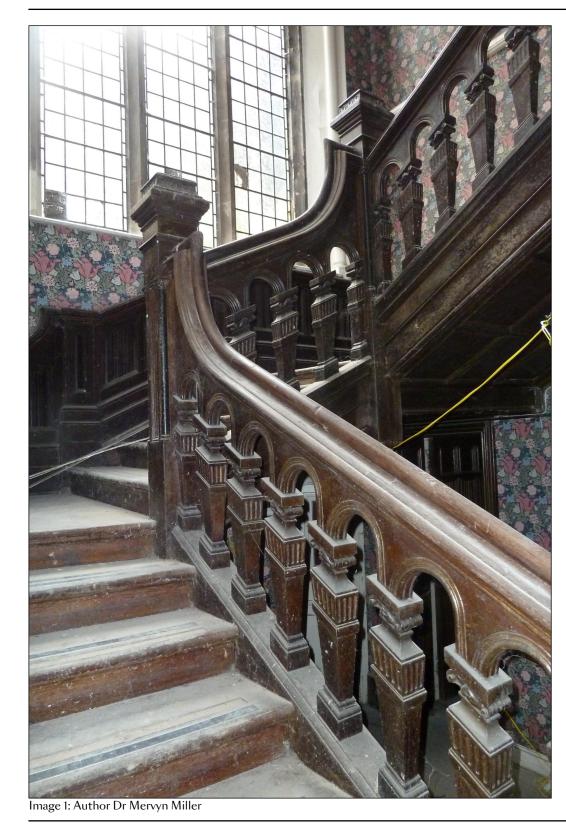
- 1) Ground floor stair off main hall.
- Stair timber largely intact. Cosmetic repair to be applied.
- Period wallpaper to be removed.
- 2) Corinthian column capital.
- Chipped stonework detailing to be repaired and replaced where applicable.
- 3) Grand hall ceiling.
- White paint over original timber to be removed and natural colour reinstated.
