Structural Observations on the
Redevelopment of
9 Godge Street.

This report considers implications of the present condition of 9 Goodge Street and proposed facade retention works.

9 Goodge Street

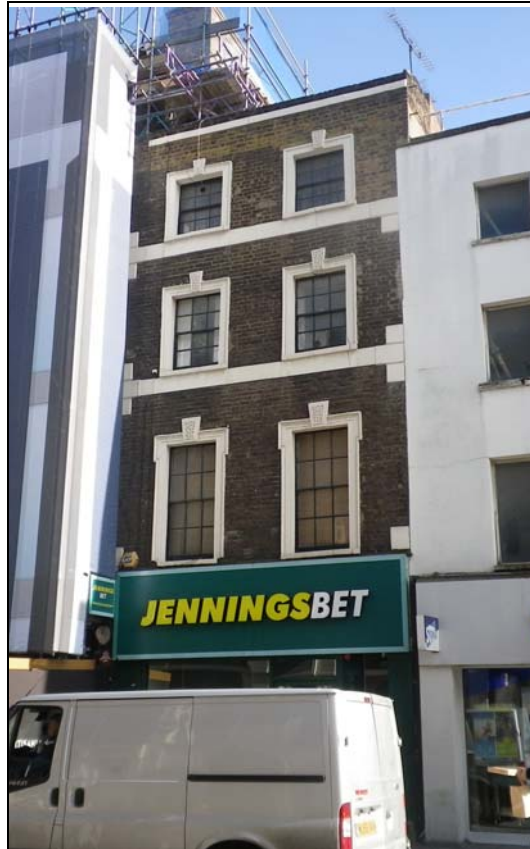
The property was constructed in the 18th Century and utilises load bearing masonry and timber floors. The property has clearly suffered for a great many years from a lack of maintenance and is generally in a very poor condition. No 9 Goodge Street is a 4 Storey building, ground and 3 upper floors or traditional masonry construction.

The faced brickwork has been subject to a degree of repair and rebuilding in the past, It is particularly noticeable that the masonry to the Western side of the elevation, right hand side when viewed from the street, has been rebuilt from parapet level right down to cill level at third floor. The whole of the parapet above the third floor window has been rebuilt. Various other repairs have been undertaken in isolated other areas.

There are signs internally of cracking between the gable wall and the open sided party walls to both sides. The floors are uneven and it can be seen internally that the door and windows frames have distorted.

Externally there have been some repairs to the brickwork though restraint straps have been installed to combat progressive bowing outwards of the front wall where it can be seen that the joist insertions into the brickwork have become markedly disconnected with relatively little bearing. This is a common feature in buildings of this age though in this case the cause is considered to be also due to bomb blast damage. The chimney stack on the exposed gable wall has a pronounced lean inward towards the property.

At this stage we are still concerned that the façade is in a very poor condition and based on the experiences as Engineers for 1-3 Goodge Street also whilst similar measures were proposed the façade did have to be rebuilt due to circumstances beyond control.

All the internal floors will require rebuilding and in a manner that ensures permanent lateral restraint from diaphragm floors.

The full token of repairs to the remaining facade will become apparent as a result of detailed and close up inspection from a scaffold.

Additional temporary works will be in the form of restraint towers and short needles to hold back the retained facade whilst stitching of cracks, replacement of lintels, failed brickwork and extensive joint repairs. Once this is complete the permanent works will be undertaken and safely connected to the retained fabric. All newly formed interfaces will be designed to accommodate differential movement between old and new without future damage to the historic facade.
