Athlone House Hampstead London N6 4RU

Structural Inspection

Date:- **May 2016**

MW Document Reference No: 7503Rja_3

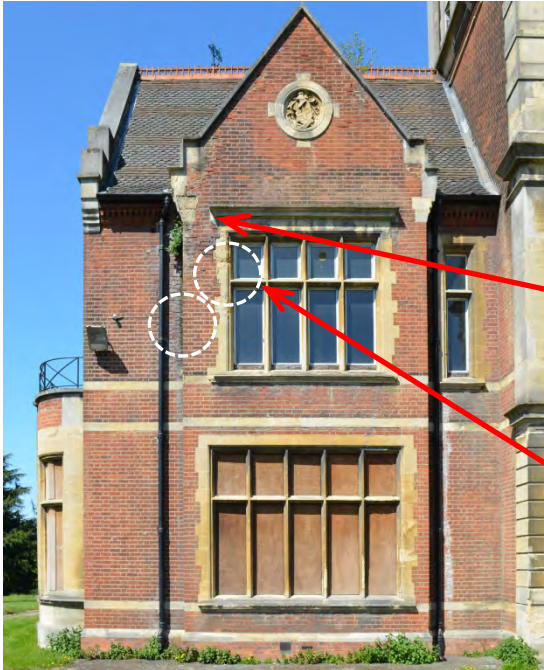
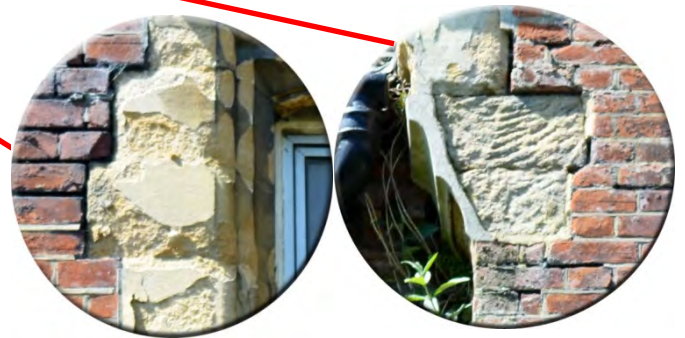
2.02

The image opposite shows the southern end of the east elevation and illustrates the typical façade configuration of brickwork with dressed Douling stone window reveals, heads, cills, transoms and mullions. Stone string courses are also set within the brickwork. It is noted that the relatively soft Douling stone shows surface decay to a large number of areas as typically illustrated in the inset details below.

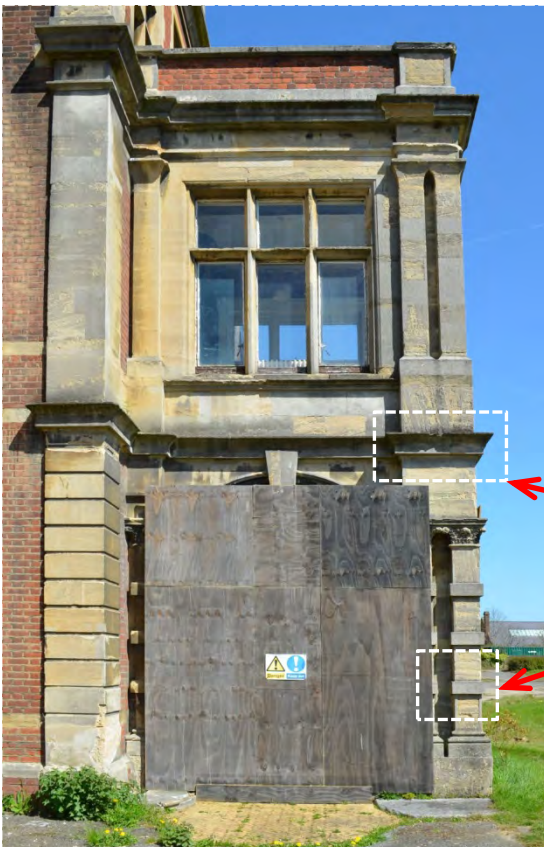
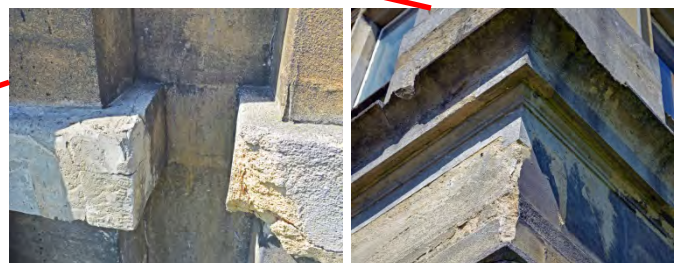
2.03

The south side of the porte-cochère to the east elevation is shown in the image opposite. Close inspection of the stonework reveals areas of mortar patching to the Douling Stone as illustrated in the inset details below. In many areas these patch repairs have performed reasonably well although the cement based material is unlikely to perform well in the long-term and the underlying natural stone is at elevated risk of frost damage and decay as a result of trapped moisture and poor breathability of the repair. Local stone repairs would be recommended and these would either take the form of whole stone replacements or the cutting in of stone slip repairs.

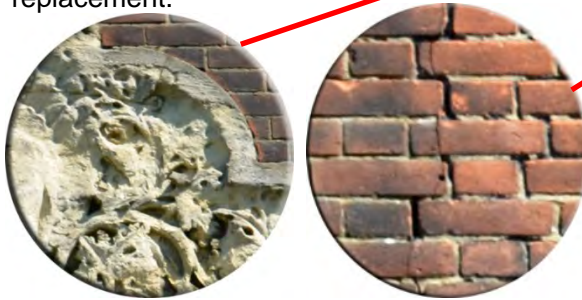
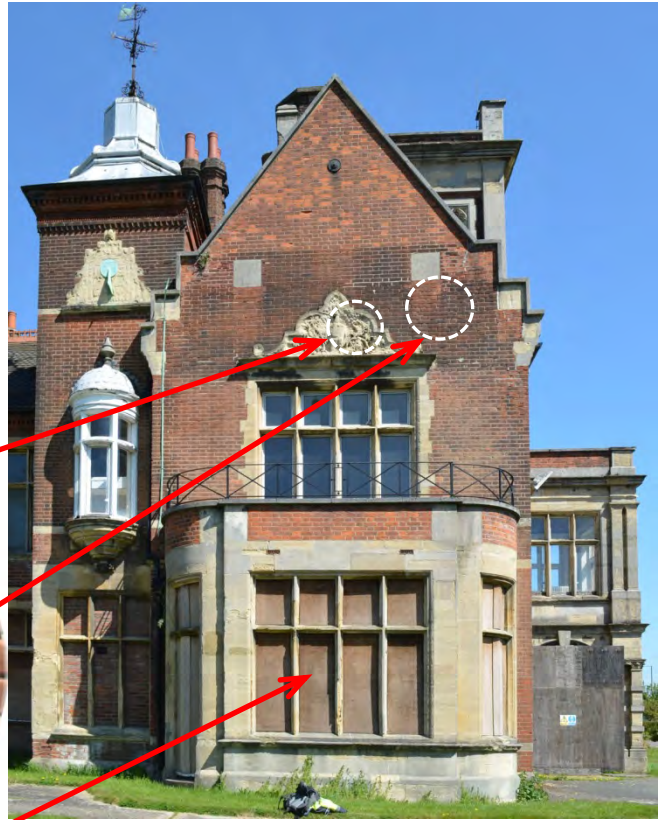
2.04 The south elevation on the south east corner, is shown in the image opposite. In common with the east elevation the Doultling Stone shows evidence of decay and historical patch repairs. The brickwork is generally performing significantly better than the stone and with the exception of isolated brickwork decay and damage, as shown in inset below, the majority of bricks are capable of being retained. Some of the carved stone details and plaques around the building are in various stages of erosion. Although these are not a structural concern there may need to be decisions made on their conservation and repair or replacement.

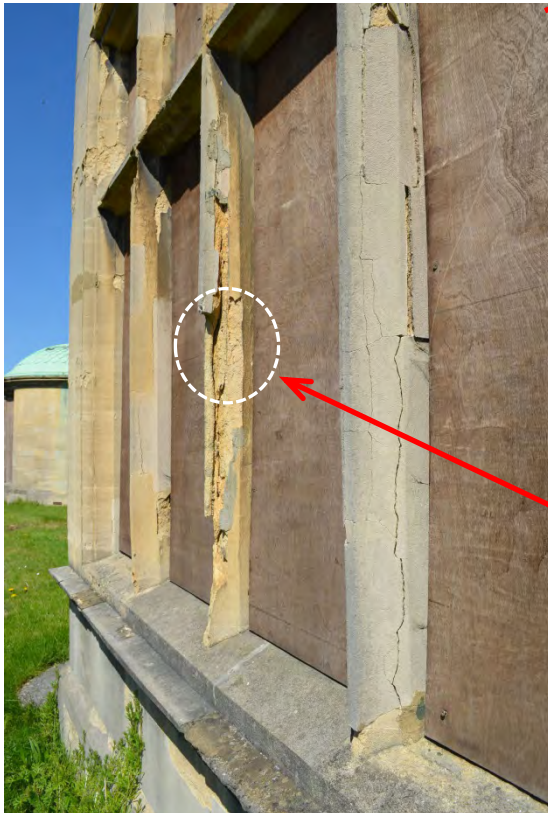
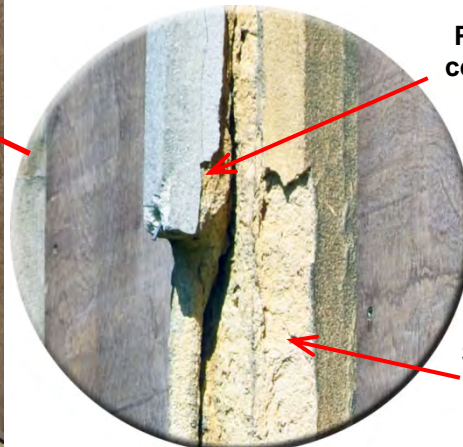
2.05

The elevations do all contain areas where deterioration has occurred through historical neglect and poor maintenance. Areas of Doultling stone mullions and window reveals have suffered from erosion and spalling as illustrated in the photograph opposite. Proposals to lower existing window cills will provide opportunity to replace the defective mullions. It would be anticipated that stainless steel backing supports would be provided to enable the increased slenderness to be accommodated.

**Poor quality
cement patch
repairs**

**Stone decay
and erosion**

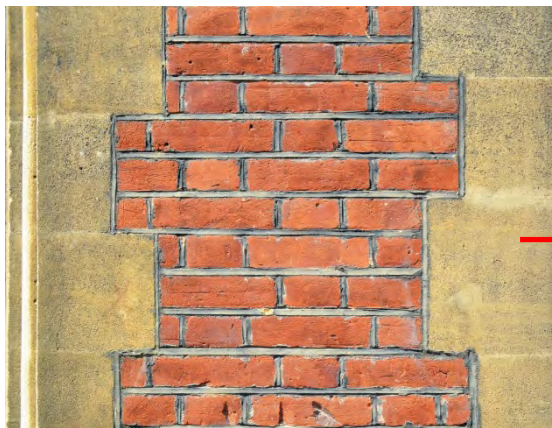
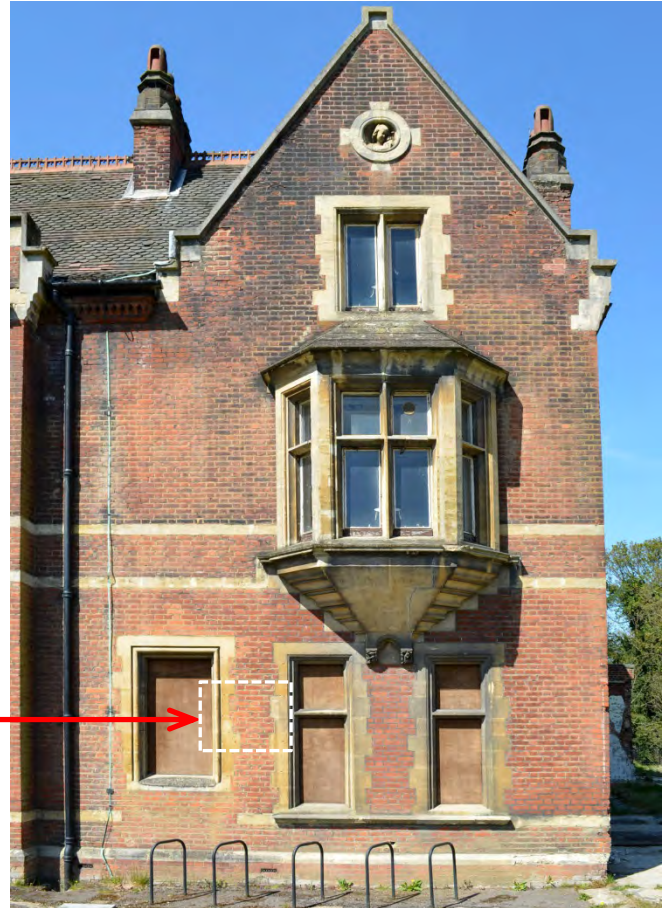
2.06 The north end of the east elevation is shown in the image opposite. The stone in this area is generally in reasonably good condition compared to the south elevation noted previously. The inset image below illustrates a typical panel of brickwork and stonework to adjacent window reveals. The joints to the brickwork appear as a relatively hard strap pointed detail which has potential to damage the brick through poor breathability. It is noted that the extent of damage witnessed in this area was not significant and this is principally a longer-term consideration.

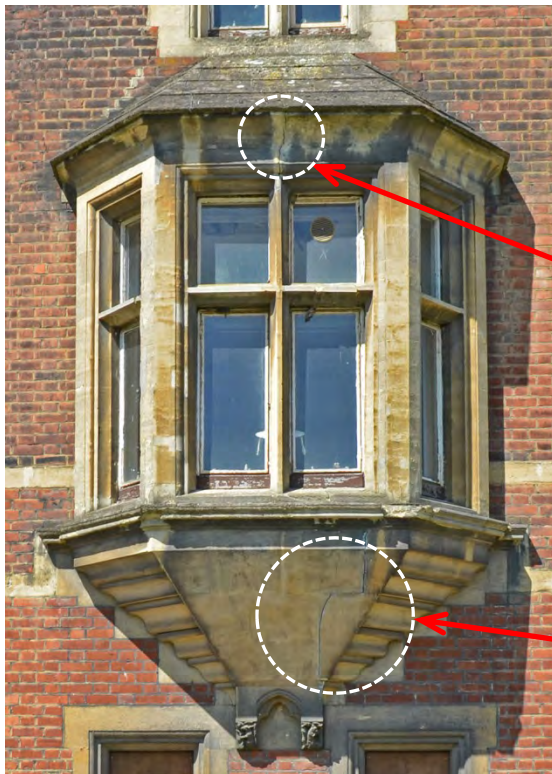
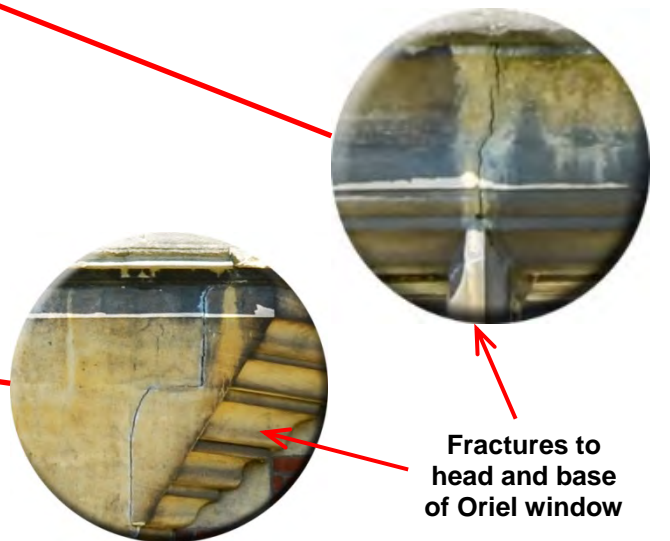
2.07

Some localised movement is evident, as illustrated opposite in the base and head of the Oriel window to this elevation. The movement appears long standing and is not considered significant. Local repairs and stitching will enable the movement to be stabilised insitu and there is no requirement for significant reconstruction anticipated.

Fractures to head and base of Oriel window

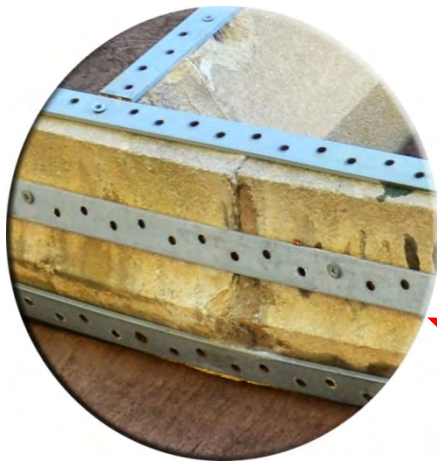
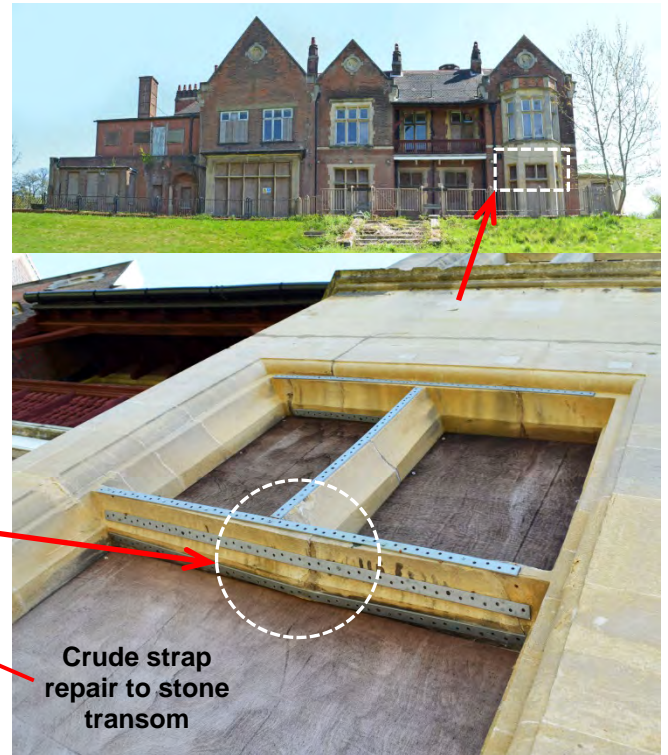
2.08 On the west elevation there is crude strapping present to the ground floor window transom and upper mullion as illustrated in the image opposite and inset detail below. It would appear that a lower mullion is missing although there is no significant evidence of removal. Reconstruction of the window configuration would be anticipated in this location.

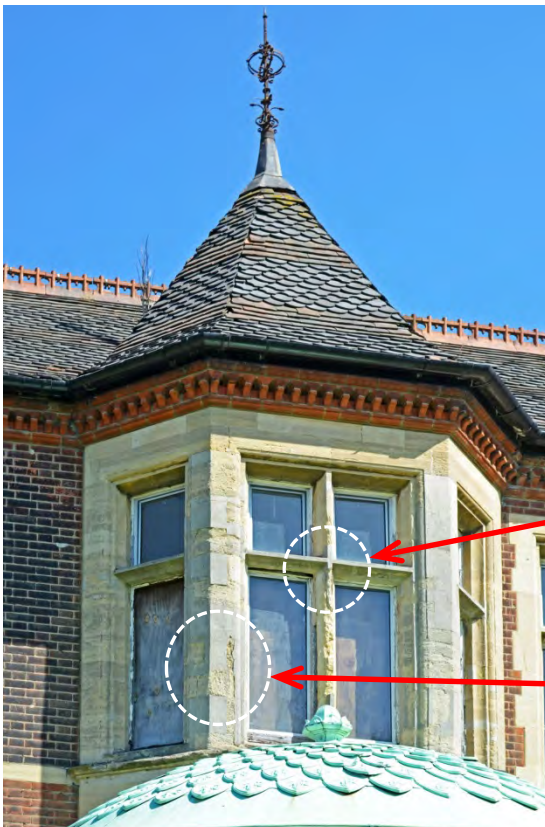
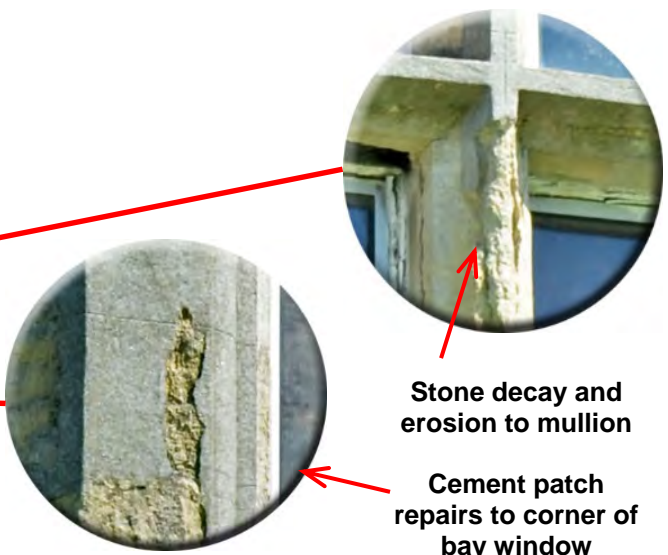
2.09

At first floor level on the south elevation there is further evidence of decay to the Douling stonework as illustrated in the bay window image opposite. The insert details show further cement patch repairs and erosion/spalling to stone mullion. Patch repairs to the stonework would be an anticipated requirement.

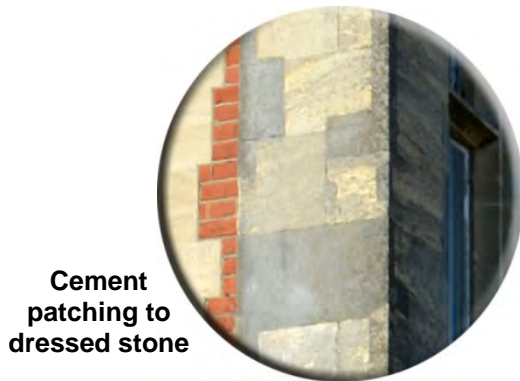
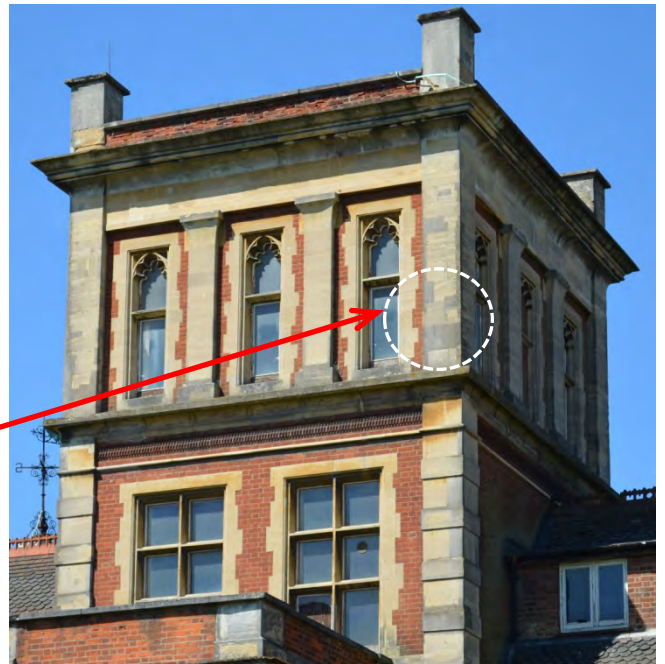
- 2.10 The tower above the east elevation is shown opposite. Structurally the tower appears stable with no evidence of significant instability. It is noted that stone repairs and cement patching is present as noted previously in other areas. The inset image below illustrates an example of the patching to this area of the building.

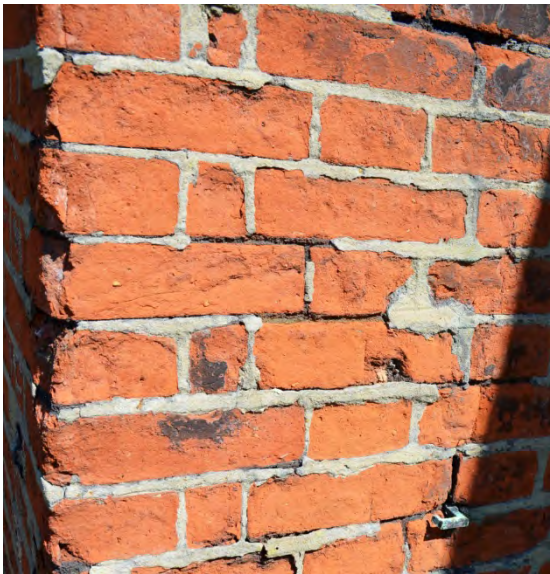
- 2.11

Although the brickwork to the elevations is generally in a condition that does not give any concern over structural stability, there are a few areas where some decay is evident to the face of the brick. The causes of brick decay can be wide ranging, and some general information on brickwork problems is provided in Appendix C for reference. The image opposite is an area at ground floor level to the south west corner of the building. The pointing in this area is of poor quality and appears cement based. The brick faces have decayed back slightly and frost action in combination with poor pointing is considered a likely cause. Repointing using a more appropriate Lime mix would be recommended. Any brick replacement should be carefully considered to ensure that an appropriate and consistent strategy is applied across the building.

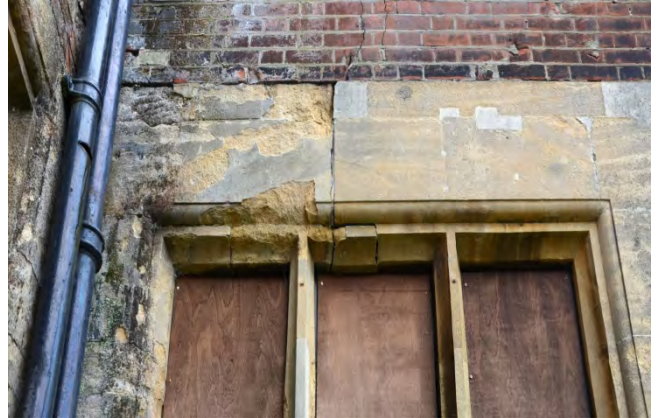
- 2.12 The image opposite illustrates the fact that in some areas the stone work decay relates to long standing leaking rainwater goods. The presence of pipes and adjacent mould staining of adjacent walls illustrates the situation. It is essential that the existing drainage system is fully investigated at the earliest opportunity.

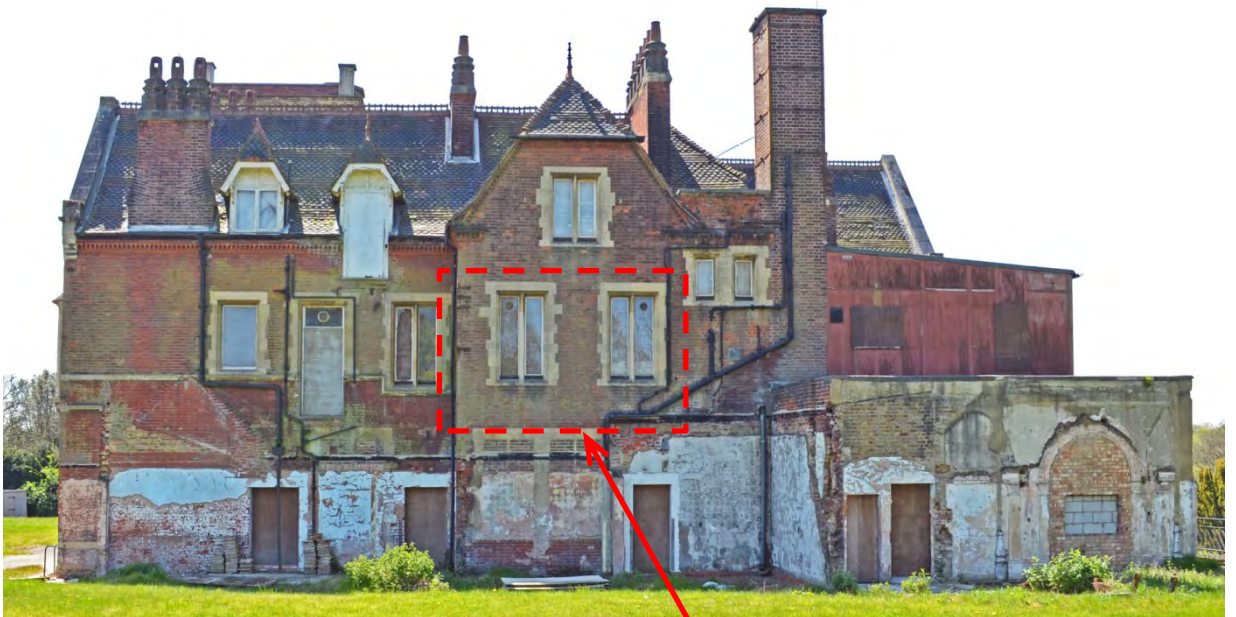
- 2.13 The north elevation has been disfigured and damaged by the later extensions, which have now been removed. The elevation is illustrated below and shows the upper floors and roof structure predominantly intact and simply in need of general refurbishment. At ground floor level some cosmetic damage has occurred as a result of becoming internal habitable spaces, but there is no evidence of significant structural damage and cosmetic repairs would be straightforward in any building refurbishment scheme.

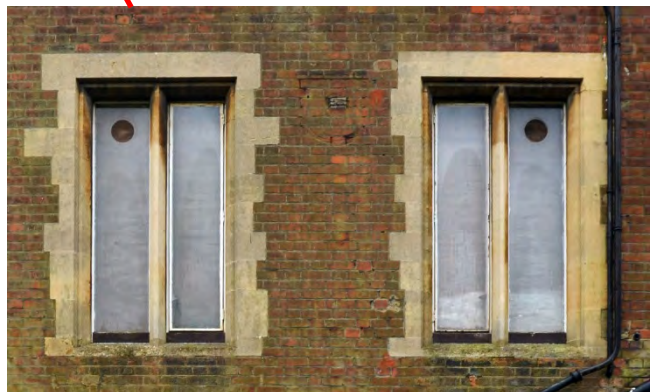
- 2.14 The image opposite shows the first floor central window pair on the north elevation and illustrates masonry in need of careful cleaning and localised cosmetic repairs, but generally not in a condition that requires extensive replacement or reconstruction.

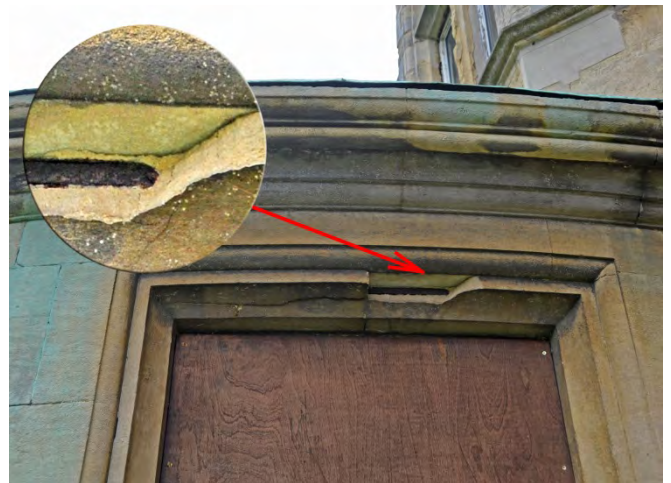
2.24

The window heads on this extension shows evidence of spalling as a result of corrosion of embedded ironwork. The photograph opposite illustrates the defect. This appears to be a local construction issue relating to this later phase of construction as similar embedded ironwork issues have not been noted to window heads on the main building. Local replacement of window heads in this area would be a straightforward and practical remedial solution should this later extension be retained.

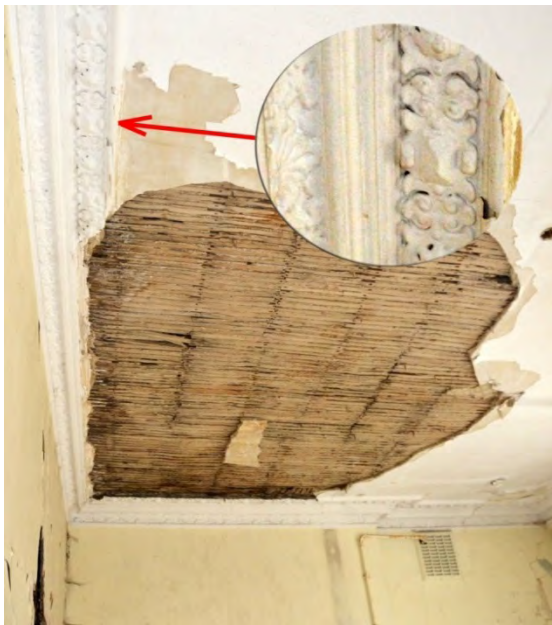
- 3.08

The image opposite illustrates an area where localised failure of plaster finishes has occurred. The original timber laths remain in place as do elements of original cornice. Repairs can be implemented in all of these locations as the supporting structure remains predominantly robust and serviceable.

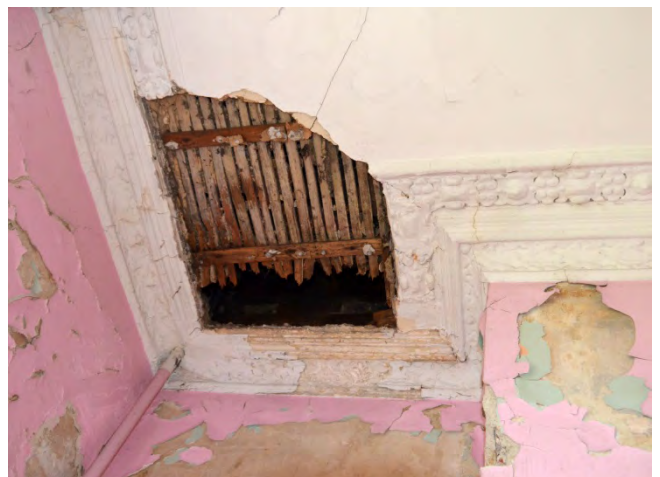
- 3.09 A similar area of localised plaster failure is illustrated in the photograph opposite. Cornice details remain and patch repair and general cosmetic conservation repairs will enable the area to be reinstated.

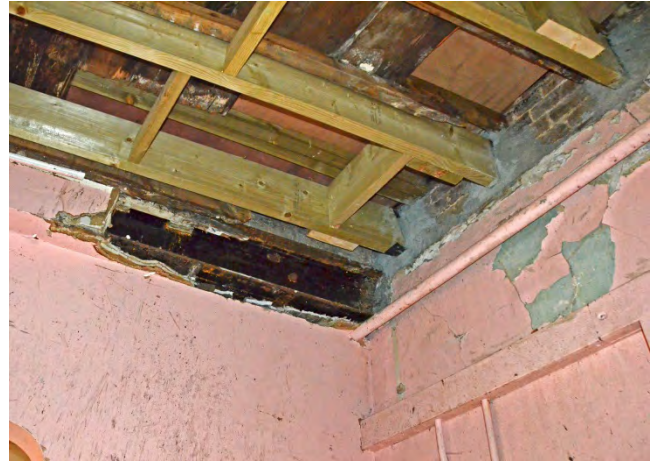
- 3.10 Around the building there are a number of areas where water ingress has occurred through localised failure of roof finishes or poor maintenance. These are not extensive and all are capable of local insitu repairs. The image opposite illustrates an area where localised repairs have already been implemented.

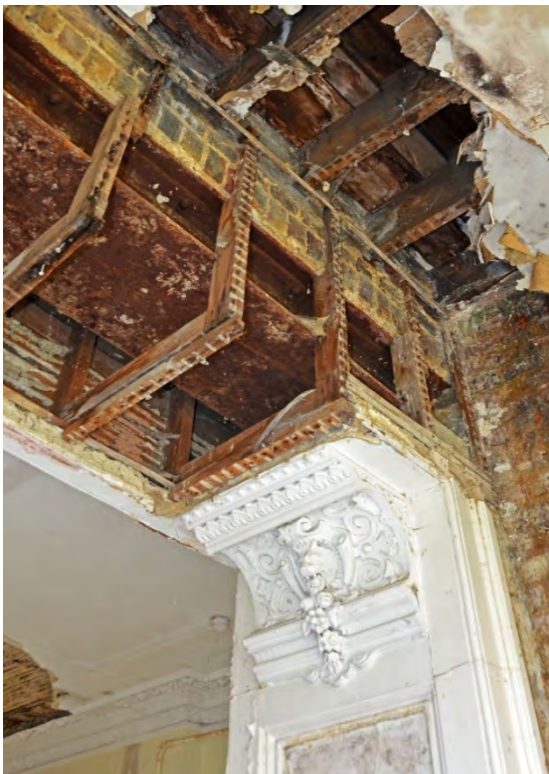
- 3.11

The areas affected by historical water ingress are generally focused around bay window heads and valley gutters. Localised repairs and effective planned maintenance will address all of these issues. The image opposite shows supporting steelwork above the first floor area located above the porte-cochère. Water ingress has occurred historically causing localised damage to plaster finishes and surface corrosion to the steelwork. The area remains structurally stable and the water ingress appears to have been halted. The steelwork would appear to be capable of retention with appropriate anti corrosion treatment and localised repairs to finishes carried out.

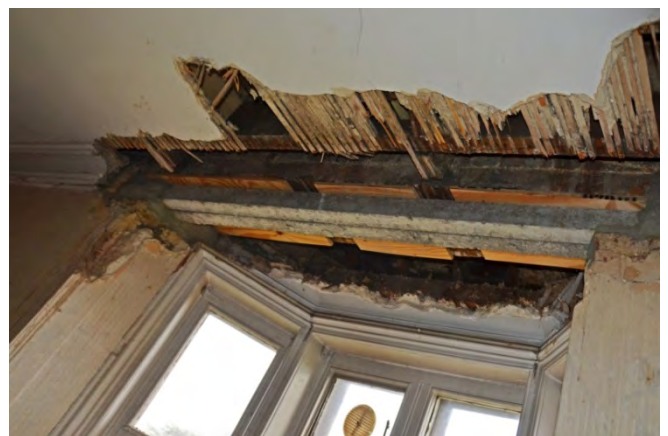
- 3.12 The photograph opposite shows the insertion of remedial concrete head to an existing bay window affected by water ingress, and illustrates the simple remedial measures appropriate in such locations.

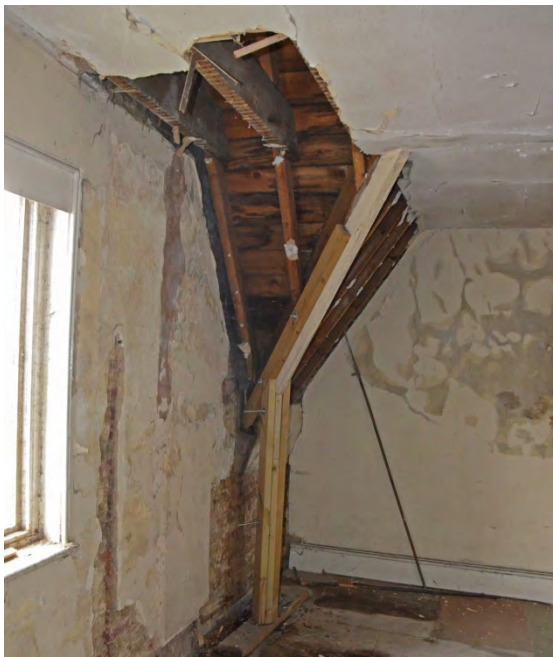
4.06

The building has suffered from isolated damage to the roof structure as illustrated in the photograph opposite. This relates to a localised area of water ingress around the base of a roof valley area. A simple temporary repair has been implemented and finishes would appear to have been locally repaired to prevent further deterioration. Whilst a more permanent repair would be required as part of more extensive refurbishment the works are relatively straightforward and simple to implement.
