# Drainage Investigation Report

## For Subsidence Management Services

**Risk Address:** 96 Haverstock Hill, Lower Belsize Park, London, NW3 2BD

**Visit Date:** 05/04/2016

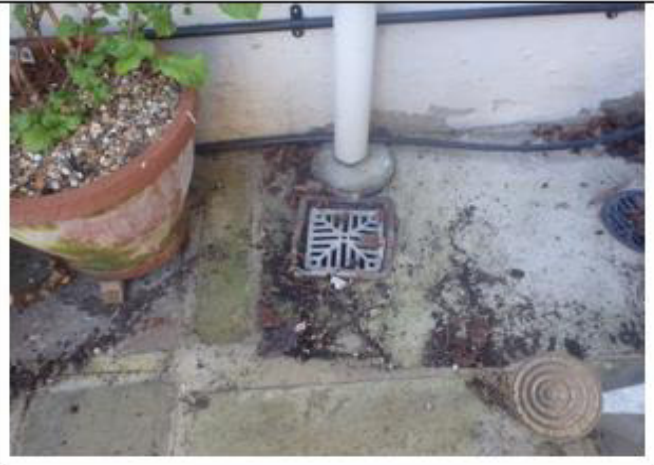
2. RWG2.

0.00	SN	Start Node from RUN C				
0.10	JN	Junction at 3 o'clock from RUN E (FWG1)				
0.40	OJL	Open Joint (large)				
0.60	FN	Finish Node at RWG2				
<b>Hydraulic Pressure Test</b>		From	To	Result	Comments	
		RWG2	0.5	<b>FAIL</b>		
<b>Address:</b>		96 Haverstock Hill, Lower Belsize Park, London, NW3 2BD

**Drain Run B: CMH1 Upstream to RWG1****Pipe Diameter:** 100mm**Responsibility:** Home Owner**Hydraulic Pressure Test:** PASS**CCTV Survey Result:** No Structural Damage**Recommended Repair:** No repairs have been recommended as the drain line was found to be free from defects.**Drain Run C: CMH1 Upstream****Pipe Diameter:** 100mm**Responsibility:** Home Owner**Hydraulic Pressure Test:** Unable to test**CCTV Survey Result:** Partial blockage - line possibly disused beyond RWG2 junction**Recommended Repair:** No repairs have been recommended as the drain line was found to be free from defects.**Drain Run D: RUN C Junction Upstream to RWG2****Pipe Diameter:** 100mm**Responsibility:** Home Owner**Hydraulic Pressure Test:** FAIL**CCTV Survey Result:** Structural Damage - Large open joint at 0.4m near gully trap**Recommended Repair:**

2. To excavate and replace existing gully including 1m of adjacent pipe work to the junction to RUN E as this falls within close proximity of the gully.

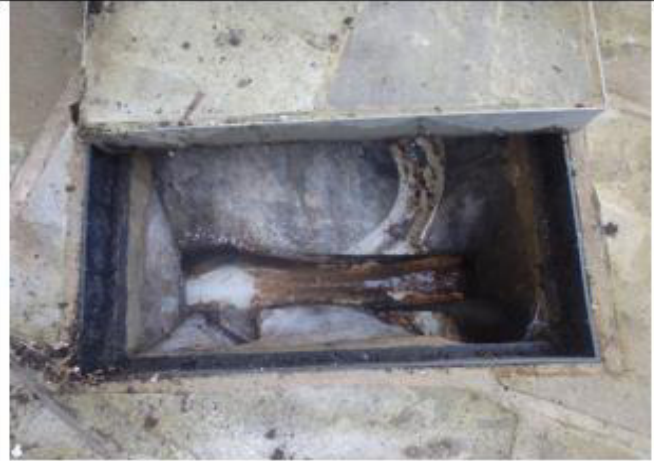
4. CMH1.

A visual inspection of the manholes revealed them to be in good condition.

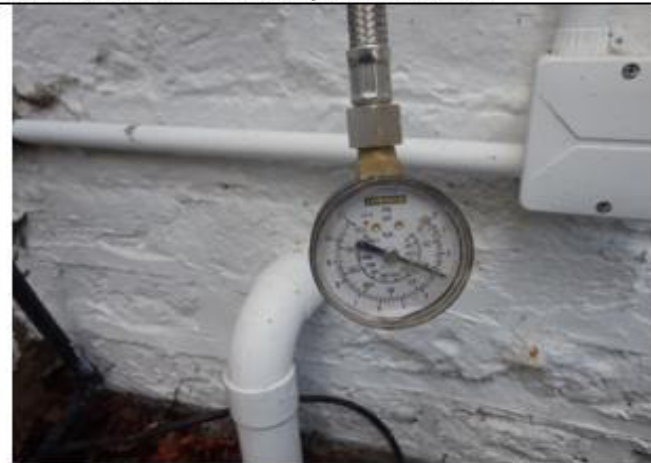
5. Mains water pressure test.

Water Main Test	From	To	Result	Notes
	ESV	Outside Tap	PASS	No drop in 20 minutes from 3.1 bar

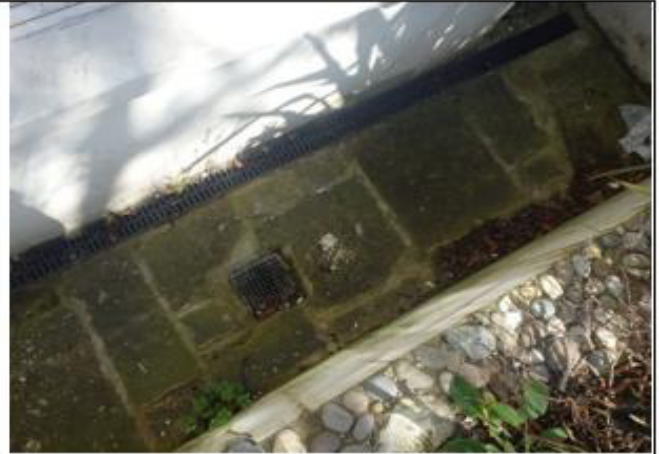
14. RWG3/Aco drain.

**CCTV Survey Result:** Structural Damage - Hole and crack in the pipe at 0.8m

3. To carry out an isolated excavation of the pipe between the ACO and the Manhole and connect to the manhole for completion.
