Engineer's Report

Our Reference **IFS-AVI-SUB-14-0052426**
Claim Reference **14C600459**
Prepared for **Aviva**

Report Date **15 August 2014**
Policyholder **Hill Limited**
Address **96 Haverstock Hill, London, NW3 2BD**

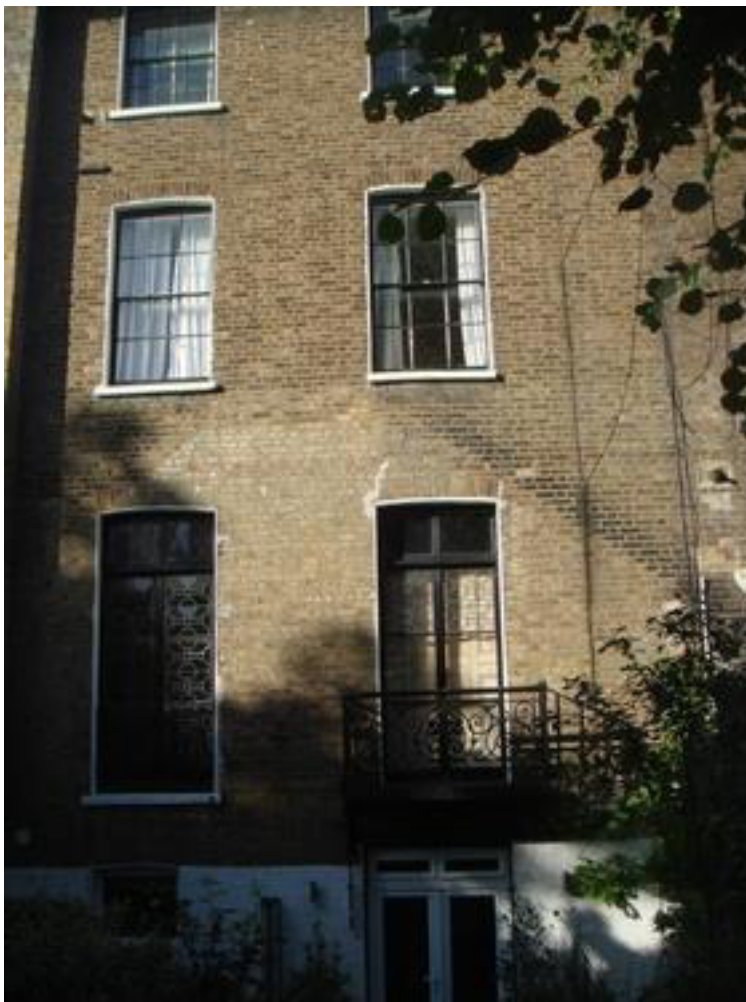
FIGURE 03 Rear Elevation.

No crack damage was recorded.

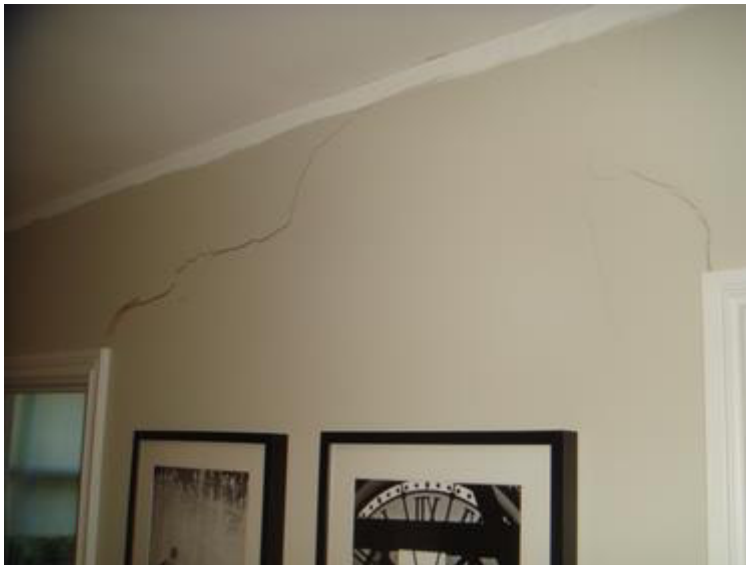
Diagonal tapering cracks in the region of 10 - 15 mm in width were recorded to the right side and rear walls of the bedroom around the ensuite and hallway doors. A further vertical tapering crack in the region of 1 - 2 mm in width was recorded to the front right of the room underside of the window.

FIGURE 04 Crack damage to the garden flat front left bedroom.

The diagonal aspect of the cracks, together with the fact that they increase in width with height is indicative of subsidence as a result of shrinkage of the clay subsoil due to the moisture extracting influence of an Elm tree located to the front of the subject property and a Maple tree situated within the adjoining property at Hay Mews Haverstock Hill.

Generally cracks 1mm wide or less will be filled (internal) or re-pointed (external). Internally, where the cracks are wider than 1mm, but less than 5mm the underlying brickwork or block work will be exposed and prior to making good the plaster finishes the cracking will be covered with expanded metal lathe. Where cracks are 5mm across or wider, some form of bed joint reinforcement will be introduced.

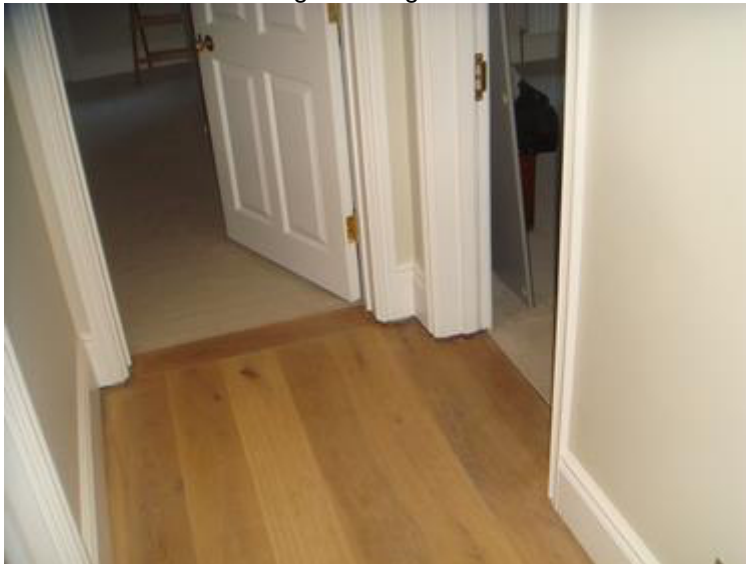
The hallway timber flooring was recorded with downwards movement of approximately 25 - 30 mm resulting in a gap with the skirting. Diagonal tapering cracks in the region of 2 - 3 mm in width were recorded to the left side wall of the hallway to above both the bedroom and bathroom doors.

FIGURE 05 Garden flat hallway floor movement.

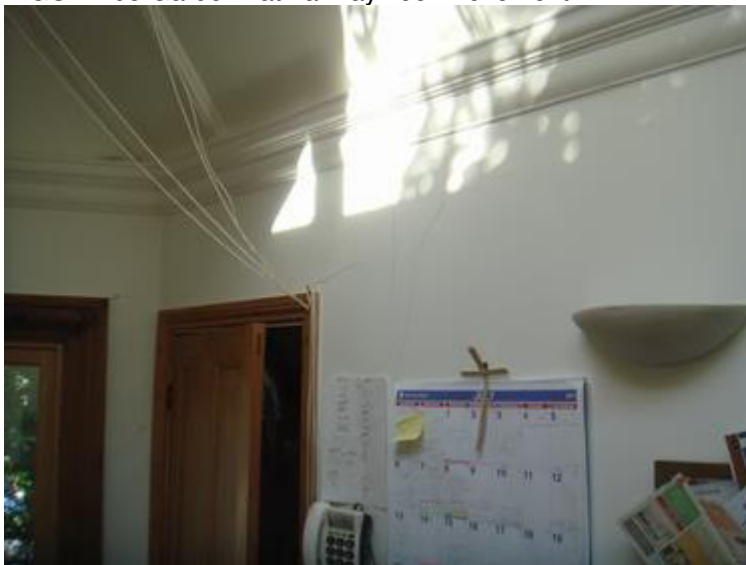
A number of both horizontal and diagonal cracks in the region of 1 - 3 mm in width were recorded to the front left of the kitchen to above the hallway and lounge doors.

FIGURE 06 Ground floor flat crack damage recorded to the front right kitchen.
