Subsidence Management Services

Response to Camden Council by Innovation Property (UK) Ltd, June 2016
96 Haverstock Hill (our reference: IFS-AVI-SUB-14-0052426)

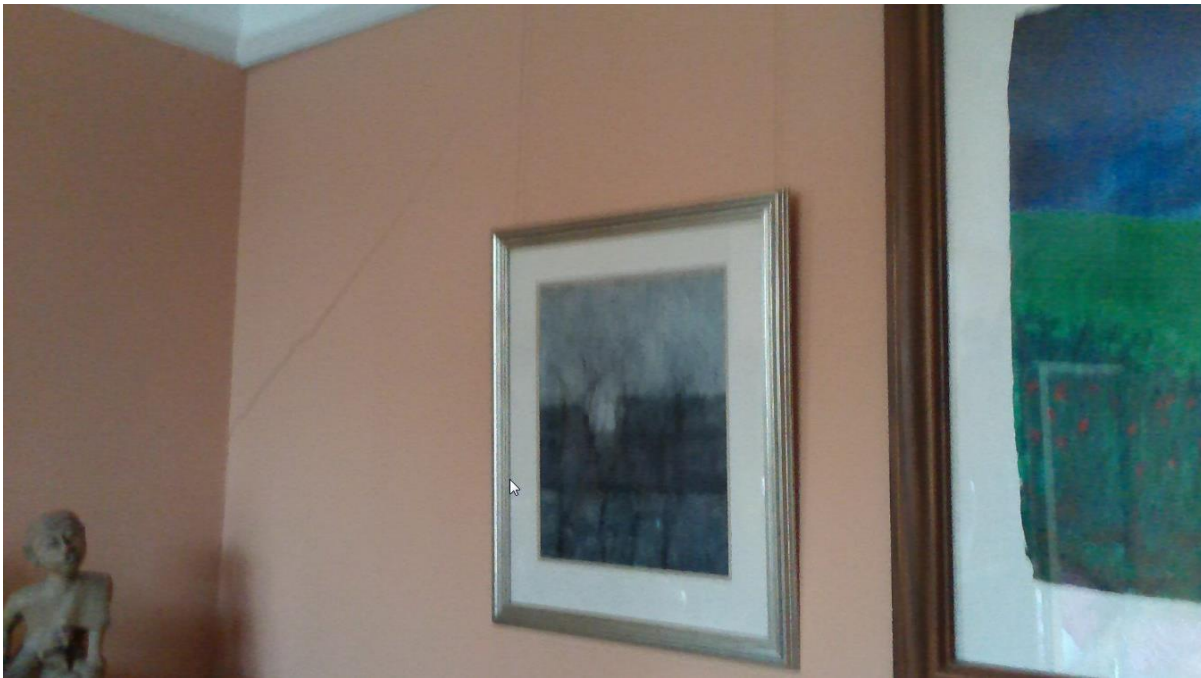
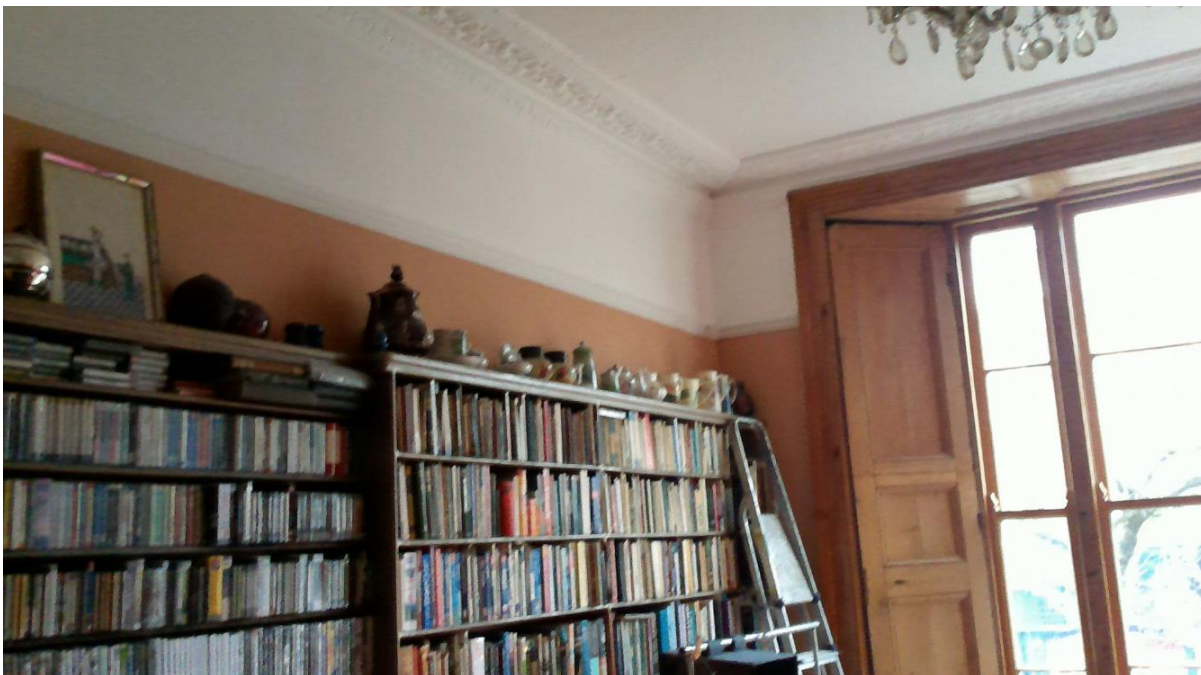
As reported by Flat A, crack damage does exist to the flat situated directly above the Garden Flat and generally this damage is consistent with the internal crack damage and movement to the rest of the property.

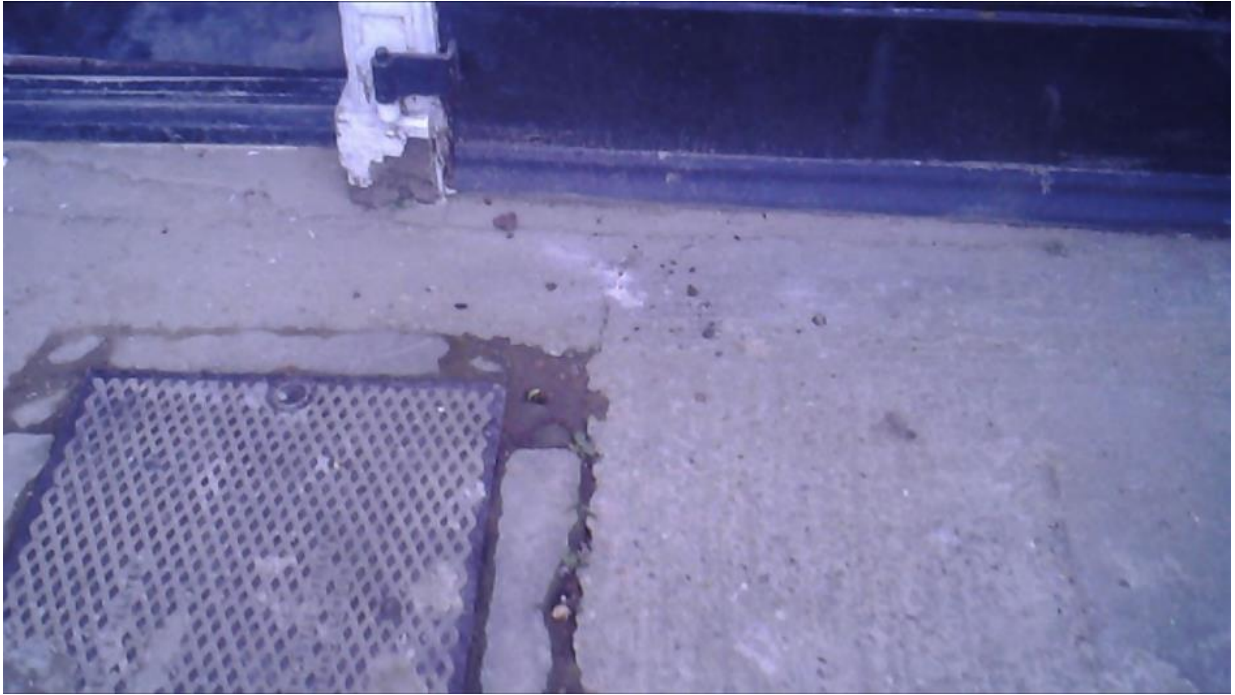
Image 1: showing the proposed location of BH3

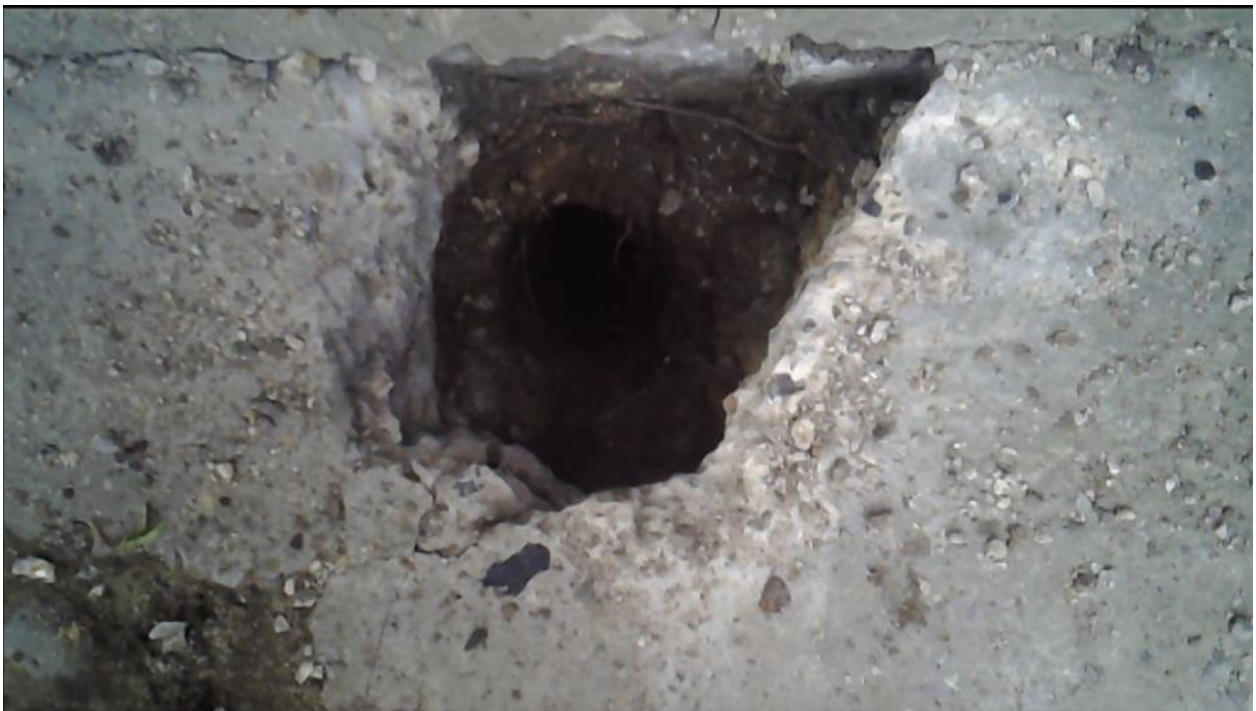
- **Under the current application, site investigations have identified functionally active Acer spp. (Sycamore) roots of 1.2mm-2.2mm in BH3 1200 - 2200mm below ground level, with moderate and severe desiccation recorded in accordance with BRE digest 412.**

- **Under the current application, site investigations have identified functionally active roots of Ulmus spp. (Elm) of 1.0-3.0mm at all three trial pit / borehole locations around the property to depths of 1500mm-3000mm below ground level.**

Image 2: showing the borehole upon completion (note roots visible within the open BH)

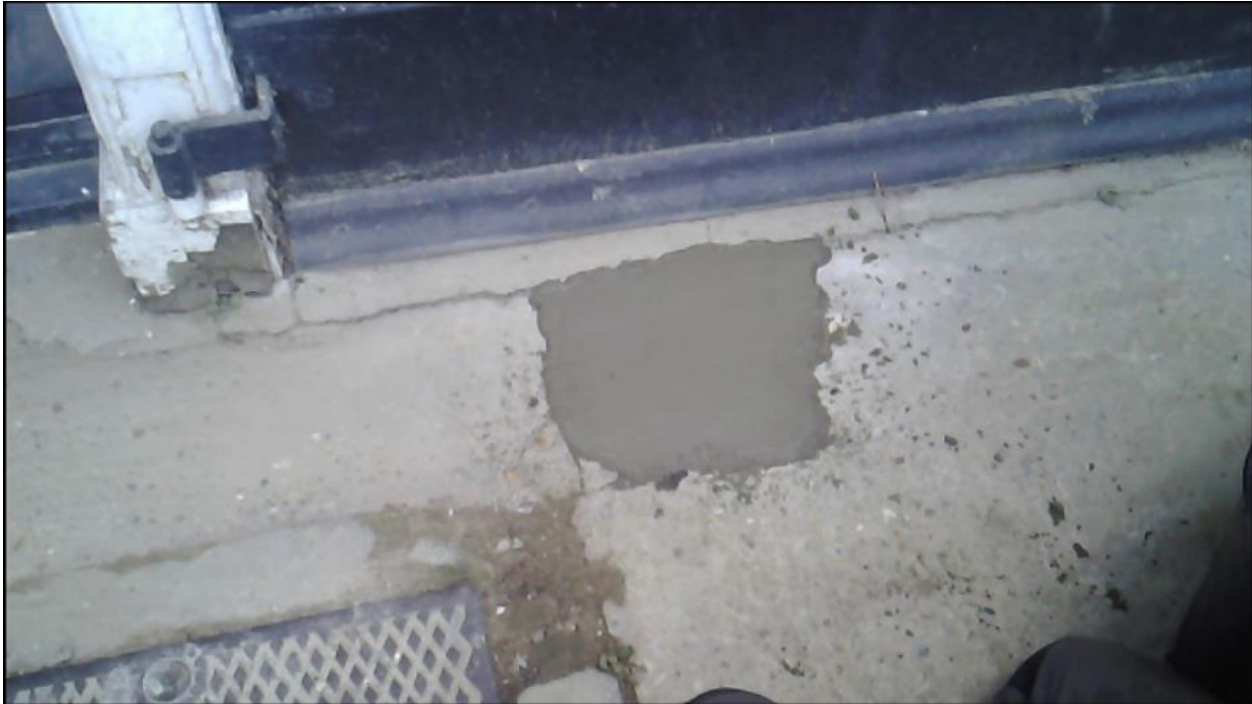
Image 3: Showing the BH upon completion

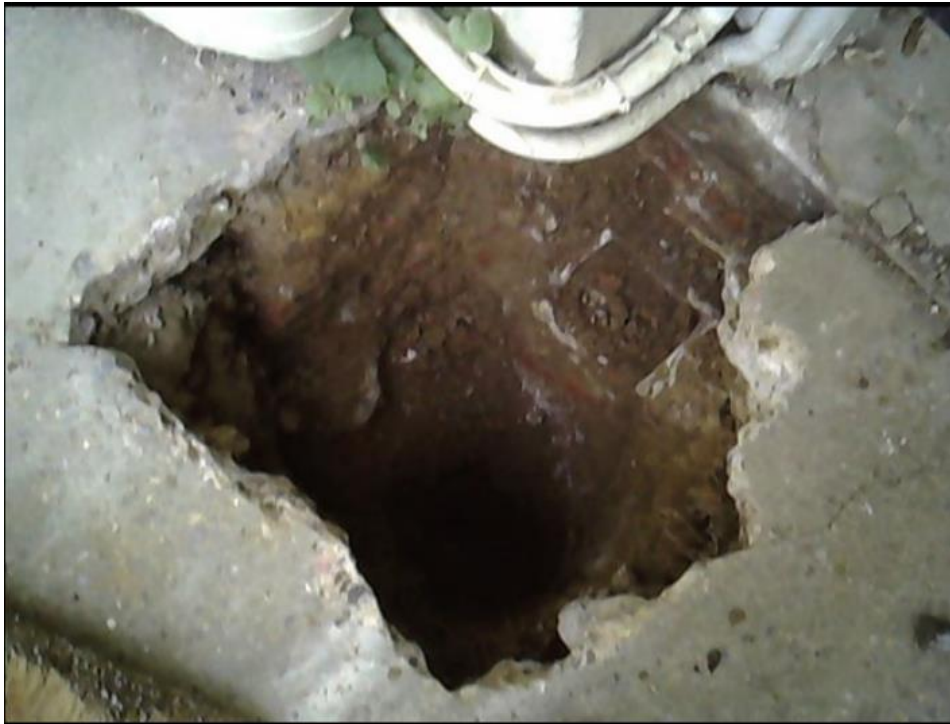
- **Site investigations on 22 October 2014 at TP/BH2 (noted in the Geotechnical Report of 3 November 2014) show functionally active roots at a depth of between 1200mm-1900mm below ground level, and below the depth of the foundations.**

Image 4: showing TP/BH2 open prior to completion

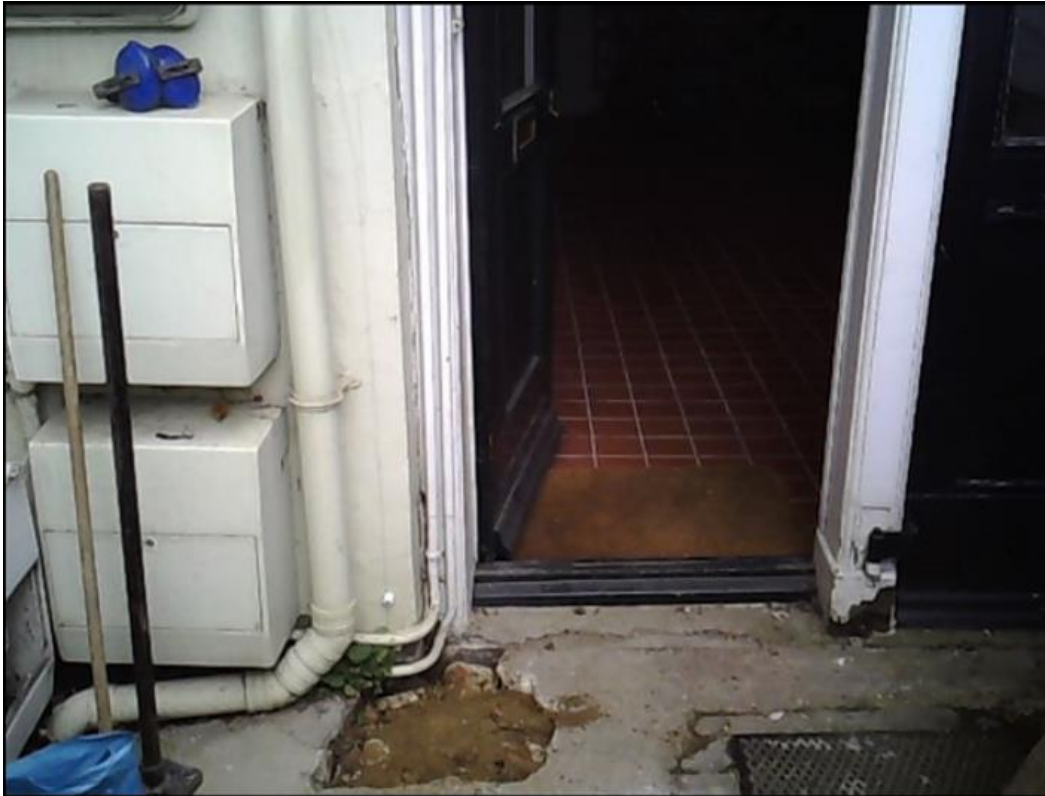
Image 5 showing TP/BH2 once finished

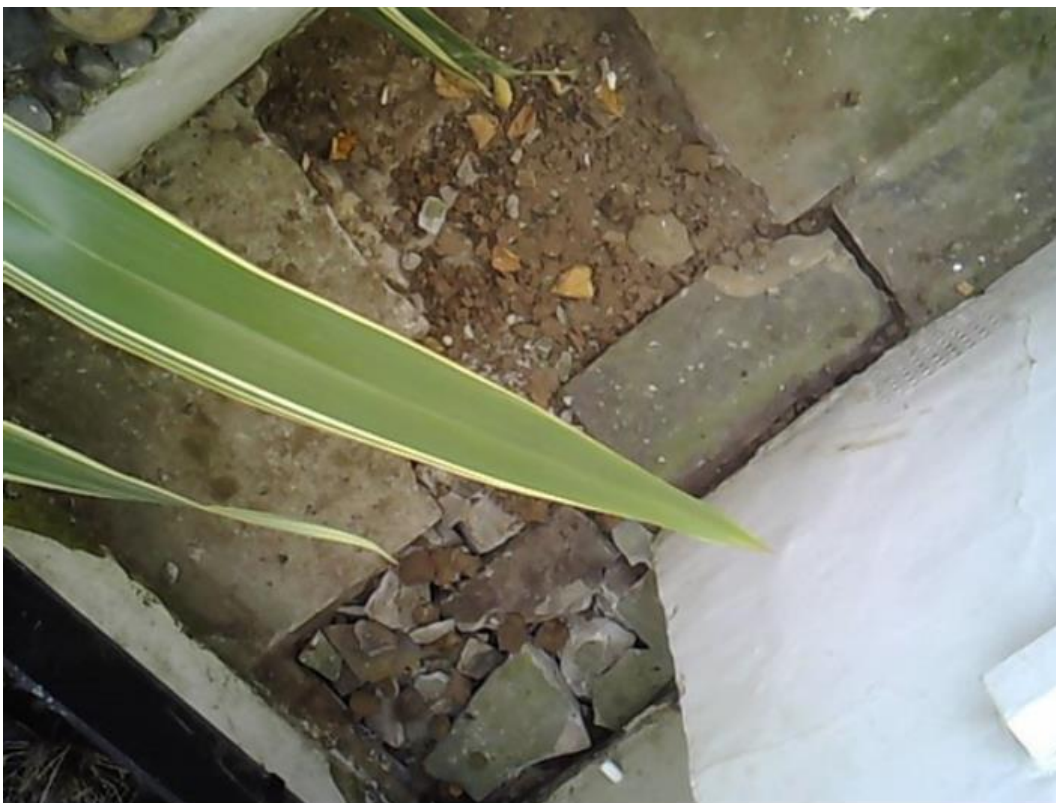
TP/BH 1 is located to the front left side of the property and next to the bedroom bay window. A copy of the site investigation dated 03 November 2014 is attached for further information.

Image 6: showing the location of TP/BH1 upon completion
