# LEVEL MONITORING

# for Subsidence Management Services

## 96 Haverstock Hill, Lower Belsize Park, London, NW3 2BD

Report Date: 18 May 2016

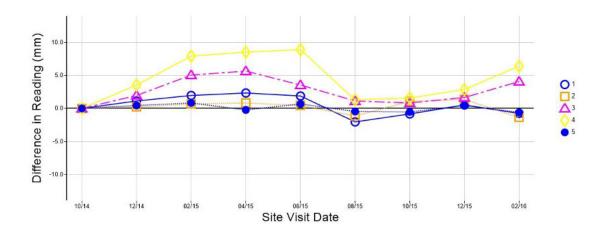
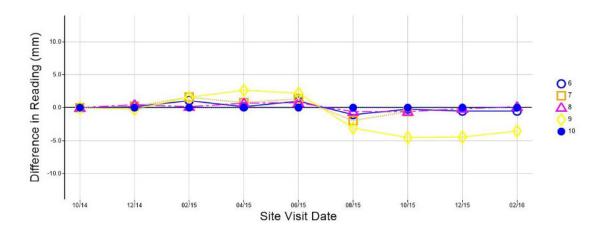
# Level Monitoring Difference Graphs

The following graphs display the progressive movement that each Level Monitoring Station recorded at each separate site visit date to give an overall look at how much the property is moving.

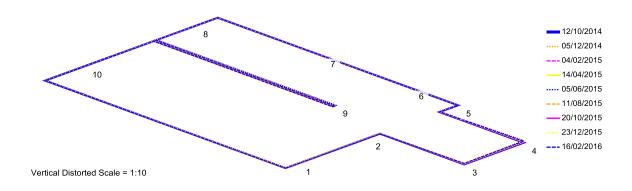
# Level Monitoring Displacement Map

The following image shows an isometric representation of the movement of the property, based on the Level Monitoring Stations that were installed.

Datum is level station 10, rear LH corner (as viewed from the front. It has an assumed value of 10.0000. No suitable remote datum so please advise if this is not acceptable as a deep datum will be required.
