Arboricultural Consultancy for Aviva

1. Case Details

Insured	Haverstock Hill Limited	Address	96 Haverstock Hill, London, NW3 2BD		
Client	Subsidence Management Services	Contact	Emily Bogie	Claim No.	IFS-AVI-SUB-14-0052426
ES Ref	NL/0110140922/TP-REV2	Consultant	Andrew Cayley Bsc (Hons) Arb, M.Arbor.A	Contact No.	0330 380 1036
Report Date	02/10/2015 Revised: 16/10/2015 & 08/06/2016

5. Technical Synopsis (Revised)

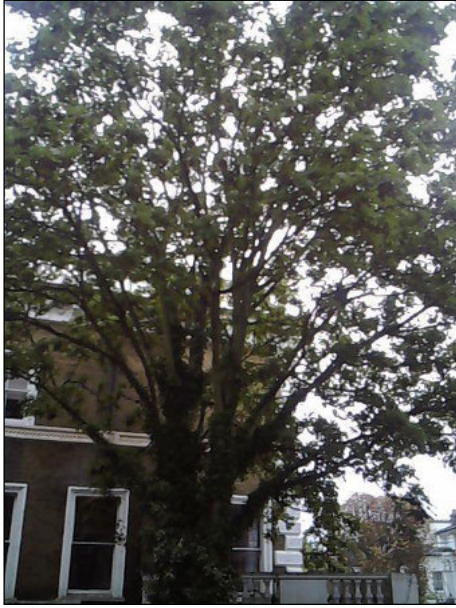
T2 - Acer

Our survey of the site identified T2 (Acer) and T3 (Elm), which, given their position relative to the damage it is our opinion that the roots identified emanate from these trees.

T2 (Acer) and cannot be discounted as contributing to the overall level of soil drying proximate to the area of damage and is therefore also considered to retain a contributory influence, albeit in a limited / secondary capacity when compared to and T3 (Elm).

Tree No.	Species	Age Cat	Approx. Height (m)	Distance to Building (m)	Ownership	Action	Requirement
T2	Acer	1	17	8	F - Commercial Third Party	Remove	Remove and treat stump to inhibit regrowth.
T3	Elm	1	15	10.5 (to front elevation; 5.5m to front steps)	C - Insured	Remove	Remove and treat stump to inhibit regrowth.
T5	Pear	1	9	1	F - Commercial Third Party	Remove	Removed by time of site visit (03/06/2016)

It is our view that, in this case, the benefits of removing T2 and T3 outweigh any harm to the amenity of the area. Other than felling the trees, underpinning does offer a solution to the damage, but at a significant additional financial cost; a root barrier is not feasible.

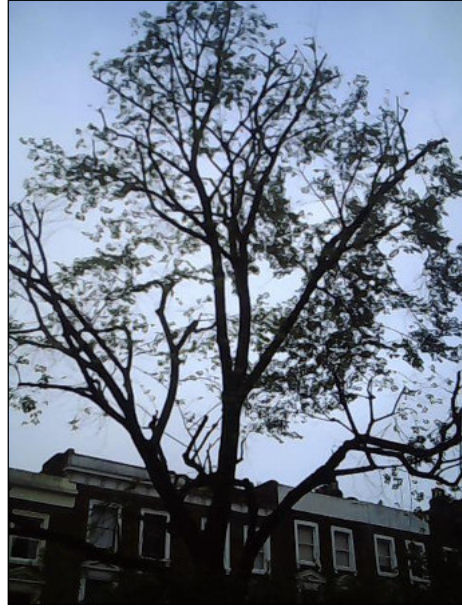
T3 - Elm

In assessing the extent of damage and the potential drying influence of the vegetation on site, T3 (Elm) is judged to be the dominant feature and accordingly we have identified it as the principal cause of the subsidence.

However, in our opinion, the above tree is the principal cause of subsidence damage to 96 Haverstock Hill and this is affecting the residents ability to enjoy the full use of their property free from damage/distress.

This view is supported by the recovery of moisture deficient clay subsoil from below confirmed foundations depths (even after winter soil rehydration) and functionally active *Ulmus spp* roots being recovered from within TP/BH1, TP/BH2 and BH3.

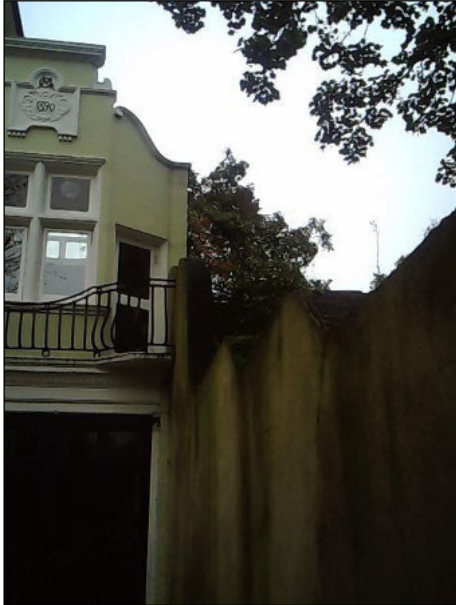
T5 - Pear

Whilst there is no positive root identification to implicate T5 (Pear), based on our assessment on site we consider that the footings of the subject property will also fall within the anticipated rooting zone of this tree.

Please note that T5 was removed at the time of our site visit and therefore no longer forms part of the ongoing claim.
