Simon Pryce Arboriculture

Report

Site: Land adjacent to 23 Elsworthy Road, London, NW3 3DL

Subject: Trees survey, constraints plan and arboricultural implication assessment

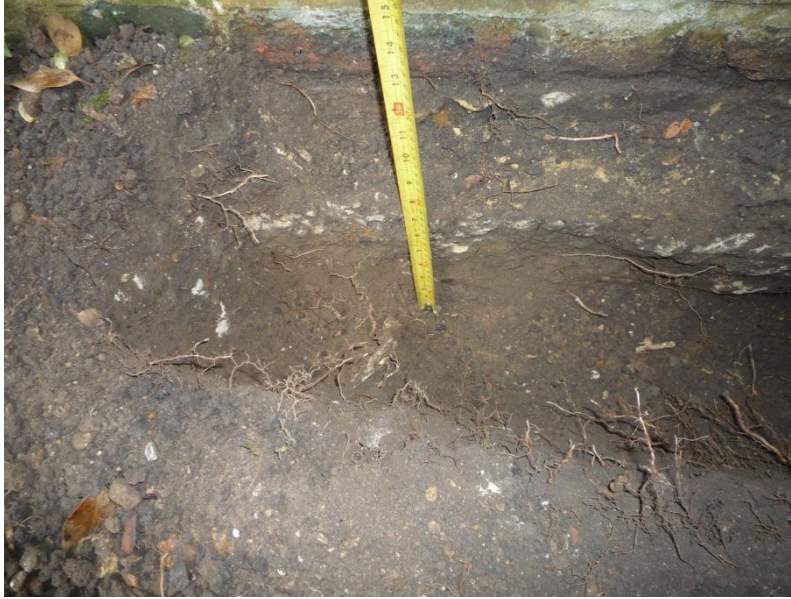
- 3.2 This was hand dug on 20 August next to the garden wall opposite the holly in the rear garden of 2 Elsworthy Terrace, tree 6 of this report. The trench was about 1.5m long by 400mm wide and revealed a stone footing that steps out from that side of the wall by 100 - 120mm. The top is about 150mm below garden level and it is 180 - 200mm deep, making an overall depth of about 330 - 350mm. The trench exposed numerous shallow roots that could be traced to the dense shrubs with the site. Below the base of the foundation roots became scarcer, with only a few fibrous ones and one about 8mm diameter coming from beneath the wall, the most likely source being the holly. (photo 1)

- 5.5 The RPA of the holly at no.2 extends about 1.3m into the site if drawn as a circle, but it is a small specimen and holly roots are not as invasive as those of most other species. The trial excavation next to the wall found only one root about 8mm diameter and a few small fibrous ones, which will not represent a significant part of the tree's root system. The crown overhangs slightly, but is trimmed regularly and the tree is not a significant constraint above or below ground.

1) Trial trench showing a few small roots growing under the wall foundation.

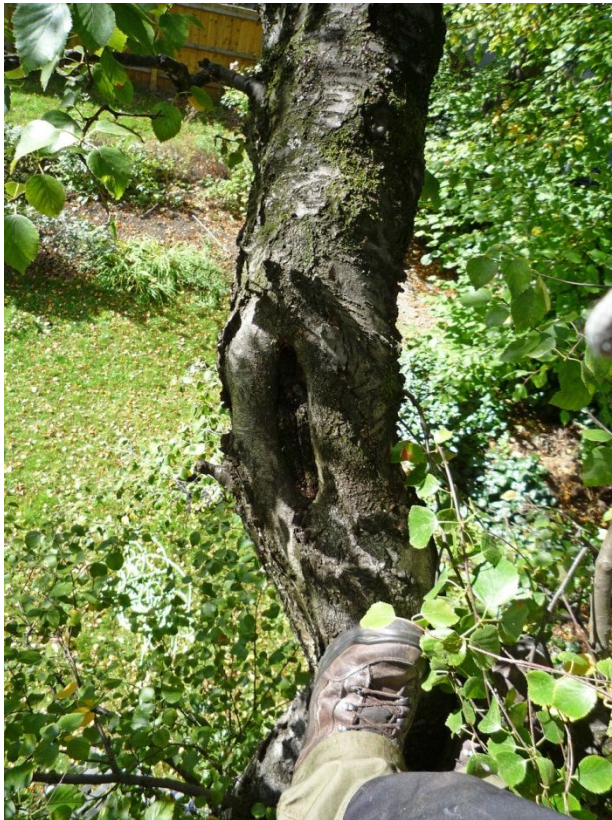
- 3.3 This was done on 30 September 2015 to investigate a decay cavity visible from the ground and the area where a rope had been tied round a branch and become ingrown. The cavity opening is about 160mm long by about 60mm wide and there is a broad band of callus round the edge, indicating that the original wound was much larger. The exposed timber is dry and weathered, but is starting to decay. It does not appear to present an imminent failure risk, but will have weakened to the limb and the decay will advance. (photo 2)

2) (L) Cavity in the limb on the W side.

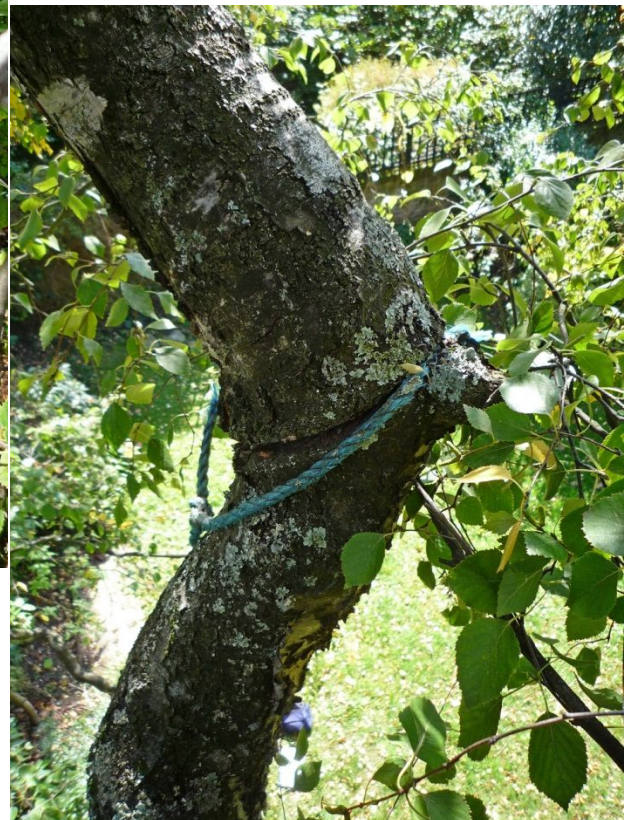
- 3.4 The ingrown rope is potentially more serious and had evidently been installed as a swing several years before. It could be loosened, but had become ingrown so could not be completely removed and one section had to be cut and left to continue becoming ingrown. That is not likely to cause much damage, but the rope had left a deep groove, which will have weakened the branch. That has been exacerbated by the rope interrupting downward sap flow, which occurs in the layers immediately under the bark, so the section above the rope has swollen. (photo 3) This often occurs after this kind of constriction and sometimes when trees or branches are ring barked. This also creates structural weakness. This can be addressed by moderate reduction in the height and spread of the crown in order to reduce its weight and wind resistance, although the tree will respond by sprouting and need to be cut back regularly as long as it is retained.

3) (R) ingrown rope after being loosened. note the deep groove left and the section above being larger.

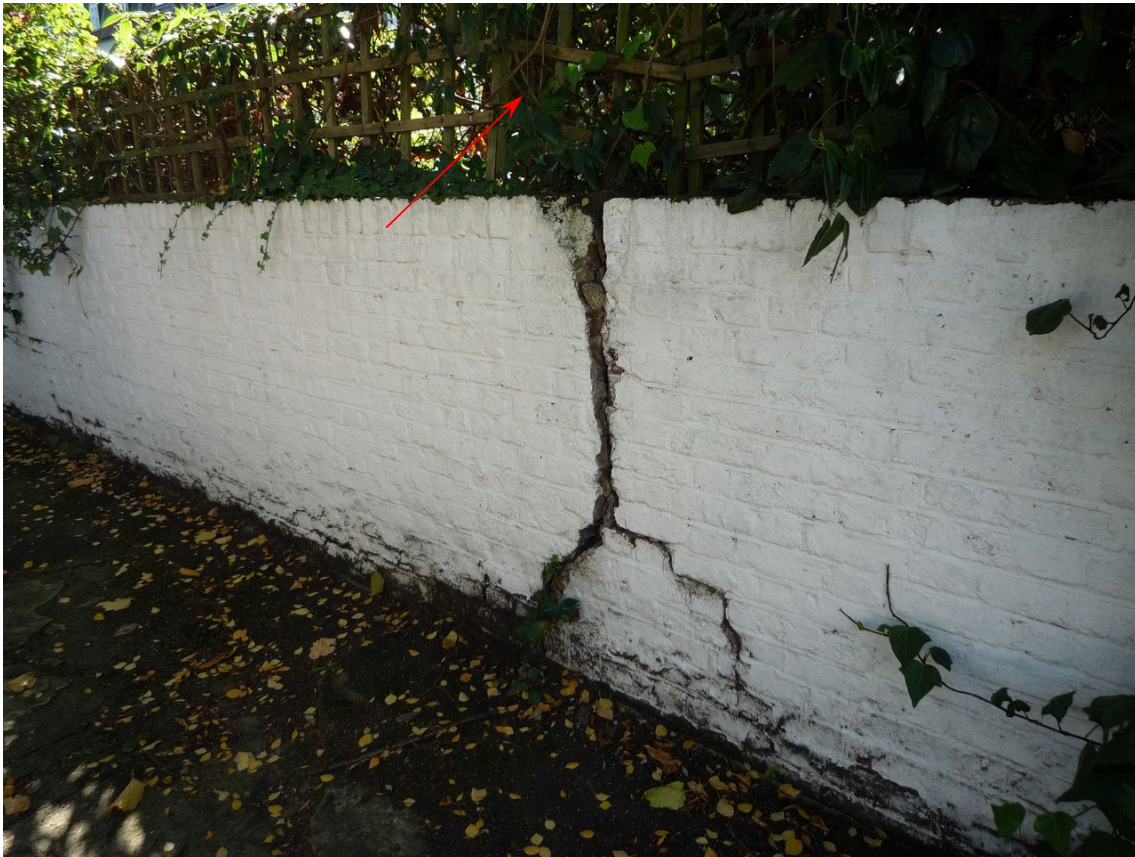
- 3.5 The base of the birch is close to the boundary wall and ground level in the garden is about 320mm higher than the drive to no.23 on the far side. There is a more or less vertical crack about 1.5m forward (north) of the tree and the section next to the tree has stepped outwards, which suggests strongly that it has been pushed by the base of the trunk expanding as it grows. That will need to be investigated in more detail but the proximity of the trunk to the back of the wall will make any repair difficult without harming the tree. (photo 4)

4) crack in the side wall seen from in front of no.23. Arrow shows the birch trunk.

- 6.2 The proposed building makes insignificant incursions into the lime RPAs, even allowing for some restriction of root spread by the road.
- 6.3 The incursion into the birch's RPA is also within tolerable limits, but it has structural defects which limit its useful life and is damaging the side wall, which would be hard to repair with it in situ. There is a strong case for removing it and planting a replacement.
