Asbestos Survey Report 10/05/2016

Refurbishment Survey

246 Belsize Road (basement and rear)

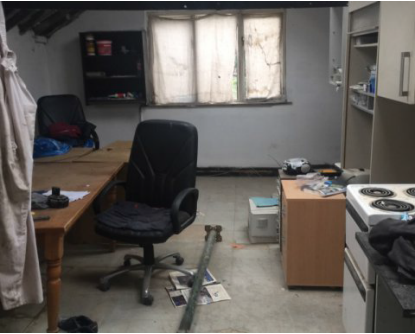
Room/location Reference:	001
Room/location Description:	All areas
Area/floor Reference:	001
Area/floor Description:	First Floor
Accessibility:	Accessible
Total ACMs:	0
Total NoACMs:	0

Ceiling:
Slate

Walls:
Brick, Plasterboard

Floor:
Timber

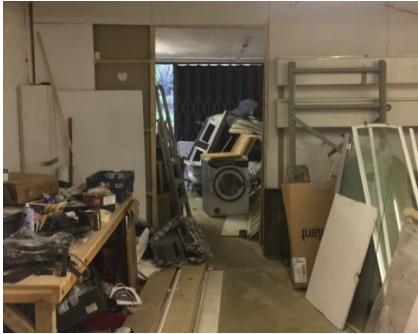
Room/location Reference:	002
Room/location Description:	All areas
Area/floor Reference:	002
Area/floor Description:	Ground Floor
Accessibility:	Accessible
Total ACMs:	0
Total NoACMs:	0

Ceiling:
Slate

Walls:
Brick, Plasterboard

Floor:
Concrete

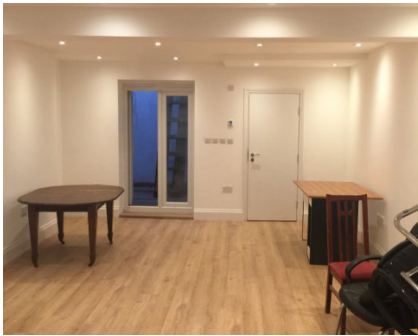
Room/location Reference:	003
Room/location Description:	All areas
Area/floor Reference:	003
Area/floor Description:	Basement
Accessibility:	Accessible
Total ACMs:	0
Total NoACMs:	0

Ceiling:
Slate

Walls:
Brick, Plasterboard

Floor:
Concrete
