Non material amendment to planning consent 2010/5099/P approved on appeal reference APP/X5210/A/11/2161172 as amended by 2014/2877/P

Summary and Recommendations

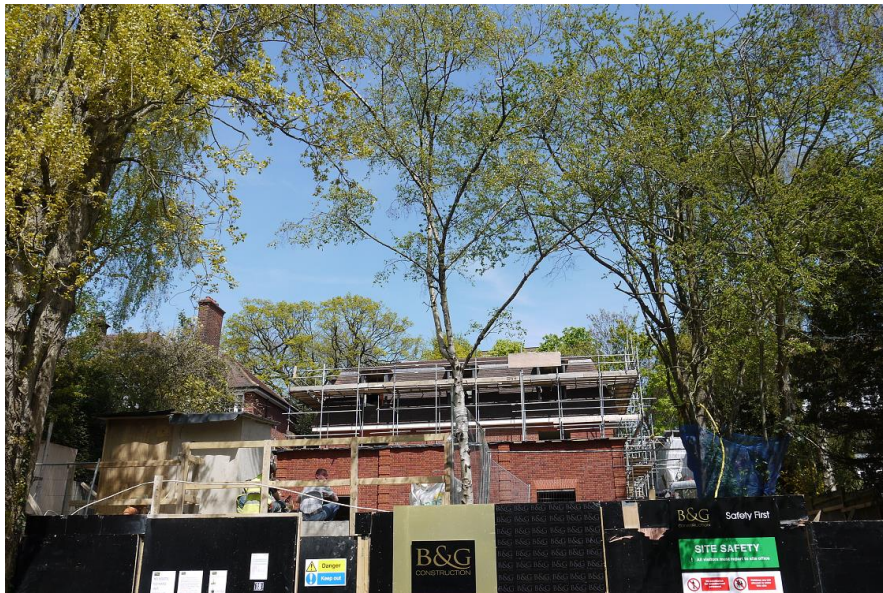
2. Martin Dobson Associates were instructed by Tim Geary of BTP Group on the 29th April to carry out an inspection of a birch tree (T3, centre tree in the photograph below) close to the front boundary of 18 Redington Road, London, NW3 7RG. The birch T3 was designated for retention in planning consent 2010/5099/P approved on appeal reference APP/X5210/A/11/2161172 as amended by 2014/2877/P.

It is evident that the wall is constructed on shallow mass concrete foundations, which are inadequate for a wall of this nature and the stability of the wall cannot be justified by calculation. The instability is compounded by the presence of the Birch Tree T3, which is in very close proximity to the rear of the wall, and at a raised level above the top of the wall.

Whereas the tree is relatively small, it is evident that it is leaning towards (and over) the pavement and we are concerned that, particularly when in full leaf, it will significantly exacerbate the instability of the wall and may cause a collapse.

10. The tree grows on an angle, leaning towards the wall and the pavement of Redington Road and with the canopy predominantly over the road (as can be seen in the landscape plan above).

16. It is considered that the risk of failure of the tree as a result of the required reconstruction works is high.
17. It is recommended that birch T3 should be removed in order to enable the reconstruction to take place without creating a potentially dangerous tree which could, if it failed, cause injury to people and/or damage to vehicles.

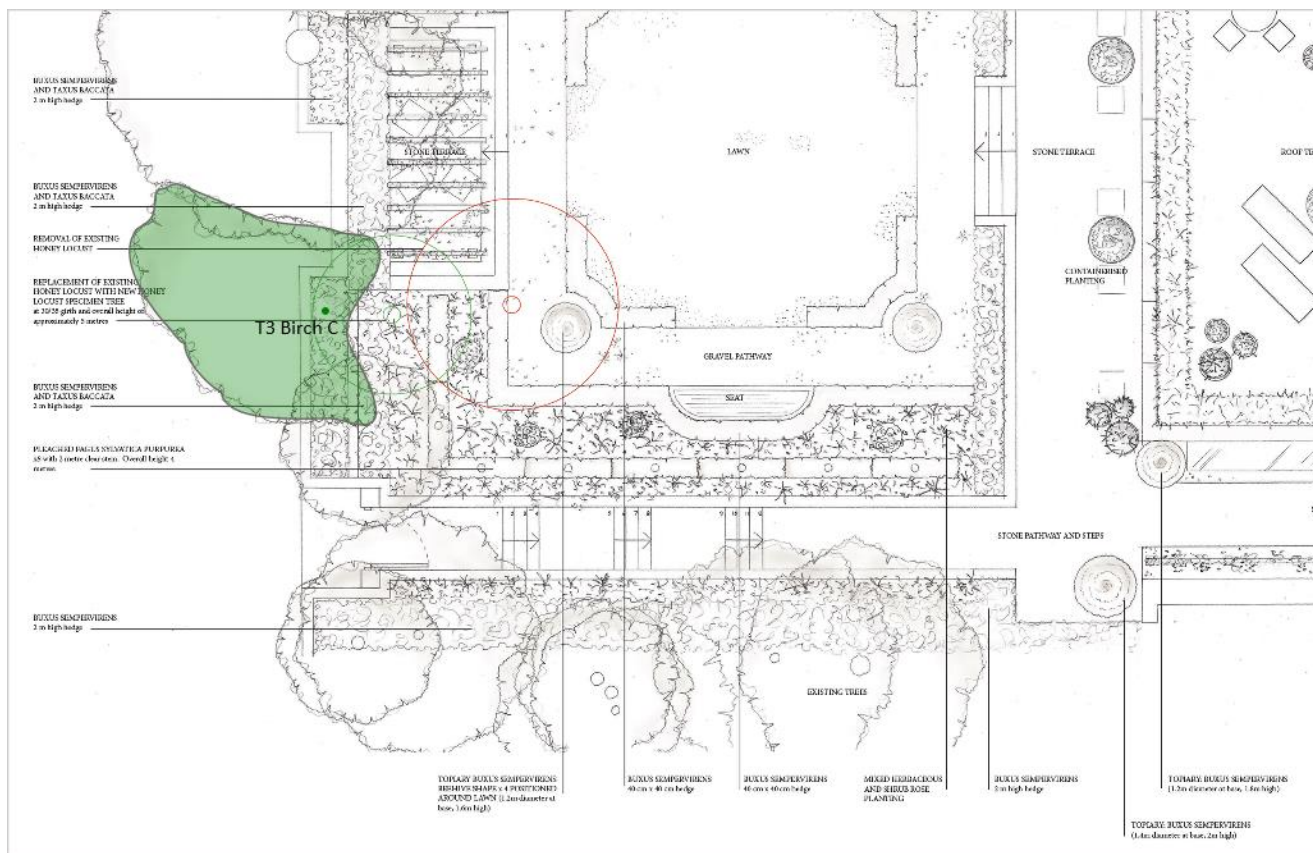
3. The birch was included as T3 in the approved Tree Survey and Arboricultural Method Assessment dated 6 September 2010 and was shown as being retained in the approved landscape drawing, an extract of which is shown below with the birch highlighted in green. The birch was classed as a category C tree of low quality with a calculated root protection area (RPA) of radius 1.4m. It is therefore considered to be of no particular importance and the amenity it affords could be replaced by planting of suitable advanced stock.
