46 Well Walk, London NW3 1BX

Interim Report on Investigation

Ref: 130581/T Attwood

Date: 17 Sep 2014

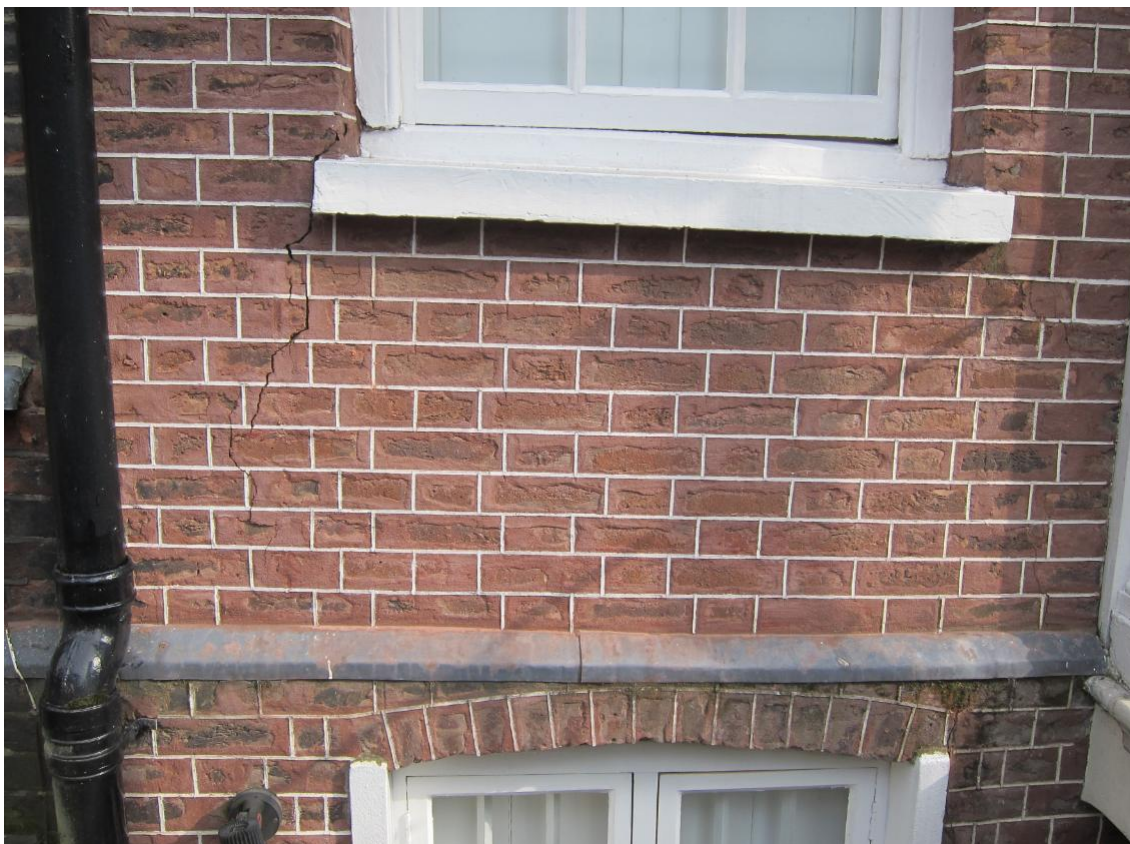
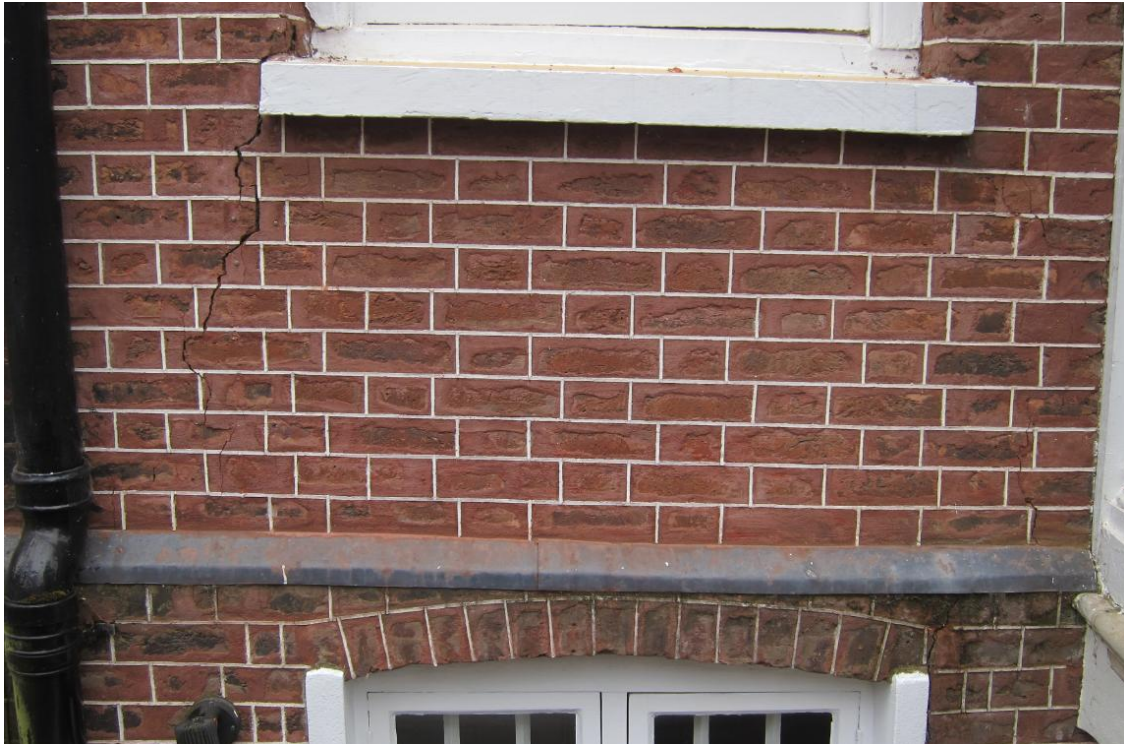
Below are shown comparative photographs taken 12 months apart of the worst areas of movement. Studying the large format versions of the photos shows that there has been a small increase in crack size in the last 12 months. This is shown in the crack widths and the slight elongation of some of the cracks, particularly in the second floor window apron. Internally there has been a little more movement to panelling and finishes.

06.09.2013

15.09.2014

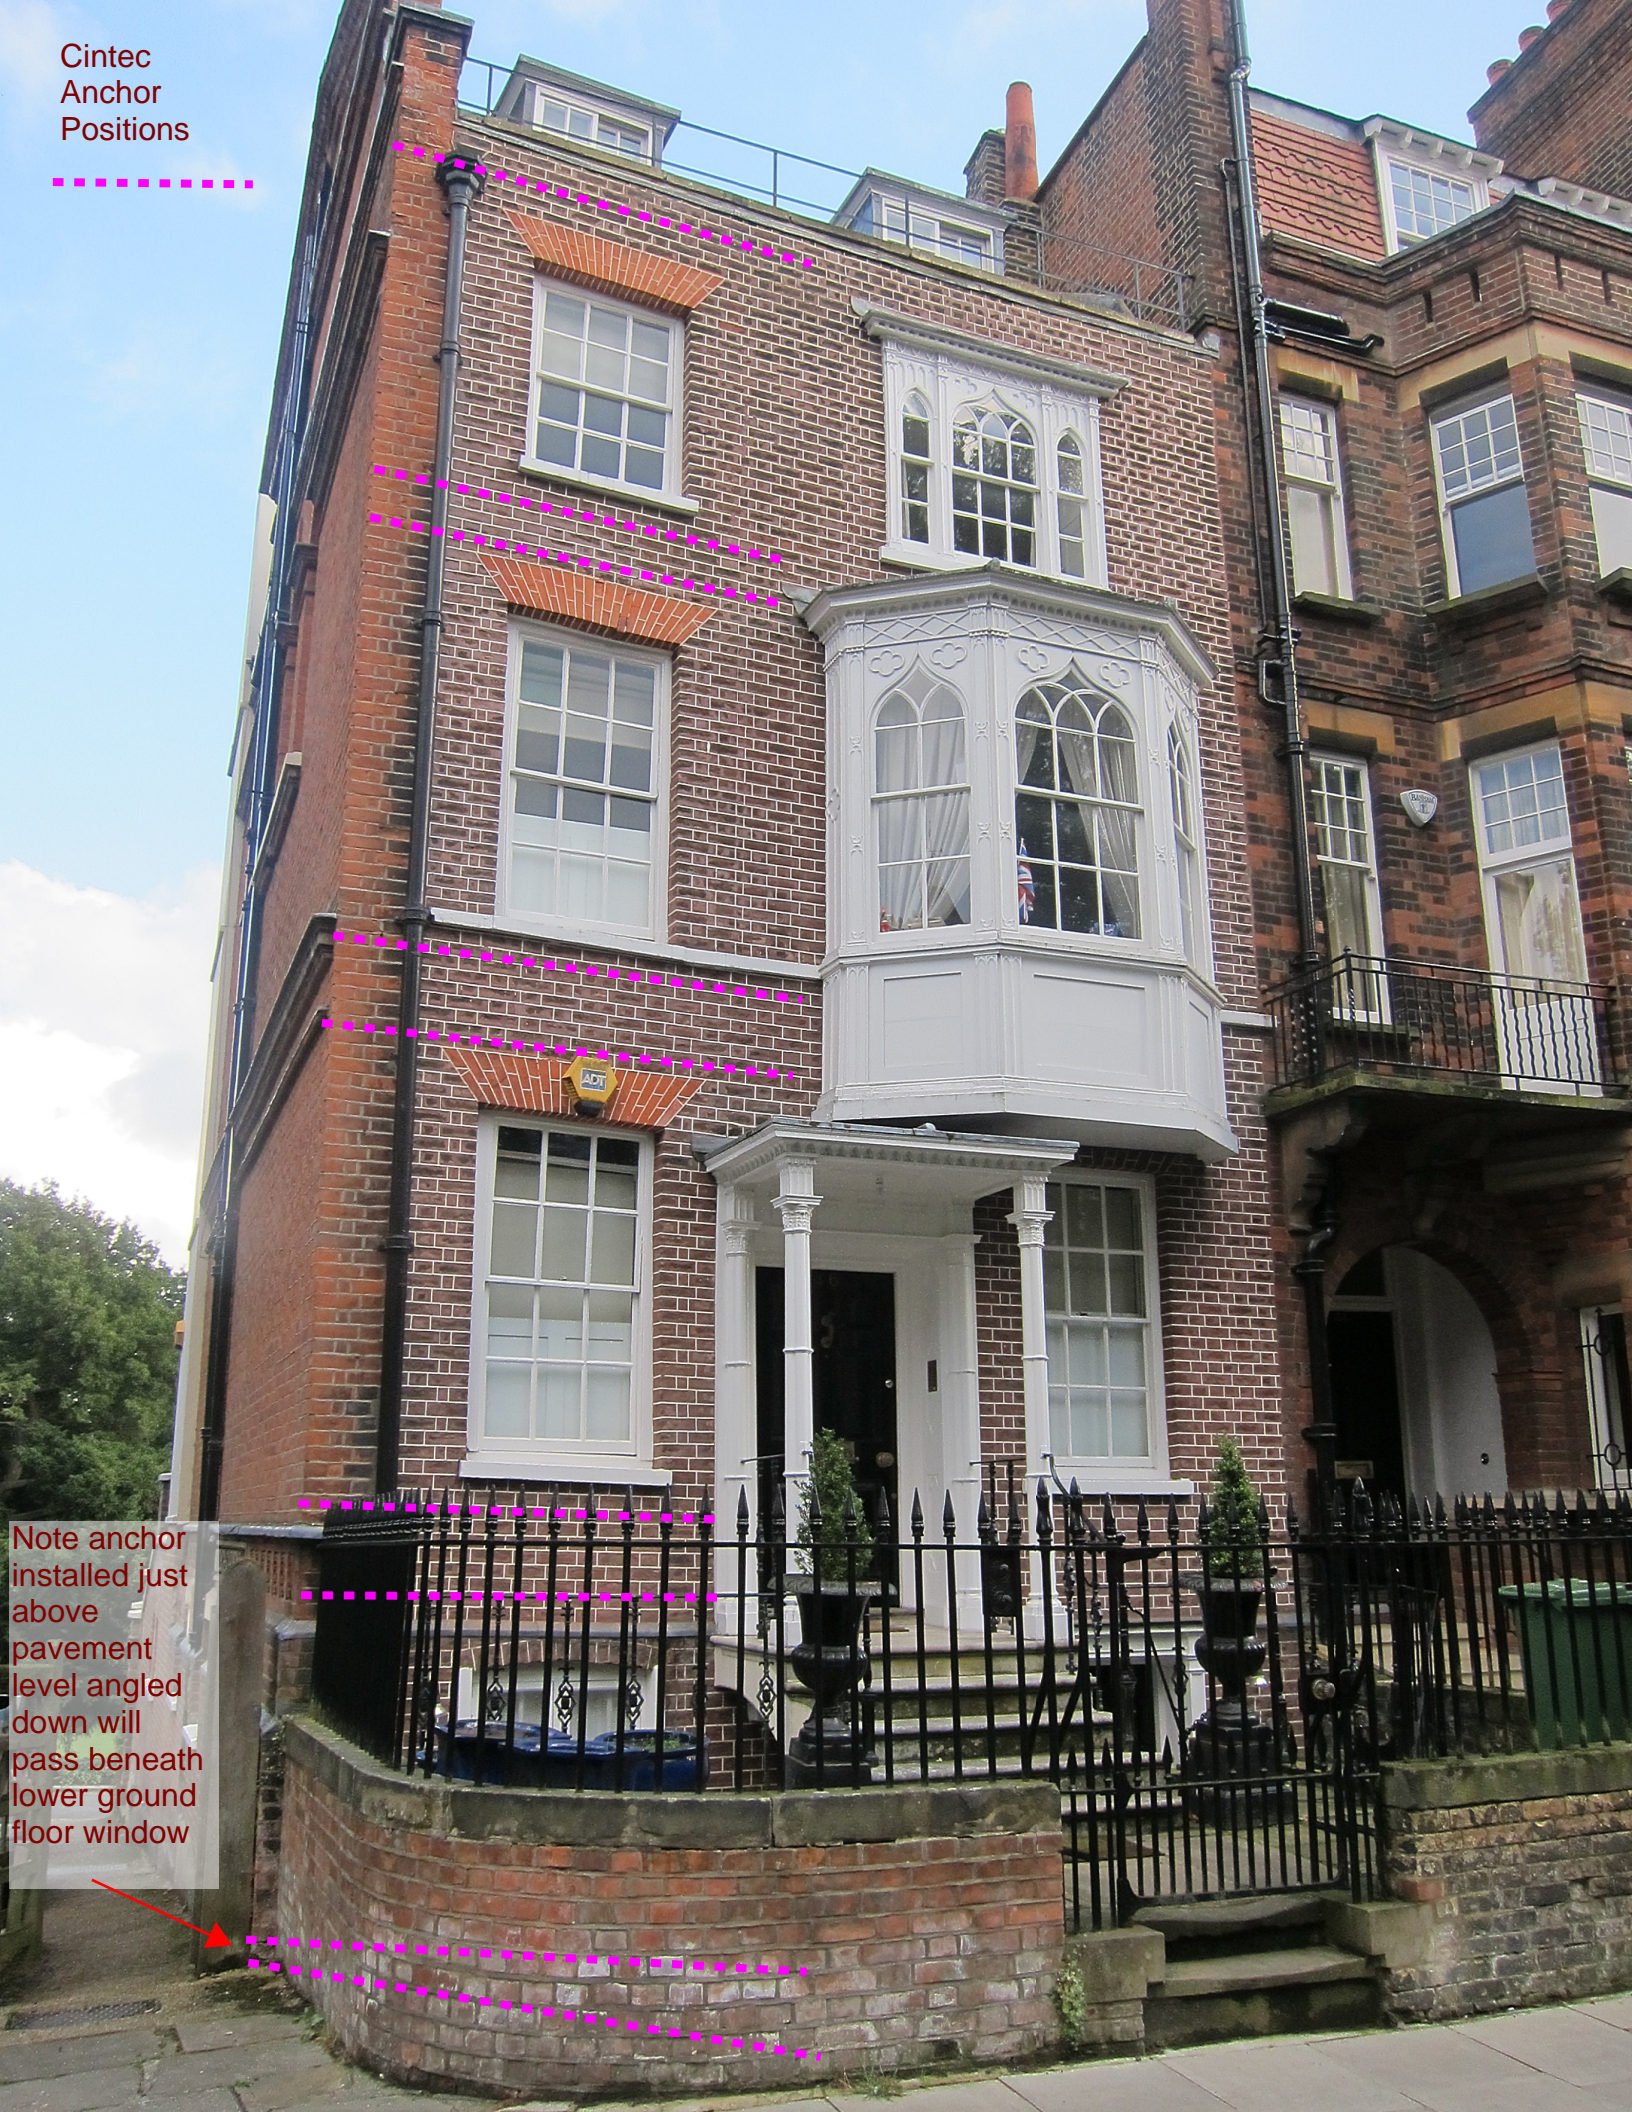
Cintec
Anchor
Positions

Note anchor
installed just
above
pavement
level angled
down will
pass beneath
lower ground
floor window

Strengthening would need to include the whole wall and hence we would recommend that Cintec anchors are installed in the elevation between the corner of Gainsborough Gardens and the pier to the left of the front door. Drilling in from the corner would also avoid opening up to the older and more important front elevation, although cosmetic repairs will be required to the cracked brickwork following installation of the anchors. Attached is a sketch showing the approximate layout of anchors.
