**46 Well Walk, London NW3 1BX**

## Revised Repair Proposals

**Ref:** 130581/T Girdler

**Date:** 19 Jul 2016

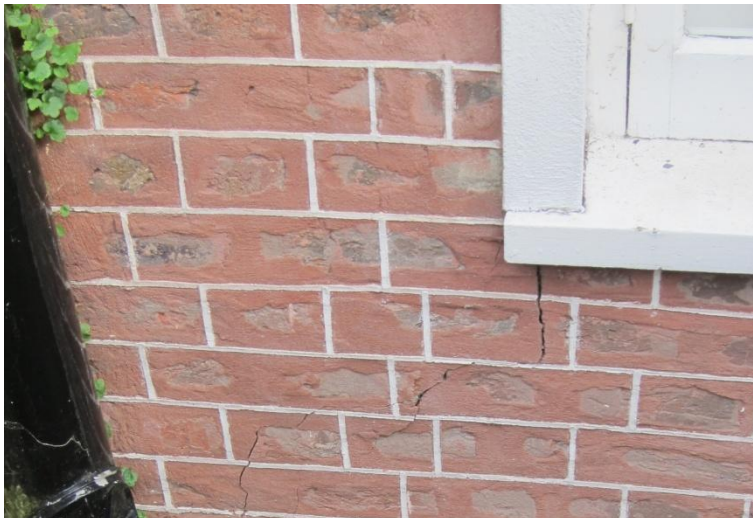
- 3.1 The image on the front sheet of this report shows the amount of coloured mortar that has been used prior to the insertion of the tuck pointing. This will allow the bricks to be carefully removed and reinstated without causing serious visual disturbance. It is acknowledged that appearance is not a primary issue but as the drilling option is not possible, a scheme that does not cause disturbance to the internal panelling and finishes or the major thickness of the wall and will not leave a visual scar, has some conservation benefits.
- 3.2 To aid the understanding of the difference between the two schemes, sketch SK010 has been produced to show the difference between the original proposal Option One and the revised proposal, Option Two. There is no more steelwork being proposed, just the method of putting it into the wall.

- 2.6 After site investigation, it has been concluded that the least damaging alternative is to insert the required stainless steel reinforcement behind the facing brick skin, in short lengths, fixed together with proprietary screw couplers. Access to place the reinforcement will require the face brickwork to be carefully cut around the mortar joints, removed and then replaced.
