TREE HEALTH & STRUCTURAL INTEGRITY REPORT

Our Ref: JPL/160201/R/sh

Date: Monday 18th July 2016

SITE ADDRESS: St Christopher's School
32 Belsize Lane
Hampstead
London
NW3 5AE

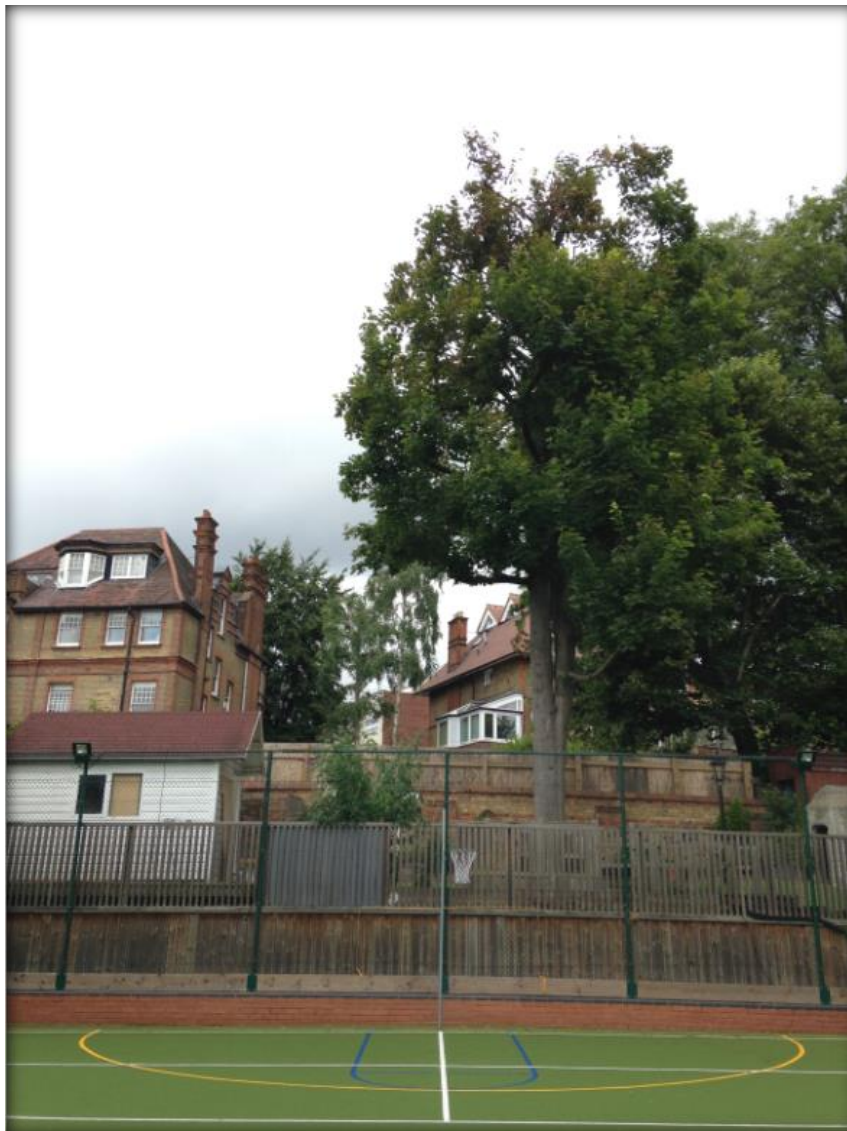
The Norway Maple tree (*Acer platanoides*) is approximately 60 years old (± 10 years) and stands at a height of 15.0 metres. The stem has a diameter of 640 millimetres, when measured at 1.5 metres above ground level and the crown has a spread of 5.0 / 4.0 / 4.5 / 3.5 metres, in the direction of the four cardinal compass points. The tree has a single stem from ground level with a crown break at 5.0 metres above ground level.

Figure 2: Showing the Norway Maple tree, as viewed from the east.

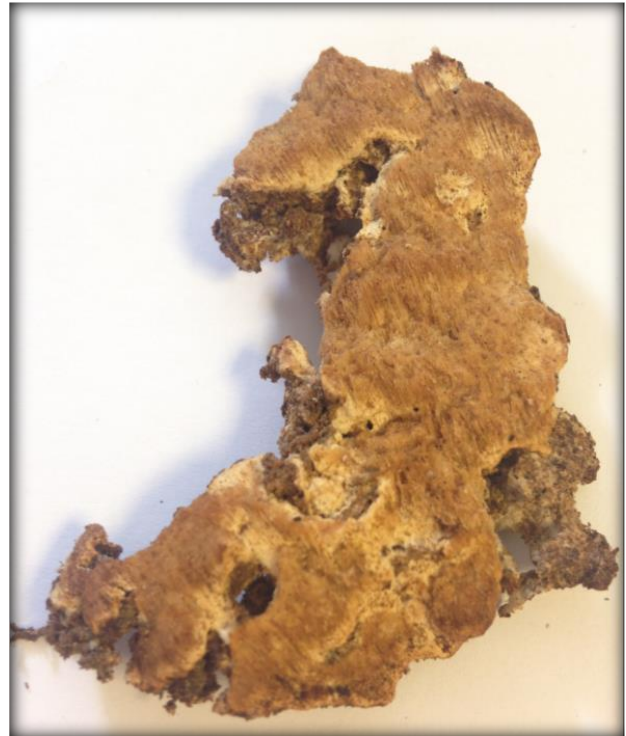
The presence of a large immature fungal fruiting body attributed as *Daedalea unicolor* was found within the cavity of the tree's main stem.

Daedalea unicolor initially affects the non-functioning heartwood and the advancement of decay can progress into the functioning sapwood of host trees.

The decay can develop extensively as it is able to spread into the previously sound sapwood. If the decay is advanced and extensive, stem breakage and wind throw can occur.

Figure 3: Showing the fungal fruiting body present within the cavity of the Norway Maple tree.

The fungal pathogen (*Daedalea unicolor*) is known to be of a persistent action and will continue to degrade the tree's main stem, buttresses and root system; unfortunately no effective control measures can be taken to stop the pathogenic decay.

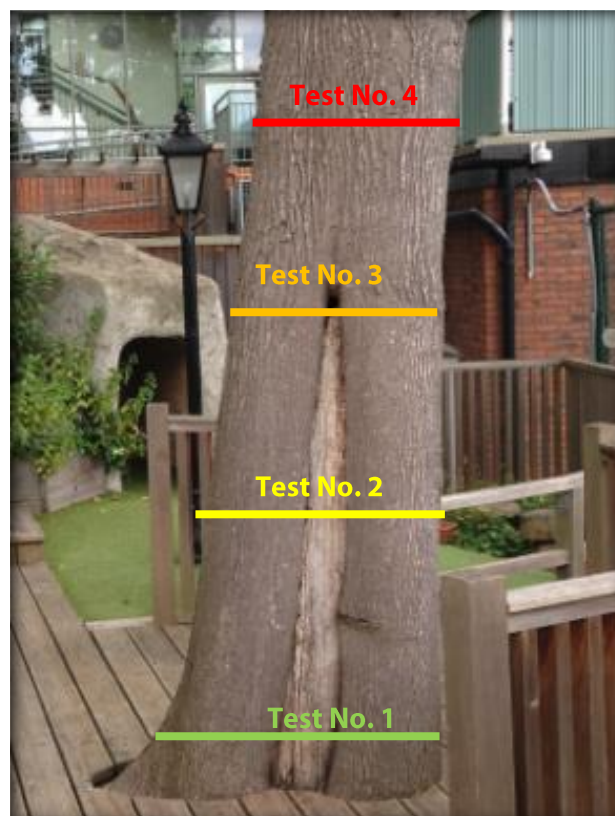
A total of sixteen tests were conducted on the Norway Maple, four tests performed upon the tree at various heights, commencing at approximately 100 millimetres above ground level just above the tree's buttresses, with the subsequent tests conducted at 1000, 1500 and 2000 millimetres above ground level. Please refer to Figure 4 for locations.

Figure 5: Showing the Resistance Micro-Drill testing locations on the Norway Maple tree.

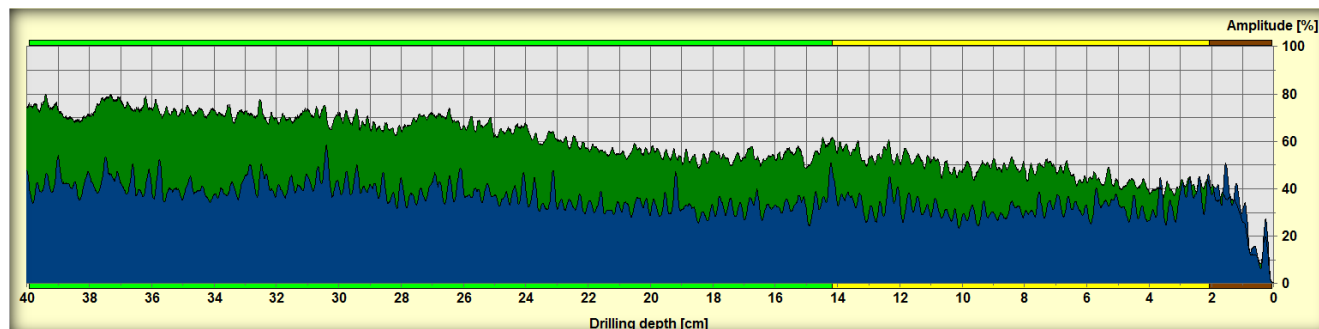
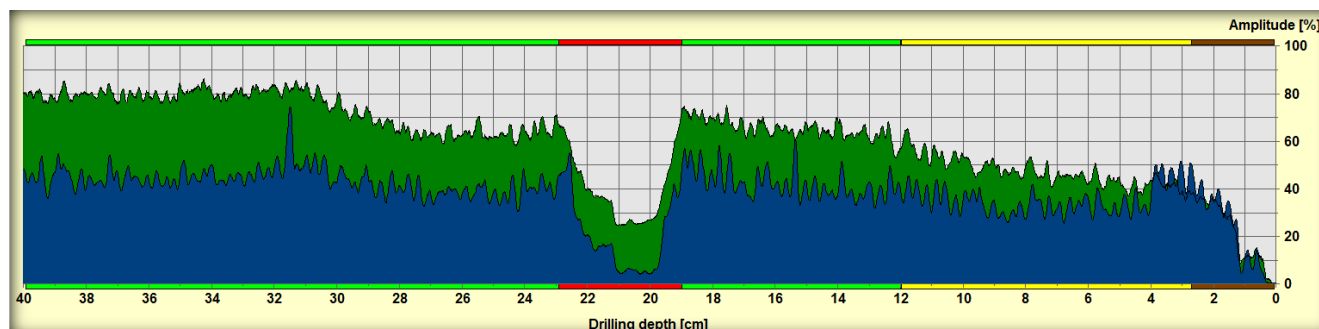
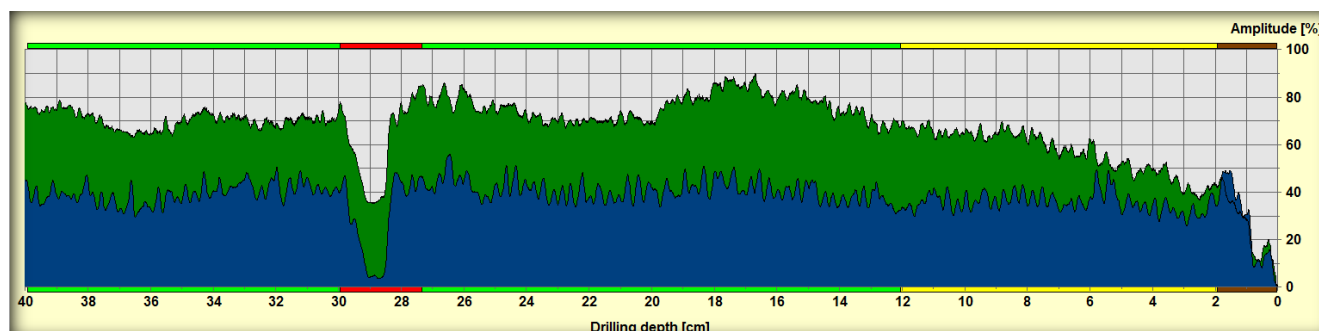
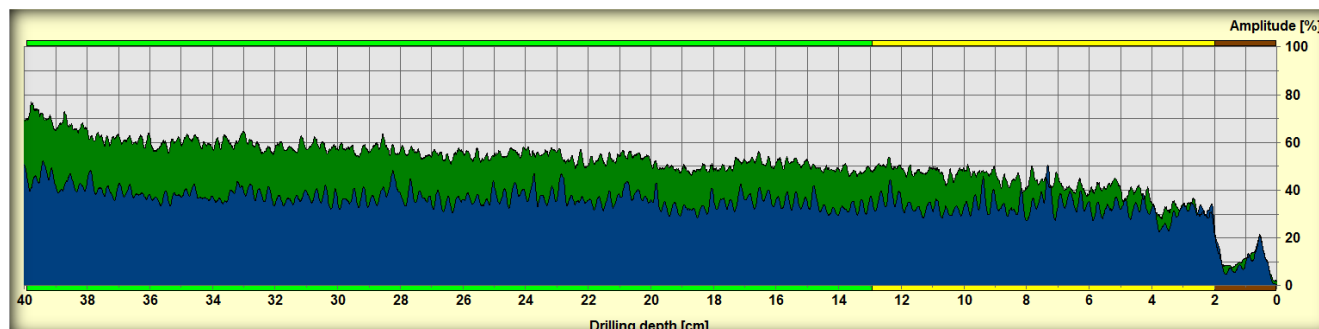
6.2 Resistance Micro-drill Test Results obtained from 100 mm above ground level.

Whilst comparing the results as shown within tests 1 to 4 (100 millimetres above ground level), the average thickness of sound wood measurement is calculated to be 31.5 centimetres of penetration, with a corresponding t/R ratio of 0.8 which does satisfy Mattheck's t/R ratio and failure criteria.

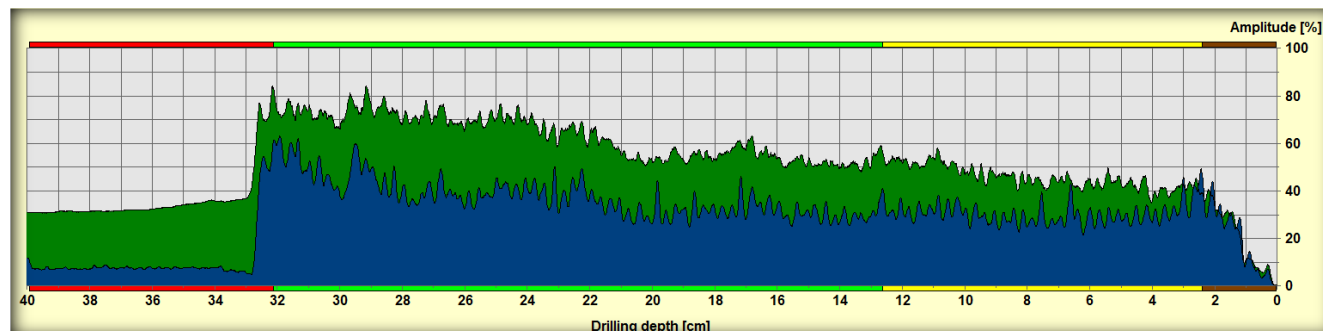
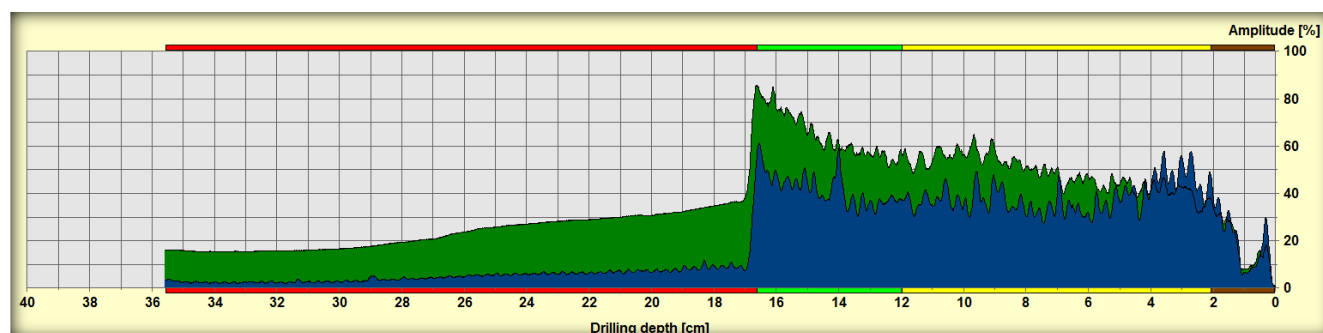
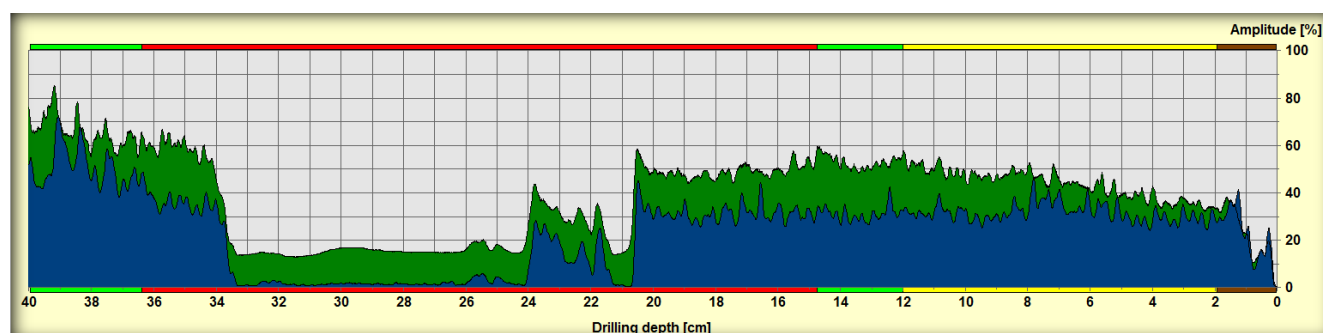
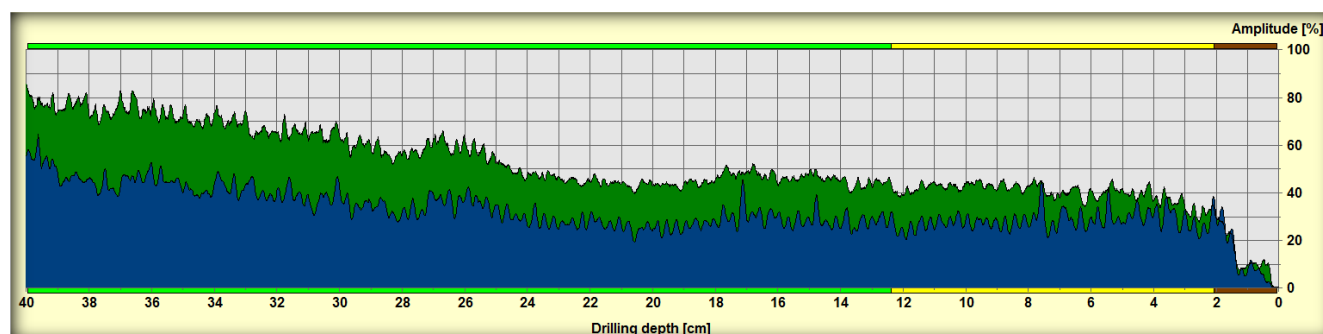
6.3 Resistance Micro-drill Test Results obtained from 1000 mm above ground level

Whilst comparing the results as shown within tests 5 to 8 (1000 millimetres above ground level), the average thickness of sound wood measurement is calculated to be 26.0 centimetres of penetration, with a corresponding t/R ratio of 0.7 which does satisfy Mattheck's t/R ratio and failure criteria.

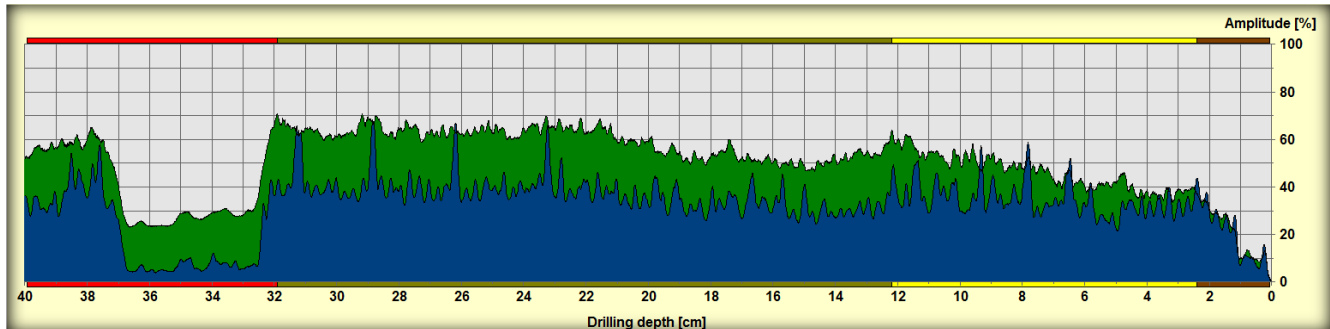
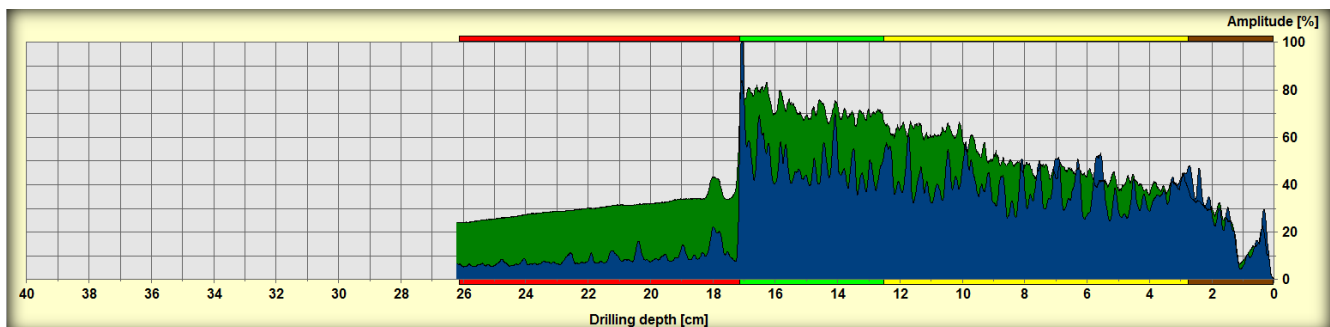
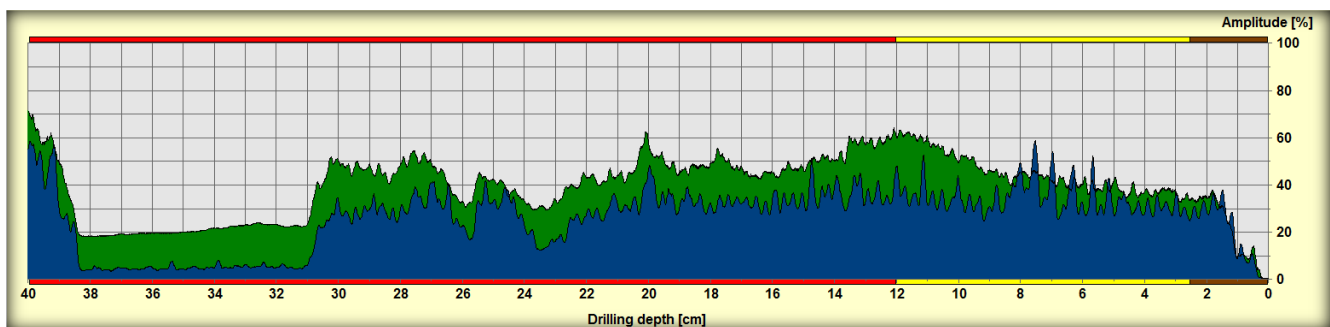
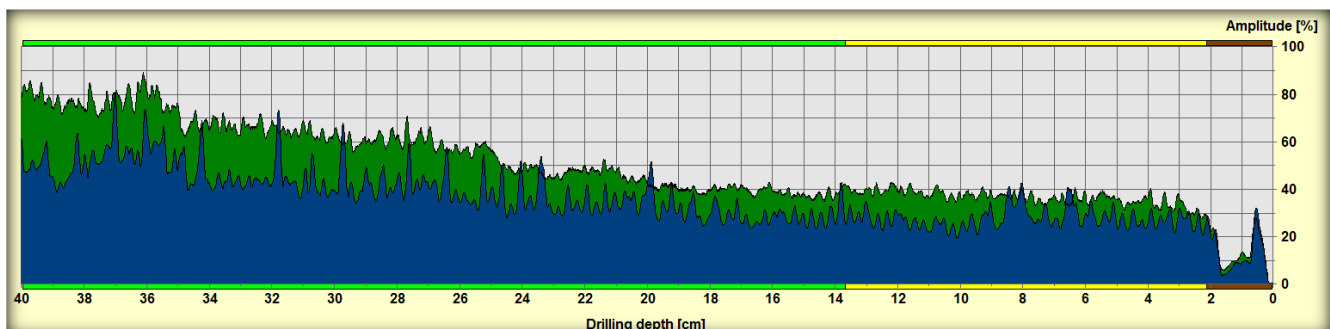
6.4 Resistance Micro-drill Test Results obtained from 1500 mm above ground level

Whilst comparing the results as shown within tests 9 to 12 (1500 millimetres above ground level), the average thickness of sound wood measurement is calculated to be 25.0 centimetres of penetration, with a corresponding t/R ratio of 0.7 which does satisfy Mattheck's t/R ratio and failure criteria.

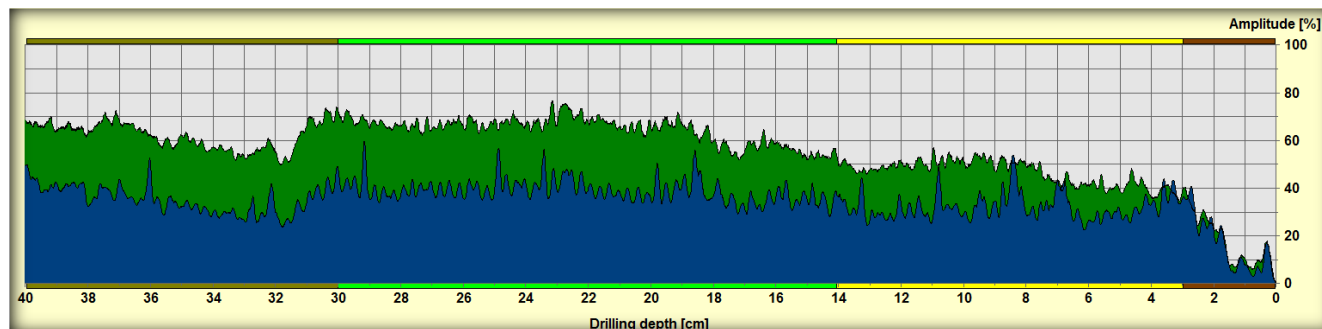
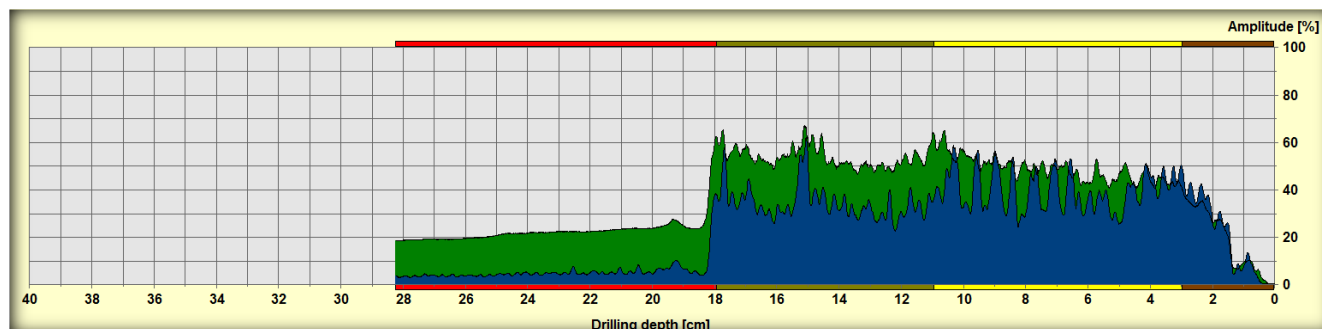
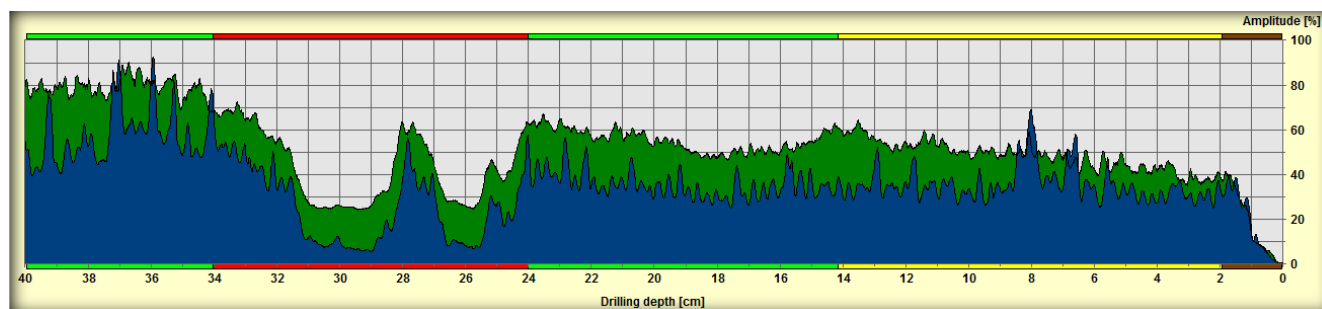
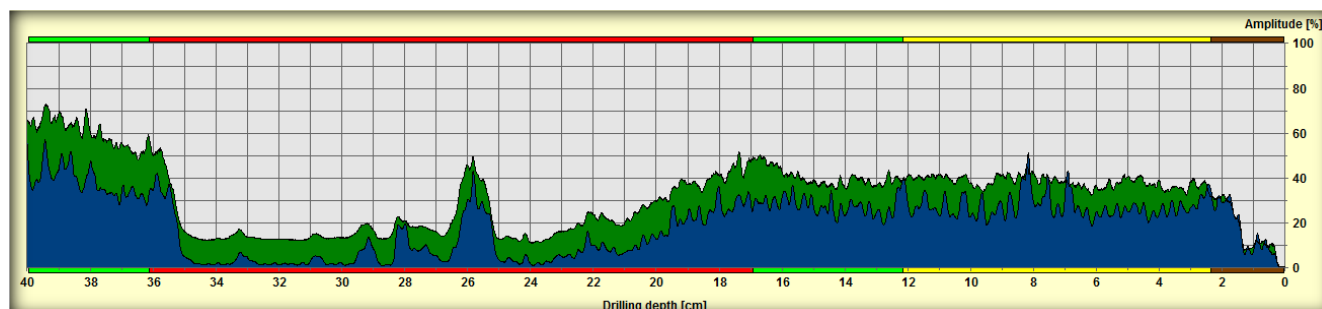
6.5 Resistance Micro-drill Test Results obtained from 2000 mm above ground level

Whilst comparing the results as shown within tests 13 to 16 (2000 millimetres above ground level), the average thickness of sound wood measurement is calculated to be 20.5 centimetres of penetration, with a corresponding t/R ratio of 0.6 which does satisfy Mattheck's t/R ratio and failure criteria.

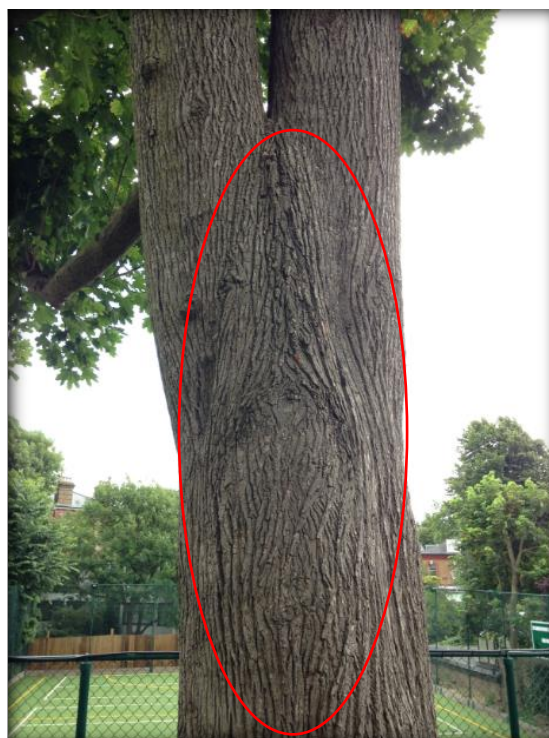
The main stem bifurcated at 4.0 metres above ground level and featured a significant 'compression fork' with adaptive growth below, between 3.0 – 4.0 metres above ground level. This is considered to be a significant structural issue, further compounded by the presence of internal decay below the bifurcation and adaptation, making it susceptible to splitting.

Figure 6: Showing the compression fork and adaptive growth below the point of bifurcation

The presence and extent of adaptive growth found below the compression fork and point of bifurcation is of concern, particularly with the known extent of internal decay within the main stem. As such, the main stem is considered to be at an increased risk of fracture.

In order to effectively reduce the tree's risk of failure, the crown must be reduced regularly, as has been conducted previously. This will reduce the tree's wind sail and alleviate the stress exerted upon the decayed rooting system and decayed main stem.

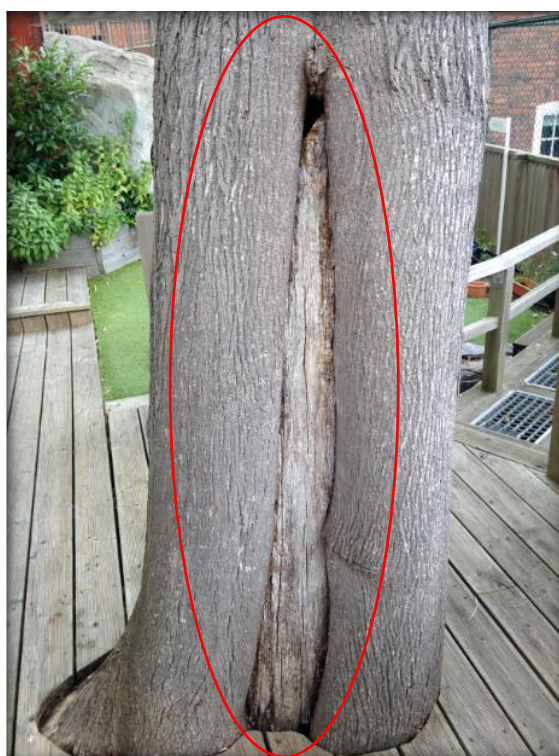
The tree's root collar and main stem featured a significant wound on the south side, reaching up to 1.5 metres above ground level. This wound is historic and suspected to be a result of mechanical damage. Heartwood is exposed, desiccated, decaying and also featured multiple boring beetle exit holes. At its widest point, the wound measured 130 millimetres when probed; the cavity revealed that it was occupied by an active wood ant's nest.

The wound wood development either side of the cavity appears to be developing well; however the tree was sounded as part of the visual assessment, using a nylon hammer, to listen for variations in resonance. Where there is wood degradation and cavities, the sound will resonate with a deeper tone than when the wood is solid. Areas of dead bark will return a loud and sharp 'crack'. Sounding was carried out around the full 360° of the stem, from ground level to a height of 2.5 metres above and poor resonance was emitted.

Figure 7: Showing the significant wound and cavity from ground level up to 1.5 metres above.

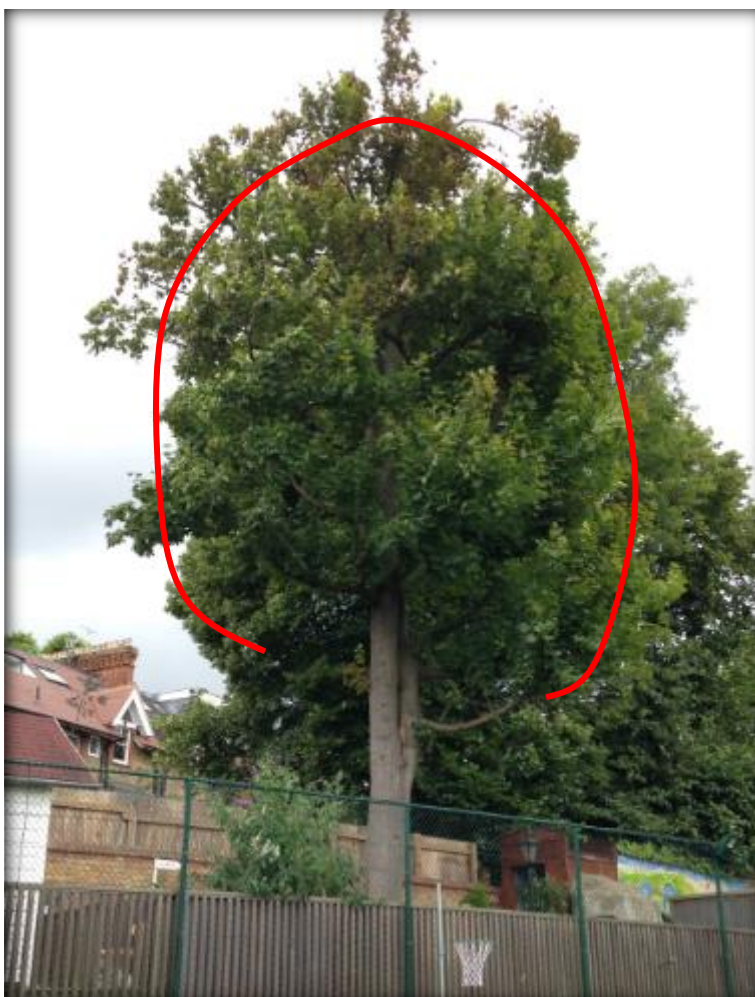
Figure 8: Showing the recommended crown reduction, as viewed from the south.

Therefore, if the tree is to be retained, the recommended crown reduction works would also drastically affect the tree's amenity value and in turn reduce its aesthetic appeal. If retained, it will also require re-inspection and a re-evaluation within two years of this assessment.

However, should this level of risk and associated expense be considered unacceptable, the only viable option thereafter would be to fell the tree and replant with an appropriate specimen, if desired.
