**REPORT TO CLIENT
ASBESTOS DEMOLITION SURVEY**

WITHIN
UPRN 02912
25 Green Wood Place
London
NW5 1LB
On Behalf Of
London Borough of Camden
Contract Code: 607-02912
Date of Issue: 18th September 2014
First Issue

An Asbestos Pre-Demolition Survey was carried out within 25 Greenwood Place, London, NW5 1LB.

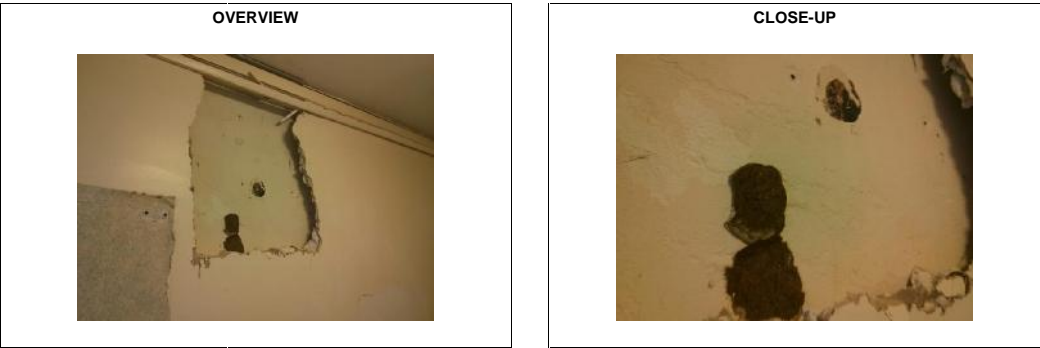
Floor:	G	Location description:	Kitchen
Room/Area:	001	Sample Number:	001
Material:	Bituminous	Item:	Adhesive to wall
Measured Extent:	small amounts		
Damage/Condition:	Low	Asbestos Type:	No asbestos detected
Notes:

Recommendations:	No Action Required										
Material Assessment Scores											
Product:	1	Condition/damage:	1	Surface treatment :	0	Asbestos Type:	0				
Priority Assessment											
Normal occupant Activity:		0									
Location:		0									
Accessibility:		0									
Extent / amount:		0									
Number of occupants:		0		Frequency of use of area:		0					
Average time area is in use:		0		Type of maintenance activity:		0					
Frequency of maintenance activity:		0									
Scores											
Material Assessment Score:				Priority Assessment Score:				Total Risk Score:

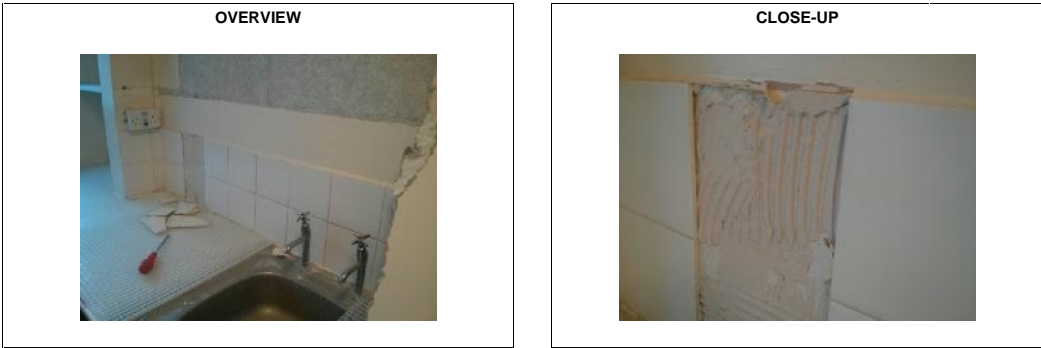
Floor:	G	Location description:	Kitchen
Room/Area:	001	Sample Number:	002
Material:	Composites	Item:	Tile grout
Measured Extent:	1 m²		
Damage/Condition:	Low	Asbestos Type:	No asbestos detected
Notes:

Recommendations:	No Action Required										
Material Assessment Scores											
Product:	1	Condition/damage:	1	Surface treatment :	0	Asbestos Type:	0				
Priority Assessment											
Normal occupant Activity:		0									
Location:		0									
Accessibility:		0									
Extent / amount:		0									
Number of occupants:		0		Frequency of use of area:		0					
Average time area is in use:		0		Type of maintenance activity:		0					
Frequency of maintenance activity:		0									
Scores											
Material Assessment Score:				Priority Assessment Score:				Total Risk Score:

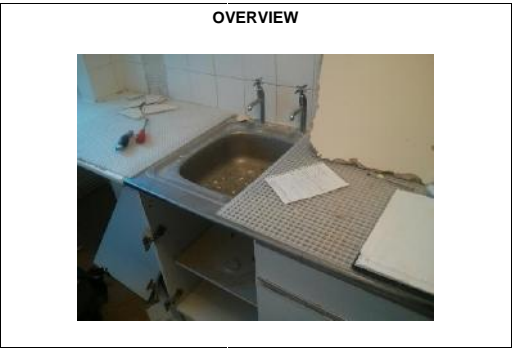
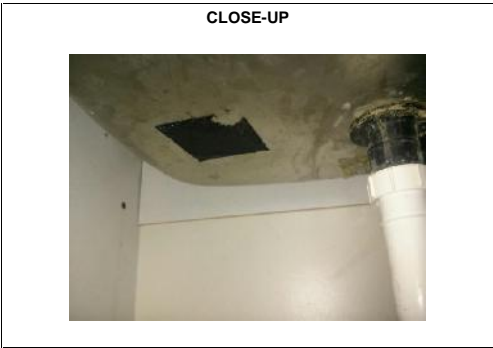
Floor:	G	Location description:	Kitchen
Room/Area:	001	Sample Number:	003
Material:	Bituminous	Item:	Sink pad
Measured Extent:	2 No.	Asbestos Type:	No asbestos detected
Damage/Condition:	Low		
Notes:

Recommendations:	No Action Required
------------------	--------------------

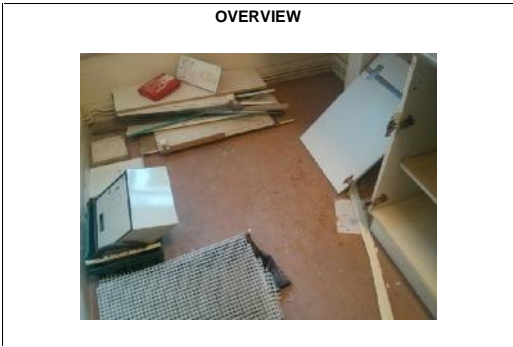
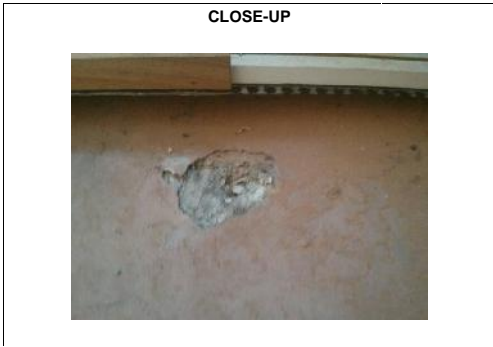
Floor:	G	Location description:	Kitchen
Room/Area:	001	Sample Number:	004
Material:	Composites	Item:	Floor covering
Measured Extent:	8 m²	Asbestos Type:	No asbestos detected
Damage/Condition:	Low		
Notes:	Sample includes screed. Plasterboard ceiling. Plasterboard and solid walls. Concrete below floor covering. Stramit board soffit. Timber ceiling joists. Timber shuttering.

Recommendations:	No Action Required
------------------	--------------------

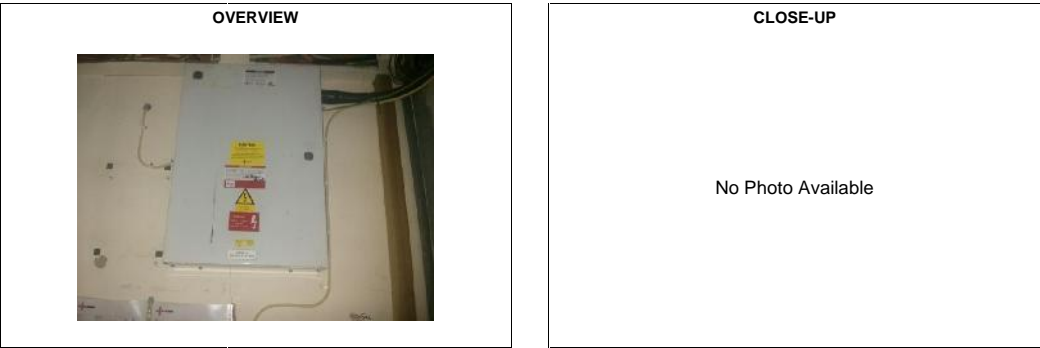
Floor:	G	Location description:	Electrical cupboard
Room/Area:	002	Sample Number:	P
Material:		Item:	Electrics
Measured Extent:		Asbestos Type:	
Damage/Condition:			
Notes:	Plasterboard ceiling. Strammit board soffit. Solid walls. Quarry tiles to floor.

Recommendations:			
Material Assessment Scores			
Product:		Condition/damage:	Surface treatment : Asbestos Type:
Priority Assessment			
Normal occupant Activity:	0		
Location:	0		
Accessibility:	0		
Extent / amount:	0		
Number of occupants:	0	Frequency of use of area:	0
Average time area is in use:	0	Type of maintenance activity:	0
Frequency of maintenance activity:	0		
Scores			
Material Assessment Score:		Priority Assessment Score:	Total Risk Score:

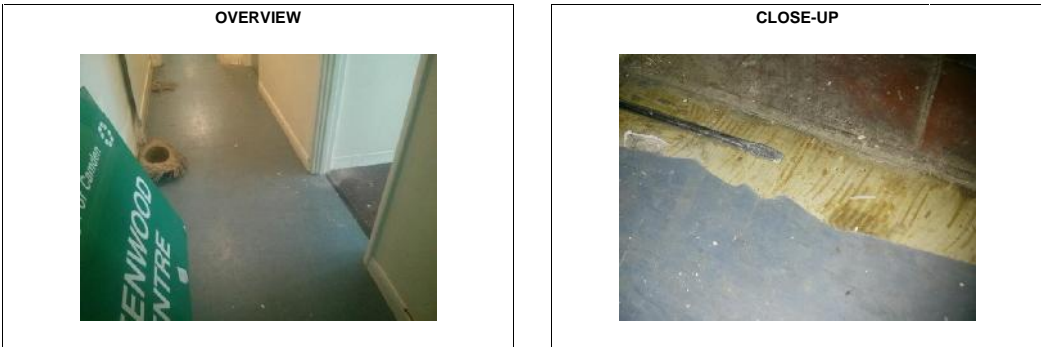
Floor:	G	Location description:	Corridor
Room/Area:	003	Sample Number:	005
Material:	Vinyl/Thermo plastic	Item:	Beige lower floor covering
Measured Extent:	12 m²	Asbestos Type:	No asbestos detected
Damage/Condition:	Low		
Notes:	Plasterboard ceiling. Strammit board soffit. Solid walls. Timber ceiling joists. Plasterboard door surrounds.

Recommendations:			
No Action Required			
Material Assessment Scores			
Product:	1	Condition/damage:	Surface treatment : Asbestos Type:
Priority Assessment			
Normal occupant Activity:	0		
Location:	0		
Accessibility:	0		
Extent / amount:	0		
Number of occupants:	0	Frequency of use of area:	0
Average time area is in use:	0	Type of maintenance activity:	0
Frequency of maintenance activity:	0		
Scores			
Material Assessment Score:		Priority Assessment Score:	Total Risk Score:

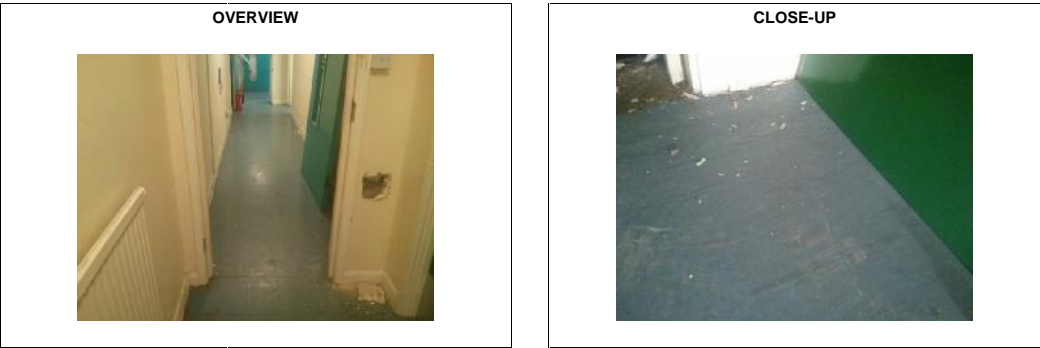
Floor:	G	Location description:	Corridor
Room/Area:	003	Sample Number:	006
Material:	Vinyl/Thermo plastic	Item:	Blue upper floor covering
Measured Extent:	12 m²	Asbestos Type:	No asbestos detected
Damage/Condition:	Low		
Notes:

Recommendations:	No Action Required
------------------	--------------------

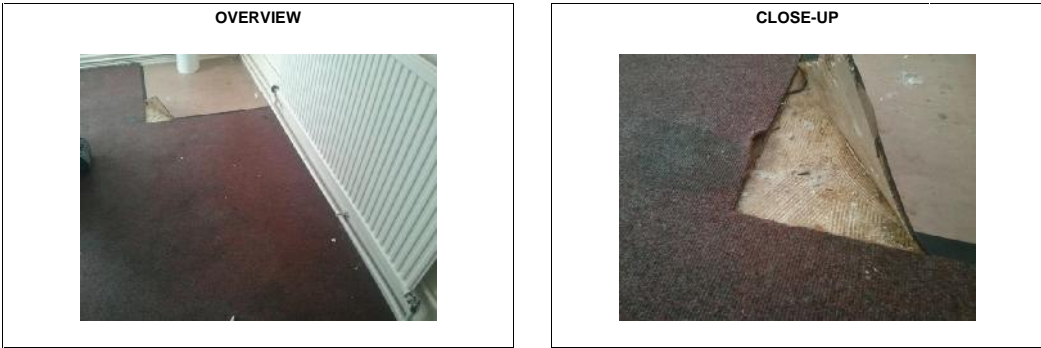
Floor:	G	Location description:	Room
Room/Area:	004	Sample Number:	007
Material:	Vinyl/Thermo plastic	Item:	Floor covering below carpet
Measured Extent:	10 m²	Asbestos Type:	No asbestos detected
Damage/Condition:	Low		
Notes:	Plasterboard ceiling. Strammit board soffit. Solid walls. Timber ceiling joists.

Recommendations:	No Action Required
------------------	--------------------

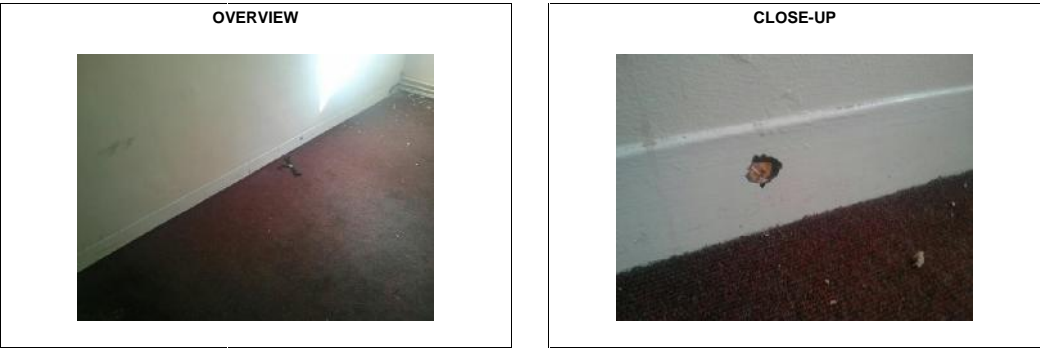
Floor:	G	Location description:	Room
Room/Area:	004	Sample Number:	008
Material:	Vinyl/Thermo plastic	Item:	Skirting
Measured Extent:	12 m	Asbestos Type:	No asbestos detected
Damage/Condition:	Low		
Notes:

Recommendations:	No Action Required										
Material Assessment Scores											
Product:	1	Condition/ damage:	1	Surface treatment :	0	Asbestos Type:	0				
Priority Assessment											
Normal occupant Activity:		0									
Location:		0									
Accessibility:		0									
Extent / amount:		0									
Number of occupants:		0		Frequency of use of area:		0					
Average time area is in use:		0		Type of maintenance activity:		0					
Frequency of maintenance activity:		0									
Scores											
Material Assessment Score:				Priority Assessment Score:				Total Risk Score:

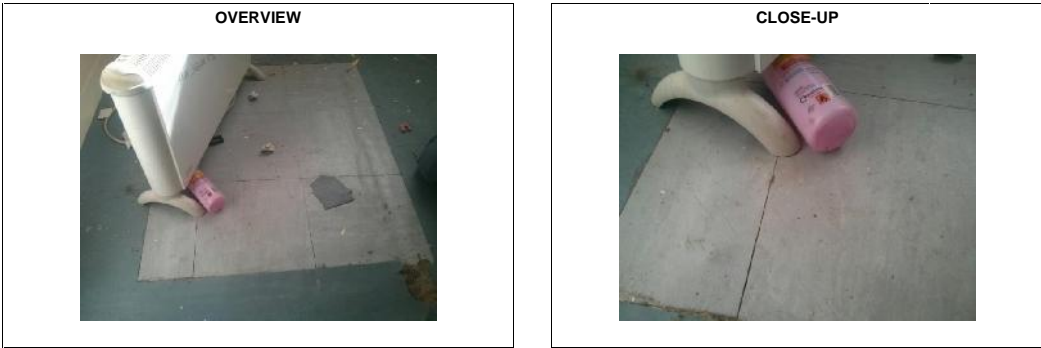
Floor:	G	Location description:	Room
Room/Area:	005	Sample Number:	009
Material:	Vinyl/Thermo plastic	Item:	Blue floor tile
Measured Extent:	1 m²	Asbestos Type:	No asbestos detected
Damage/Condition:	Low		
Notes:	Plasterboard ceiling. Strammit board soffit. Solid walls. Timber ceiling joists.

Recommendations:	No Action Required										
Material Assessment Scores											
Product:	1	Condition/ damage:	1	Surface treatment :	0	Asbestos Type:	0				
Priority Assessment											
Normal occupant Activity:		0									
Location:		0									
Accessibility:		0									
Extent / amount:		0									
Number of occupants:		0		Frequency of use of area:		0					
Average time area is in use:		0		Type of maintenance activity:		0					
Frequency of maintenance activity:		0									
Scores											
Material Assessment Score:				Priority Assessment Score:				Total Risk Score:

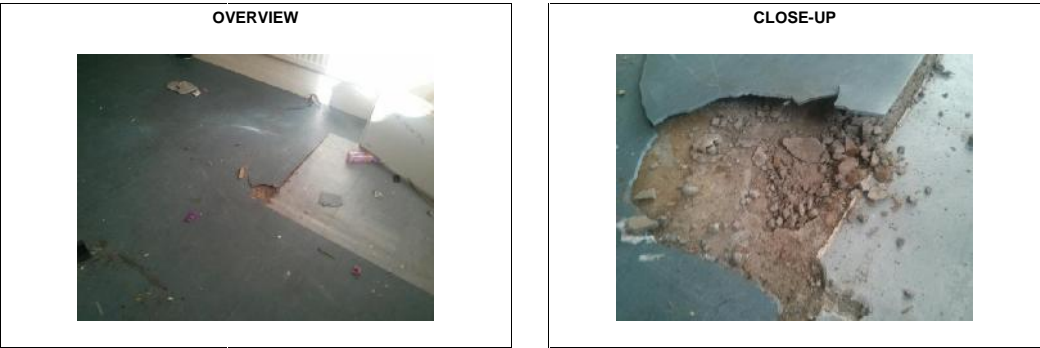
Floor:	G	Location description:	Room
Room/Area:	005	Sample Number:	010
Material:	Composites	Item:	Screed below vinyl
Measured Extent:	10 m²	Asbestos Type:	No asbestos detected
Damage/Condition:	Low	Notes: Plasterboard ceiling. Strammit board soffit. Solid walls. Timber ceiling joists. Plastic skirting.

Recommendations:	No Action Required
------------------	--------------------
