**REPORT TO CLIENT
ASBESTOS DEMOLITION SURVEY**

**WITHIN
UPRN L03276 - 37 Greenwood Place**

**On Behalf Of
London Borough of Camden**

**Contract Code: 607-03276
Date of Issue: 3rd September 2015**

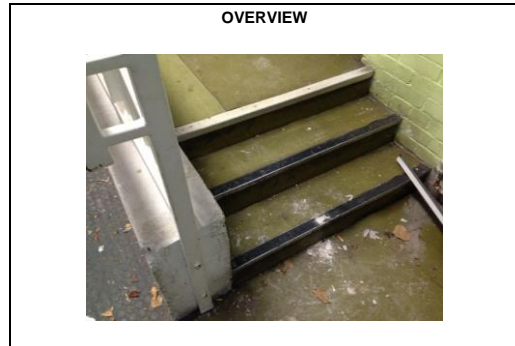
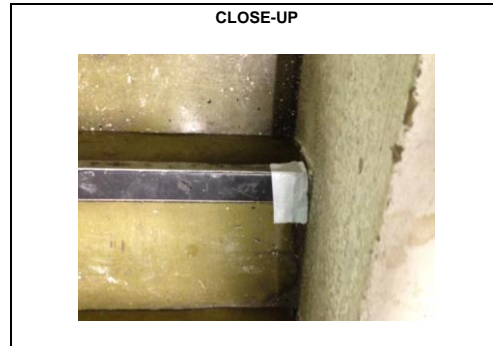
Floor:	G	Location description:	Corridor
Room/Area:	002	Sample Number:	001
Material:	Composites	Item:	Black stair nosing
Measured Extent:	2 m ²	Asbestos Type:	Chrysotile
Damage/Condition:	Low		
Notes:

Material Assessment Scores							
Product:	1	Condition/damage:	1	Surface treatment :	0	Asbestos Type:	1

Scores					
Material Assessment Score:	3	Priority Assessment Score:		Total Risk Score:

Recommendations:	Remove
-------------------------	--------

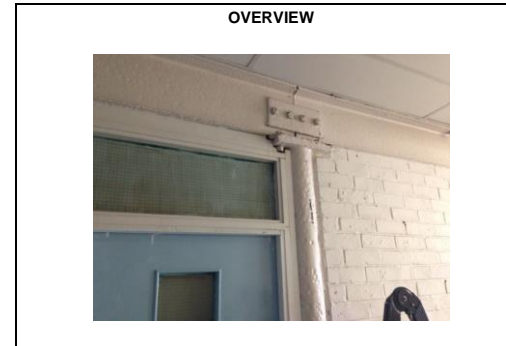
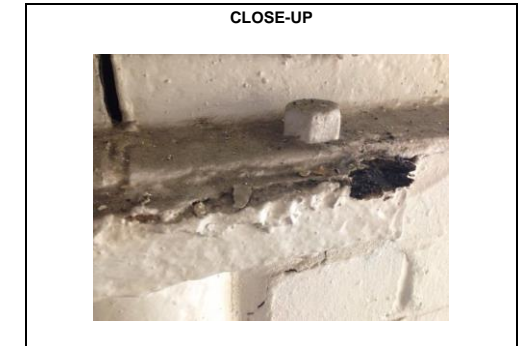
Floor:	G	Location description:	Corridor
Room/Area:	005	Sample Number:	002
Material:	Bituminous	Item:	Packer between RSJ and column
Measured Extent:	0.05 m visible	Asbestos Type:	No asbestos detected
Damage/Condition:	Medium		
Notes:	All column heads not visible, maybe present throughout

Material Assessment Scores							
Product:	1	Condition/damage:	2	Surface treatment :	0	Asbestos Type:	0

Recommendations:	No Action Required
-------------------------	--------------------

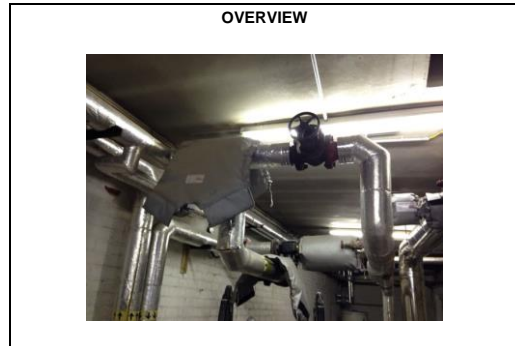
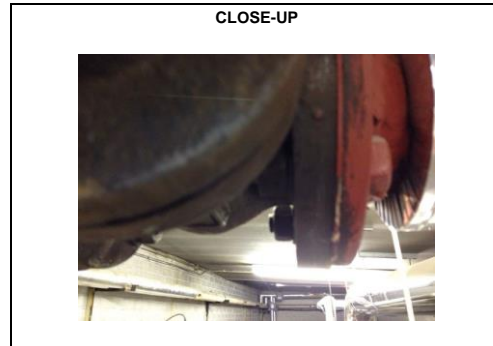
Floor:	G	Location description:	Boiler room
Room/Area:	015	Sample Number:	003
Material:	Gasket	Item:	Gasket to pipework
Measured Extent:	1 No. visible	Asbestos Type:	Chrysotile
Damage/Condition:	Good		
Notes:	Present to all flanges throughout boiler room

Material Assessment Scores							
Product:	2	Condition/damage:	0	Surface treatment :	0	Asbestos Type:	1

Scores					
Material Assessment Score:	3	Priority Assessment Score:		Total Risk Score:

Recommendations:	Remove
-------------------------	--------

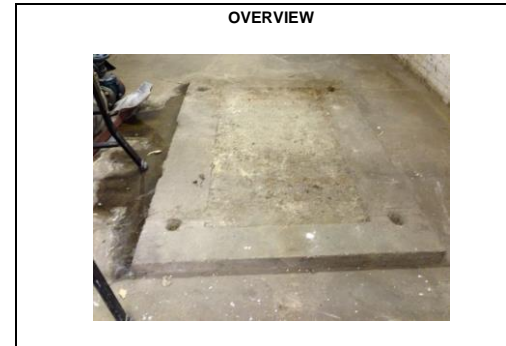
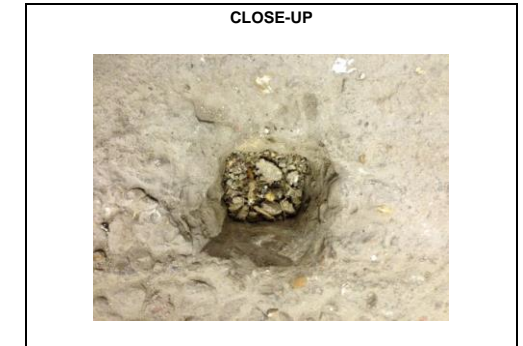
Floor:	G	Location description:	Boiler room
Room/Area:	015	Sample Number:	004
Material:	Debris	Item:	Debris to holes in redundant plinth
Measured Extent:	Small amounts	Asbestos Type:	No asbestos detected
Damage/Condition:	High		
Notes:	Visible to 4 holes in corners of plinth

Material Assessment Scores							
Product:	3	Condition/damage:	3	Surface treatment :	3	Asbestos Type:	0

Recommendations:	No Action Required
-------------------------	--------------------

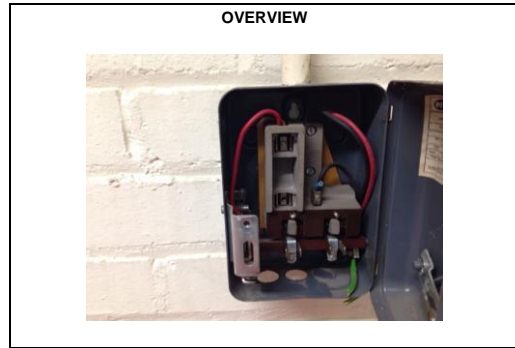
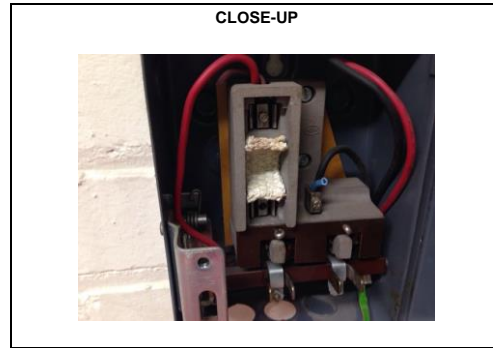
Floor:	G	Location description:	Store
Room/Area:	020	Sample Number:	005
Material:	Rope/Yarn/Textile	Item:	Fuses pads
Measured Extent:	1 No.	Asbestos Type:	Chrysotile
Damage/Condition:	Low		
Notes:	Item removed as sample

Material Assessment Scores					
Product:	2	Condition/damage:	1	Surface treatment :	2
		Asbestos Type:	1

Scores			
Material Assessment Score:	6	Priority Assessment Score:	
Total Risk Score:

Recommendations:	Remove
-------------------------	--------

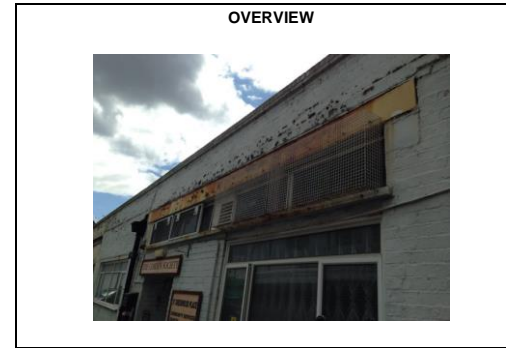
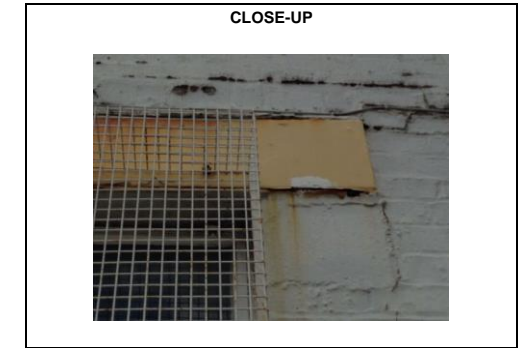
Floor:	Ext	Location description:	External elevations
Room/Area:	001	Sample Number:	006
Material:	Insulating board	Item:	Beam cladding
Measured Extent:	5 m	Asbestos Type:	Amosite Chrysotile
Damage/Condition:	Low		
Notes:

Material Assessment Scores					
Product:	2	Condition/damage:	1	Surface treatment :	1
		Asbestos Type:	2

Scores			
Material Assessment Score:	6	Priority Assessment Score:	
Total Risk Score:

Recommendations:	Remove
-------------------------	--------

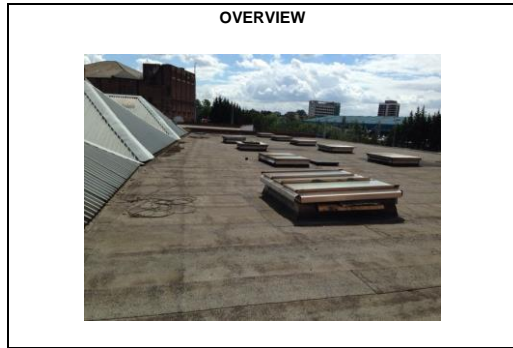
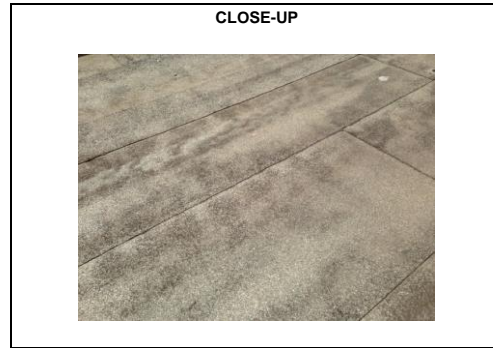
Floor:	Ext	Location description:	Roof
Room/Area:	002	Sample Number:	007
Material:	Bituminous	Item:	Roofing felt
Measured Extent:	420 m ²	Asbestos Type:	No asbestos detected
Damage/Condition:	Low		
Notes:	Polystyrene to water tank

Material Assessment Scores							
Product:	1	Condition/damage:	1	Surface treatment :	0	Asbestos Type:	0

Recommendations:	No Action Required
-------------------------	--------------------
