**Simon Pryce Arboriculture**

Date: 30 July 2016  
Your ref:  
My ref 15/063/2  
FAO Brian Kernahan  
By e mail

**Birch tree in front of 51 Belsize Park Gardens, NW3**

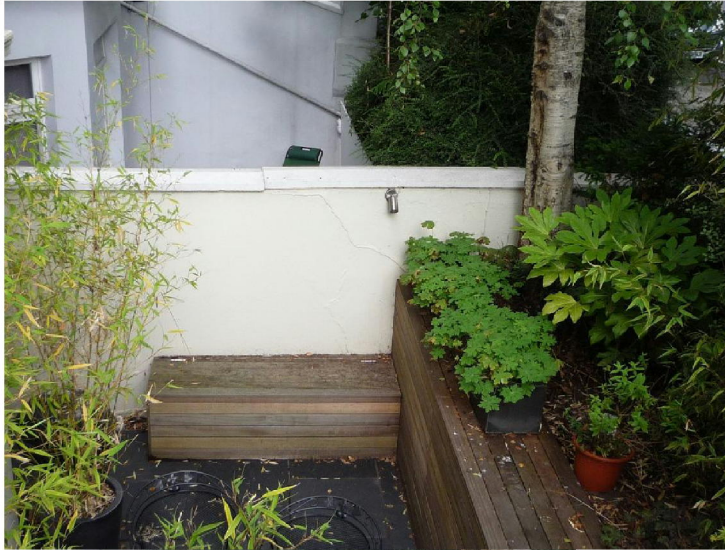
8. This is shown on the photographs. The side wall next to the tree has been displaced laterally towards no.49 by approximately 30mm, so there is a crack in the coping on the top and a diagonal crack that ascends from near the base of the tree towards the house. This goes right through the wall as the crack is mirrored by one on the side facing no.49. That crack is wider due to the wall being displaced towards no.49.
9. The trunk was also damaging two plastic electrical cable conduits attached to the wall just above ground level.

10. The local subsoil is London clay, which creates a potential for trees to cause subsidence if the roots cause significant soil drying below foundations. However in this case the wall is being displaced sideways with no signs of vertical movement and I agree with Mr. Papworth that this is due to direct pressure from the expansion of the lower trunk and main roots as the tree grows. Birches are not particularly large growing, but can develop trunks 400 - 500mm in diameter at maturity. As the tree is currently about 300mm diameter at ground level and touching the wall it could push it up to another 100mm, if the tree is left to continue growing, so the damage will worsen significantly and it is likely that it will affect the retaining wall as well.

1) Crack from no.51  
August 2015

13. In view of these points the most appropriate option here is to remove the tree, so that the wall can be rebuilt in its existing form and on the correct property boundary. The problems with the tree are due entirely to its location next to the wall and a suitable new tree elsewhere in the raised planting bed would make a similar or better contribution to the conservation area without these problems.

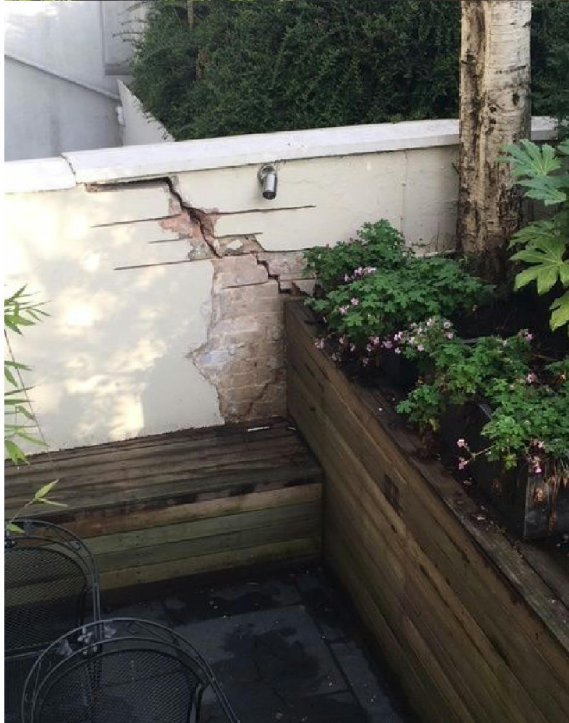
17. The side facing no.51 has been repaired, but the base of the trunk is in contact with the wall and the tree is not fully grown, so the damage will worsen significantly if it is retained.

2) Same crack in April 2016, while being repaired, showing the full extent of the distortion and damage that had been hidden by the render and paint. This has now been filled and re rendered, but the distortion cannot be remedied.

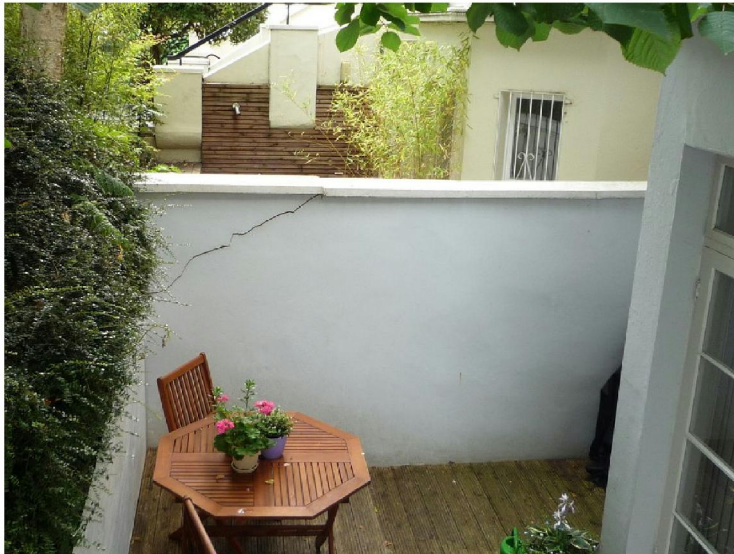
16. The local subsoil is London clay, which creates a potential for subsidence, but the damage here has been caused by direct pressure from the main roots and lower trunk displacing the boundary wall towards no.49.

3) View from no.49, September 2015, wider on this side due to the wall being pushed in this direction.

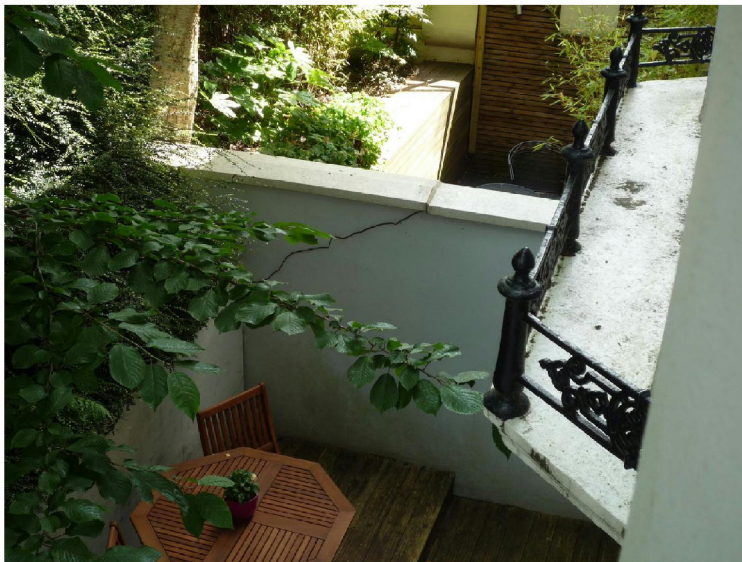
4) Same crack in July 2016, wider although the other side of the wall has been repaired

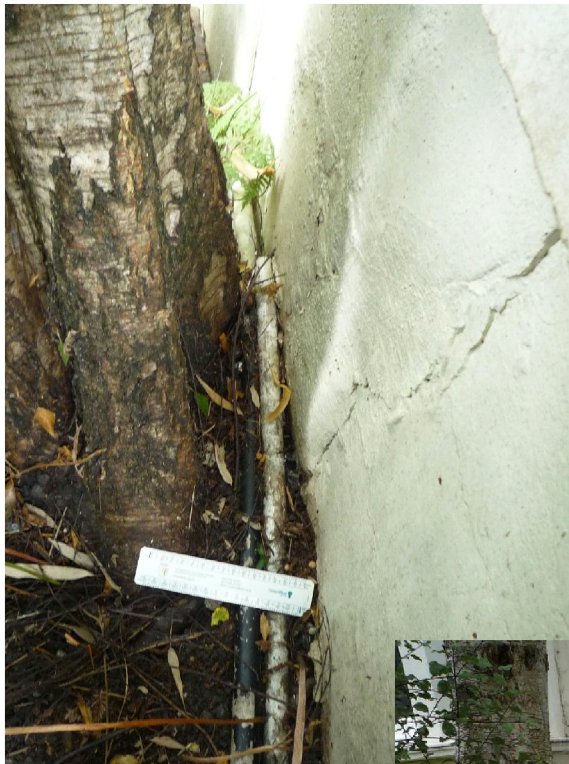
7. The tree is about 15m high and has a single vertical trunk about 270mm in diameter at about 1.5m above ground. The crown has a radial spread of 3 - 5m, reducing on the side facing the house where it has been pruned in the past to create clearance and to the right due to the proximity of the lime in front of no.49. There is some minor dead wood in the crown, but the foliage is of normal density and healthy looking. The base of the trunk is touching the side boundary wall, which is preventing normal root buttress development on that side.

5) Lower trunk showing base touching the wall, vertical crack and broken conduit. September 2015

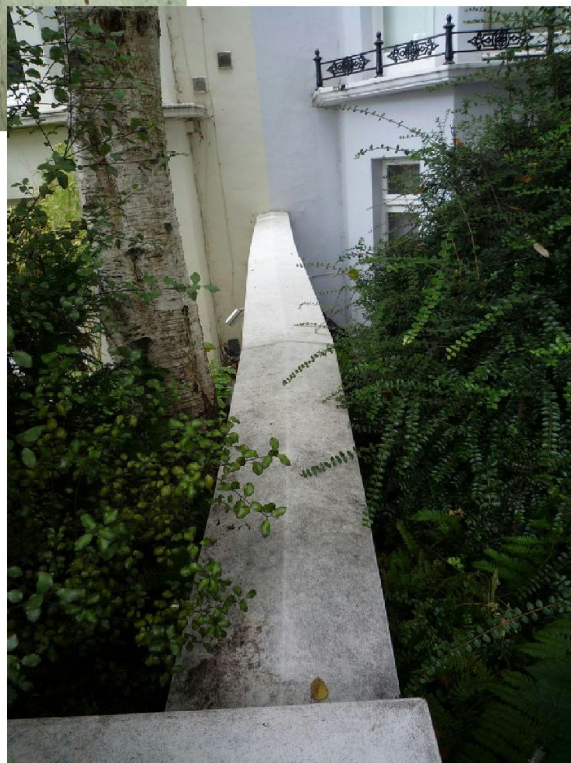
6) View along the top of the wall towards the house showing the degree of lateral distortion, September 2015.

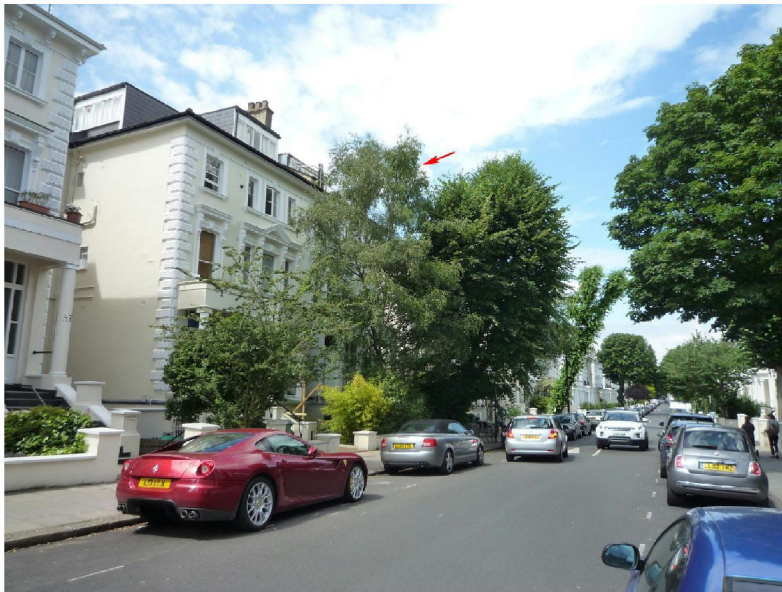
14. Any modification to the wall sufficient to accommodate the tree's growth would alter its appearance considerably, so would probably need conservation area consent. Camden's decision would need to make a balance between that and the tree's amenity value. Its contribution to the street scene is limited, as the lime at no.49 hides it almost completely when approaching from the right and the other trees in this section of the street make it much less noticeable as an individual than it would otherwise be and would mitigate the effect of removing it until a better sited replacement established. The regular pruning to clear the building makes its branch structure unnatural and leaves it asymmetrical when seen from the other direction.

7) View along the street from the L, birch indicated by the arrow.

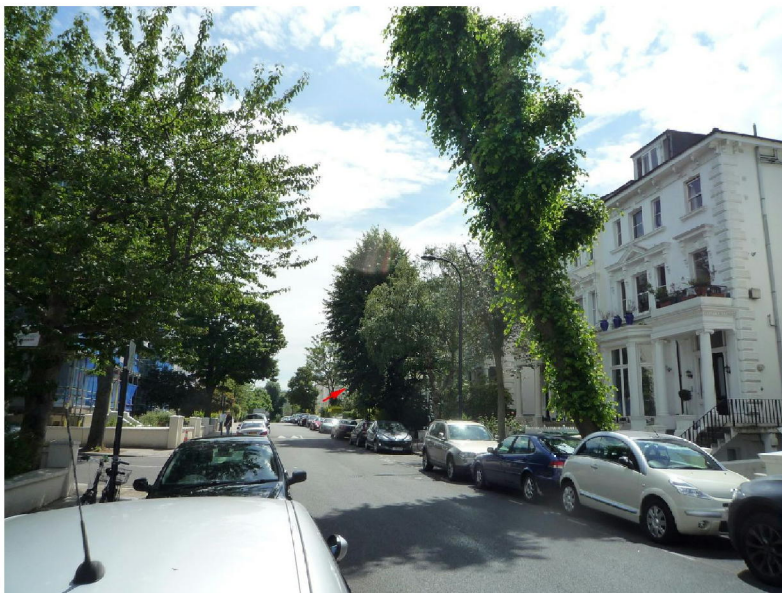
8) View from the R, birch is hidden by the lime, arrow indicates its location.
