Arboricultural Appraisal Report

Subsidence Damage Investigation at:

16 Heath Hurst Road
Hampstead
London
NW3 2RX

CLIENT:	Crawford & Company
CLIENT REF:	SU1503854
MWA REF:	SUB160115-501
MWA CONSULTANT:	David Mahon (B.Sc Hons MICFor MArborA)
REPORT DATE:	26-01-2016

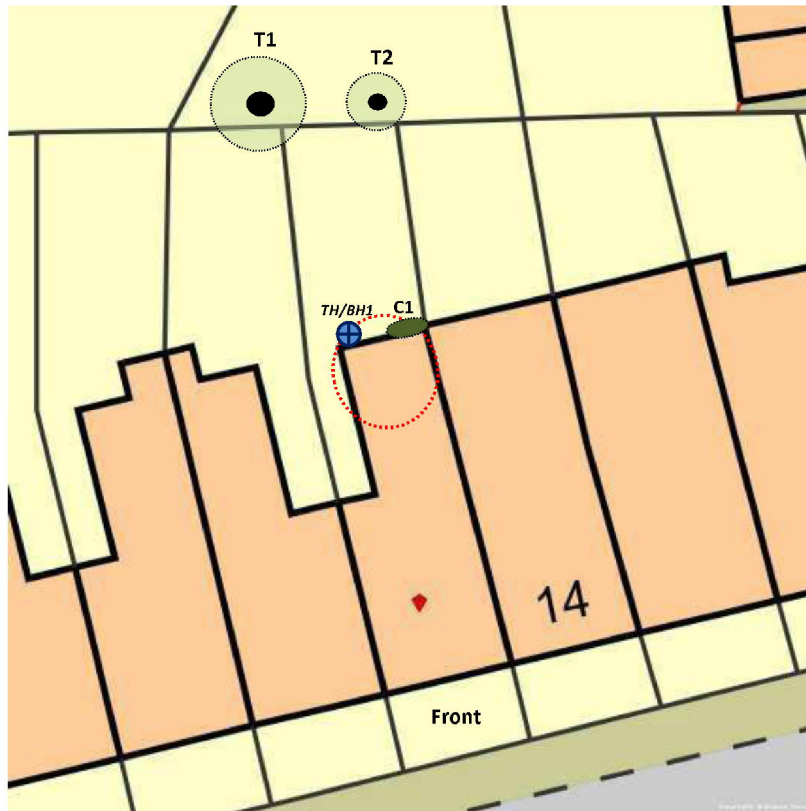
SITE PLAN

The current damage affects the rear projection with internal cracking at ground and first floor levels with external cracks on the rear left hand elevations. The damage was first noticed in September 2015.

Approximate areas of damage

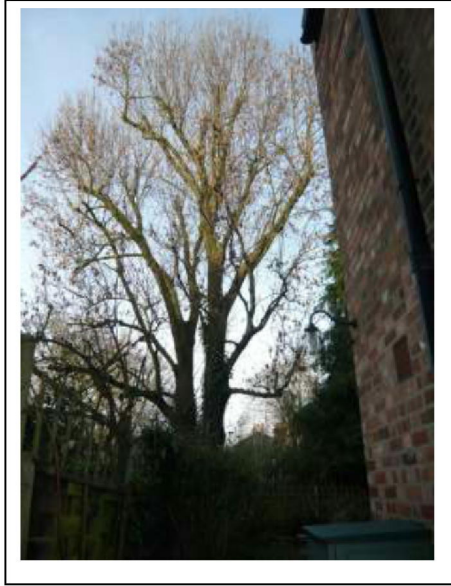
View of T1

Roots were observed to a depth of 2600mm bgl in BH1 and recovered samples have been positively identified (using anatomical analysis) as ash, the origin of which will be T1 confirming the influence of this tree on the soils below the foundations. The Rosa species roots are from non-significant vegetation.

Based on the technical reports currently available, engineering opinion and our own site assessment we conclude the damage is consistent with shrinkage of the clay subsoil related to moisture abstraction by vegetation. Having considered the available information, it is our opinion that T1 is the principal cause of the current subsidence damage. If an arboricultural solution is to be implemented to mitigate the current damage and allow the soils beneath the property to recover to a position such that an effective repair solution can be implemented we recommend that T1 is removed.

Tree No.	Species	Ht (m)	Dia (mm)	Crown Spread (m)	Dist. to building (m)	Age Classification	Ownership
T1	Ash – Twin Stem	*17.0	*600	*12.0	9.5	Younger than property	3 rd Party:- 4 Keats Close
Management history		Reduced in past ~ (within the last five years)					
Recommendation		Remove and treat stump to inhibit regrowth

Consideration has been given to pruning as a means of mitigating the vegetative influence, however in this case, this is not considered to offer a viable long term solution due to the proximity of the responsible vegetation.

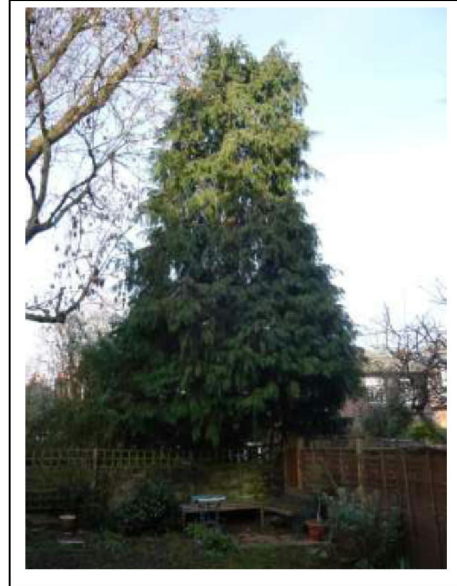
View of T2

Tree No.	Species	Ht (m)	Dia (mm)	Crown Spread (m)	Dist. to building (m)	Age Classification	Ownership
T2	Lawson Cypress	*9.0	*300	6.0	9.0	Younger than property	3 rd Party:- 4 Keats Close
Management history		No Recent Management					
Recommendation		Do not allow to exceed current dimensions					
C1	Jasmin	3.0	<70	3.0	1.0	Younger than property	Policy holder
Management history		Subject to past management					
Recommendation		Do not allow to exceed current dimensions
