ADDENDUM TECHNICAL REPORT

**16 Heath Hurst Road
Hampstead
London
NW3 2RX**

SUBSIDENCE CLAIM

DATE 20 July 2016

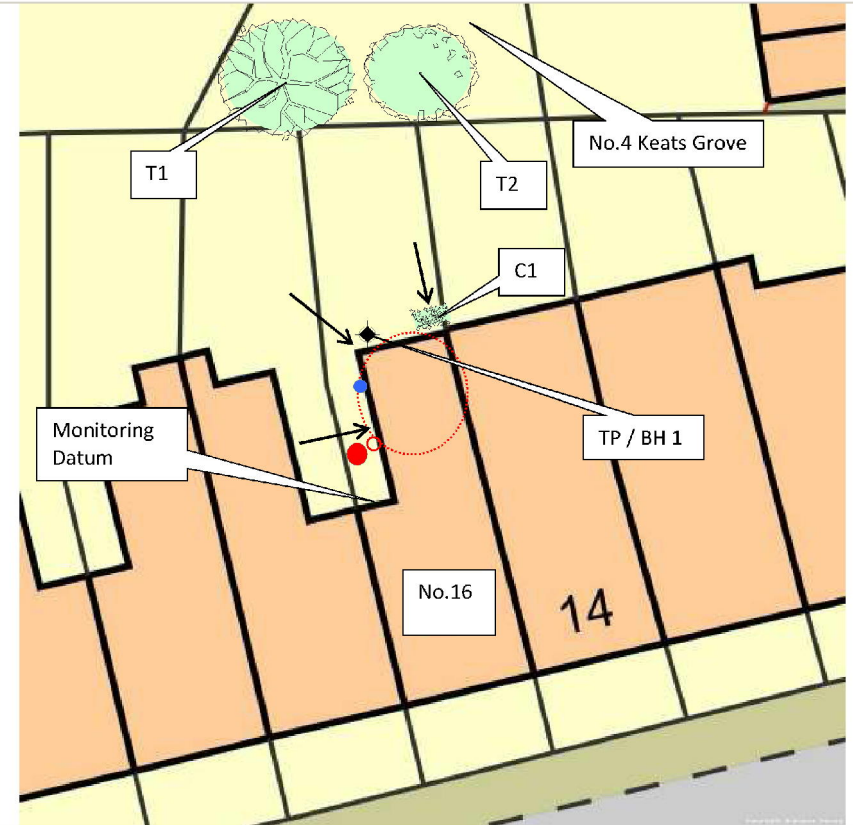
Site Plan

Cyclical movement has been recorded up to June 2016, with the property moving upward through the wet period of 2015/2016. This type of movement can only be created by rehydrating soil, following clay shrinkage subsidence. The movement is focused to point 3 which is nearest the Ash tree (T1).

MWA have formed an arboricultural report which cites the Ash tree (T1) as the effective and substantive cause of the movement. No other local vegetation has been identified as a contributory cause. The Lawson Cypress (T2) and Jasmin shrub (C1) are identified as posing a future risk only.

Property stability is expected following the removal of the Ash tree (T1) and we are happy that the work can proceed without risk of heave damage being created.
