SITE INVESTIGATION FACTUAL REPORT

Report No: 287859
Client: Crawford Claims Management
Site: 16 Heath Hurst Road, London

Client Ref: SU1503854-
Date of Visit: 04/12/2015

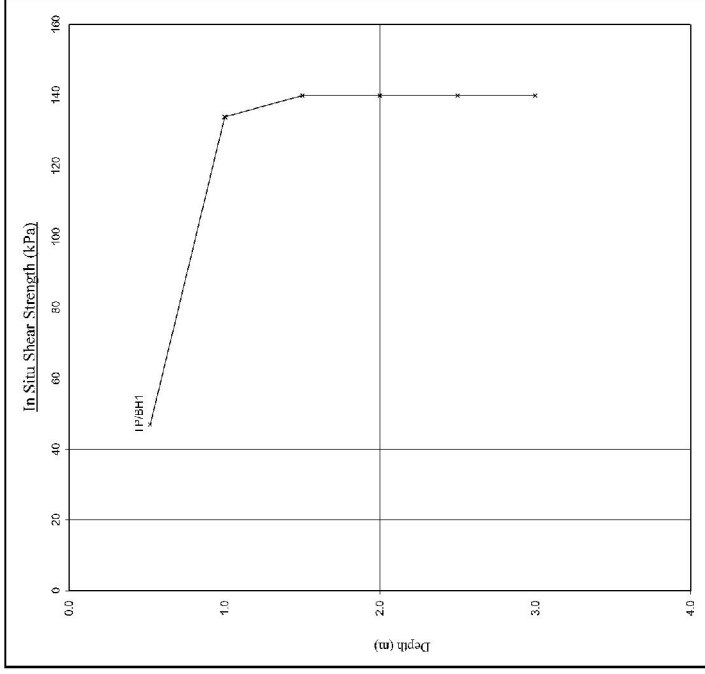
Shear Strength Profiles

Notes:
 1. Unless otherwise stated, values of Shear Strength were determined in situ by CU using a Picon Hand Vane the calibration of which is limited to a maximum setting of 140 kPa.
 2. Unless specifically noted the profiles have not been related to a site datum.
