Heritage Surveys Limited

Conservation Plan & Statement of Heritage Significance Report

136-180, 181-203, 204 - 238 Levita
House and 62 – 76 Chalton Street
Ossulston Estate
Chalton Street
London
NW1 1JJ

Report date: 18 July 2016

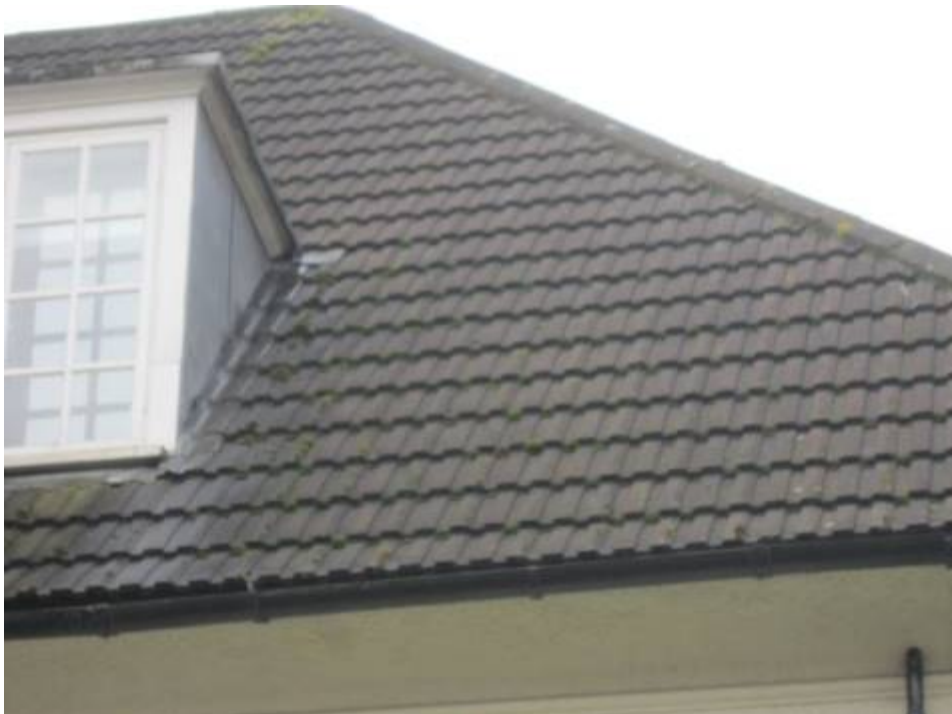
Photograph 2 Recovered roof to 3 storey section of 204 – 238, concrete interlocking tiles

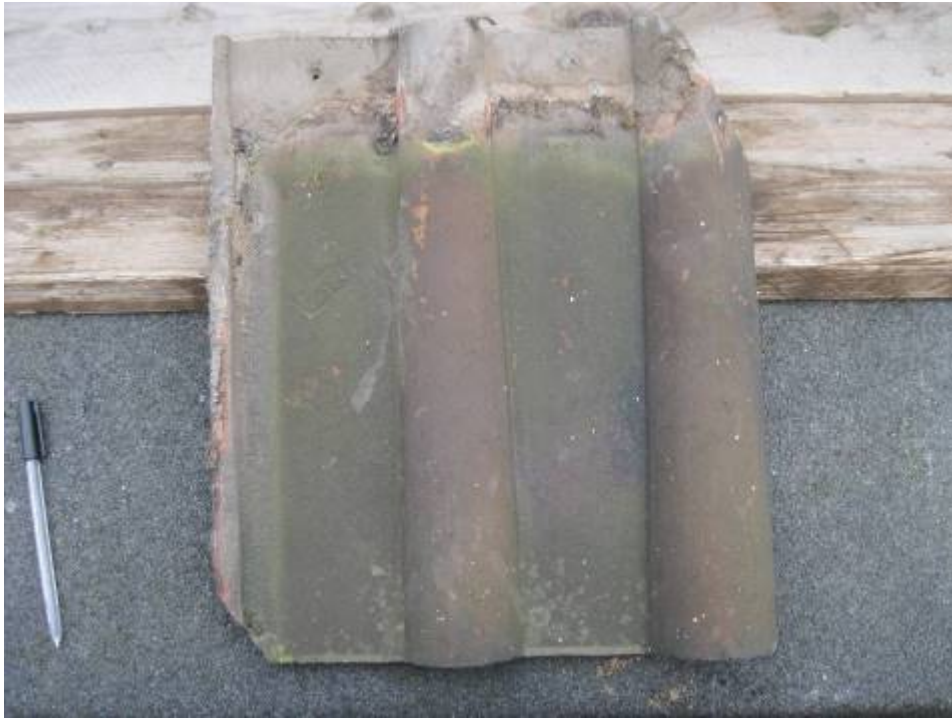
Photograph 11 Existing tile condition

The proposal is to strip all of the pitched roof coverings and replace with new Sandtoft Bridgewater matching profile tiles (please refer to Appendix 2).

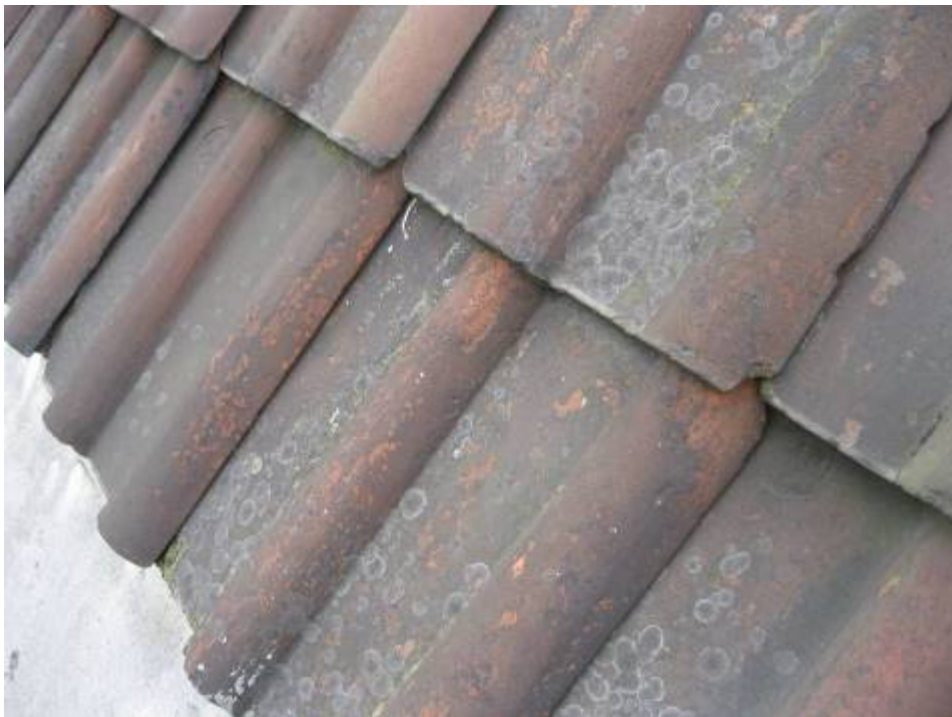
Photograph 12 Existing tile condition

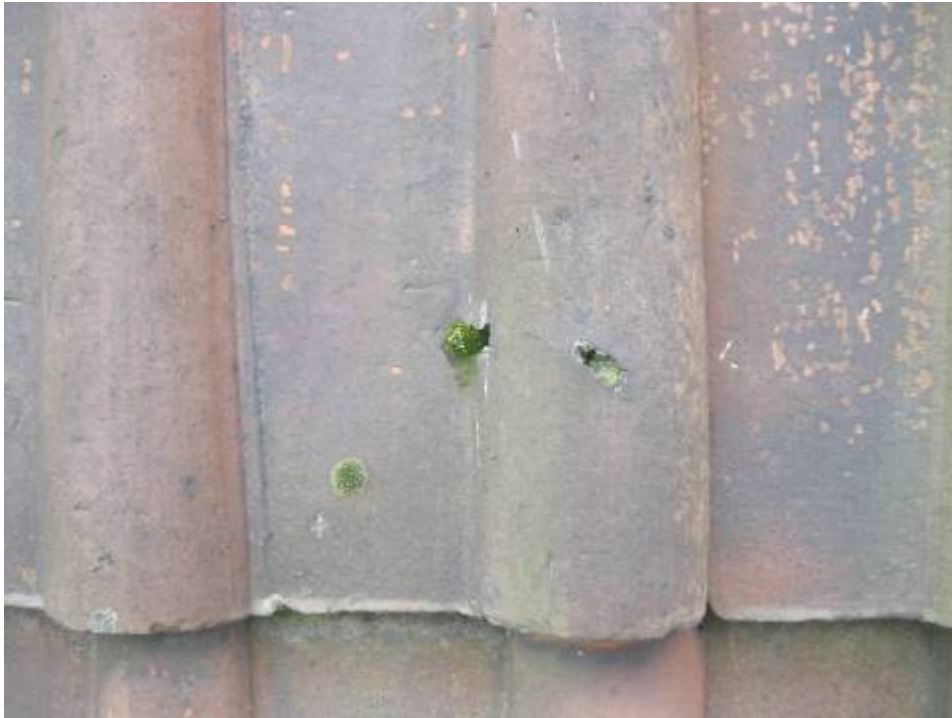
Photograph 13 Existing tile condition

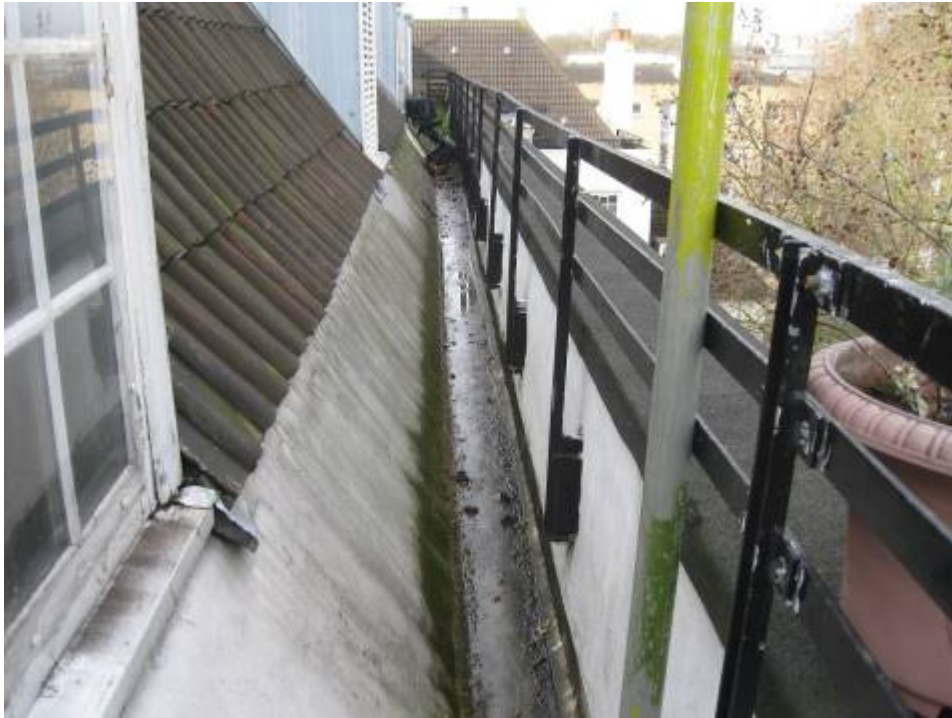
These are lined with asphalt and are in a poor state of repair. (Photos 15, 16, 17 and 19). It is proposed to repair and insulate these and coat them with a liquid membrane solution, replacing lead flashings and taking the opportunity to increase the depth of the gutter to prevent potential overflowing damaging the fabric and internal finishes. This proposal will not have any external visual impact on the elevations as the works will be entirely concealed behind the high parapet walls.

Photograph 17 Parapet Gutter

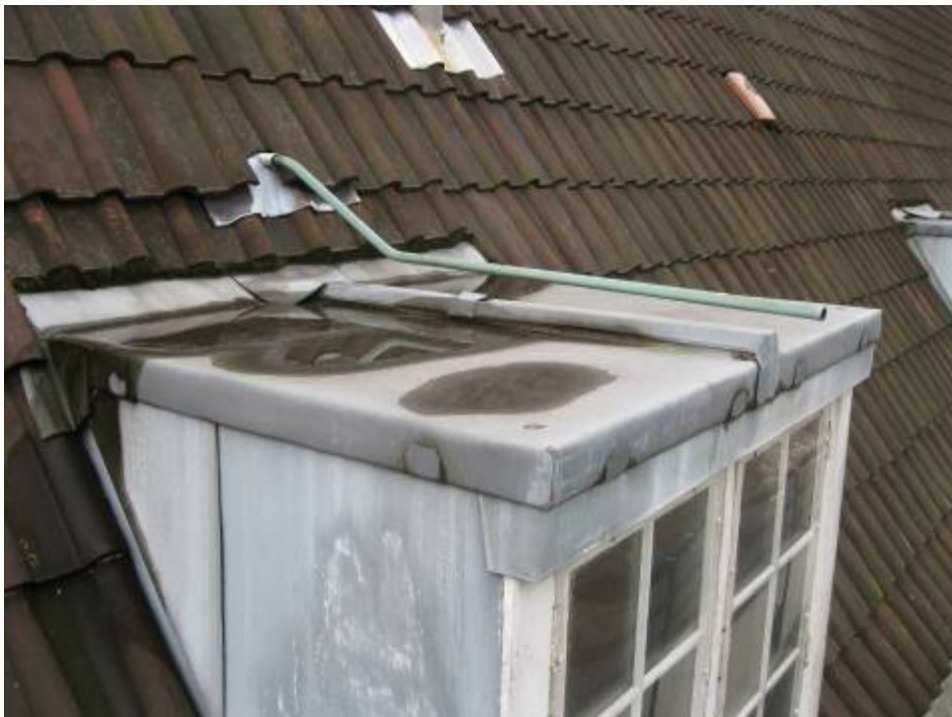
Photograph 18 Zinc clad dormer

The recommendation is that the zinc cladding to the dormers and all other lead weatherings are replaced, with lead to match what was probably the original material used on these blocks when first built, as used elsewhere on the estate, and in accordance with current best practice. (Photos 15, 18 and 19). Again the opportunity will be taken to install modern thermal insulation without impacting significantly on the appearance of the dormers.

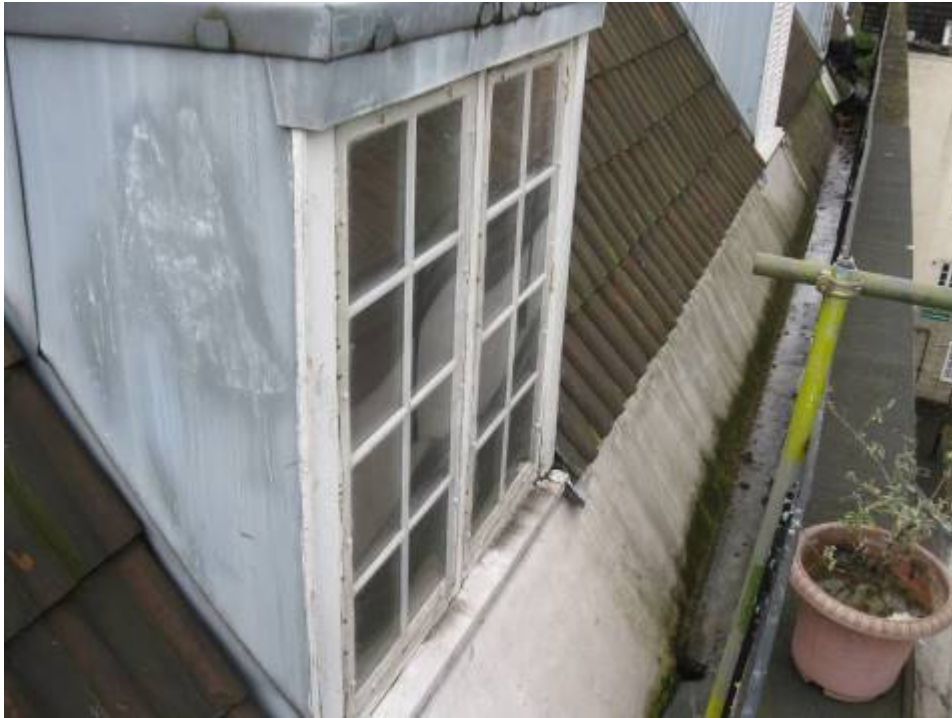
Photograph 19 **Dormer window, covered in clear polythene type sheet**

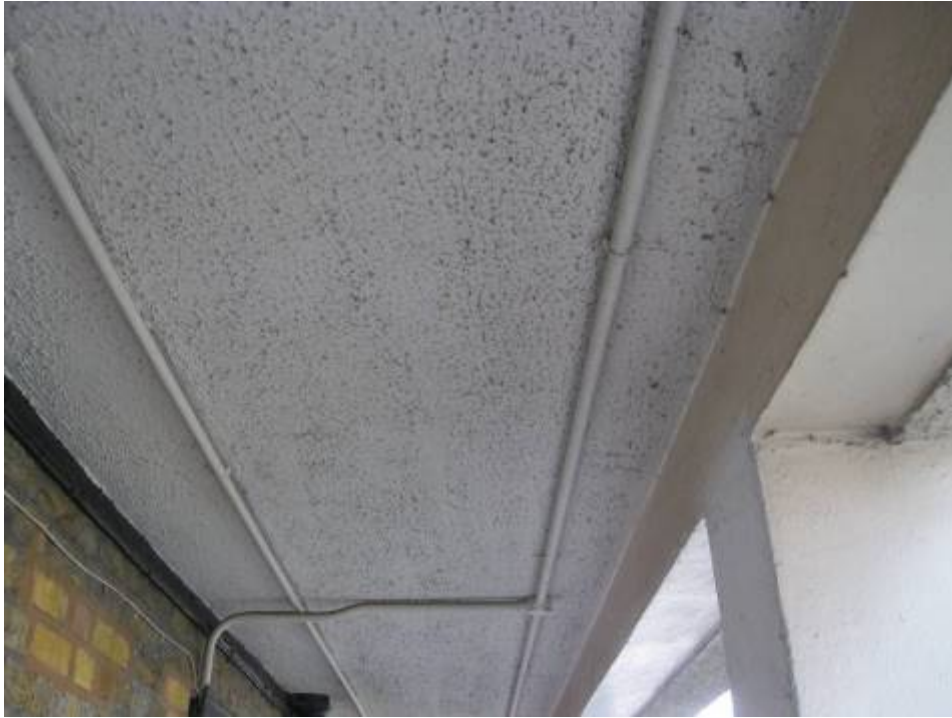
Photograph 23 Access balcony soffit

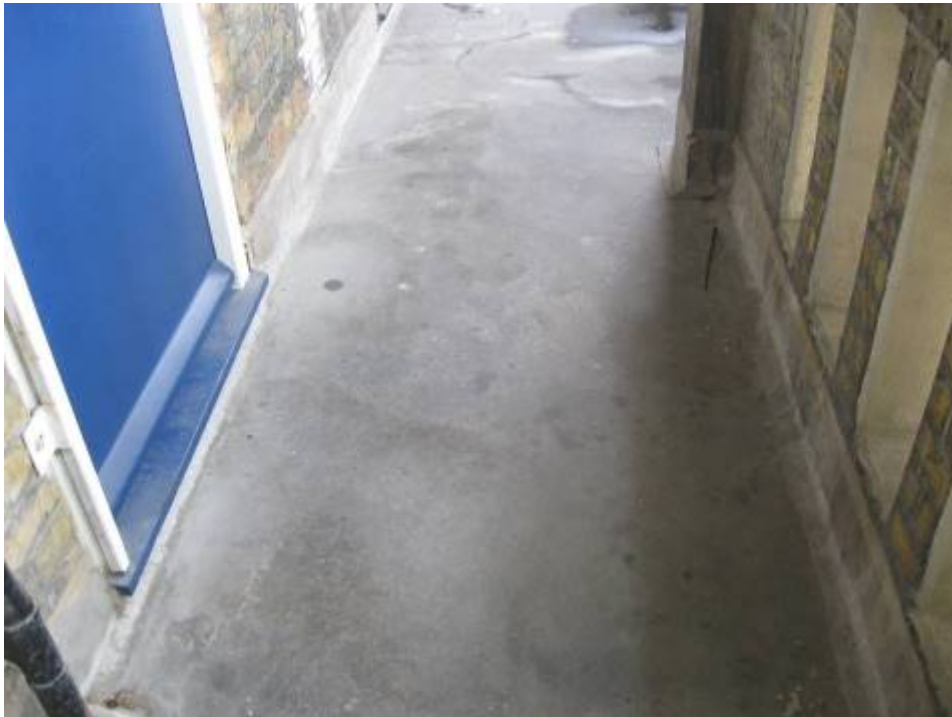
The asphalt surfaces are discoloured and deteriorating. To replace the asphalt on a like for like basis will involve considerable disruption to residents as the existing material would need to be removed entirely. It is therefore proposed to apply a proprietary resin liquid slip resistant finish (e.g. TORDEK) over the existing surfaces. This is rapid drying and will involve minimal disruption to the residents, and retain the original building fabric without harming it's special interest. Resin coatings will give a greatly improved appearance to these walkways and protect the structure from water penetration and concrete degradation.

Photograph 25 Access balcony walkway surface

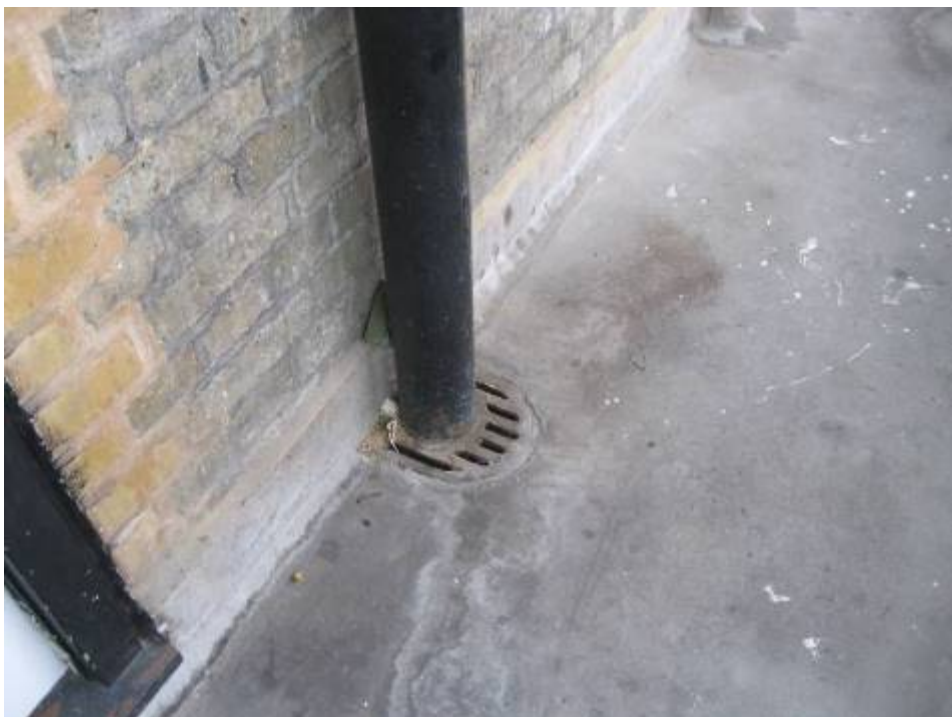
Photograph 26 Access balcony drainage

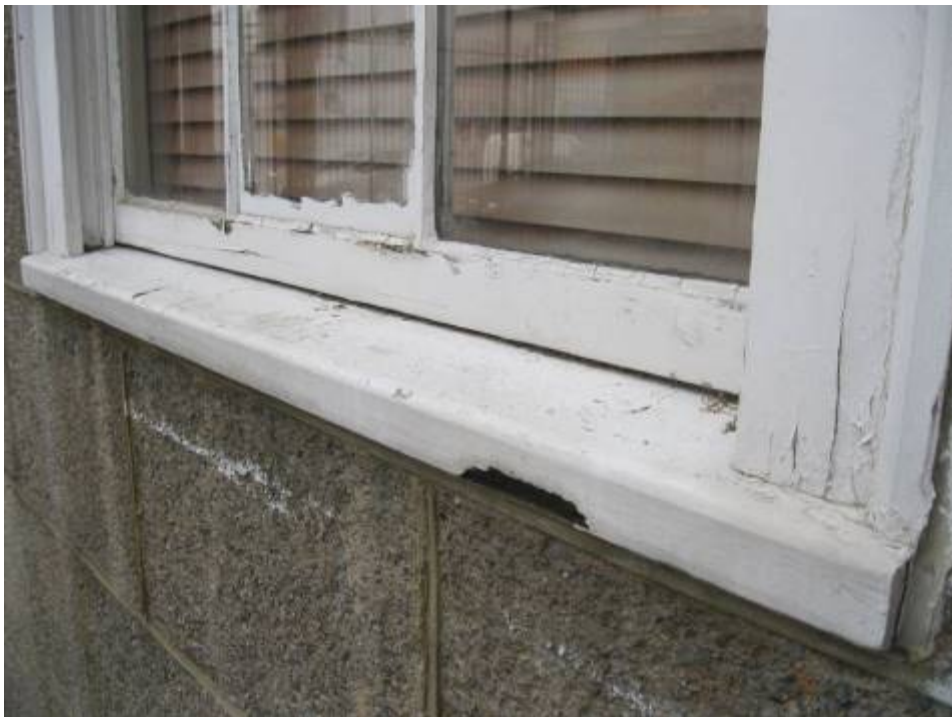
All windows are single glazed timber and many are in a poor state of repair. They have reached the end of their serviceable life with evidence of timber decay, extremely poor decorations, glazing defects, draughts and poor levels of thermal insulation. There have also been a number of non-standard alterations to the windows which spoils the elevational detail.

Photograph 28 Window condition

To strive towards modern standards, it is proposed to replace all of the windows. The principle of installing double glazing has been established elsewhere in the listed estate (please see 1.8 earlier).

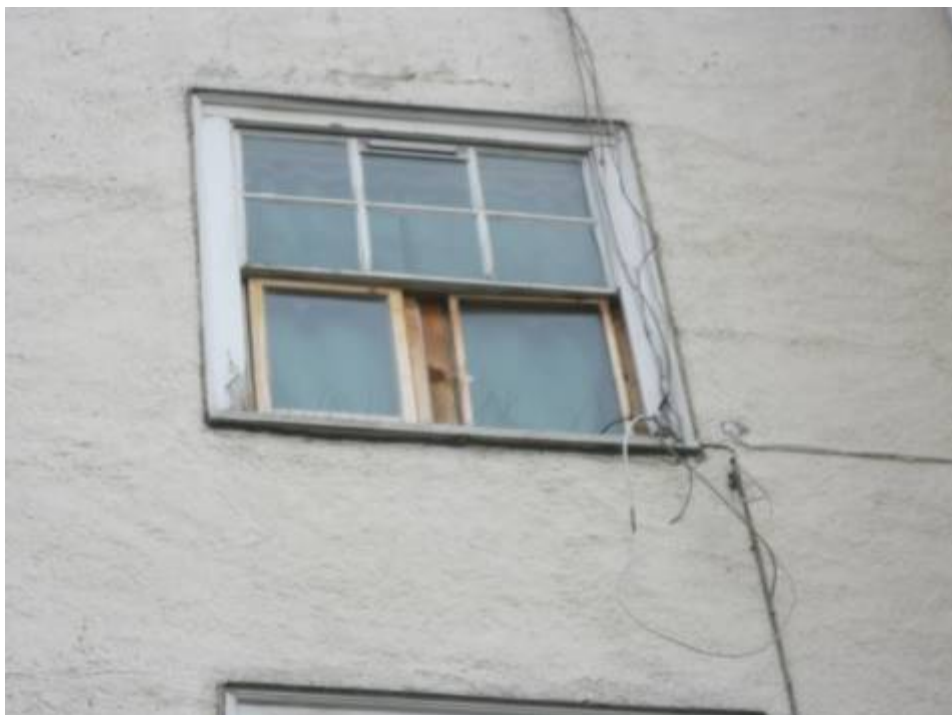
Photograph 30 Improper alteration to window

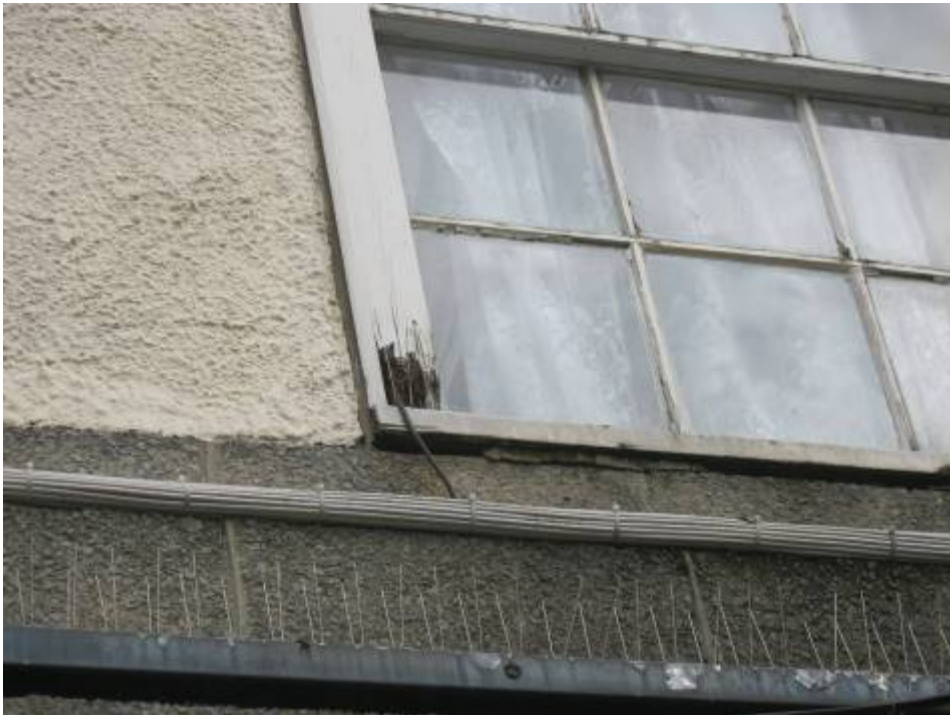
Photograph 31 **Window decay**

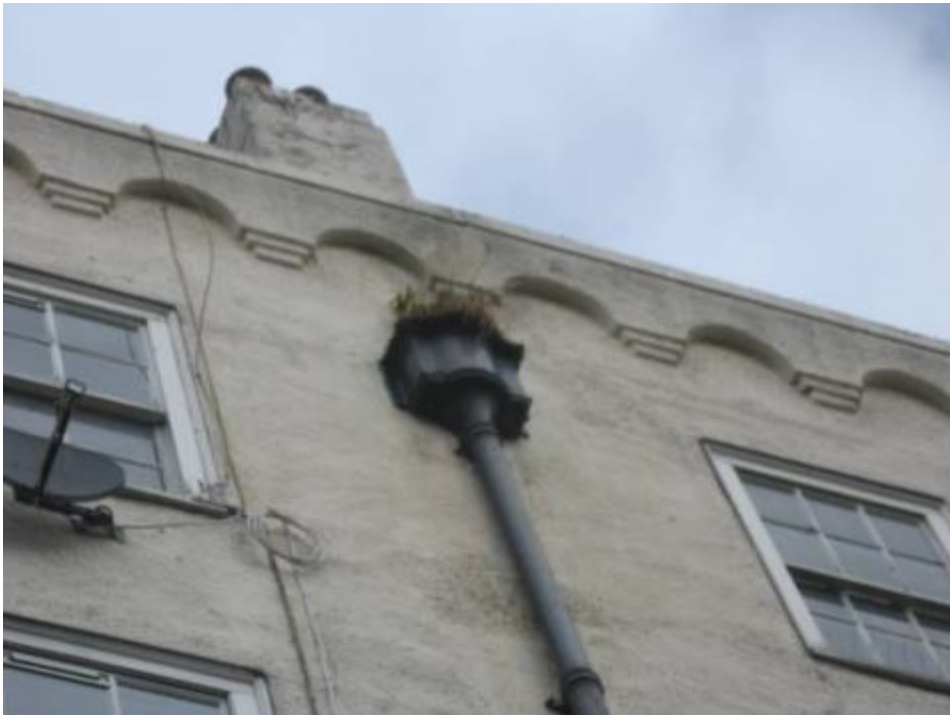
Photograph 33 **Blocked rainwater hopper**

These appear to be in cast iron, with ornate hoppers to the main blocks. The intention is to carry out pre decoration repairs or renewals as appropriate which will be established once scaffolding is erected. Replacement sections will be cast iron to match. The project will retain the hoppers. It is noted that the majority of downpipes on the access balcony elevation have already been replaced using a proprietary "Timesaver" type cast iron system. These pipes will be repainted only.

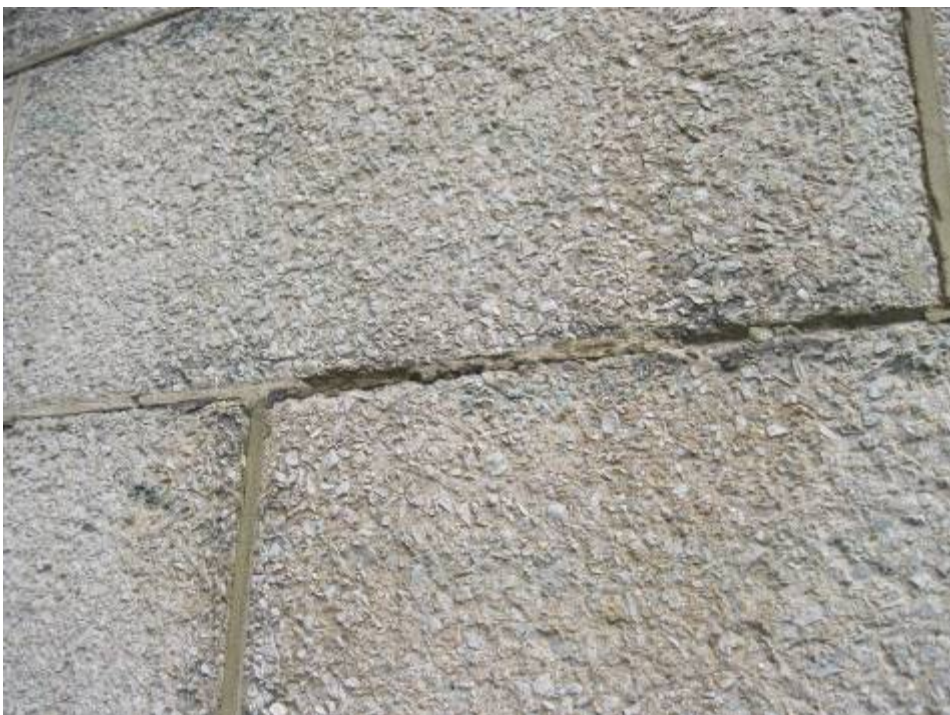
With regard to the stone elevations, these will be re-pointed as existing pointing is defective in places and non-matching sand cement struck joints in others.

Photograph 34 **Defective pointing**

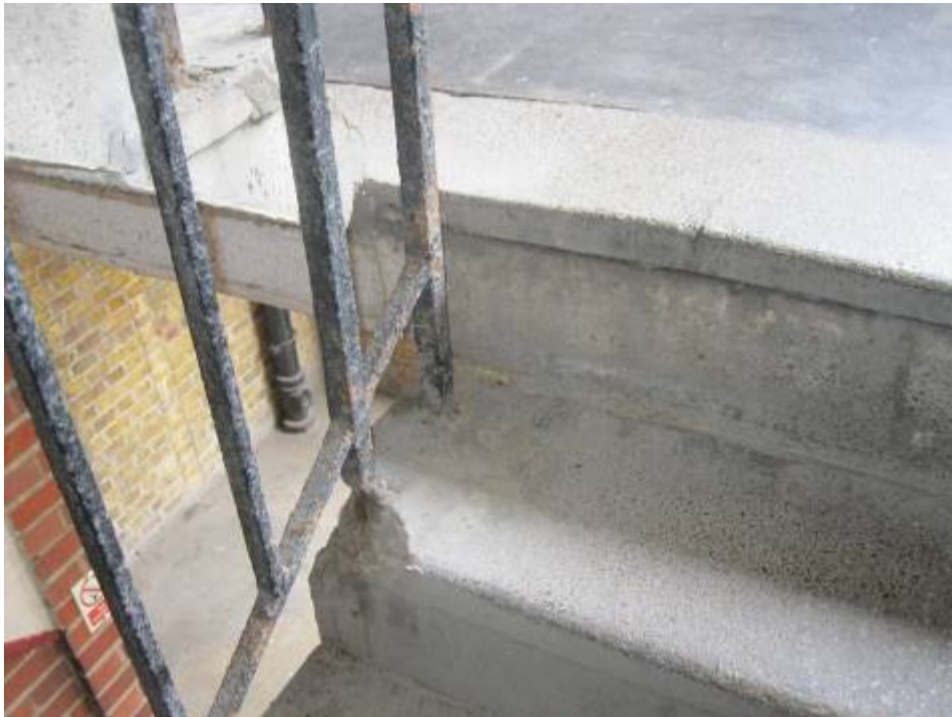
Photograph 35 **Communal stair repairs and redecorations required**

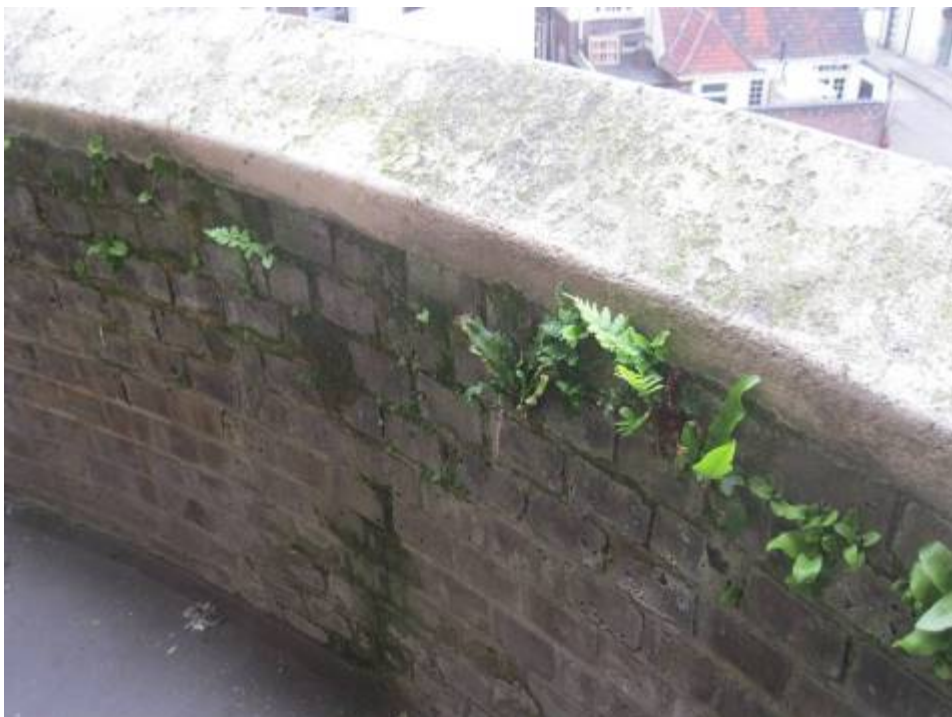
Photograph 36 **Poor condition of access balcony parapet**

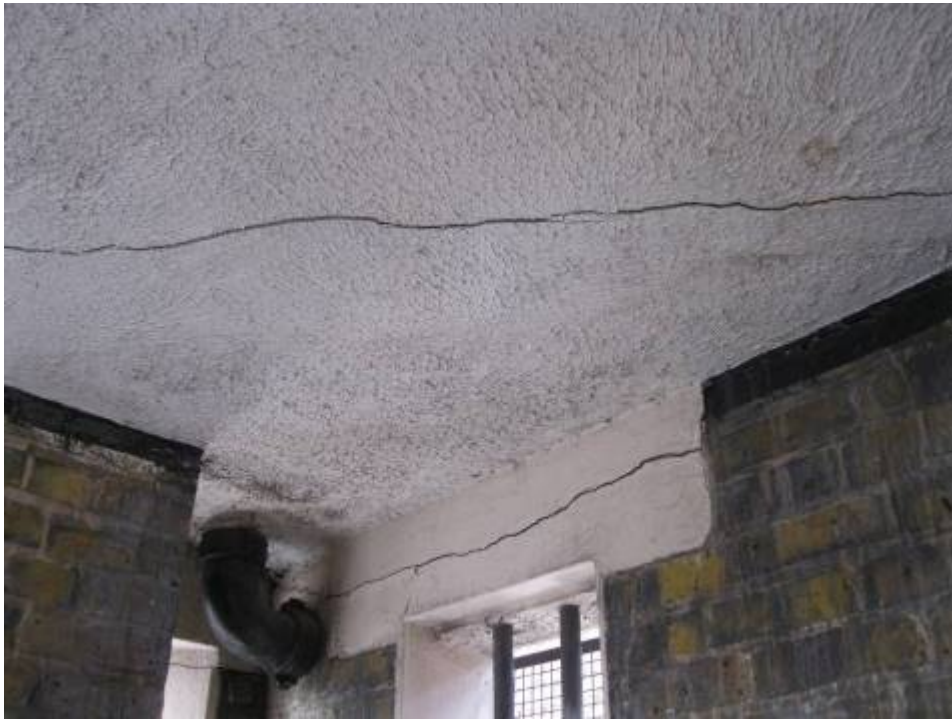
Photograph 37 Structural movement in 135 – 180

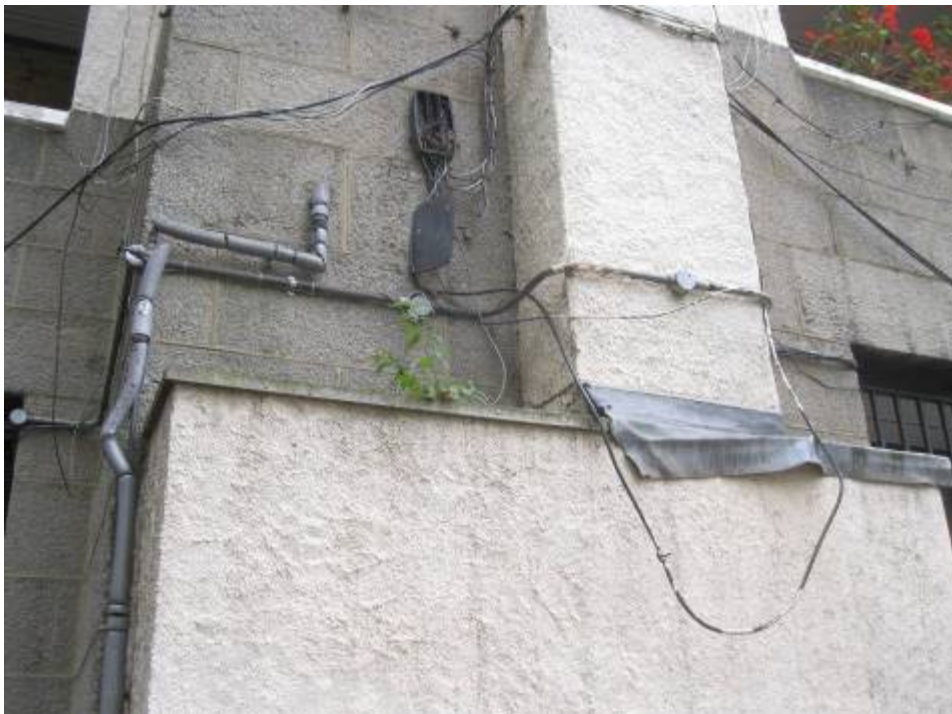
Photograph 38 Damaged flat roof, cable condition, and poorly insulated water supply

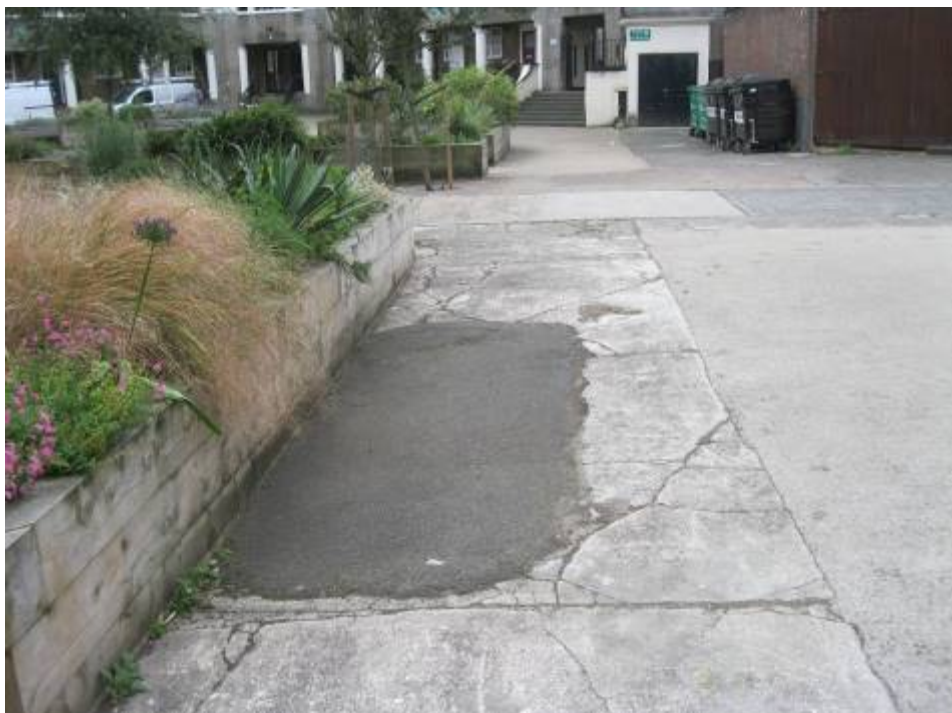
Photograph 40 Courtyard typical paving condition
