# Demolition / Refurbishment Asbestos Survey Report

Merchant Land Investments Ltd

61 – 65 Charlotte Street

31<sup>st</sup> March 2016

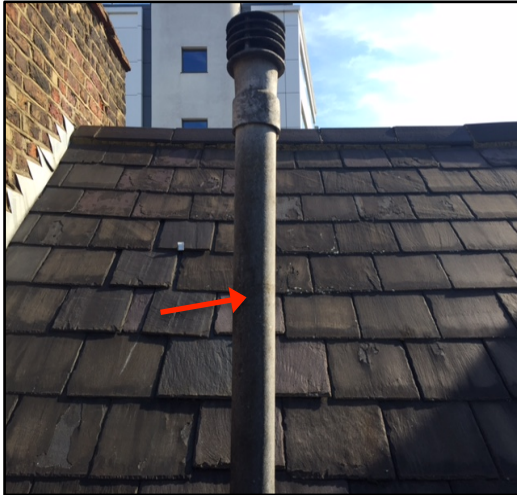
Sample Ref: B01

Material Sampled: Asbestos Cement flue pipe  
(runs into ceiling void above flat)

Analysis Result: **Chrysotile (white) Asbestos**

Approximate Quantity: 2 LM

Condition: **Good Condition**

Material Assessment Score: **3**

Remarks / Recommendations: Remove.

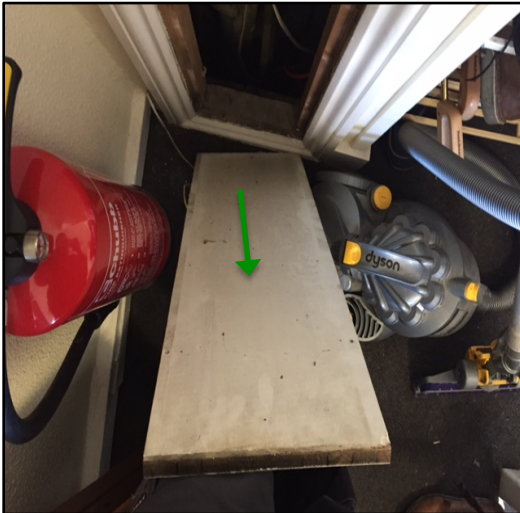
Sample Ref: B02

Material Sampled: Board lining to riser

Analysis Result: **No Asbestos Detected**

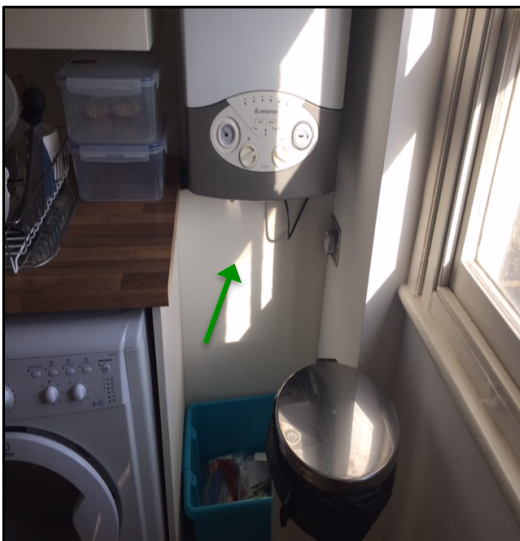
Sample Ref: B03

Material Sampled: Panel below boiler

Analysis Result: **No Asbestos Detected**

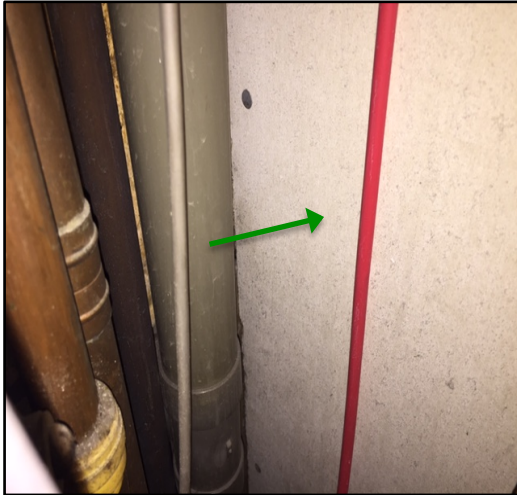
Sample Ref: B04

Material Sampled: Board lining to riser

Analysis Result: **No Asbestos Detected**

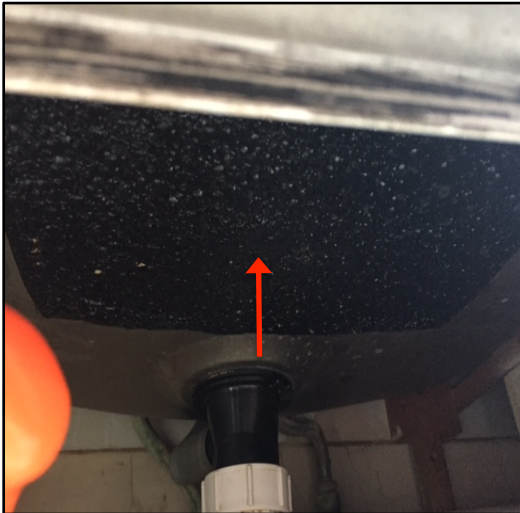
Sample Ref: B05

Material Sampled: Asbestos Composite sink pad

Analysis Result: **Chrysotile (white) Asbestos**

Approximate Quantity: <1 Sqm

Condition: **Good Condition**

Material Assessment Score: **2**

Remarks / Recommendations: Remove.

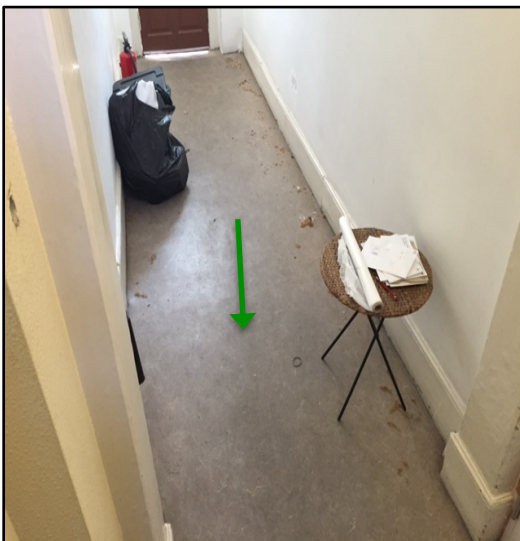
Sample Ref: B06

Material Sampled: Floor lino

Analysis Result: **No Asbestos Detected**

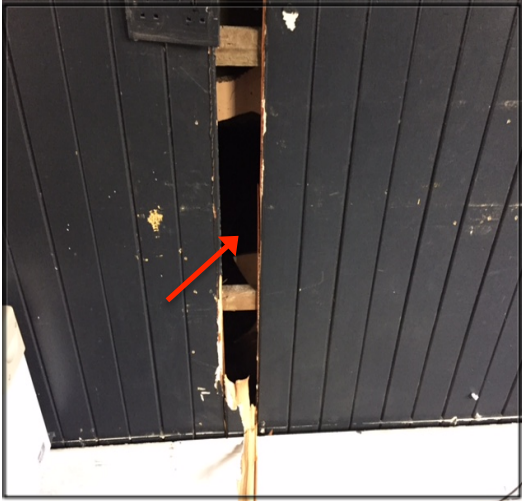
Sample Ref: B07

Material Sampled: Asbestos Cement panels to former fire place  
(located behind wooden panels)

Analysis Result: **Chrysotile (white) Asbestos**

Approximate Quantity: 3 Sqm

Condition: **Good Condition**

Material Assessment Score: **3**

Remarks / Recommendations: Remove.

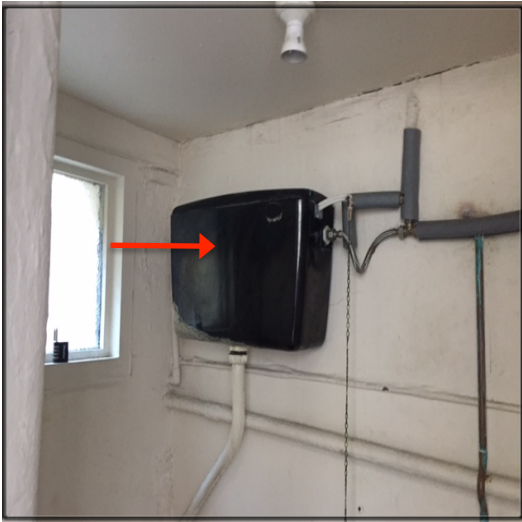
Sample Ref: B08

Material Sampled: Asbestos Composite toilet cistern

Analysis Result: **Amosite (brown) Asbestos**

Approximate Quantity: 1 Item

Condition: **Good Condition**

Material Assessment Score: **3**

Remarks / Recommendations: Remove.

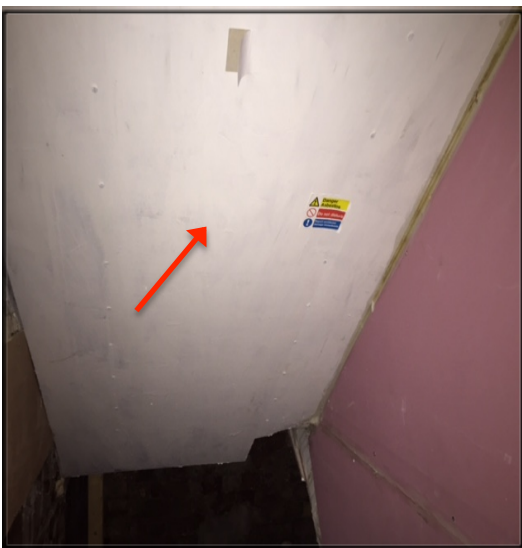
Sample Ref: B09

Material Sampled: Asbestos Insulation Board lining under stairs

Analysis Result: **Amosite (brown) Asbestos**

Approximate Quantity: 3 Sqm

Condition: **Good Condition**

Material Assessment Score: **5**

Remarks / Recommendations: Remove.

This form of Asbestos can only be removed by a licensed contractor.

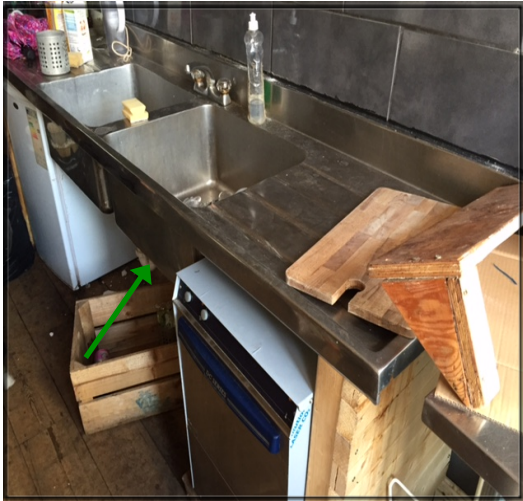
Sample Ref: B10

Material Sampled: Bitumen lining to sink

Analysis Result: **No Asbestos Detected**

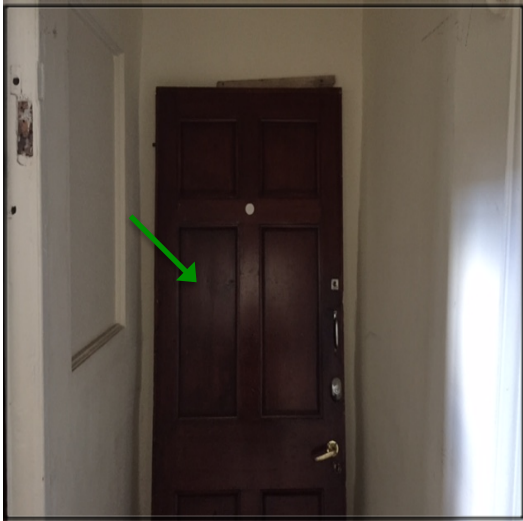
Sample Ref: B11

Material Sampled: Door panel (to rear of door)

Analysis Result: **No Asbestos Detected**

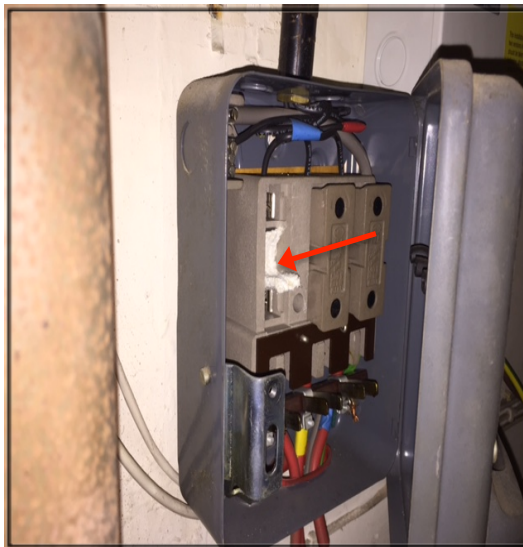
Sample Ref: B12

Material Sampled: Asbestos Textile flash guards within switch gear

Analysis Result: **Chrysotile (white) Asbestos**

Approximate Quantity: <1 Sqm

Condition: **Good Condition**

Material Assessment Score: **3**

Remarks / Recommendations: Remove.

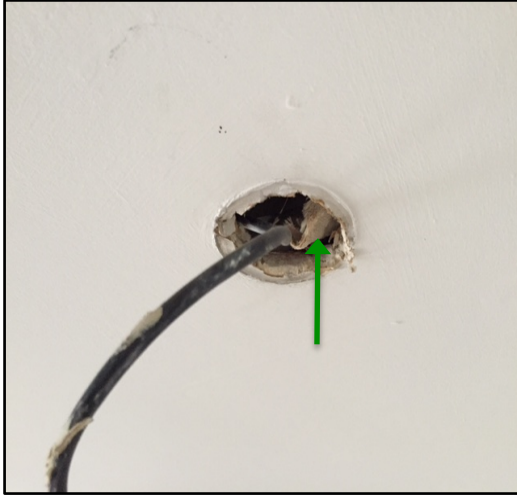
Sample Ref: B13

Material Sampled: Textile covers to ceiling down lights

Analysis Result: **No Asbestos Detected**  
Approximate Quantity:  
Product Type:  
Condition:  
Surface Treatment:

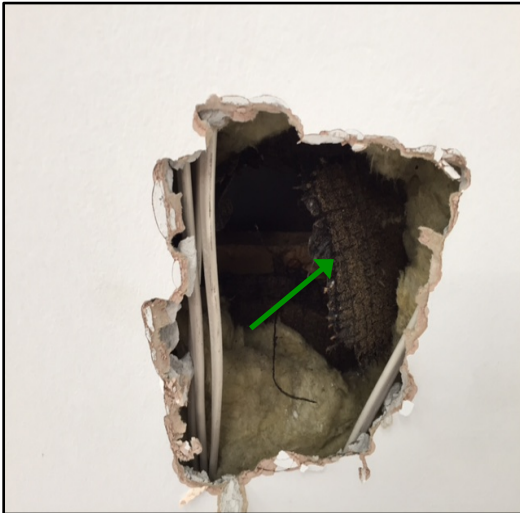
Sample Ref: B14

Material Sampled: Bitumen roof liner

Analysis Result: **No Asbestos Detected**  
Approximate Quantity:  
Product Type:  
Condition:  
Surface Treatment:

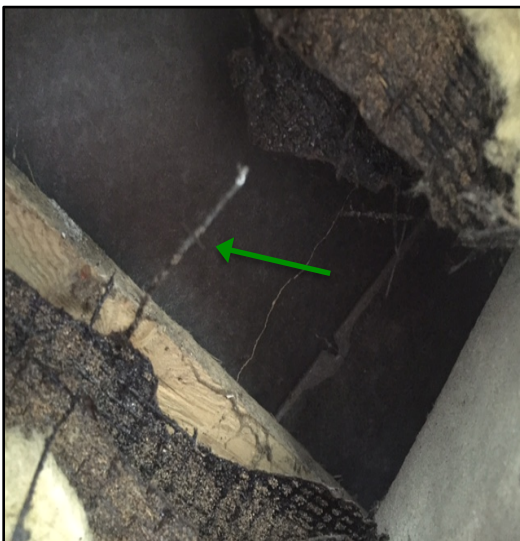
Sample Ref: B15

Material Sampled: Roof tiles

Analysis Result: **No Asbestos Detected**  
Approximate Quantity:  
Product Type:  
Condition:  
Surface Treatment:
