CONDITION SURVEY
of
FRONT PAVEMENT, NORTH EAST ELEVATION
at
**OUR LADY'S CATHOLIC PRIMARY SCHOOL
PRATT STREET
CAMDEN TOWN
LONDON NW1 0DP**

JULY 2016

OUR LADY'S R.C. PRIMARY SCHOOL
 PRATT STREET
 LONDON
 NW1 0DP
 THE GOVERNORS
 NEW NURSERY EXTERNAL CHURCH CONDITION SURVEY (PART ONLY)
 1st July 2016

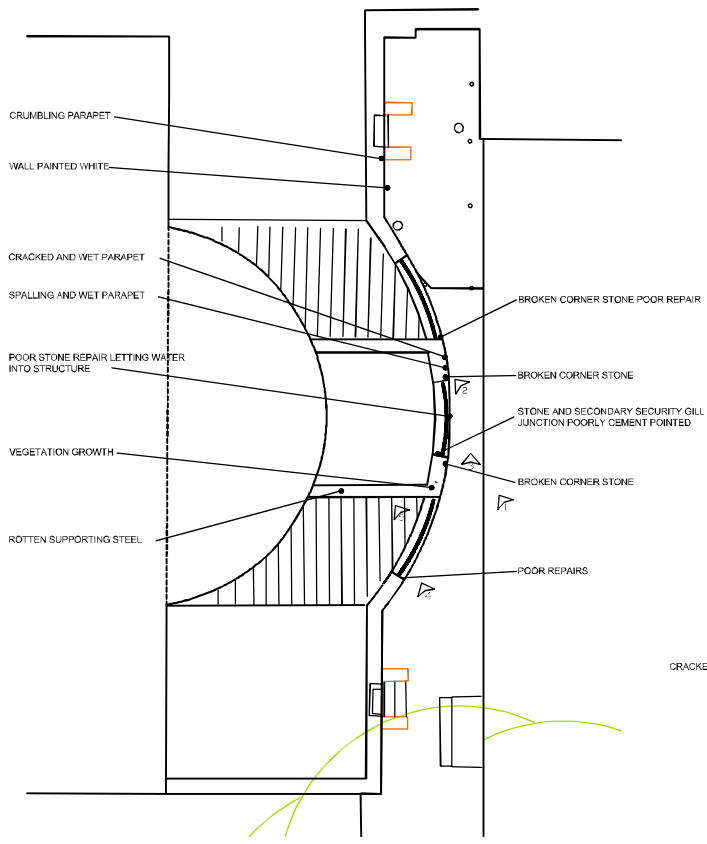
JULY 2016 WE
 1:50 @ A1
 2403G1

The condition of the stonework can be described as poor. 3No football size triangular sections are missing, one has been poorly repaired, one is missing and the third is loose. There are marks and penny-size chips all over the stone. Some repairs are tennis ball size and repairs have been undertaken using a range of materials. This damage is likely to have occurred during WWII.

The face of the stone at high level is spalling. The cornice and coping stones have been weathered in with waterproof material leading to accelerated decay of the stone. Spalling and loose stone overhead level is evident. Remedial works required. Stone to the cornice and coping is loose. Cement repairs at high level are spalling and urgent repairs are required.

POOR STONE REPAIR LOOSE REPAIR, RISK OF FALLING

The poorly repaired coping has deteriorated and is at risk of falling. It is already letting water into the structure. W&B recommend urgent remedial works prior to failure. There is strong evidence of stone which has already fallen and areas which are going to fall. Works to be undertaken by a qualified stone mason.

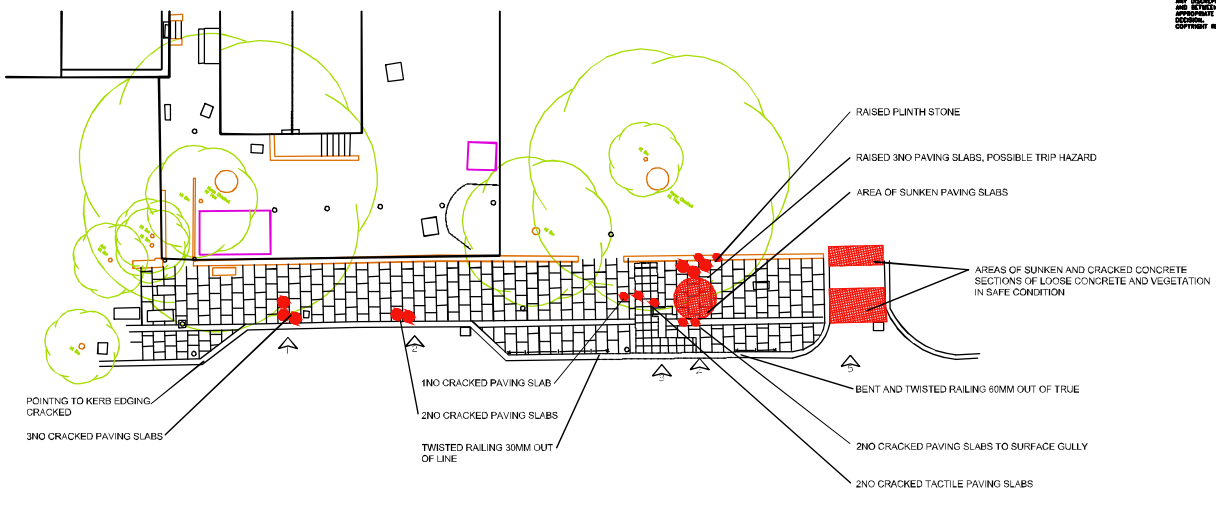
JULY 2016 WE
1:100 @ A1
2403/G2

Concrete paving finished in bumpy dot non-slip finish. Paving falls to central gully. One area, 2m x 2m, has sunken approximately 50mm. One paving slab has uplifted by 30mm and is a trip hazard. It is, however, located out of the normal flow of pedestrian traffic. Cracked paving slabs are noted (see photos and plans for details).

3NO CRACKED PAVING SLABS

2NO CRACKED PAVING SLABS

2NO CRACKED TACTILE SLABS
1NO CRACKED PAVING SLAB
2NO CRACKED PAVING SLABS TO SURFACE GULLY

AREA OF SUNKEN PAVING SLABS
RAISED PLINTH STONE
RAISED 3NO PAVING SLABS

AREAS OF SUNKEN AND CRACKED CONCRETE SECTIONS OF LOOSE CONCRETE AND VEGETATION
