ASBESTOS REFURBISHMENT/DEMOLITION SURVEY

William Ellis School
Highgate Road
London
NW5 1RN

Lantern Services
Barnet by Pass
South Mimms
Potters Bar
Hertfordshire
EN6 3NQ

This Survey was carried out on:	
Start date	14/06/2016
Completion Date	14/06/2016

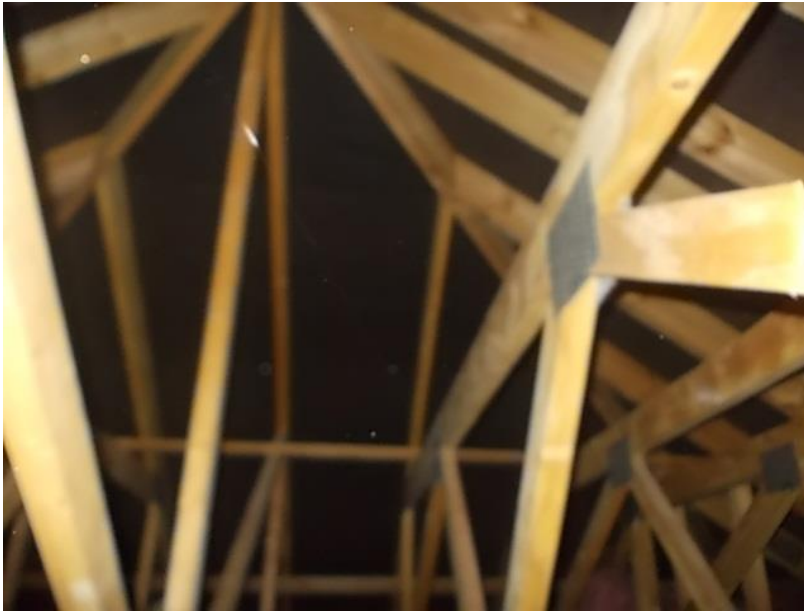
Sample Ref	Description	Location & Extent	Asbestos Type
KA001	GROUND FLOOR LOFT SPACE- BITUMEN FELT LINING TO ROOF	N/A	NADIS

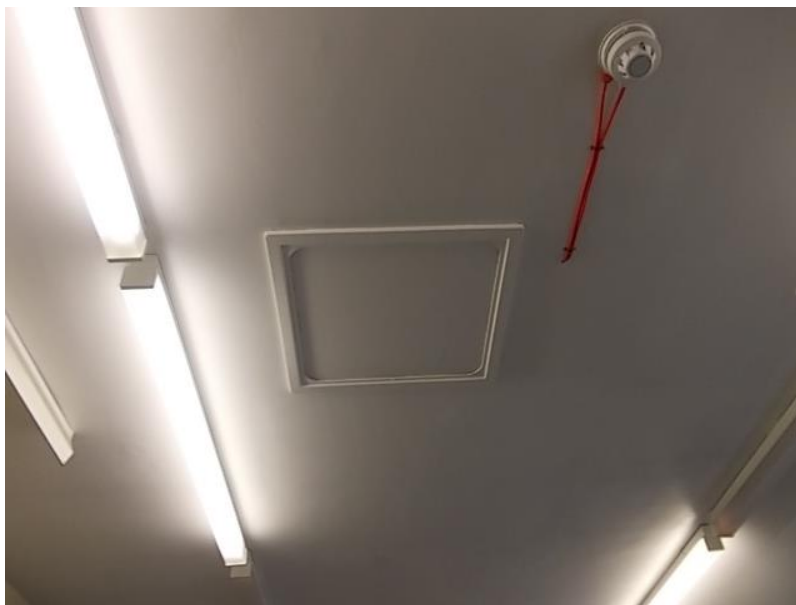
Sample Ref	Description	Location & Extent	Asbestos Type
KA002	GROUND FLOOR ROOM 1- INSULATING BOARD LINING TO LOFT HATCH	N/A	NADIS

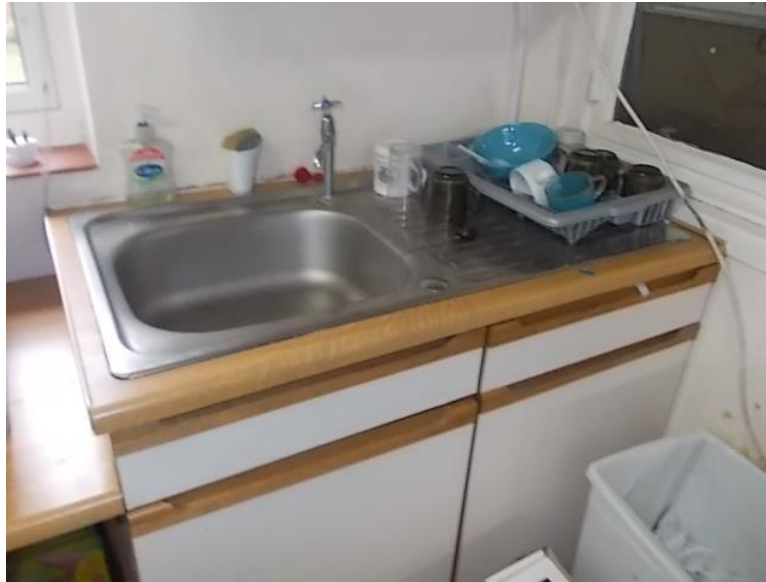
Sample Ref	Description	Location & Extent	Asbestos Type
KA003	GROUND FLOOR ROOM 3- MASTIC ACOUSTIC PADS BENEATH SINK UNIT	N/A	NADIS

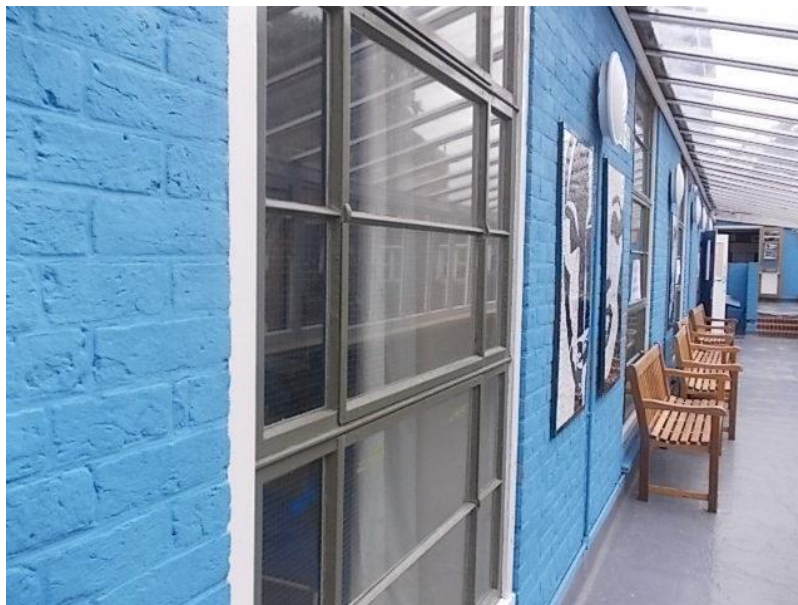
Sample Ref	Description	Location & Extent	Asbestos Type
KA004	SECOND FLOOR CORRIDOR 1- PUTTY SEALS TO METAL WINDOWS	N/A	NADIS

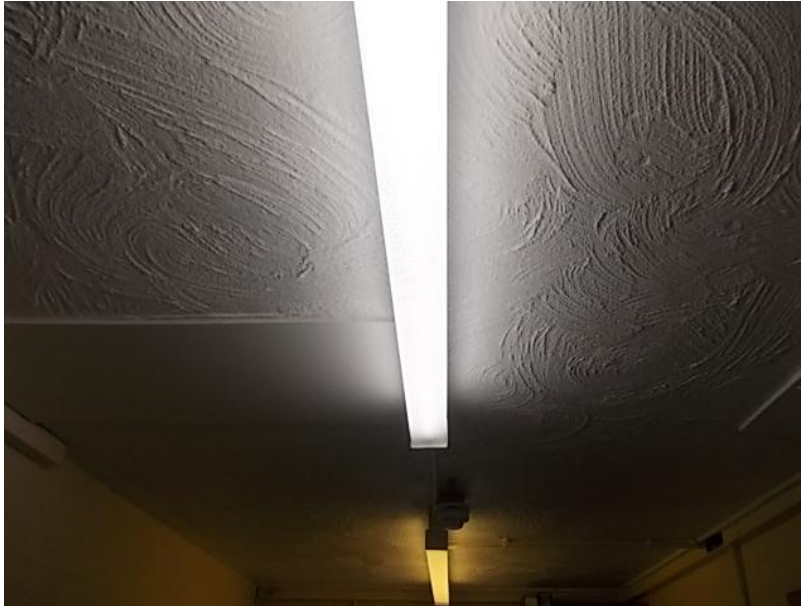
Sample Ref	Description	Location & Extent	Asbestos Type
KA005	FIRST FLOOR HEAD OF YEAR 10- TEXTURED COATING TO CEILING	N/A	NADIS

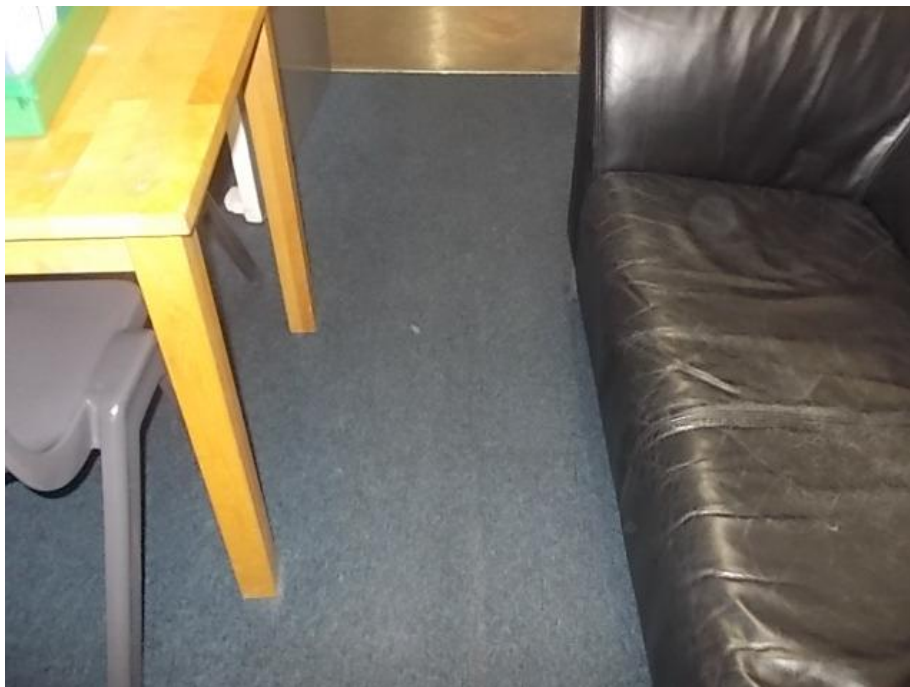
Sample Ref	Description	Location & Extent	Asbestos Type
KA006	FIRST FLOOR HEAD OF YEAR 10- VINYL FLOOR COVERING	N/A	NADIS

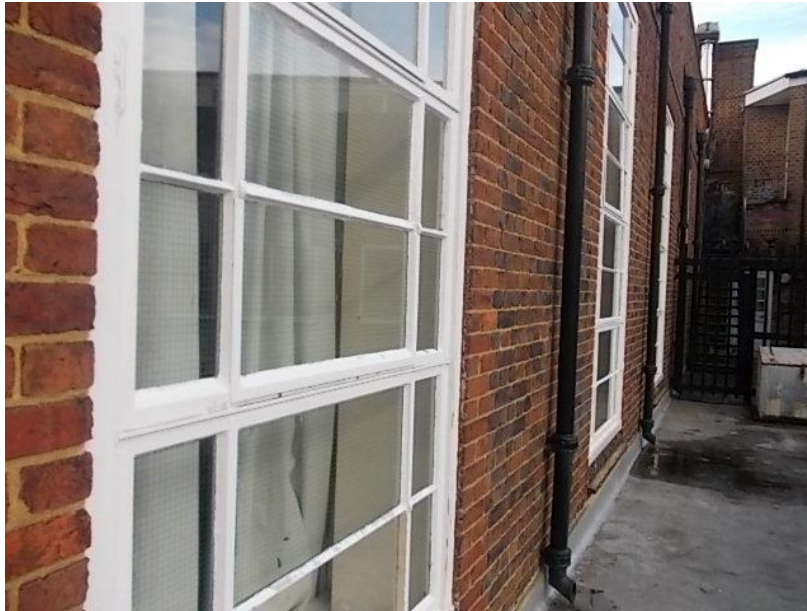
Sample Ref	Description	Location & Extent	Asbestos Type
KA007	FIRST FLOOR EXTERNAL BALCONY- PUTTY SEALS TO METAL WINDOWS	N/A	NADIS

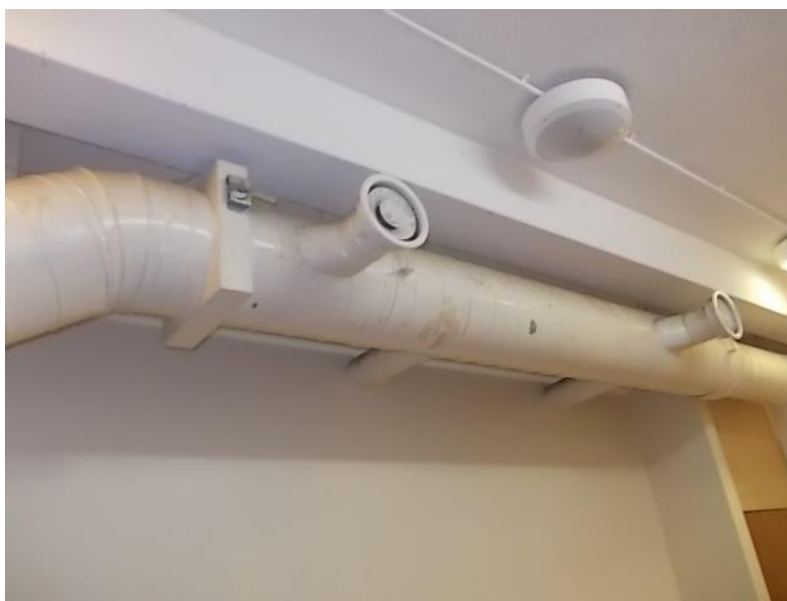
Sample Ref	Description	Location & Extent	Asbestos Type
KA008	GROUND FLOOR PUPIL CHANGING- MASTIC SEALS TO METAL DUCTWORK	N/A	NADIS

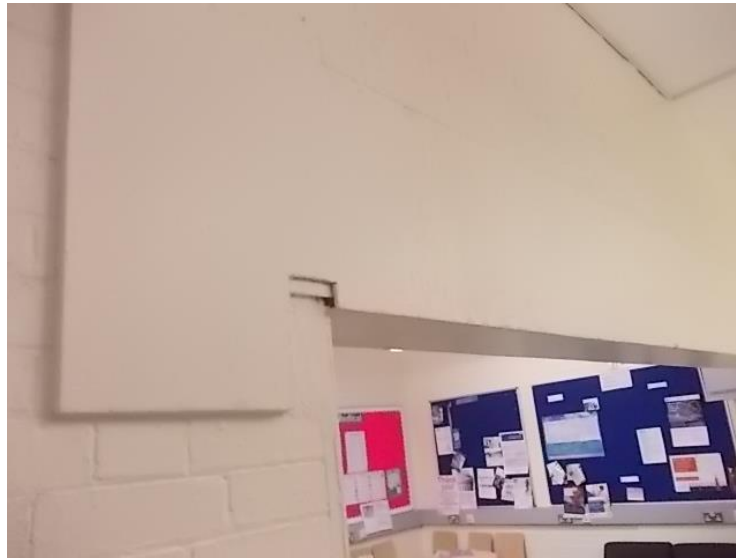
Sample Ref	Description	Location & Extent	Asbestos Type
KA009	GROUND FLOOR ROOM 16- CEMENT BASED CHIPBOARD TO SUPPORT BEAM	N/A	NADIS

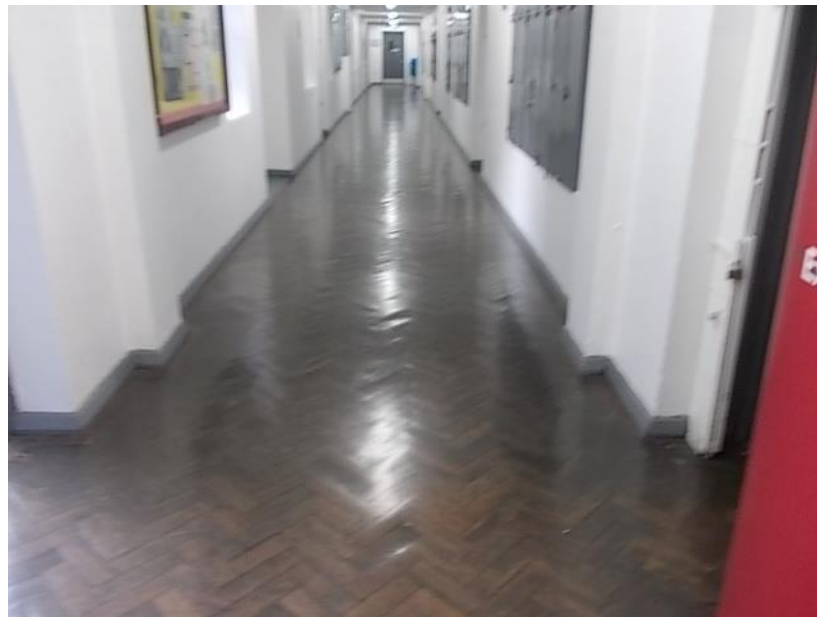
Sample Ref	Description	Location & Extent	Asbestos Type
KA010	FIRST FLOOR MAIN CORRIDOR- BITUMEN ADHESIVE TO PARQUET FLOORING	N/A	NADIS

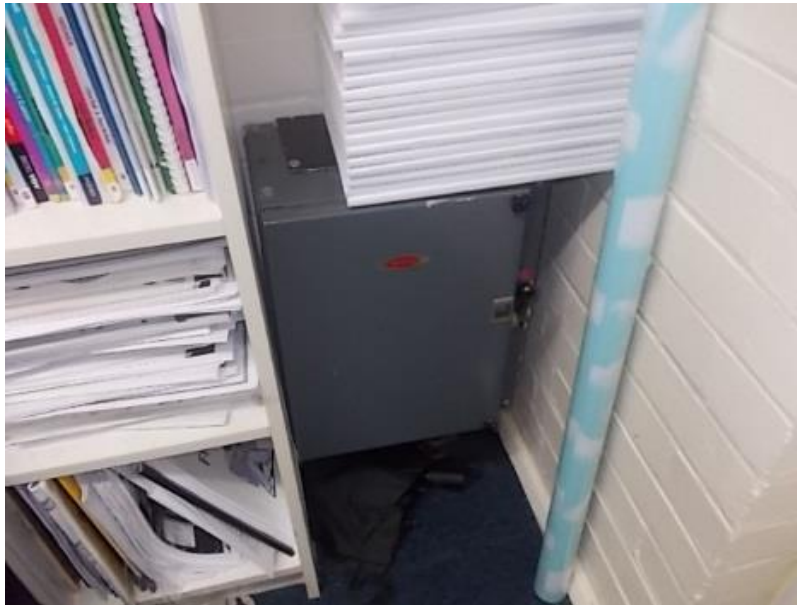
Sample Ref	Description	Location & Extent	Asbestos Type
Presumed No access	MEM Fuse Boxes – presumed to contain asbestos flash guards	Various	Chrysotile
