# 63 GOLDHURST TERRACE SOUTH HAMPSTEAD, LONDON ARBORICULTURAL IMPACT ASSESSMENT

Document Title Arboricultural Impact Assessment						
Prepared for	Ground and Project Consultants Limited					
Prepared by	TEP - Market Harborough					
Document Ref	5957.001

Author	Mike Bennetto
Date	August 2016
Checked	Robin Grimes
Approved	Jonathan Smith

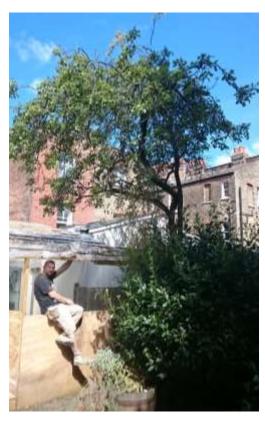
- 4.2 Tree T1 is a middle-aged plum tree in poor physiological and structural condition. It exhibits twiggy dieback throughout the canopy and has a top-heavy appearance due to unsympathetic pruning of the lower crown.

Figure 2 Top-heavy form of tree T1

- 5.2 1 individual tree would be removed to facilitate the development proposals. It is a middle-aged plum tree in poor condition growing approximately 3m away from the existing rear elevation of the property. It exhibits twiggy dieback throughout its canopy and has an asymmetric crown due to past pruning. In the absence of development it is anticipated that this tree would continue to decline and decrease in value. Its removal is required to accommodate the underground excavation of the basement and the creation of the rear lightwell which would be created approximately 1m from the trees stem.

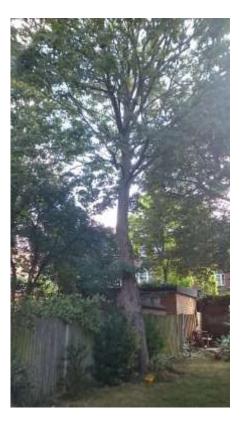
- 4.3 Tree T2 is a middle-aged sycamore estimated to in the region of 50 years of age. It is the best quality tree in the garden exhibiting no significant visible defects. It has good crown heath and has responded well to past pruning with the development of new wood to seal the pruning wounds.

Figure 3 View north at tree T2

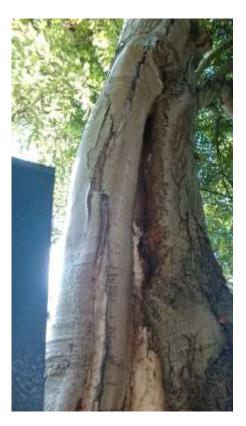
Tree survey reference	Feature/s of note
ТЗ	Minor stem cavity and numerous vertical bark cracks that extend into the canopy.

- 4.4 Tree T3 is a horse chestnut in impaired structural condition. It has a shallow stem cavity extending from 0.5m to 2.5m and further multiple bark cracks and fissures on the stem and scaffold branches. A large individual fungal bracket is visible on a primary branch at around 5m and is likely to be a juvenile *Polyporus squamosus* fruit body. The decay associated with this pathogen is commonly restricted to a small area of wood

but extensive decay can occur when contiguous areas become infected from multiple or large wounds, such as is the case in this instance. It is therefore reasonable to conclude that the presence of this fungi (if confirmed) increases the likelihood of future branch shedding or complete stem failure.

Figure 4 Longitudinal stem cavity on tree T3

- 7.1 In addition to the proposed removal of tree T1 to facilitate development the future removal and replacement of tree T3 should also be considered. In its current condition this horse chestnut represents an increased risk of failure with the potential to harm the occupants of No.63 Goldhurst Avenue and the adjacent gardens should it do so. The suspected fungal infection by *Polyporus squamosus* further compounds this situation. As the tree is located in a Conservation Area, a separate Section 211 notice should be issued to the council prior to any works being undertaken.
- 7.2 All tree surgery work should be carried out by a qualified contractor in accordance with British Standard 3998:2010 Tree work Recommendations.
