GUILFORD PLACE WC, CAMDEN, LONDON WC1N

Loss of fabric at Guilford place WC - Images prior to collapse.

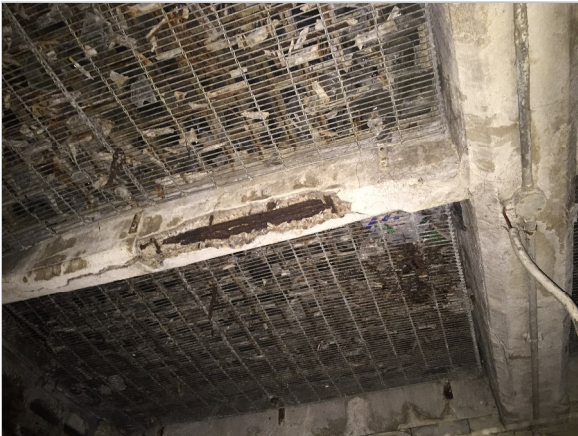
Following the removal of the pavement light panels, the upper surfaces of the reinforced concrete beams were exposed where it was found that the condition of the beams supporting the pavement panels were in a poor and friable condition. It would appear that due to historic water ingress the concrete beams were apparently suffering from carbonation and chloride induced corrosion causing sections of the concrete surface to spall revealing corroded and laminated reinforcing bars.

Fig 1. Image beam delamination and spalling, gents side.

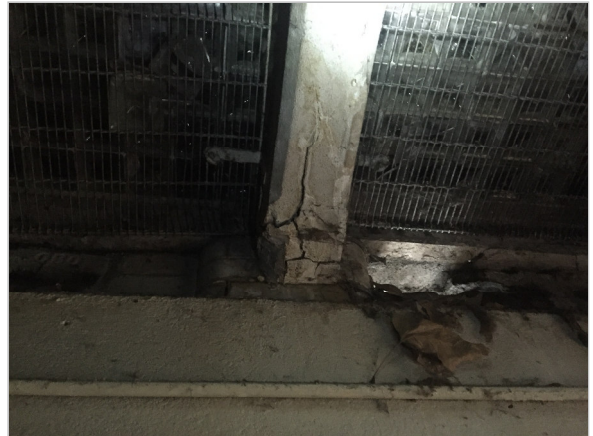
Fig 2. Image beam bearing, gents side

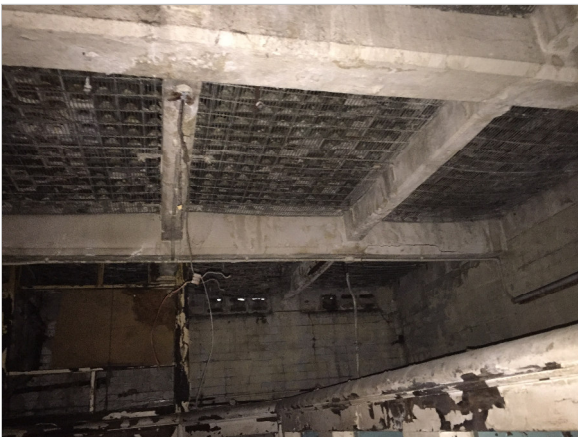
Fig 3. Pavement light underside showing cracking and surface salts.

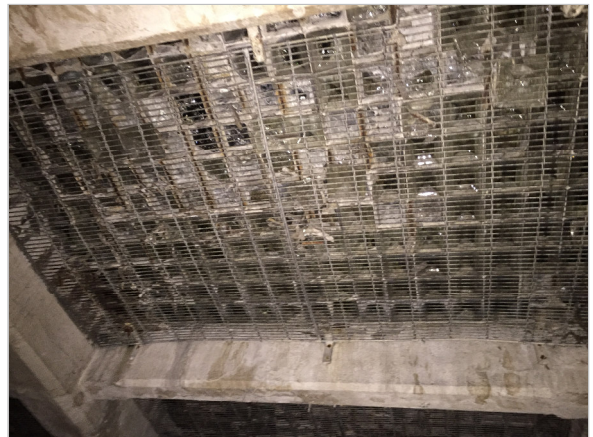
Fig 4. Pavement light underside showing exposed reinforcement and with safety cage installed.

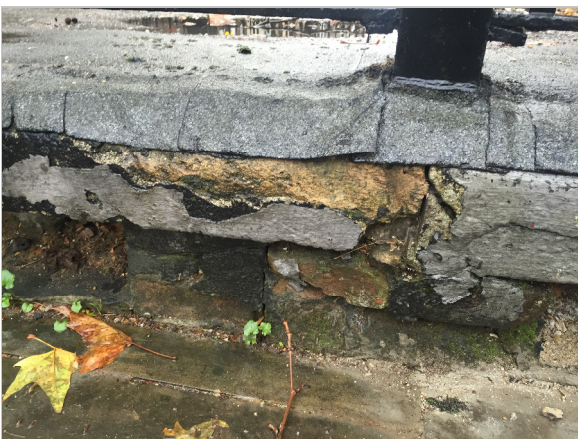
Fig 5. Image of beam bearing external.

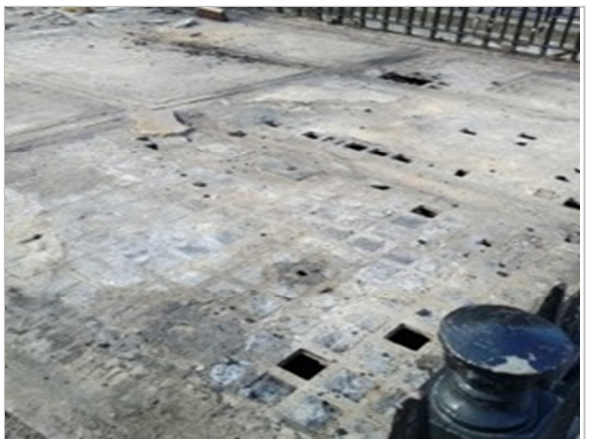
Fig 6. Pavement light condition following removal of asphalt

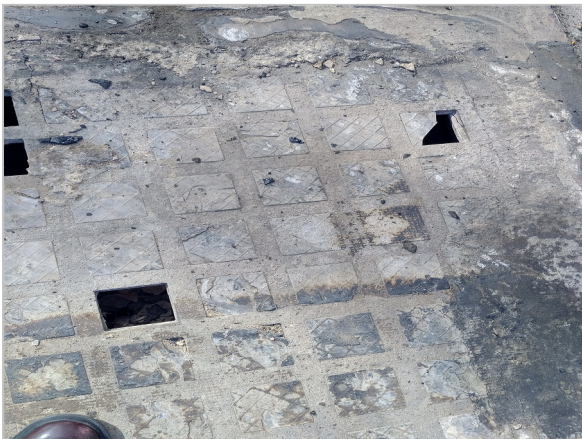
Fig 7. Pavement light condition following removal of asphalt.
