Existing Basement Condition Survey

8 Rothwell Street		Drawing Number: 1506_L111EX
Stage 0 Draft	-	08.01.16
Strip-out	A	16.02.16
Planning Draft	B	02.03.16
Planning	C	25.03.16
		Status: Planning
Drawn by: LK	Date: 25.03.16	Rev: C
		1:50 @A3

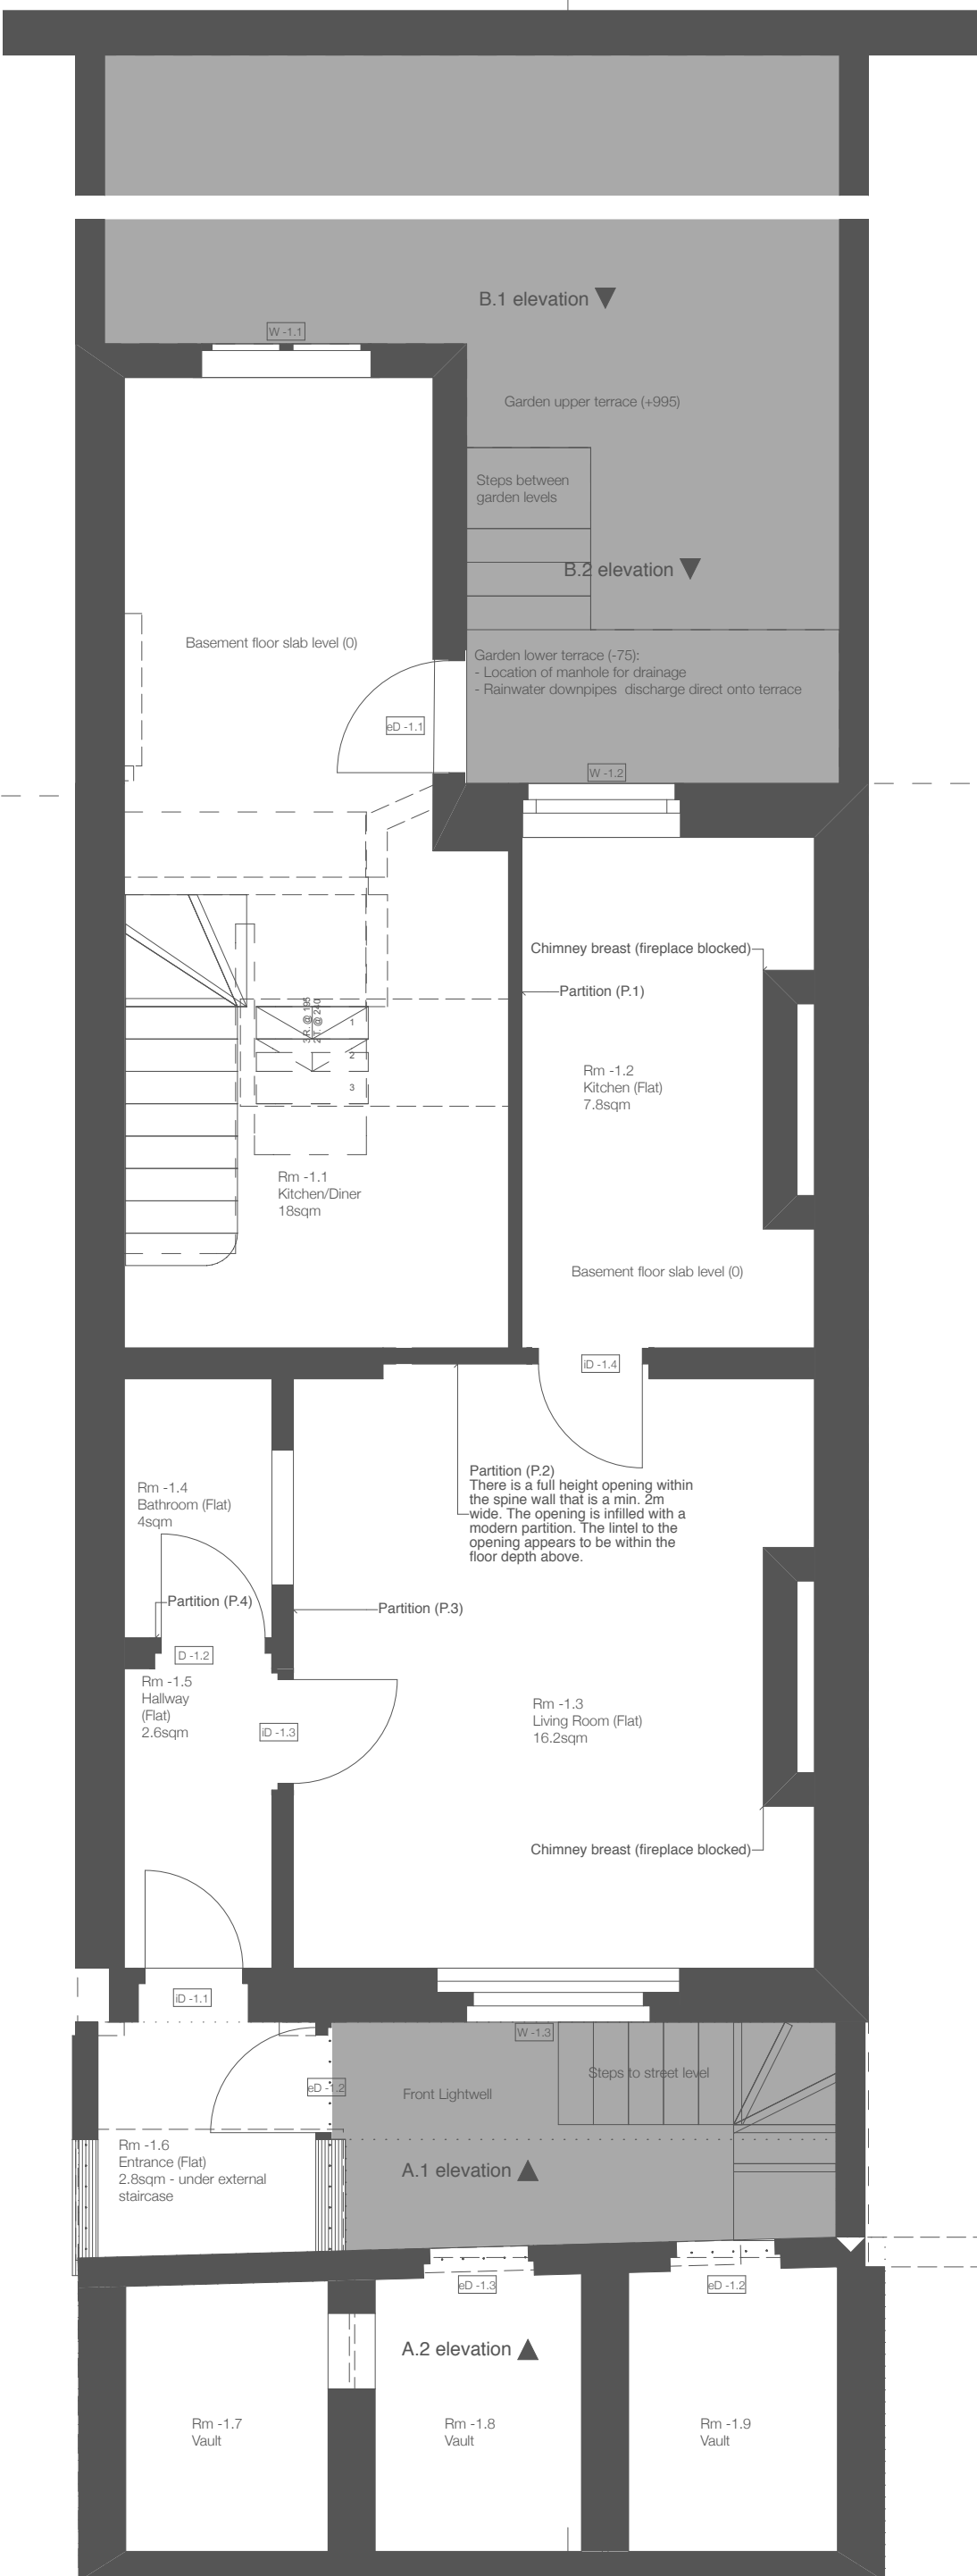
The internal layout is likely to be dated circa 1990 when the studio flat was formed although there is also evidence of historic alterations to the original layout prior to this. Partitions (P.1/3/4) are likely to have been erected circa 1990. Partition (P.2) is likely to be the original brickwork spine wall on which the upper floor structure bears. There is an opening formed in this partition (P.2). The opening through the masonry wall is at least two metres wide and is full height with no down stand. There will be a beam concealed above the opening within the floor depth above spanning across between the retained sections of wall either side and providing support to the structure above. This approx. 2m wide opening has been reduced in width to form the single door opening between the kitchen and studio room with lighter weight masonry and timber stud infill material provided to the side and above the door opening between the rooms. There is some cracking of the infill material in partition (P.2), which has appeared at changes in construction between the original thicker spine wall and the adjacent lighter weight infill material. The interior condition of the lower ground floor walls and ceilings is in very poor condition and surface finishes stained, aged and deteriorating. With the exception of the internal staircase in the dwelling kitchen (Rm-1.1), there are no original features (such as fireplaces, skirting, coricing) in situ which is to be expected given the basement would likely have been servant quarters/scullery in the original house. The internal timber doors are likely to have been installed circa 1990 when the studio flat was created. These doorsets are in poor condition and do not comply with current fire standards.

There is no evidence of a damp proof course which is to be expected of a building of this age. Areas of damp have been detected in the basement at the rear and flank wall of the flat kitchen (Rm-1.2), the rear wall of the larger dwelling kitchen (Rm-1.1), the flank wall of the flat bathroom (Rm-1.4), flat hall (Rm-1.5) and the external wall of the light well in the flat bedroom (Rm-1.3) at the junction with the external staircase.

The basement floor substrate is a modern screed on a plastic mabrane likely to have been laid circa 1990 when the studio flat was formed. The level difference across the top of the screed is significant (10cm variation across the plan). The screed had been overlaid with carpet and vinyl sheet flooring by the previous occupants.

The garden area at the rear is mostly raised to approximately a metre above basement level with steps leading up from the lowered garden area outside of the kitchen door up to the level above. The perimeter boundary walls are generally sound with some areas of missing mortar and damaged brickwork.

The external windows are single-glazed timber sash windows and likely original (W-1.2, W-1.3) with the exception of the kitchen to the rear of the lower ground floor which has a modern double-glazed timber casement (W-1.1). The sash windows require overhaul but the timber frames are generally sound with no evidence of significant rot or decay.

Stone steps lead down into the front exterior light-well area. The top surface of the steps has been overlaid with a cement render which is cracking and deteriorating and allowing vegetation growth below. The loose cement coating will need to be cut back to expose the underlying stonework for inspection. There are stone flags provided to the floor in the light-well area. The joints between the slabs are open with vegetation growth between. The light well floor levels vary and are not set to adequate falls to the existing gully resulting in ponding. There are three vaults formed to the front of the light-well area beneath the public footpath. The vaults are finished internally with a render tanking system that is failing in areas allowing damp through to the surface.
