SITE INVESTIGATION FACTUAL REPORT

Report No: 287264
Client: Cunningham Lindsey - Maidstone
Site: 54 Compayne Gardens, London

Client Ref: 6095485-
Date of Visit: 20/10/2015

Site: 54 Compayne Gardens, London NW6

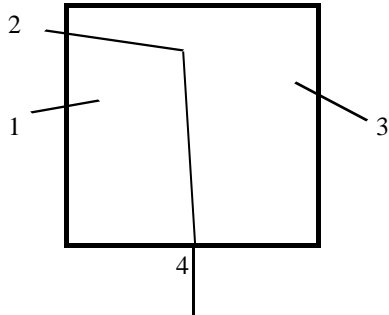
M/H: 1 Depth: 950mm

Manhole Condition

As built

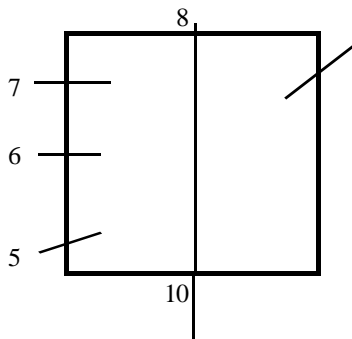
M/H: 4 Depth: 600mm

Chamber Dimension (mm): 650 X 450

Manhole Condition

As built
