ARBORICULTURAL ASSESSMENT REPORT

For:	Client:	Cunningham Lindsey (Maidstone)
	Insurer:	AXA Insurance UK plc
Site:	Policyholder:	[REDACTED]
	Risk Address:	54 Compayne Gardens, NW6 3RY
Refs:	OCA Ref:	63797
	Client Ref:	6095485
	Insurer Ref:	2152992

Report By:	David O'Connell		
Title:	Senior Arboriculturist	Date:	11 December 2015

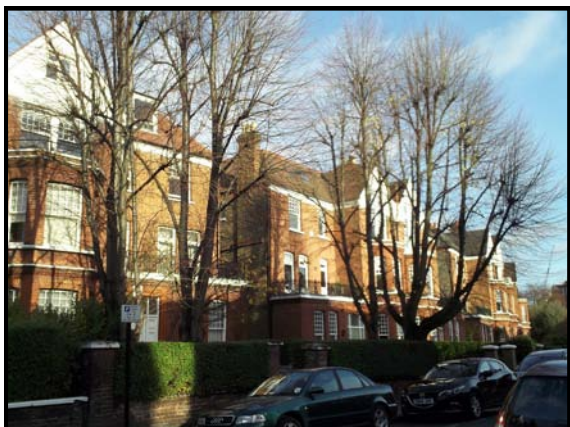
Tree No	Common Name	Age Class	Condition	Height (m)	Crown Spread (m)	Stem diam. (mm)	Dist to bldg (m)	Pruning history	Recommendation	Tree work constraints	Notes	Owner address	Owner
T1	Lime	MA	P	11.5	4.2	550	5.7	Pollard. 2 years' regrowth.	Fell and treat stump.	None	Large cavity in stem	54 Compayne Gardens, London, NW6 3RY	PH
T2	Lime	MA	F	11	5.4	450	8.4	Pollard. 2 years' regrowth.	Fell and treat stump.	None		54 Compayne Gardens, London, NW6 3RY	PH
T3	Lime	MA	F	11.6	6.1	300	6.7	Pollard. 2 years' regrowth.	Fell and treat stump.	None	Difficult access in hedge behind storage bin and behind wall. Estimated as no access to stem .	54 Compayne Gardens, London, NW6 3RY	PH
T4	Lime	MA	F	12.3	8.3	500	6.9	Pollard. 3 years' regrowth.	Fell and treat stump.	Limited access to stem.	Stem diameter estimated as no access .	54 Compayne Gardens, London, NW6 3RY	PH
S1	Mexican Orange Blossom	SM	F	1.2	1.5	10	0.1		No work required.	N/A		54 Compayne Gardens, London, NW6 3RY	PH

1. T1 lime to T4 lime

Tree No:	Species	Works Required
T1	Lime	Fell as close to ground level as practicable and treat stump
T2	Lime	Fell as close to ground level as practicable and treat stump
T3	Lime	Fell as close to ground level as practicable and treat stump
T4	Lime	Fell as close to ground level as practicable and treat stump
T6	Ash	Fell as close to ground level as practicable and treat stump
C2	Clematis	Fell as close to ground level as practicable and treat stumps

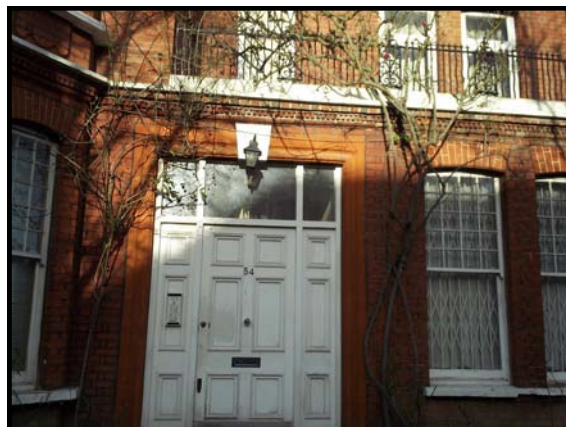
2. C1 Rose

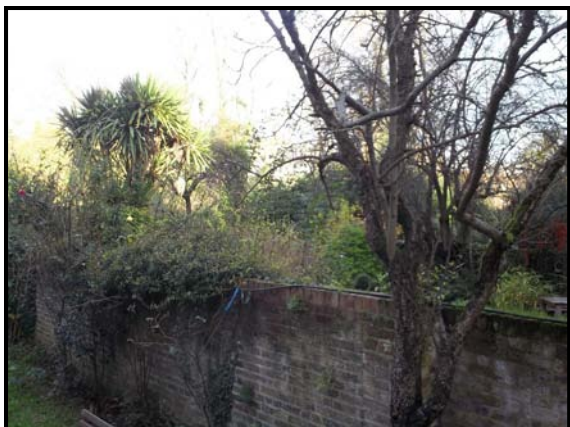
3. T5 Apple & G1

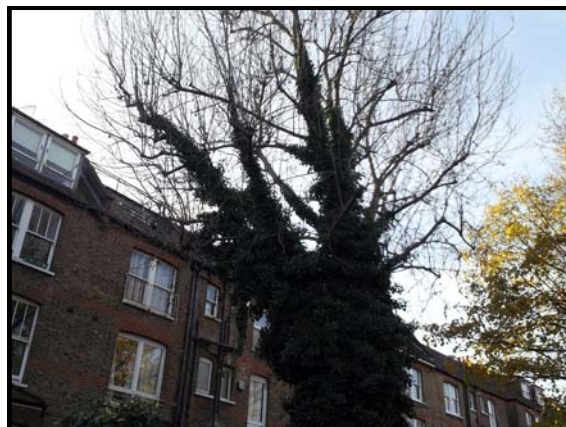
T5	Apple	EM	F	6	4	180	2.9	Pruned regularly	No work required.	N/A		54 Compayne Gardens, London, NW6 3RY	PH
T6	Ash	MA	F	19.5	10.4	600	8.5	Pollard. 4 years' regrowth.	Fell and treat stump.	Possible difficult access sur to the rear garden being narrow.	Measurements are estimated as no access to 3rd party land and ivy growing on main stem .	54 Compayne Gardens, London, NW6 3RY	PH
C1	Rose (Climbing)	SM	F	8	4.5	50	0.1	Pruned regularly	No work required.	N/A		54 Compayne Gardens, London, NW6 3RY	PH

4. T6 Ash

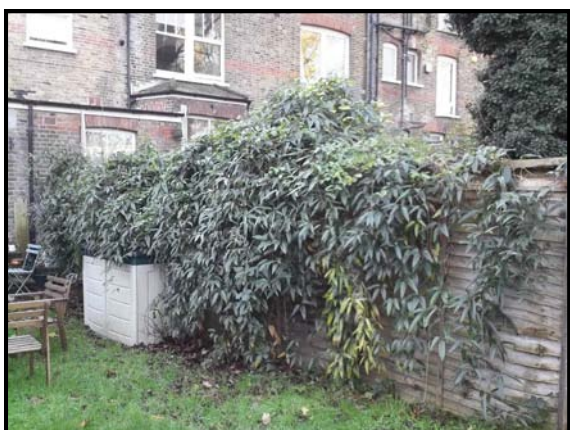
Tree No	Common Name	Age Class	Condition	Height (m)	Crown Spread (m)	Stem diam. (mm)	Dist to bldg (m)	Pruning history	Recommendation	Tree work constraints	Notes	Owner address	Owner
C2	Clematis	SM	F	2.2	9	5	0.5	No significant past tree works	Fell close to ground level (approx 50mm).	None	On fence. could be policy holders	54 Compayne Gardens, London, NW6 3RY	PH
G1	Mixed Species	YO	F	2	9	5	3.5	Pruned regularly	No work required.	N/A	Jasmine, Rose, Ivy and Holly	54 Compayne Gardens, London, NW6 3RY	PH
G2	Mixed Species	MA	F	11	20	500	20	No significant past tree works	No work required.	N/A	woodland area, with ash, london plane, lime,	Camden Borough Council.	LA
H1	Privet	SM	F	2.4	8	50	0.5	Trimmed regularly	No work required.	N/A		54 Compayne Gardens, London, NW6 3RY	PH
H2	Privet	EM	F	2.4	5	50	0.5	Trimmed regularly	No work required.	N/A		54 Compayne Gardens, London, NW6 3RY	PH

5. C2 Clematis

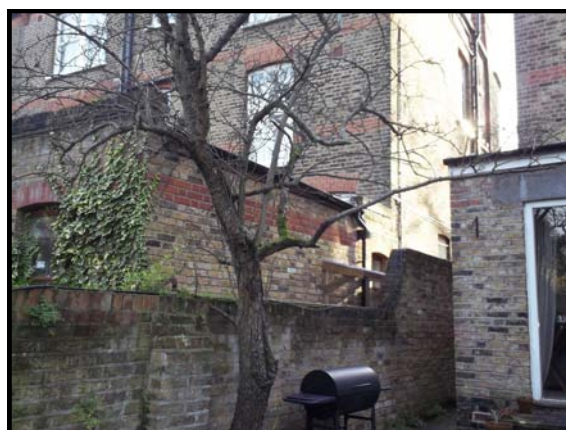
6. Apple
