1-38-3689

REPORT

on the impact on trees

4 Tavistock Place, London, WC1H 9RA

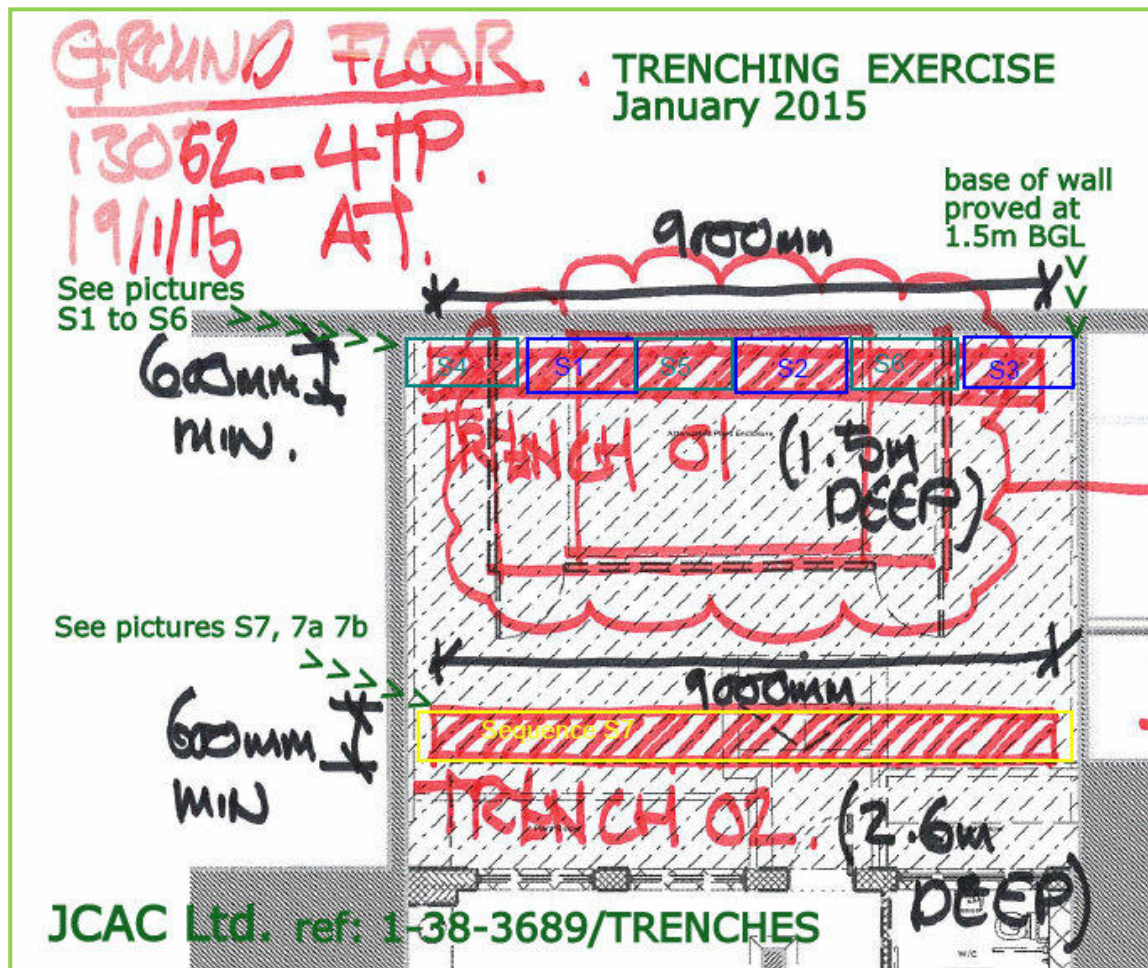
Images from trenching exercise - plan and photos

Two extensive trial strip trenches were excavated as shown in the images appended, to a depth of 1.5m (TRENCH 01- see appendix) and 2.6m (TRENCH 02) below garden level. These established that roots of the London planes had not underpassed the wall to any marked extent. It is of note that only very small diameter roots were encountered in both trenches, and minimally in the deeper trench 02. The sparse roots encountered (see photos S1-S6) appeared to have grown through the weak lime mortar of the unusually deeply founded wall. The subsoil encountered was mainly sand and gravel. This is, when well-compacted as was the case in the trenches, tends to be a poor medium for root development.

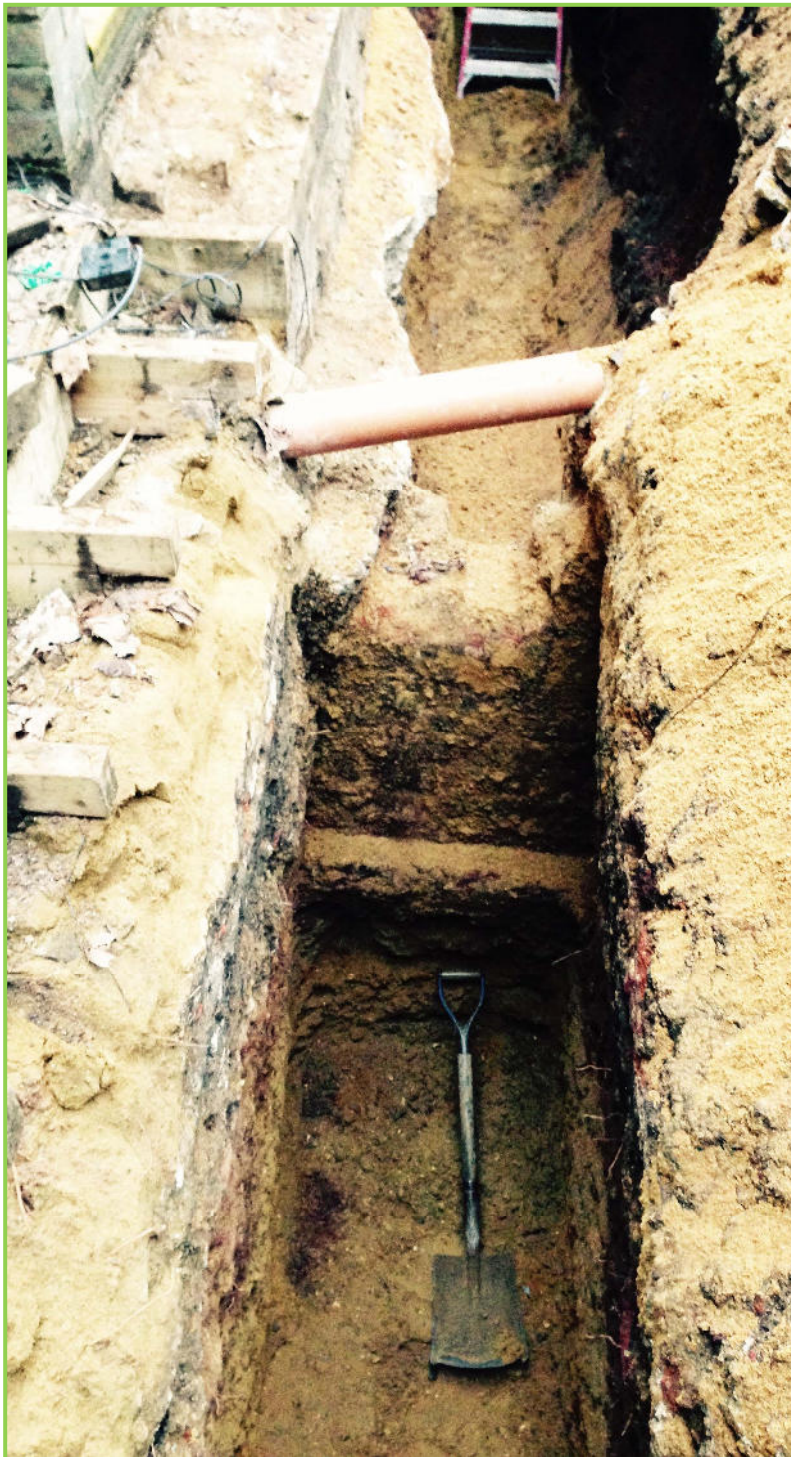
S7b

Trench bottomed out at
2.6m below rear garden
level

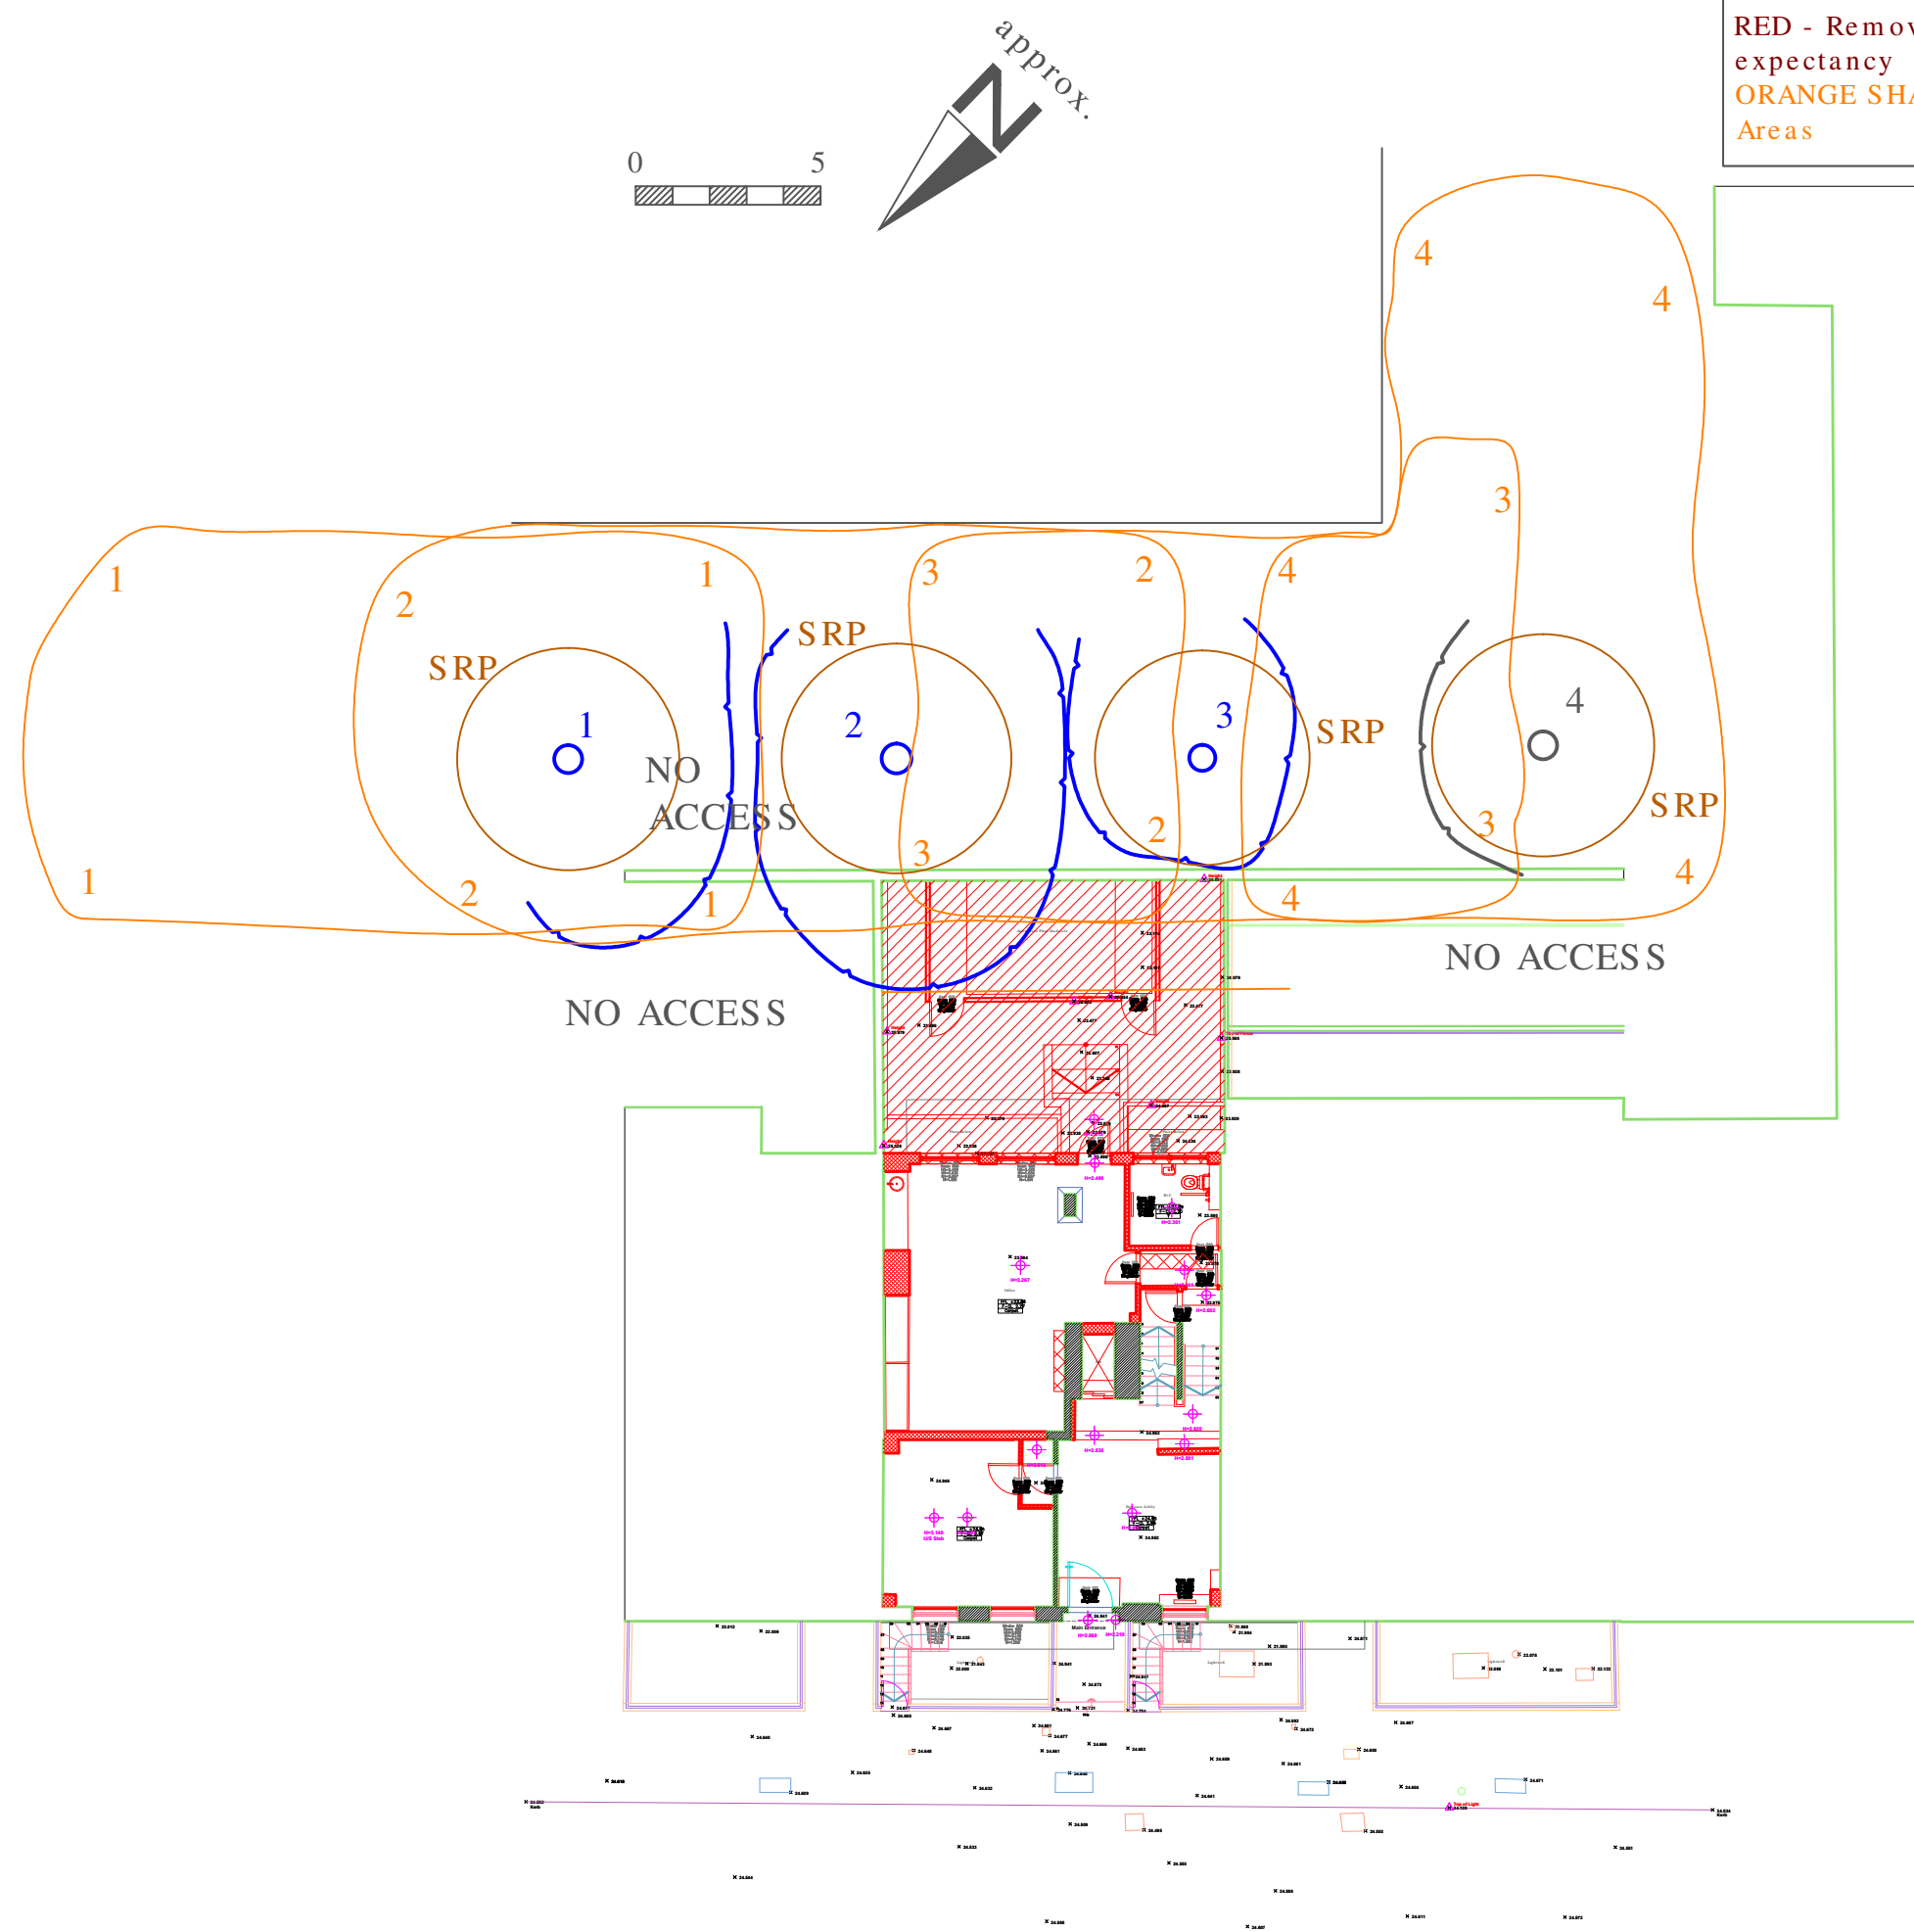
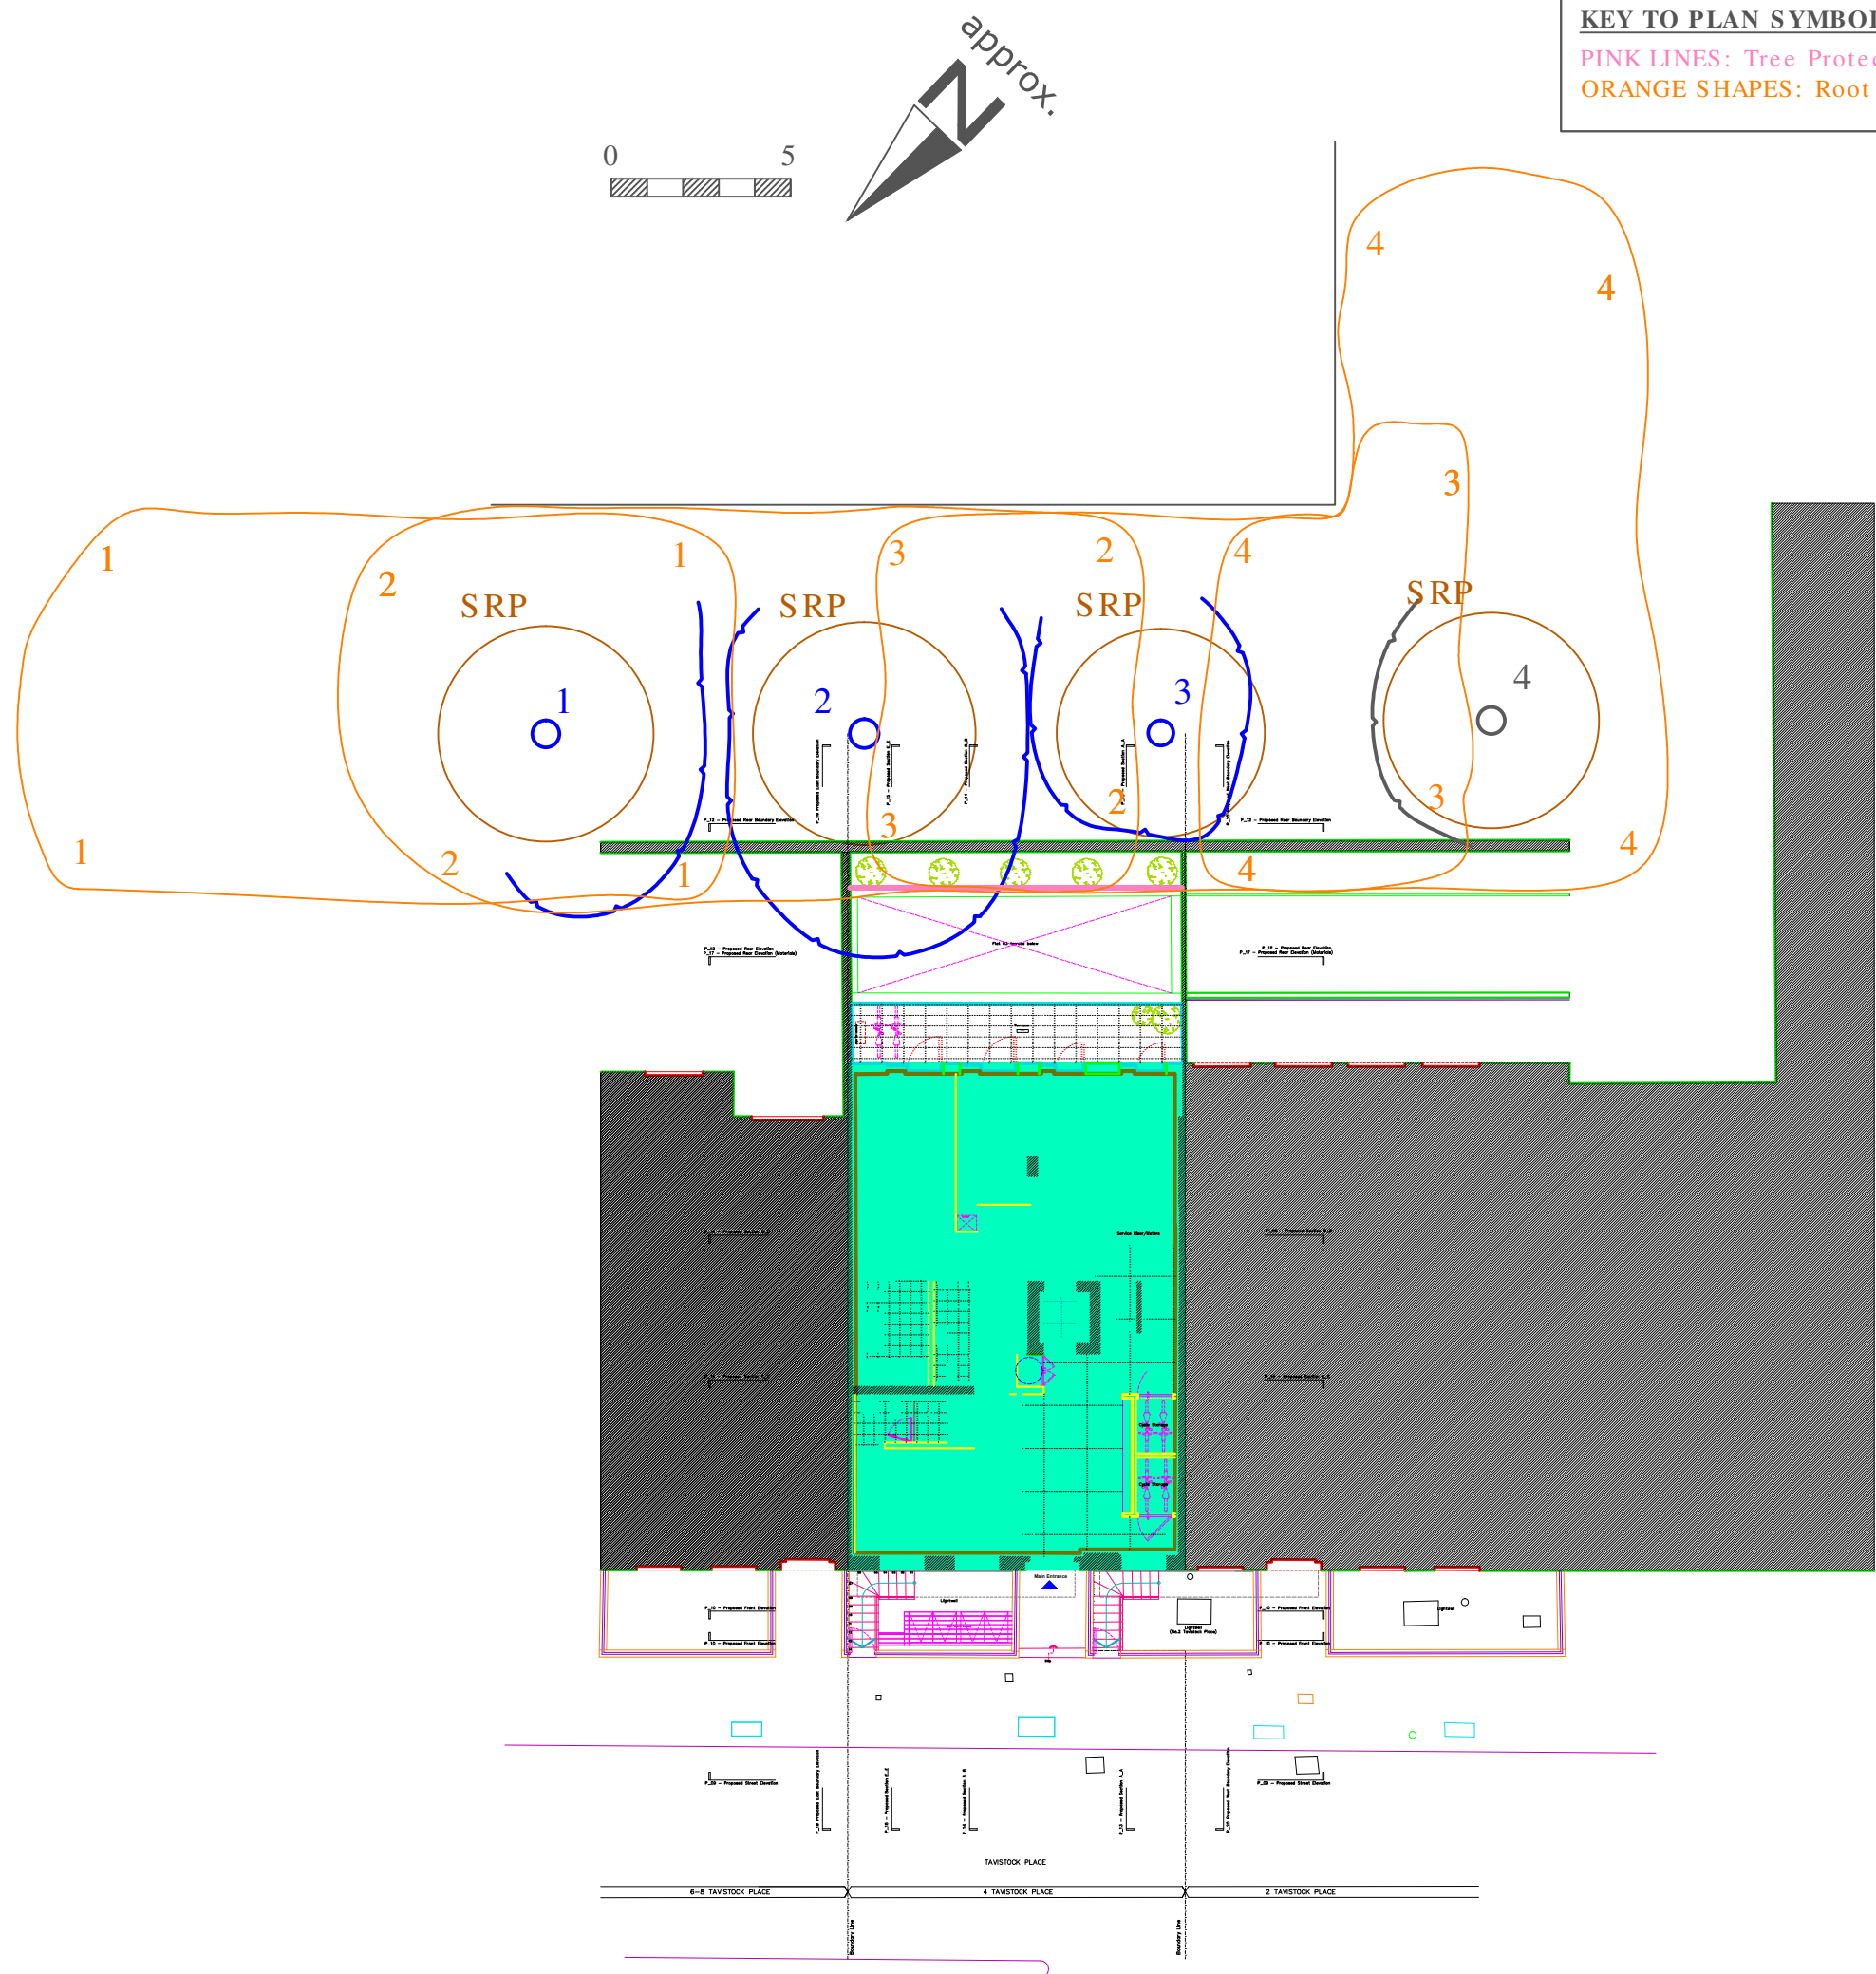
ref: 1-38-3689/P1
rev. 24.02.15
1:200 scale @ A3

Regular reduction of the trees has likely over time diminished the extent of the root systems (see *Coder*, 'Crown Pruning Effects on Roots' (1997)). On the plans appended I have shown the RPAs modified in accordance with the assessment recommended at BS5837:2012 section 4.6.2, to 80% of the orthodox RPA. It is on the other hand very likely that significant anchorage roots in or near the SRP will have remained exactly as the orthodox SRP as these are essential to tree stability : the SRPs lie completely within the adjacent curtilage to the SE. The root systems are also likely to feature many grafts by reason of the trees' close proximity to one another and the constraints of the built form nearby. On the basis of the combination of the long term pruning cycle and the root-hostile substrate encountered it can be concluded that no significant encroachment on the RPA (or SRP) of any retained tree is entailed in the proposal which involves excavation via contiguous piles at the position of trench 02 to form a basement courtyard.
