**Addison Lee,
6 – 9 Spring Place,
Camden,
London.
NW5 3BH.**

Management Survey and Asbestos Register
June 2013

Report type: Survey and Assessment of Asbestos Containing Materials

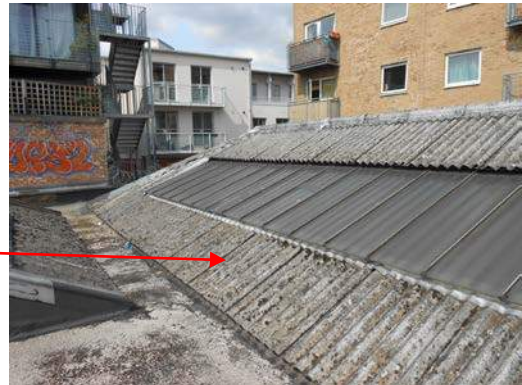
Location: Rear roof, apex sections.

Lab result: Chrysotile.

Material Risk Score: 4 Product Type: 1
Damage/deterioration: 1
Surface treatment: 1
Asbestos type: 1

Total Risk Score: 4 – Very low risk

The sheets are sound, have no signs of impacts, and are in good condition.

The recommended action is to manage the roof sheets in situ, with no cutting or drilling.

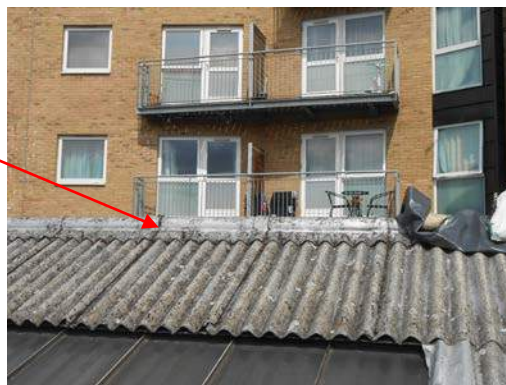
Location: Rear roof, apex sections.

Lab result: Chrysotile

Material Risk Score: 4

Product Type: 1
Damage/deterioration: 1
Surface treatment: 1
Asbestos type: 1

In general, the cement covers are in fair condition with no signs of damage or any major material breakage.

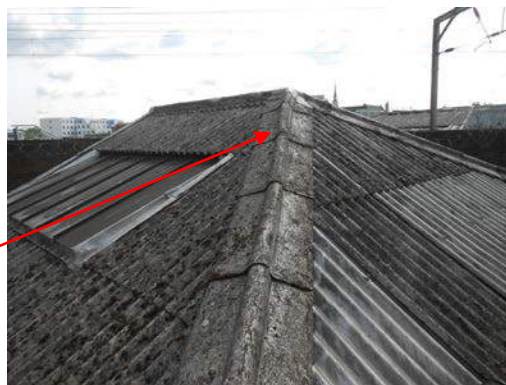
Location: Rear roof, apex sections.

Lab result: **Chrysotile**

Material Risk Score: 4

Product Type: 1
Damage/deterioration: 1
Surface treatment: 1
Asbestos type: 1

In general, the cement covers are in fair condition with no signs of damage or any major material breakage.

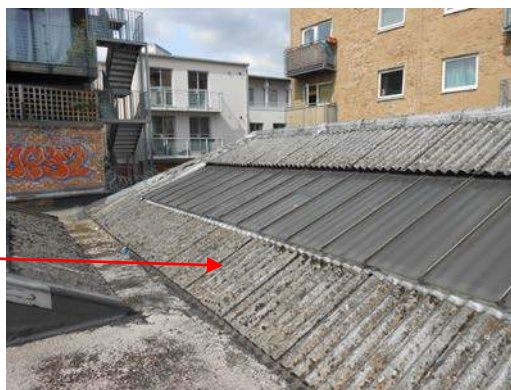
Location: Front roof, apex sections.

Lab result: **Chrysotile & Crocidolite.**

Material Risk Score: 6 Product Type: 1
Damage/deterioration: 1
Surface treatment: 1
Asbestos type: 3

Total Risk Score: 6 – Low risk

Chrysotile & Crocidolite asbestos fibres can often be found in older cement cladding sheets like these.

The sheets are sound, have no signs of impacts, and are in good condition.

The recommended action is to manage the roof sheets in situ, with no cutting or drilling.

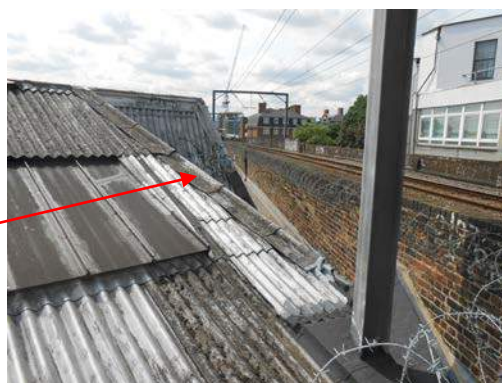
Location: Rear roof, apex sections.

Lab result: **Chrysotile & Crocidolite.**

Material Risk Score: 6

Product Type: 1
Damage/deterioration: 1
Surface treatment: 1
Asbestos type: 3

In general, the cement covers are in fair condition with no signs of damage or any major material breakage.

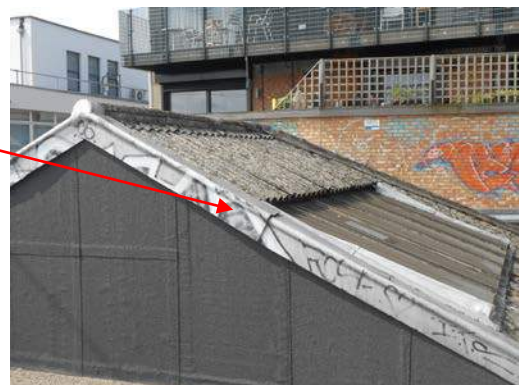
Sample no: 5029.02

Lab result: NAD (no asbestos detected)

Material Risk Score: 0
Product Type: 0
Damage/deterioration: 0
Surface treatment: 0
Asbestos type: 0

Comments: This sample was taken from the cement hip covers to the apex roof sections on the rear roof (coverage is to all cement hip coverings 'this appears to be of a new material but should be treated as asbestos containing for any future removal purposes'). The sample showed that **no asbestos was detected**.

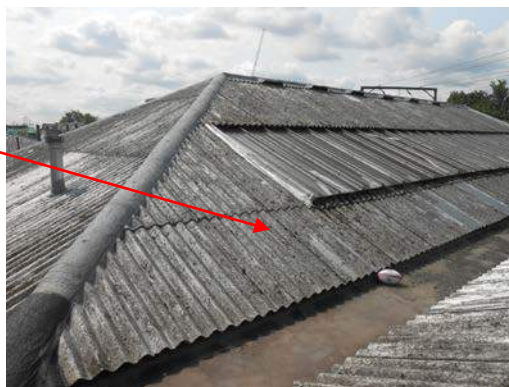
Sample no: 5029.08

Lab result: NAD (no asbestos detected)

Material Risk Score: 0
Product Type: 0
Damage/deterioration: 0
Surface treatment: 0
Asbestos type: 0

Comments: This sample was taken from the corrugated cement roof sheets to the apex roof section on the front roof (coverage is to all cement hip coverings 'this appears to be of a new material but should be treated as asbestos containing for any future removal purposes'). The sample showed that **no asbestos was detected**.

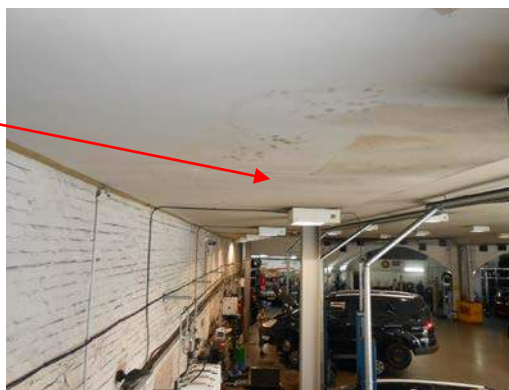
Sample no: 5029.09

Lab result: NAD (no asbestos detected)

Material Risk Score: 0
Product Type: 0
Damage/deterioration: 0
Surface treatment: 0
Asbestos type: 0

Comments: This sample was taken from the ceiling boards above the office in workshop 1 (coverage is throughout workshop 1 and 2, approximately 65 metres x 28 metres). The sample showed that **no asbestos was detected**.

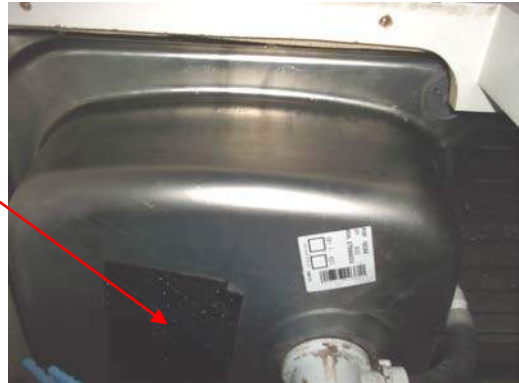
Sample no: 5029.10

Lab result: NAD (no asbestos detected)

Material Risk Score: 0
Product Type: 0
Damage/deterioration: 0
Surface treatment: 0
Asbestos type: 0

Comments: This sample was taken from the sink pad to the underside of the sink unit in the ground floor works canteen (coverage is 1 pad). The sample showed that **no asbestos was detected.**

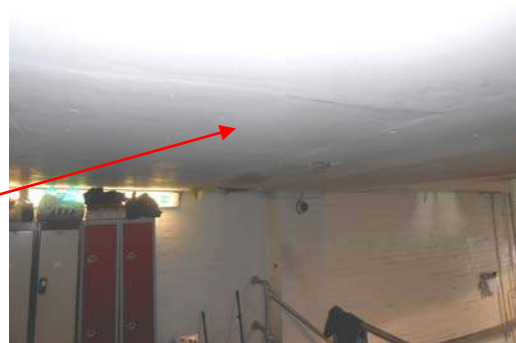
Sample no: 5029.11

Lab result: NAD (no asbestos detected)

Material Risk Score: 0
Product Type: 0
Damage/deterioration: 0
Surface treatment: 0
Asbestos type: 0

Comments: This sample was taken from the ceiling boards to the mezzanine rest area in workshop 2 (coverage is throughout workshop 1 and 2, approximately 65 metres x 28 metres). The sample showed that **no asbestos was detected.**

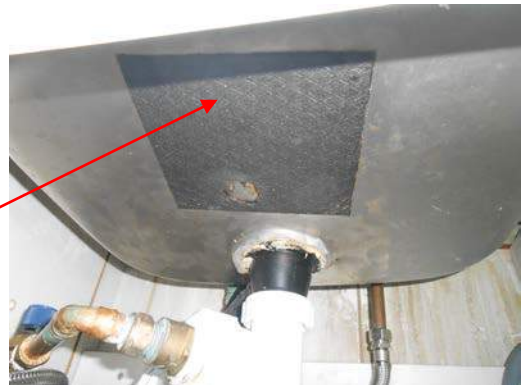
Sample no: 5029.12

Material Risk Score: 0

Product Type: 0
Damage/deterioration: 0
Surface treatment: 0
Asbestos type: 0

Comments: This sample was taken from the sink pad to the underside of the sink unit in the first floor kitchen (coverage is 1 pad). The sample showed that **no asbestos was detected**.
