**Arboricultural &
Planning Integration Report**

**15 Rudall Crescent
London
NW3 1RR**

September 2016

Arboricultural & Planning Integration Report

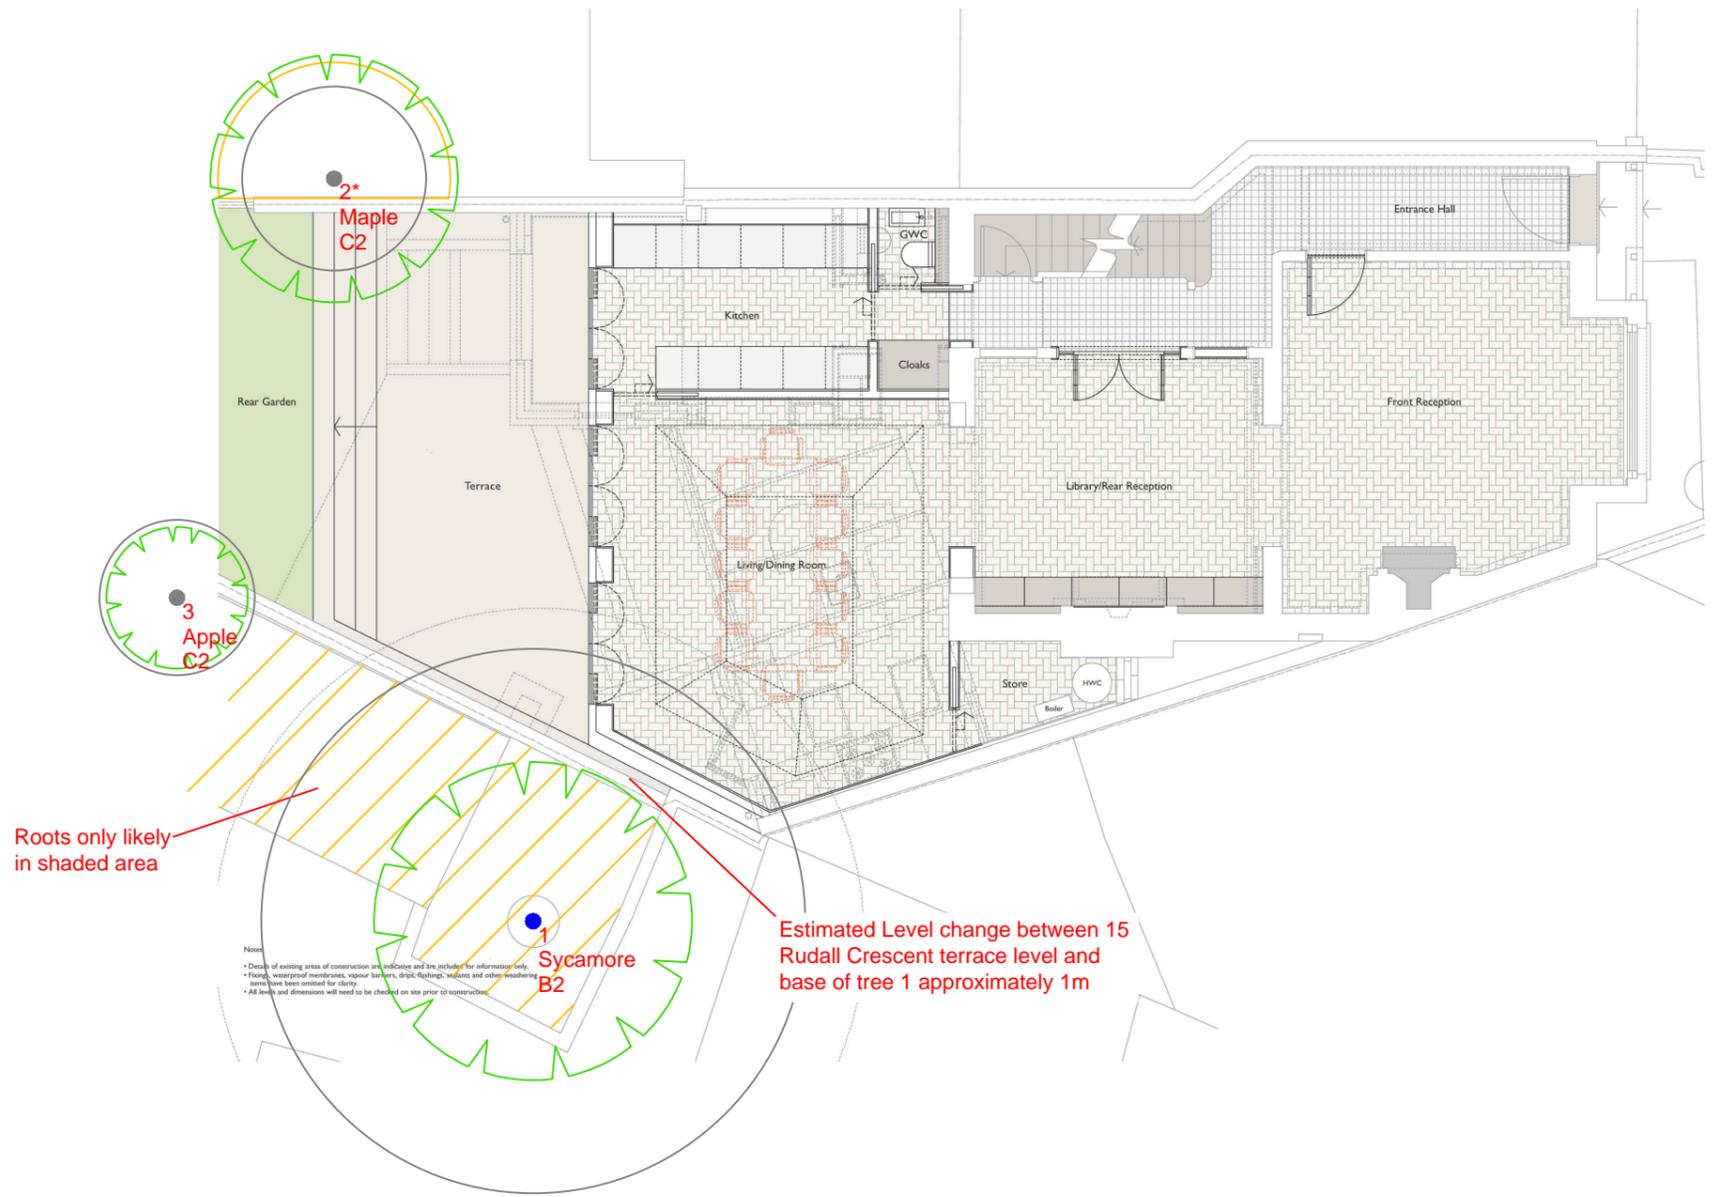
Drawing Title: Arboricultural Impact Assessment	1-200@A3
Appendix: A	Rev A, Sept 2016

- 8.1 BS5837:2012 gives a root protection area (RPA) for each retained tree by reference to section 4.6. The RPA is usually described as a circle with a radius (Root Protection Area Radius (RPR) of the prescribed distance within which no activity should occur, *though the shape and position of the RPA can be modified by the arboriculturist to meet individual site conditions according to the probable distribution of tree roots.* Intrusion into the RPA can usually take place only where the ground is adequately protected in accord with the requirements of section 7 of BS5837:2012 but on this site the level change between the base of the large sycamore (T1) and the proposals suggests that the rooting area of this tree is unlikely to include the site (see Appendix A for probable distribution of tree 1's roots.

Roots only likely in shaded area

Estimated Level change between 15 Rudall Crescent terrace level and base of tree 1 approximately 1m
