Drain Doctor Plumbing & Drainage

12 Platts Lane

11 August 2016

CCTVSURVEY/REPORT

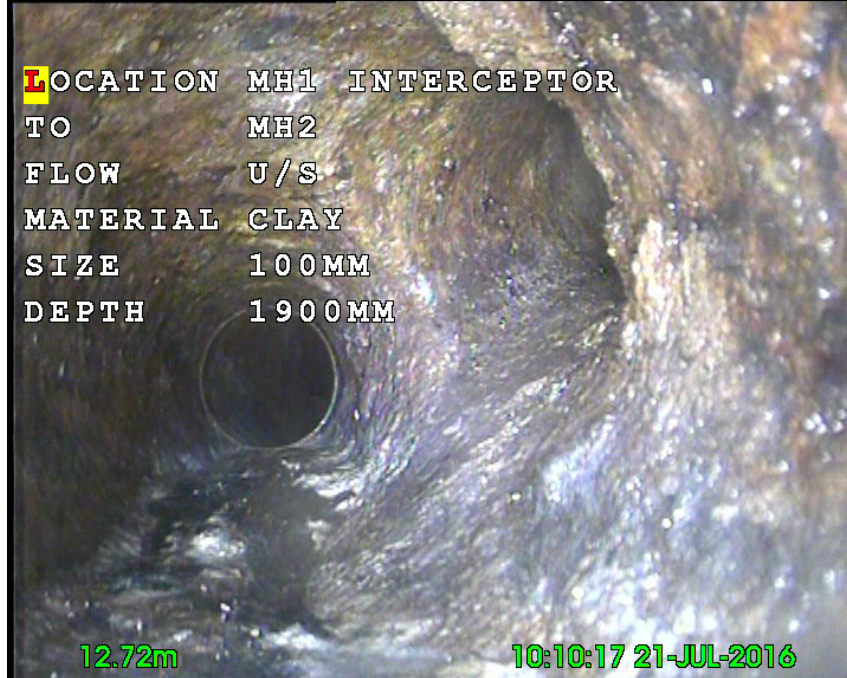
Photo: 1_1_5_A.jpg
 12.72m, Junction, at 3 o'clock, diameter 100mm

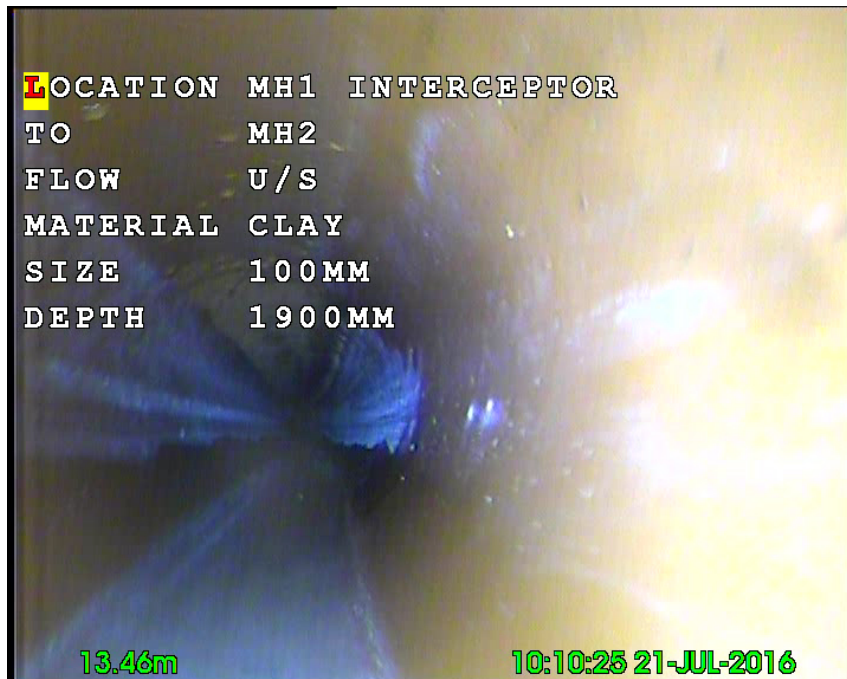
The line is in good structural condition. We noted that the line changes material from Clay to Plastic at 13m approx'. Serviceability would improve greatly to remove encrusted scale and restore full mechanical efficiency. We also noted holding water in the newer plastic pipework which would indicate a belly in the pipework

Photo: 1_1_7_A.jpg
 13.46m, Material changes, polyvinyl chloride

Descale entire system to restore full mechanical efficiency. Total cost to complete this work is £340.00+vat.

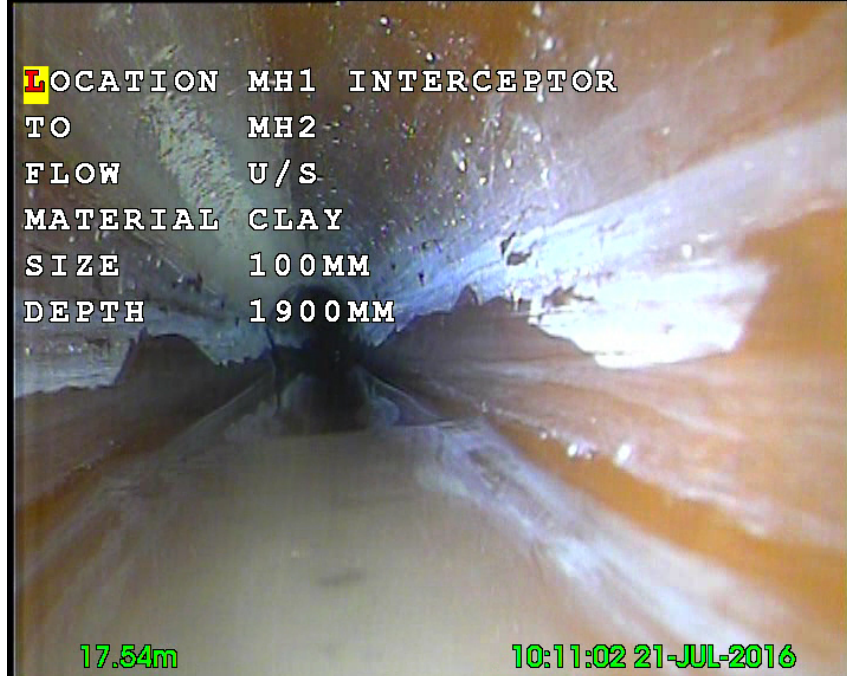
Photo: 1_1_8_A.jpg
17.54m, Clear water level, 15% of the vertical dimension Remarks:
Belly Start

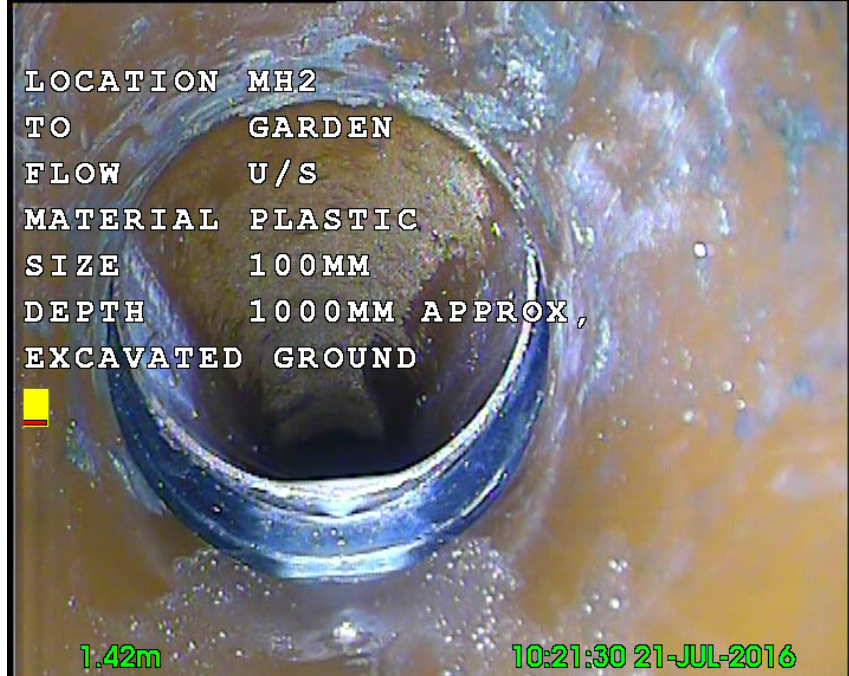
Structural defects			
Section	PLR	Grade	Fault description
2	Garden X	4	Joint displaced, 30mm of diameter
5	SVP X	3	Multiple defects at 0.0m
6	MH3 X	3	Fracture, circumferential, from 12 to 12 o'clock

This line is a recent addition and is manufactured from PVC. We noted a very large displaced joint in the line which is likely to worsen over time. This can be repaired using 'No Dig' technology. I would recommend fitting a Point to Point structural repair to repair the joint.

Photo: 2_3_12_A.jpg
1.42m, Joint displaced, 30mm of diameter

Section 2, Supply and fit 'Point to Point repair on line. Total cost £435.00+vat.

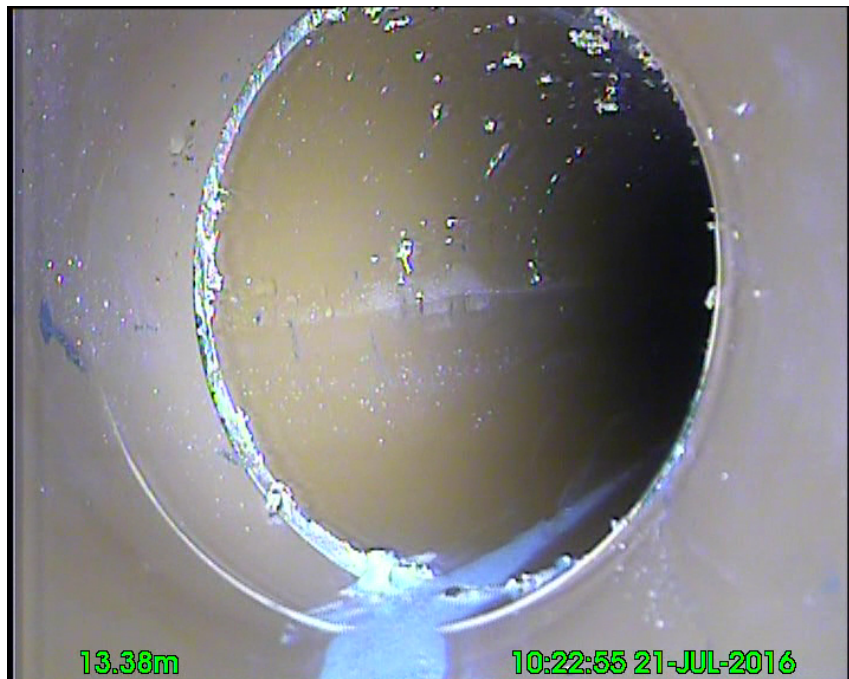
Photo: 2_3_13_A.jpg
13.38m, Line deviates right

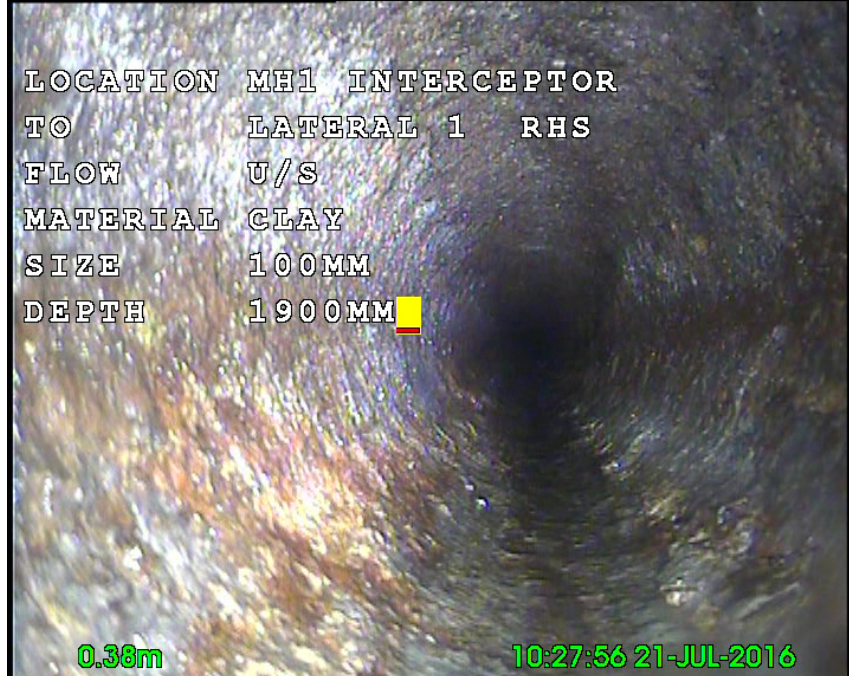
Service defects			
Section	PLR	Grade	Fault description
1	MH2 X	3	Multiple defects at 13.5m
3	Lat 1 X	3	Attached deposits, encrustation, from 12 to 12 o'clock, 5% cross-s
8	Interceptr X	3	Settled deposits, fine, 20% cross-sectional area loss

This line would benefit from a de-scale to improve mechanical efficiency. Structurally the line is in good condition.

Photo: 3_4_20_A.jpg
0.3m, Attached deposits, encrustation, from 12 to 12 o'clock, 5%
cross-sectional area loss, Start

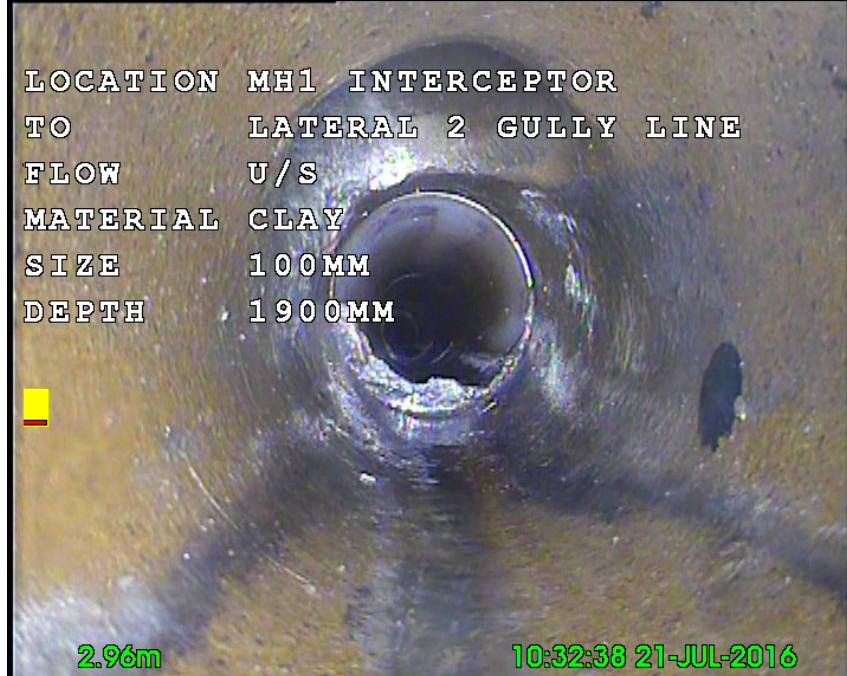
Photo: 4_5_26_A.jpg
2.96m, Junction, at 12 o'clock, diameter 100mm

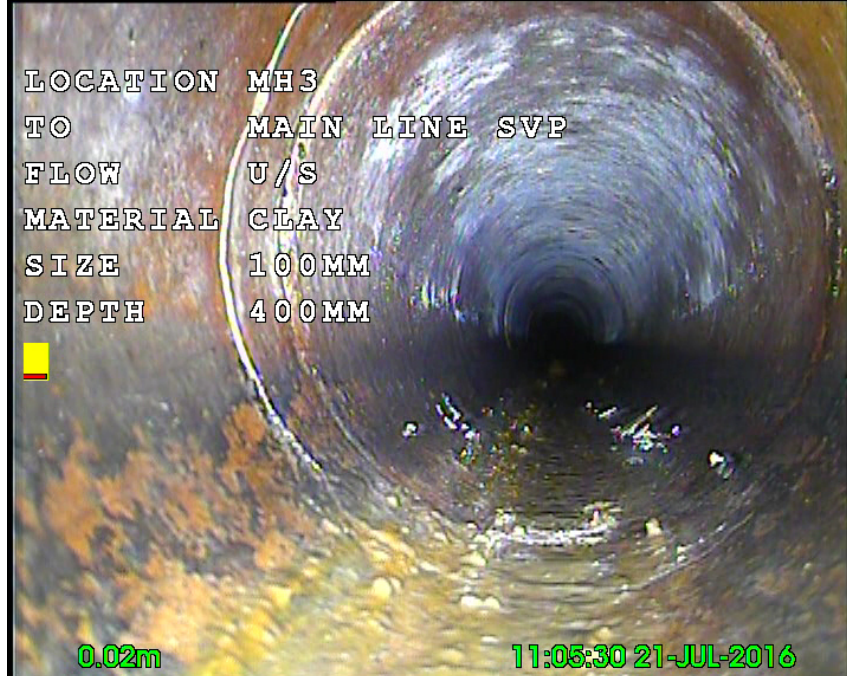
We noted a couple of fractures within the system here. We would recommend a full hydro-scrub prior to the fitment of a 6m structural liner

Photo: 5_6_32_A.jpg
 0.02m, Fracture, circumferential, from 6 to 12 o'clock

Section 5, Supply and fit 6m liner to drain to complete permanent repair. Total cost £720.00+vat.

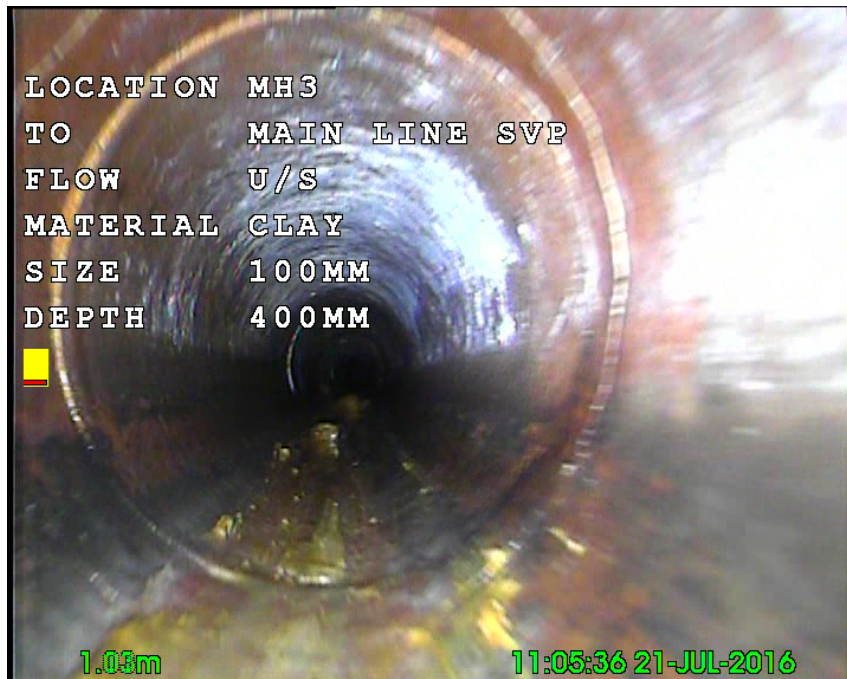
Photo: 5_6_33_A.jpg
 1.11m, Fracture, circumferential, from 12 to 12 o'clock

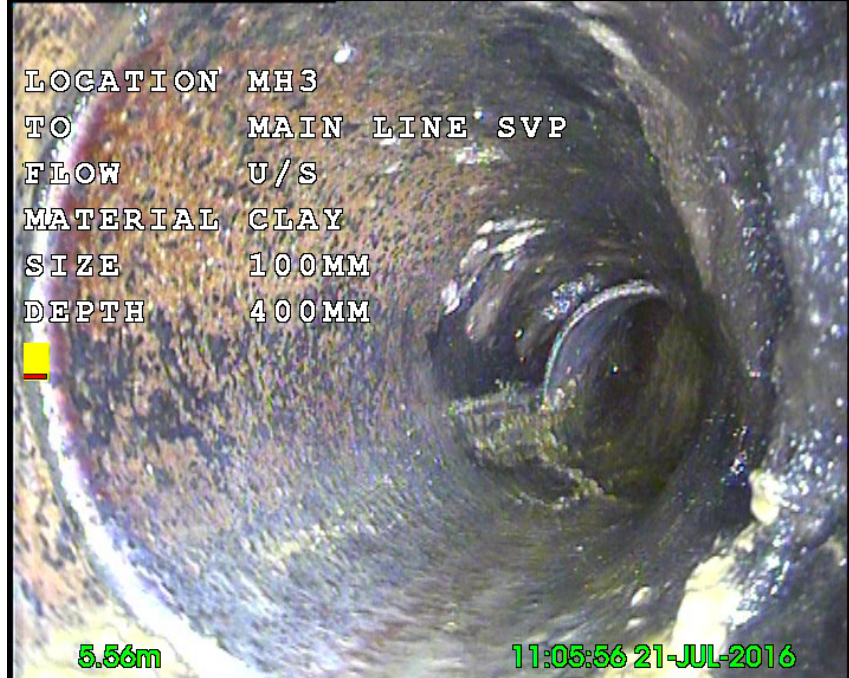
Photo: 5_6_34_A.jpg
5.56m, Line deviates right

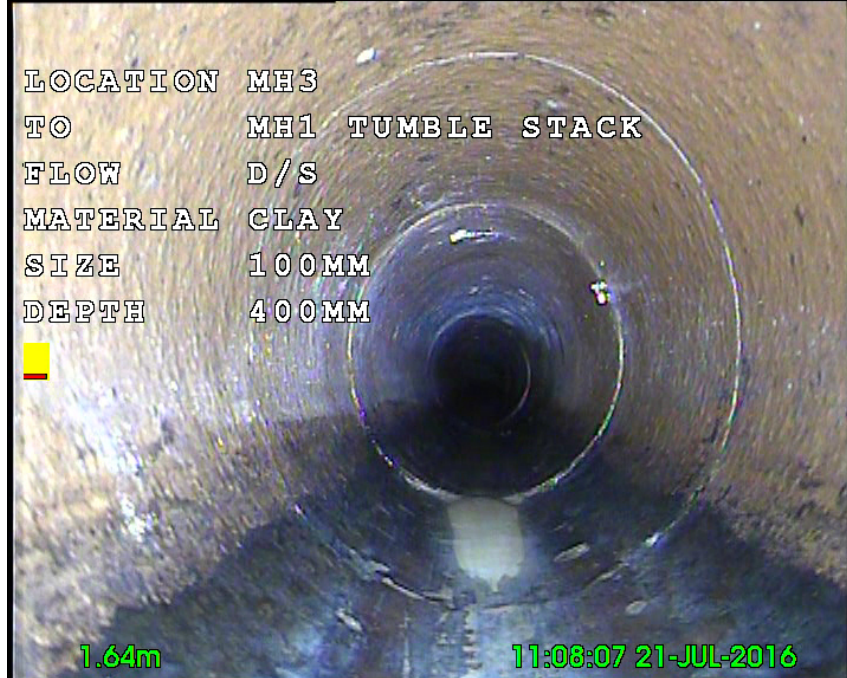
Photo: 6_7_39_A.jpg

The line only has one structural fault here. Recommend fitting a 'Point to Point' structural repair to permanently fix issue.

1.64m, Fracture, circumferential, from 12 to 12 o'clock

Section 6, Supply and fit 'Point to Point repair on line. Total cost £435.00+vat.

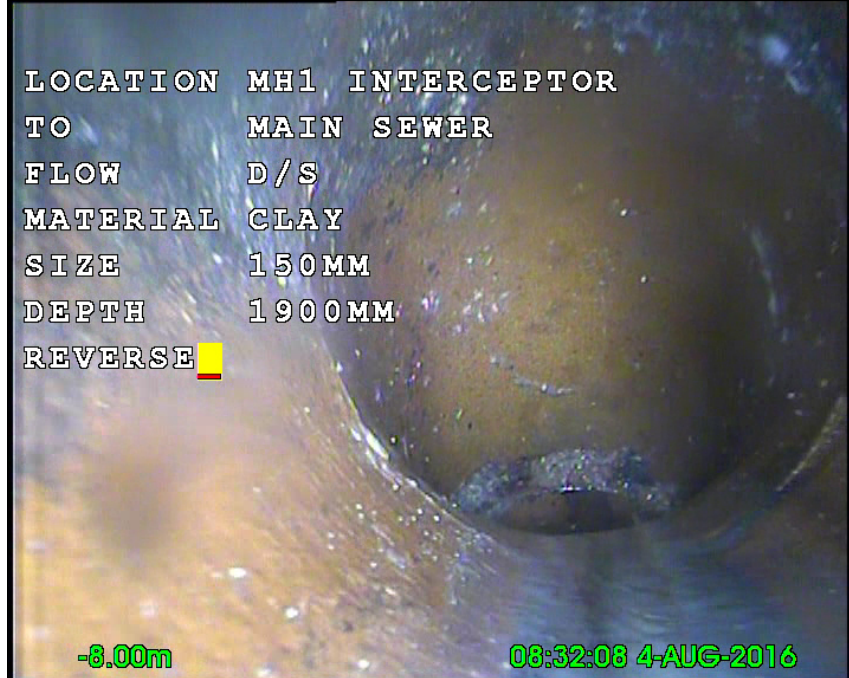
Photo: 8_9_49_A.jpg
8m, Line deviates down Remarks: 1/2 Turn
