Arboricultural Survey (BS5837:2012) & Impact Assessment Report

Senior School
University College School
Frognaal
London
NW3 6XH

10th June 2016

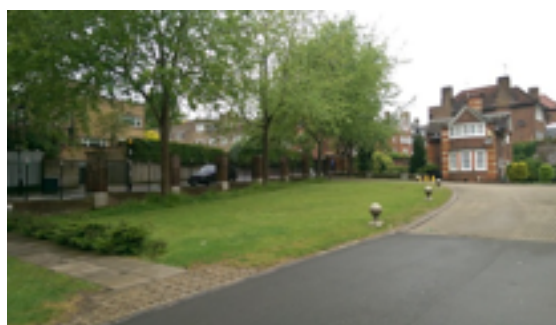
C.2 Photograph of trees T1 - T5, located on the boundary with Frognal, Senior Branch, University College School, as viewed in a north westerly direction

4.15 Trees T2-T5 are generally structurally sound and in good condition. As a species characteristics there are tight union with the main forks but this is not a significant structural defect for any of the trees. The trees offer balanced form with greater extended spread to the east and west by virtue of the aspect and the relative close proximity of each tree to one another. The trees are rated as 'B.1' category trees (BS5837: 2012) offering excellent amenity value and they are therefore proposed for retention.

4.17 For these works in this area, it is only tree T5 which is likely to require a design construction solution to allow for minor encroachment of up to 1.0m within the eastern root plate of this tree. All of the trees in this area will require protection from the construction process in the form of tree protection fencing, with works within the RPA of T5 also requiring close adherence to the tree protection guidelines and an Arboricultural Method Statement (AMS).

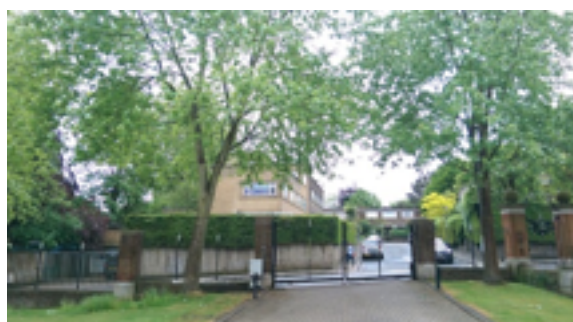
C.4 Photograph of trees T6 & T7, located on the boundary with Frognal, Senior Branch, University College School, at existing vehicular exit gates, as viewed in a westerly direction

4.18 Trees T6-T8 comprise 3 Silver Maple trees also which are located on the front boundary opposite Central Block. The trees are generally structurally sound and as with the trees previously discussed, there is some evidence of included bark within main unions as is characteristic of species. The trees all have straight main stems, good buttress roots at the base within the soft landscaped surrounding ground and in this area offer a balanced set of trees, rated as 'B.1' category (BS5837: 2012) due to the good condition and excellent amenity value offered.

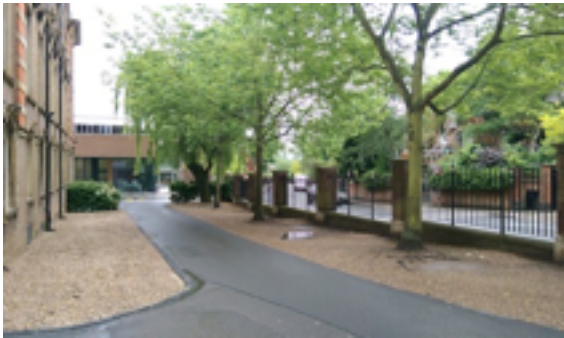
C.6 Photograph of trees T12 - T15, located on the boundary with Frognal, Senior Branch, University College School, as viewed in a southerly direction

4.24 Trees T12 - T14 are the southern most Silver Maple trees which similarly to trees T9 - T11 are currently sited within an area which comprises compacted gravel / beach shingle at ground level to provide an *ad hoc* car parking area surrounding the trees. All 3 trees are generally structurally sound but they do lack vigour in comparison to the remainder of the grouping and the girth size is notably less for tree T14 in particular. The initial buttress and anchorage roots are also damaged by the parking of cars with little occluding growth occurring where damage has taken place likely due to the repeated action of this during term time. As with trees T9 - T11 there is inevitably damage in the form of compaction to the root system below ground level. These 3 trees are also rated as 'B.1' category (BS5837: 2012).

T14	Maple	12	260	N: 4 E: 3 S: 3 W:4	M	G	F	B.1	20 years +	Tree is structurally sound but is a smaller specimen than those surrounding. The base of the tree is surrounded by a gravel area for parking cars with some root damage evident. This tree has low vigour due to the proximity to the adjacent Willow and likely compaction / root severance from the installation of moped parking area directly adjacent. The crown of tree is generally structurally sound. Tree has smallest stem of avenue.	No action required at present	3.1
T15	Willow	13	890	N: 4 E: 5 S: 8 W:5	M	F	G	B.1	15-20 years	Tree is generally structurally sound at the base although there is increased there are significant ground works surrounding. The tree has a significant lean to the south with good compensating buttress roots. There is one main stem with a 1st lateral branch at a height of 2m from ground level. At the main crown break at a height of 4m from ground level 2 main stems originate. The western stem was previously crown reduced at 9m to reduce end weighting within upper crown. The eastern stem was previously reduced at 9-11m. The tree was last reduced 2 years ago to previous reduction points.	Crown reduce to previous reduction points retaining some of furnishing growth to balance. Crown thin 15% and remove any remaining deadwood. Crown lift & remove all epicormic growth to 5m	10.7

4.26 As applied for trees T9-T11 the same requirements will be necessary for trees T12-T15 also incorporating the parking spaces. This will likely require the implementation of level changes and therefore close adherence to an AMS will be required to ensure that this will not detrimentally impact both the health and structural integrity of the trees. The main factors requiring design solutions are as follows:

- Removal of existing driveway without damaging tree roots
- De-compaction of exposed ground within the RPA of trees by process of *Terraventing*
- Supplement of soil level where eroded within this area
- Implementation of a replacement driveway using a load bearing cellular membrane without affecting current levels
- Use of a porous infill aggregate allowing for filtration of water and oxygen into the soil
- Implementation of related landscape works without level changes of soil within RPA

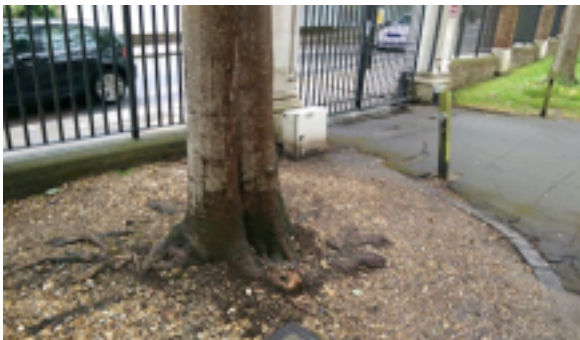
C.7 Photograph of tree T9, located on the boundary with Frognal, Senior Branch, University College School, as viewed in a westerly direction

4.20 Trees T9 - T11 are 3 further Silver Maple trees which are currently sited within an area which comprises compacted gravel / beach shingle at ground level on the western boundary with Frognaal. All 3 trees are generally structurally sound and have minor defects only. The initial buttress and anchorage roots are however damaged by the parking of cars with little occluding growth occurring where damage has taken place likely due to the repeated action of this during term time. Clearly there is damage below ground level in the form of a compacted root system which is reflected in the slightly sparser crown density of trees in this area. The trees grow collaboratively both in this area and with the overall formal planting despite the dissection of this area with a hard landscape vehicular and pedestrian entrance / exit. Tree T9 is the broadest tree of the 13 specimens but still sits well within the grouping. These 3 trees are also rated as 'B.1' category (BS5837: 2012).

T9	Maple	13	410	N: 5 E: 5 S: 4 W:5	M	G	G	B.1	20 years +	Tree is generally structurally sound. Main stem has some damage at 1.0m on western side. Main union for crown break at 3m. The base of the tree is currently surrounded by the gravel area for parking cars. Many roots within a 1.5m radius of the tree are exposed and damaged. Crown of tree is broad and spreading comparatively to others in avenue.	No action required at present	4.9
T10	Maple	15	390	N: 4 E: 4 S: 4 W:5	M	G	G	B.1	20 years +	Tree leans slightly to the south being slightly unbalanced in this direction. Main unions at 3-6m generally sound. The base of the tree is surrounded by a gravel area for parking cars w/ many roots within a 1.5m radius of the tree are exposed and have been damaged.	No action required at present	4.7

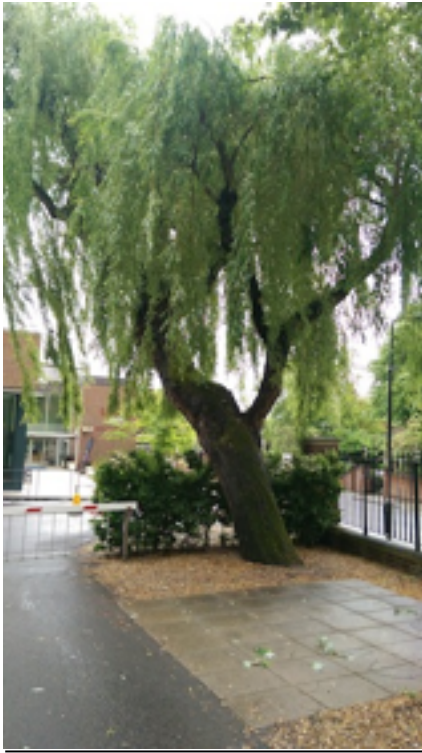
C.9 Photograph of tree T15, as viewed in a westerly direction

4.25 Tree T15 is a mature Weeping Willow tree (*Salix babylonica*) which is growing at the southern point of this boundary line prior to the main access. The tree clearly has a significant history with storm damage points throughout as highlighted within the tree survey notes and a comprehensive pruning history. The tree leans heavily to the south over the main entrance area with the crown cyclically reduced to manage its over-extended form to the south. The tree does have a relatively limited lifespan taking account age, location and species, and should be monitored annually and/or after extreme weather circumstances. This tree is rated as a 'B.1' category (BS5837: 2012) specimen with its reduced stance limitin the amenity value and form of the tree.
