THE COCK TAVERN, 23 PHOENIX ROAD, LONDON,  
NW1 1HB

WINDOW CONDITION SURVEY REV A

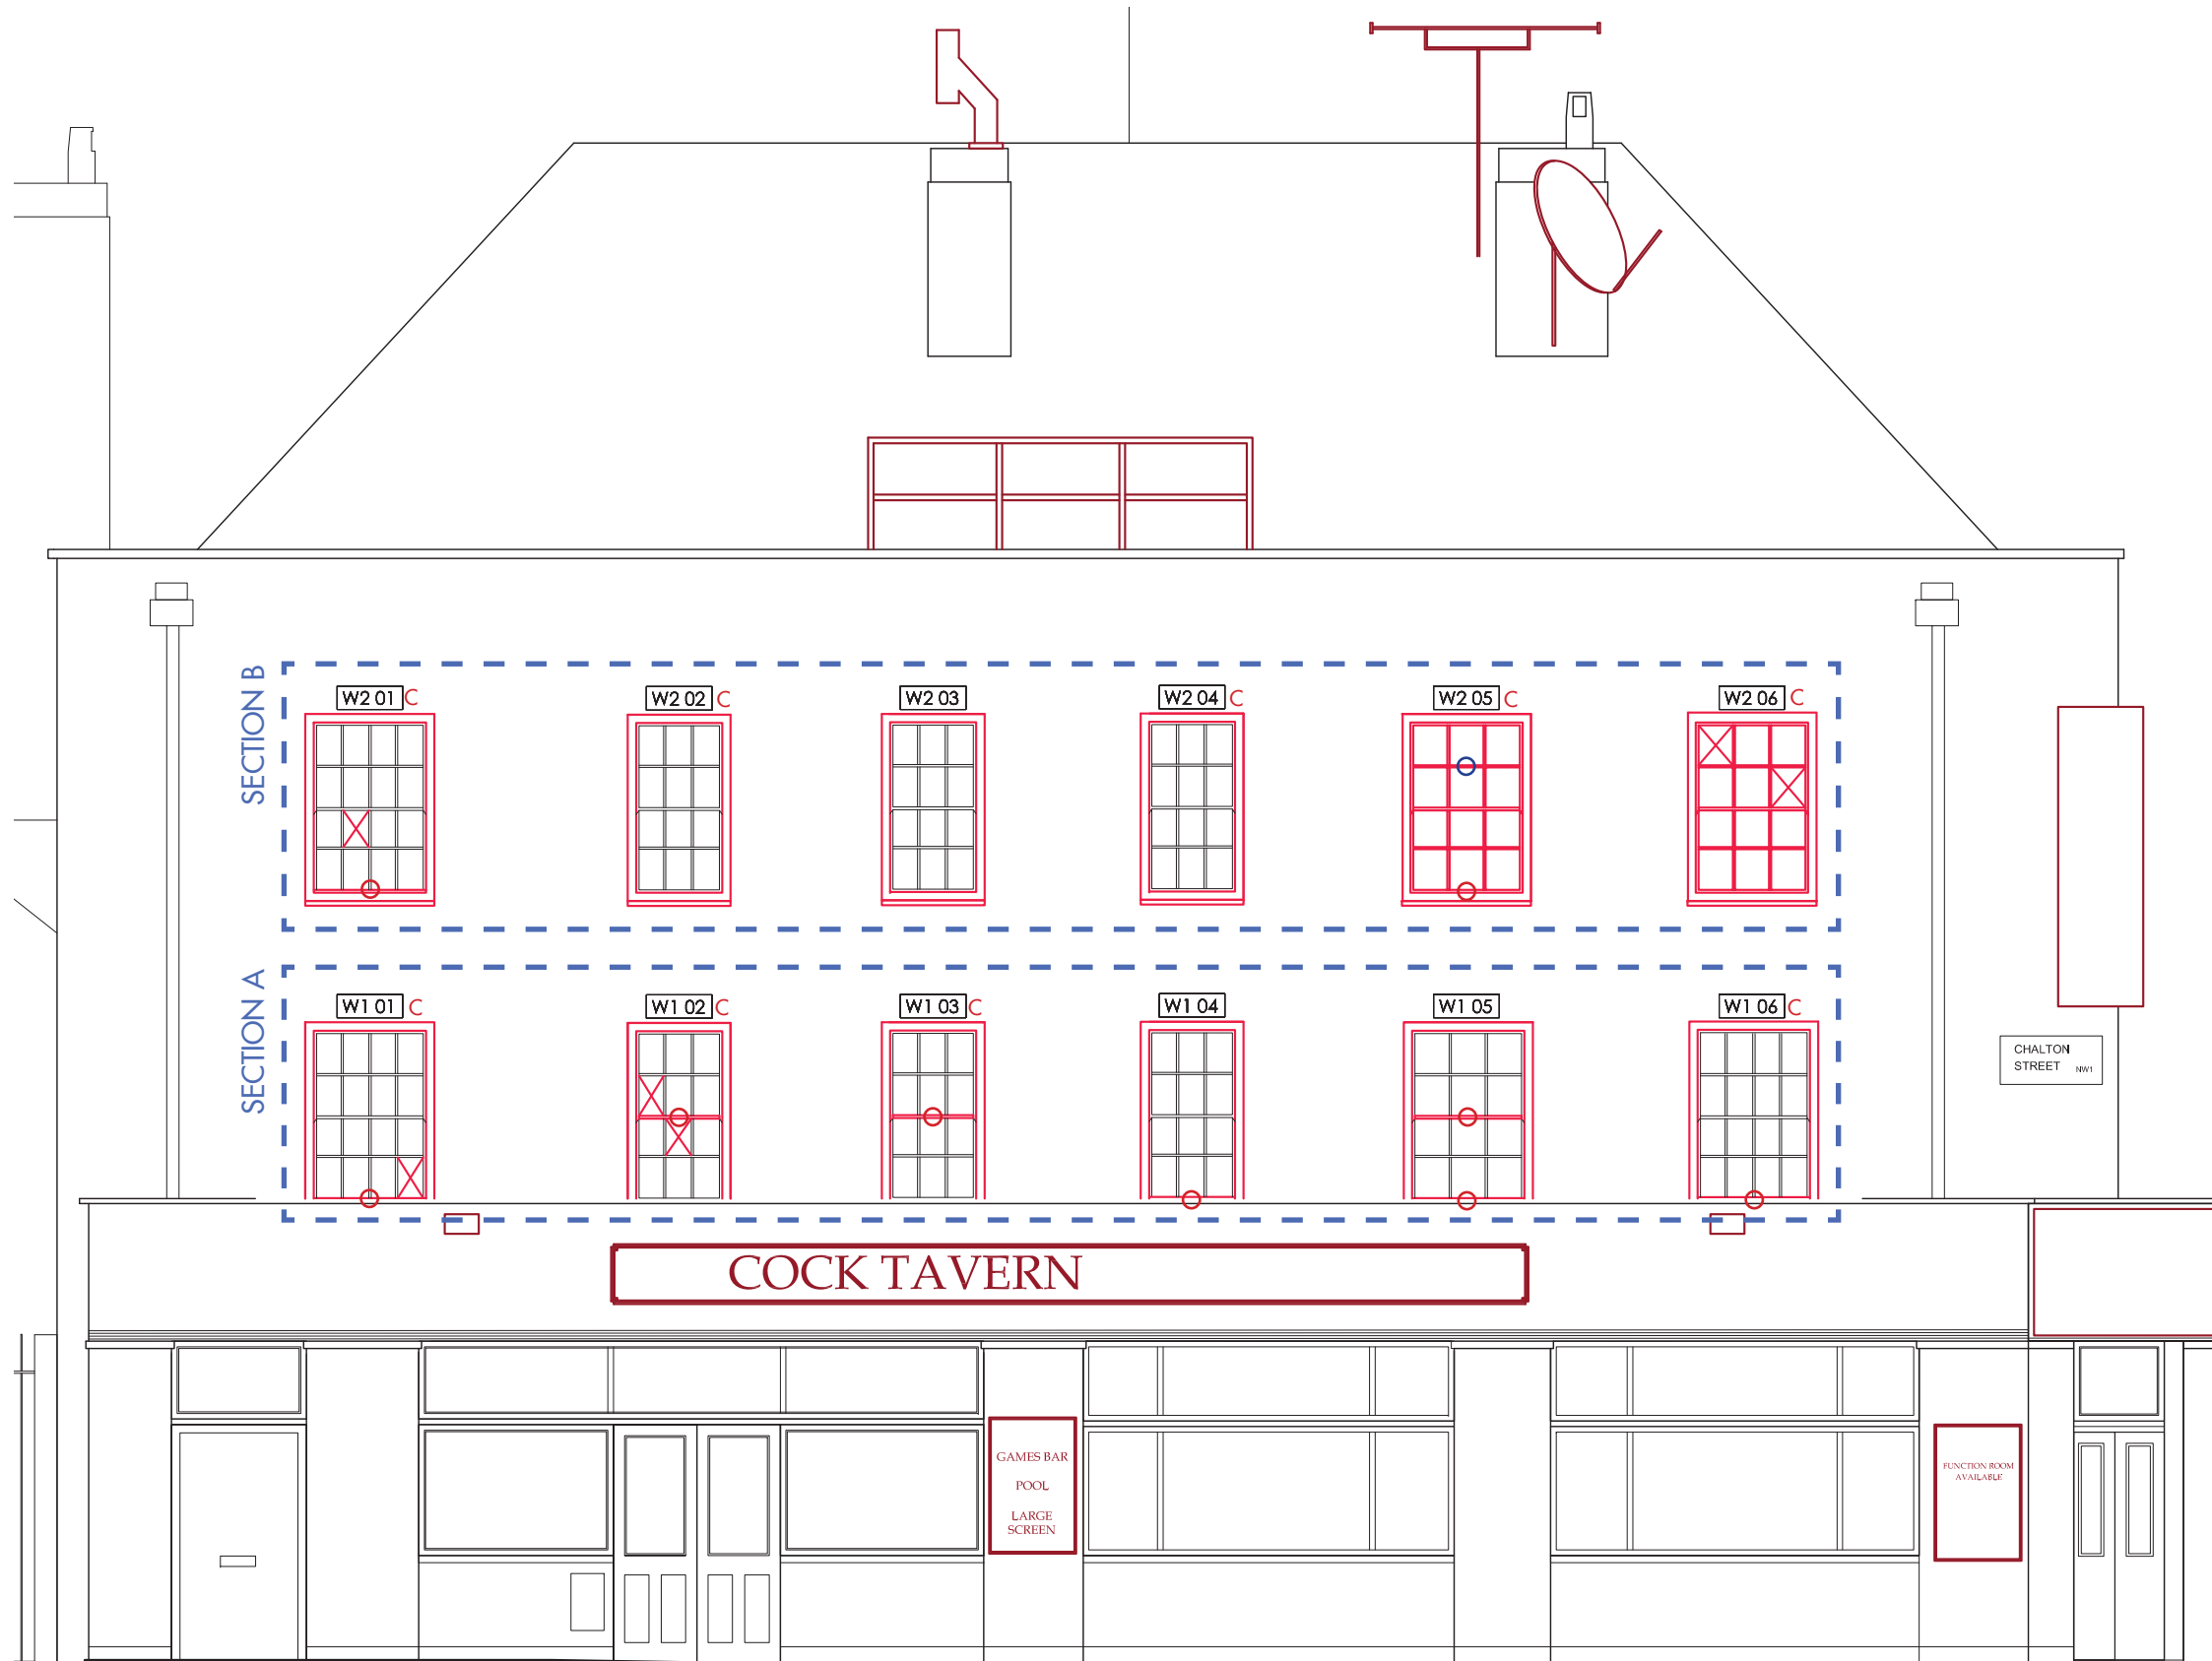
## 1.0 SOUTH WEST ELEVATION

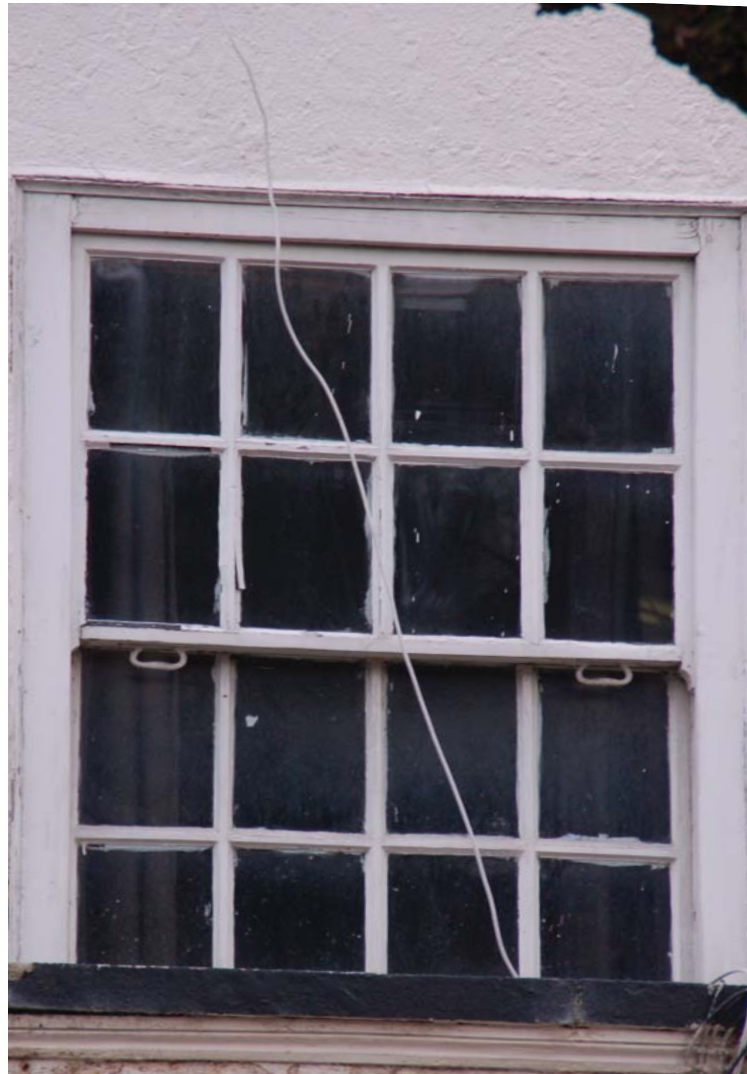
W1 01  
Rotten cill, beyond repair. Damaged runners and window lock. External sash handles need re-fitting. External box severely damaged beyond repair. Glazed window light broken.

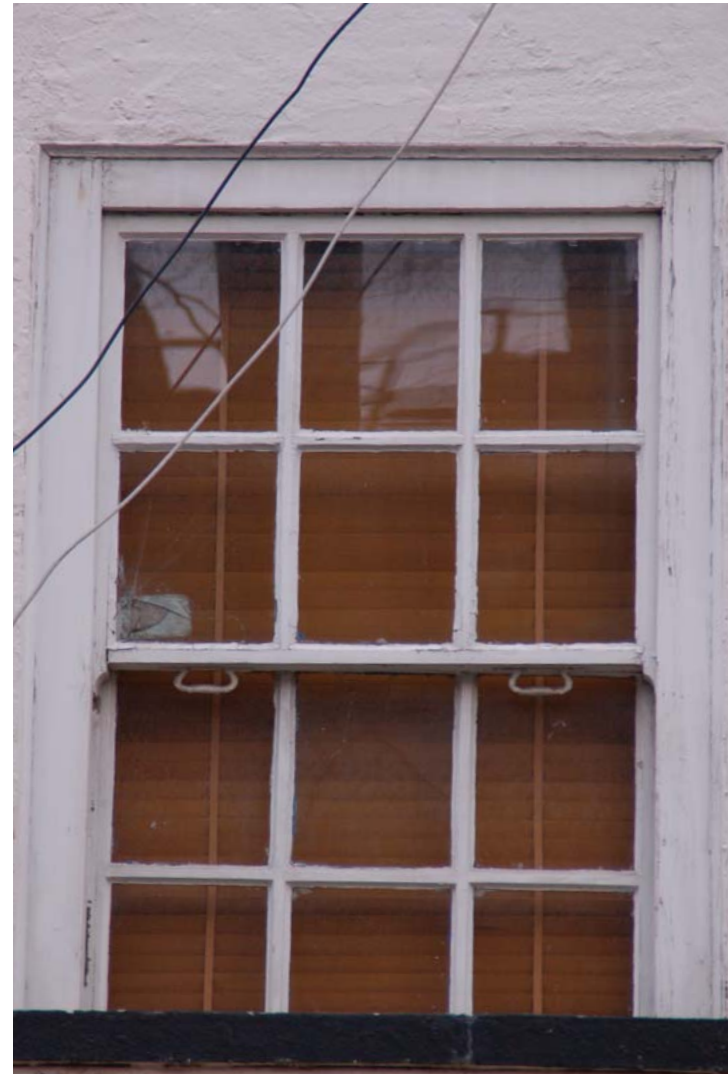
W1 02  
Rotten cill, beyond repair. Damaged runners and window lock. External sash handles need re-fitting. Bottom rail to top sash rotten. External box severely damaged beyond repair. Glazed window light broken.

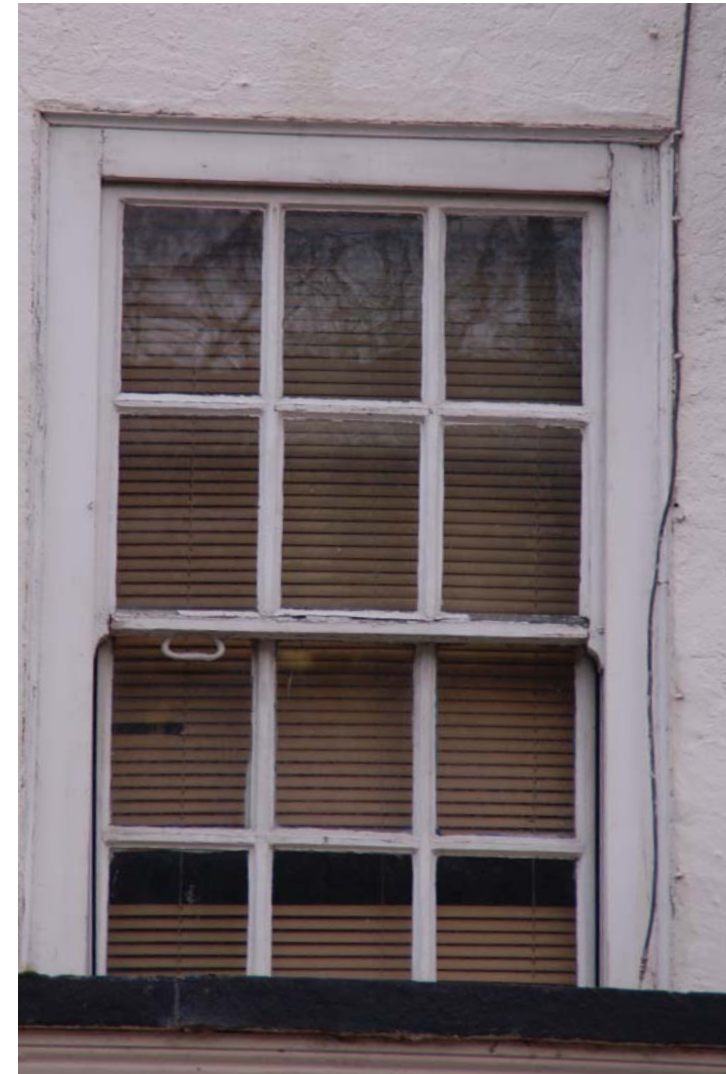
W1 03  
Rotten cill, beyond repair. Bottom rail to top sash rotten. Damaged runners and window lock. External sash handles need re-fitting. External box severely damaged beyond repair.

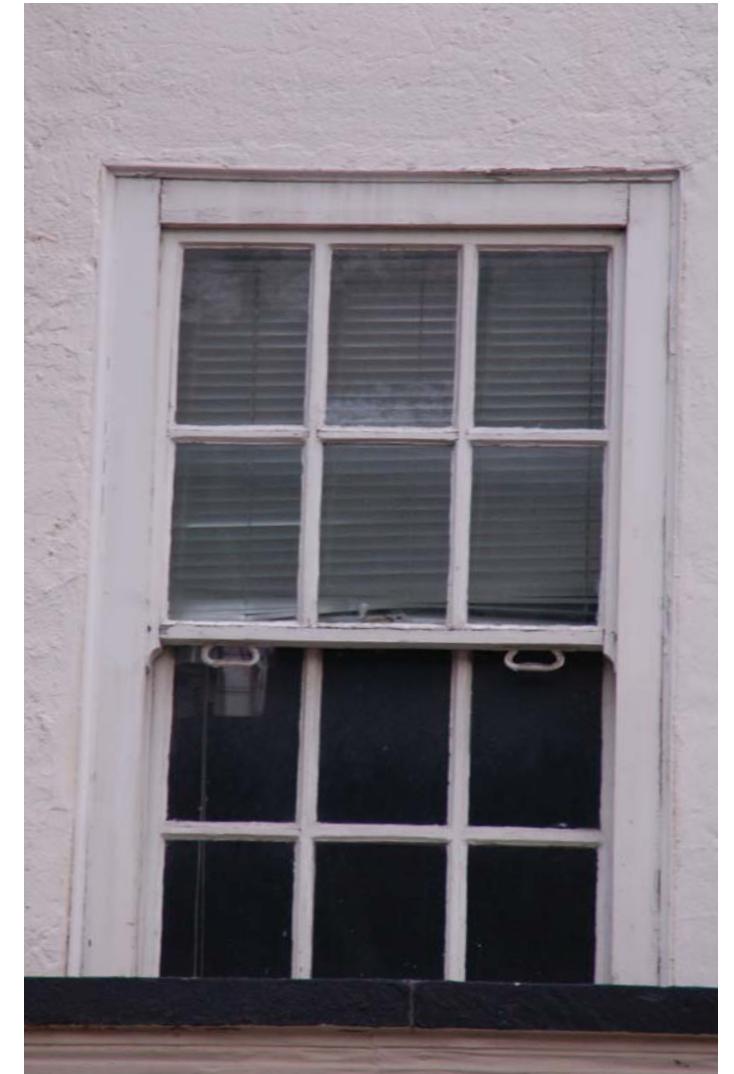
W1 04  
Rotten cill, beyond repair. Damaged runners. Bottom rail to bottom sash rotten. Rope for pulley damaged and window requires re-weighting (see fig. 1). External sash handles need re-fitting. External box severely damaged beyond repair.

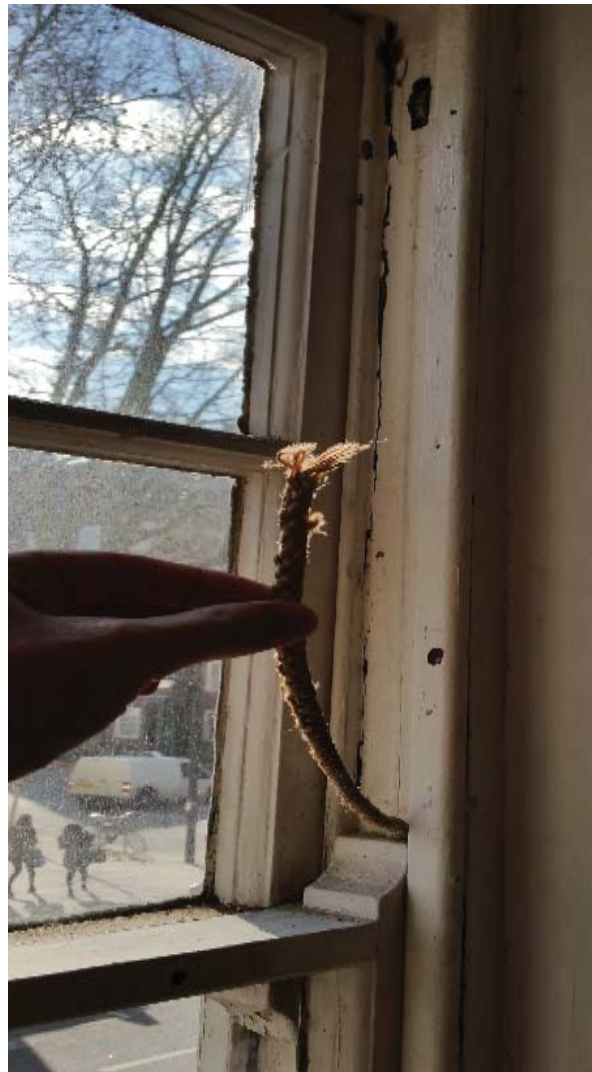
fig. 1 - Rope for window's counter weight system torn.

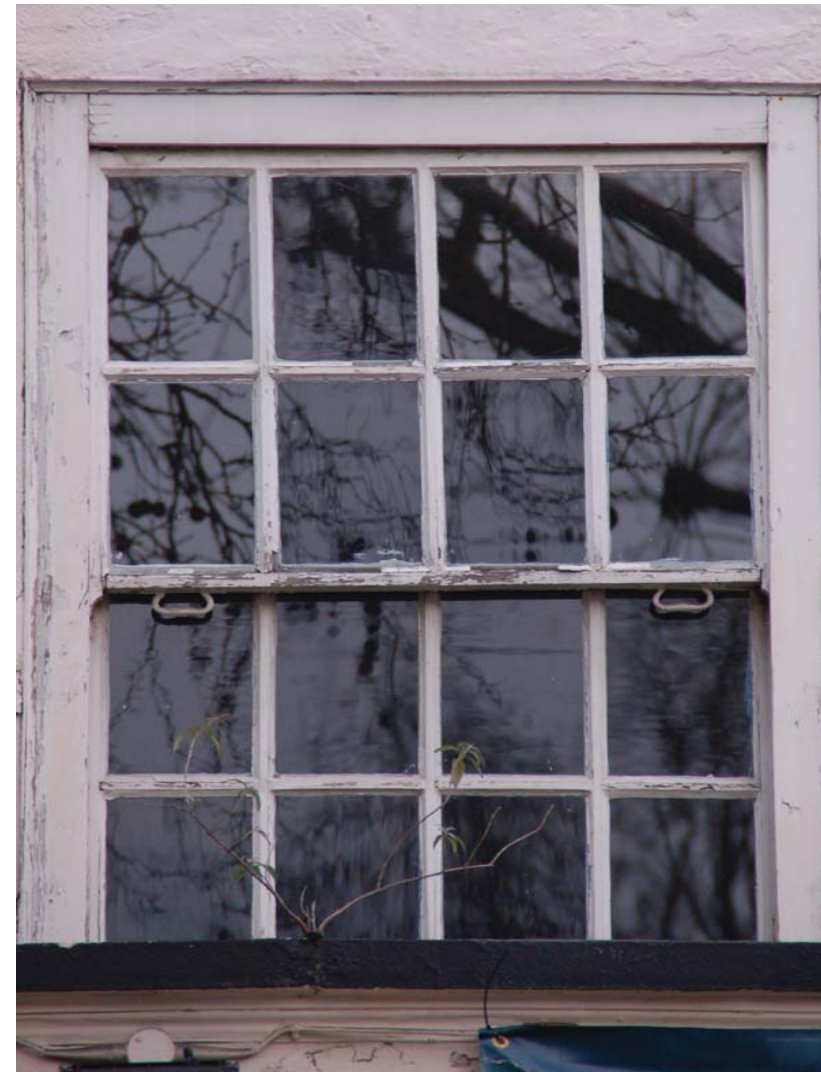
Rotten cill, beyond repair. Damaged runners and window lock. External sash handles need re-fitting. Bottom rail to top sash rotten. External box severely damaged beyond repair.

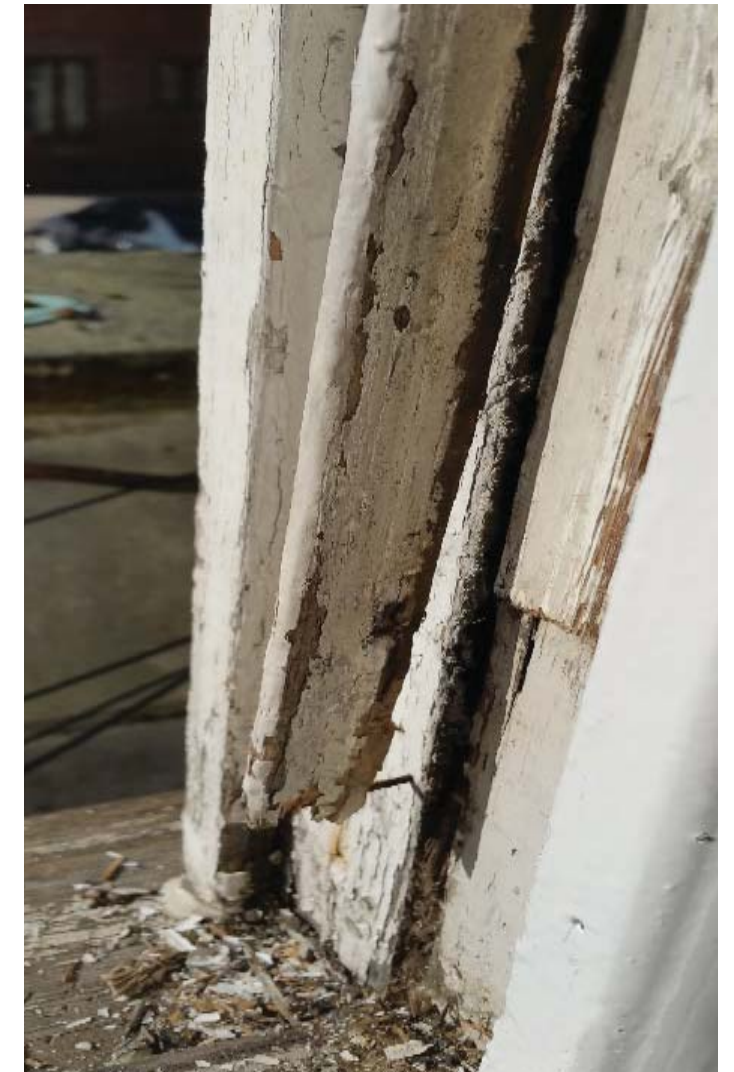
fig. 2 - Rotten box, runner and cill which are beyond repair

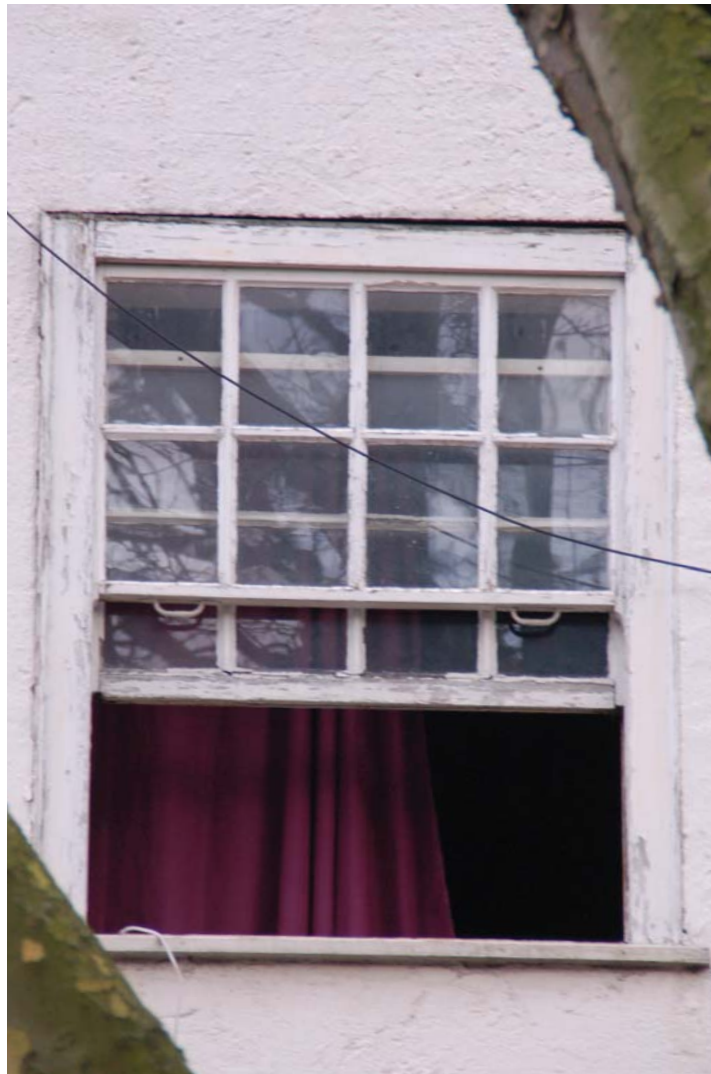
W2 01  
Rotten cill, beyond repair. Damaged runners and window lock, replacements required. Bottom rail to bottom sash rotten. External sash handles need re-fitting. External box severely damaged beyond repair.

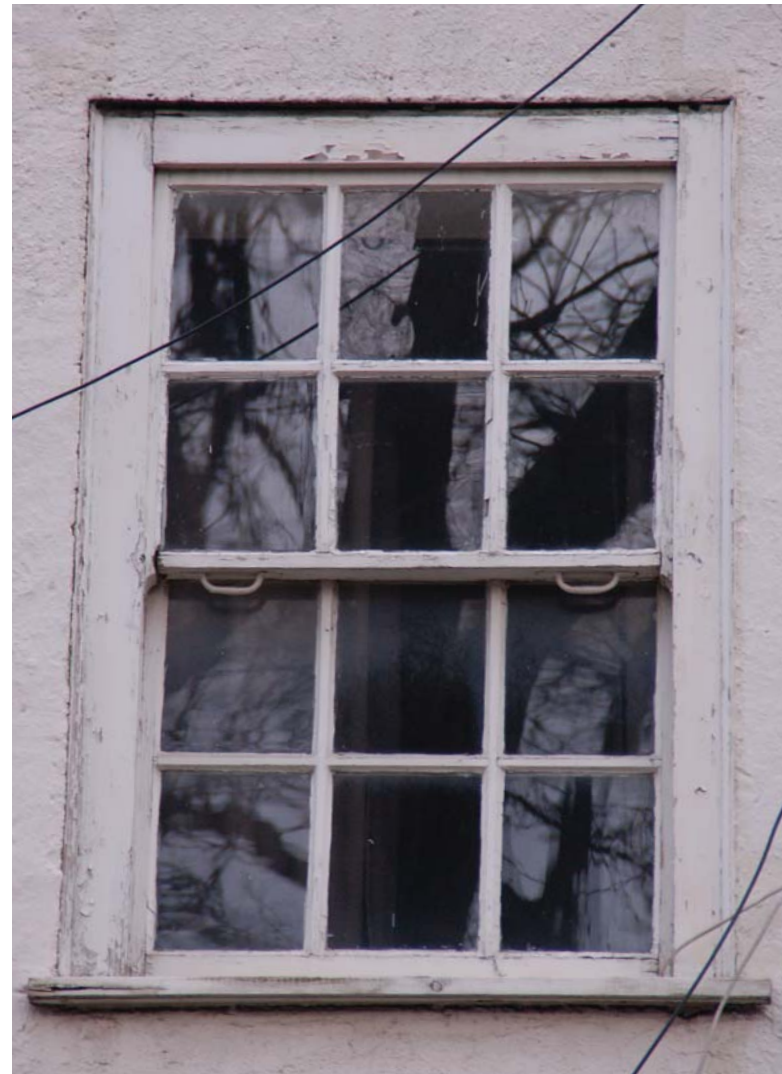
W2 02  
Rotten cill, beyond repair. Damaged runners and window lock. External sash handles need re-fitting. External box severely damaged beyond repair.

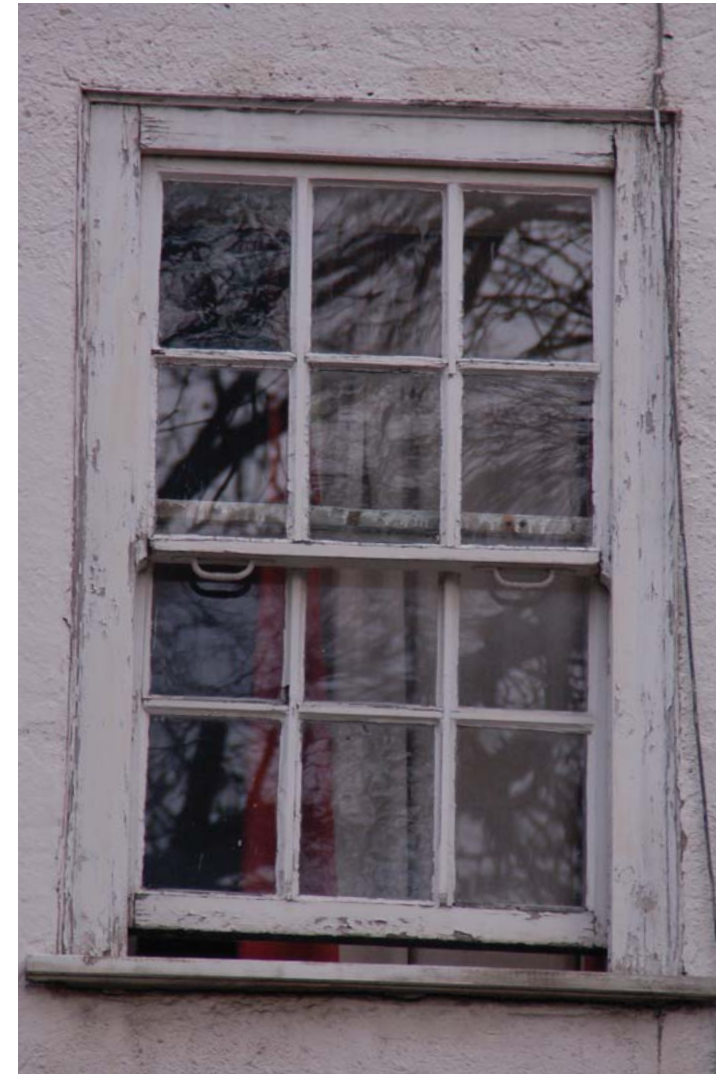
W2 03  
Rotten cill, beyond repair. Damaged runners. External sash handles need re-fitting. External box severely damaged beyond repair.

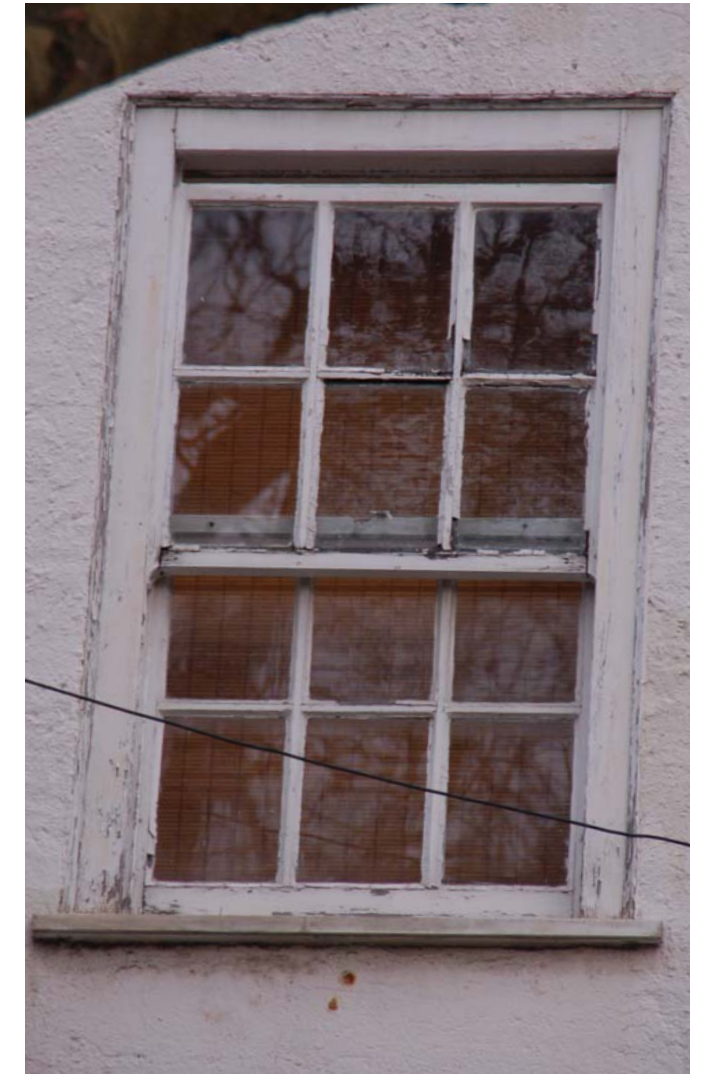
W2 04  
Rotten cill, beyond repair. Damaged runners and window lock. External box severely damaged beyond repair.

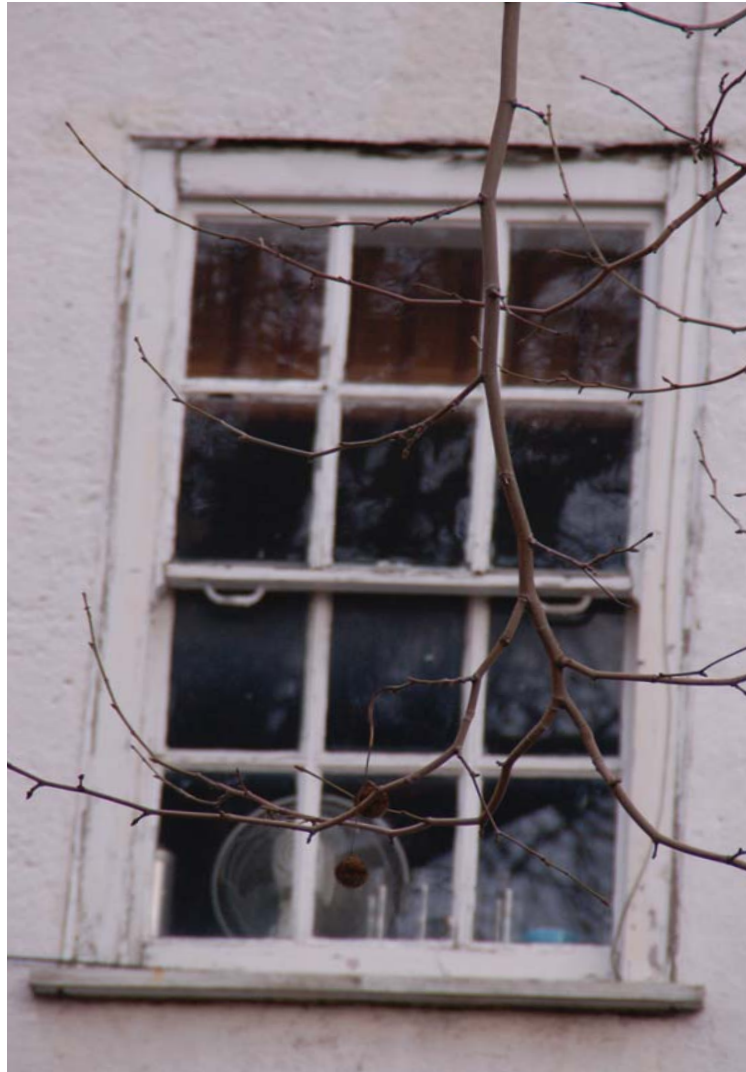
1.2 SOUTH WEST ELEVATION  
SECTION 'B'

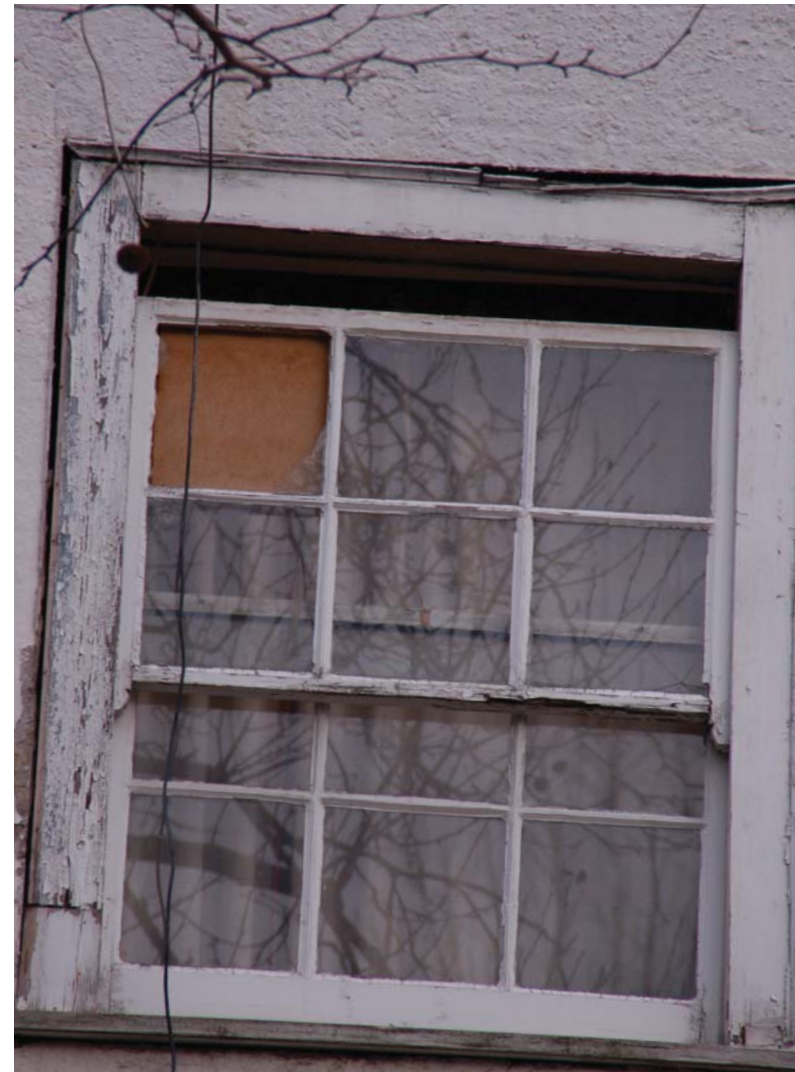
Rotten cill, beyond repair. Damaged runners and window lock. External sash handles need re-fitting. Bite to centre mullion on upper sash. Bottom rail to bottom sash rotten. External box severely damaged beyond repair.

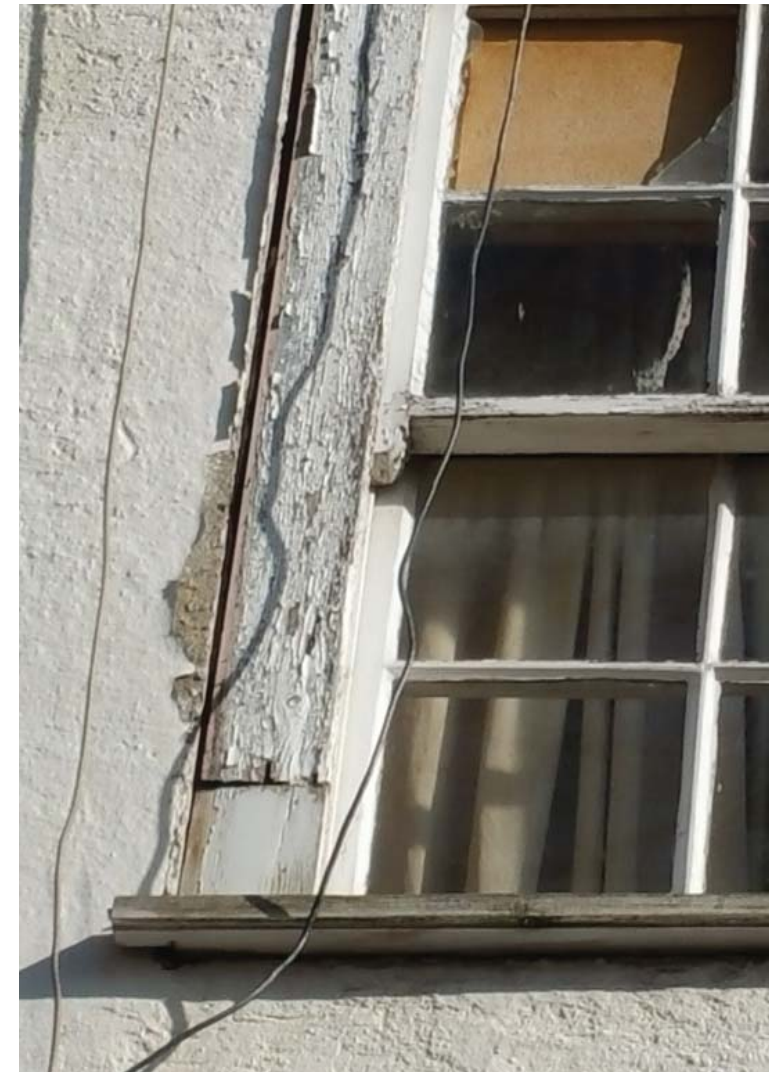
fig. 3 - Shattered glass panel. Damaged frame, coming away from brickwork.

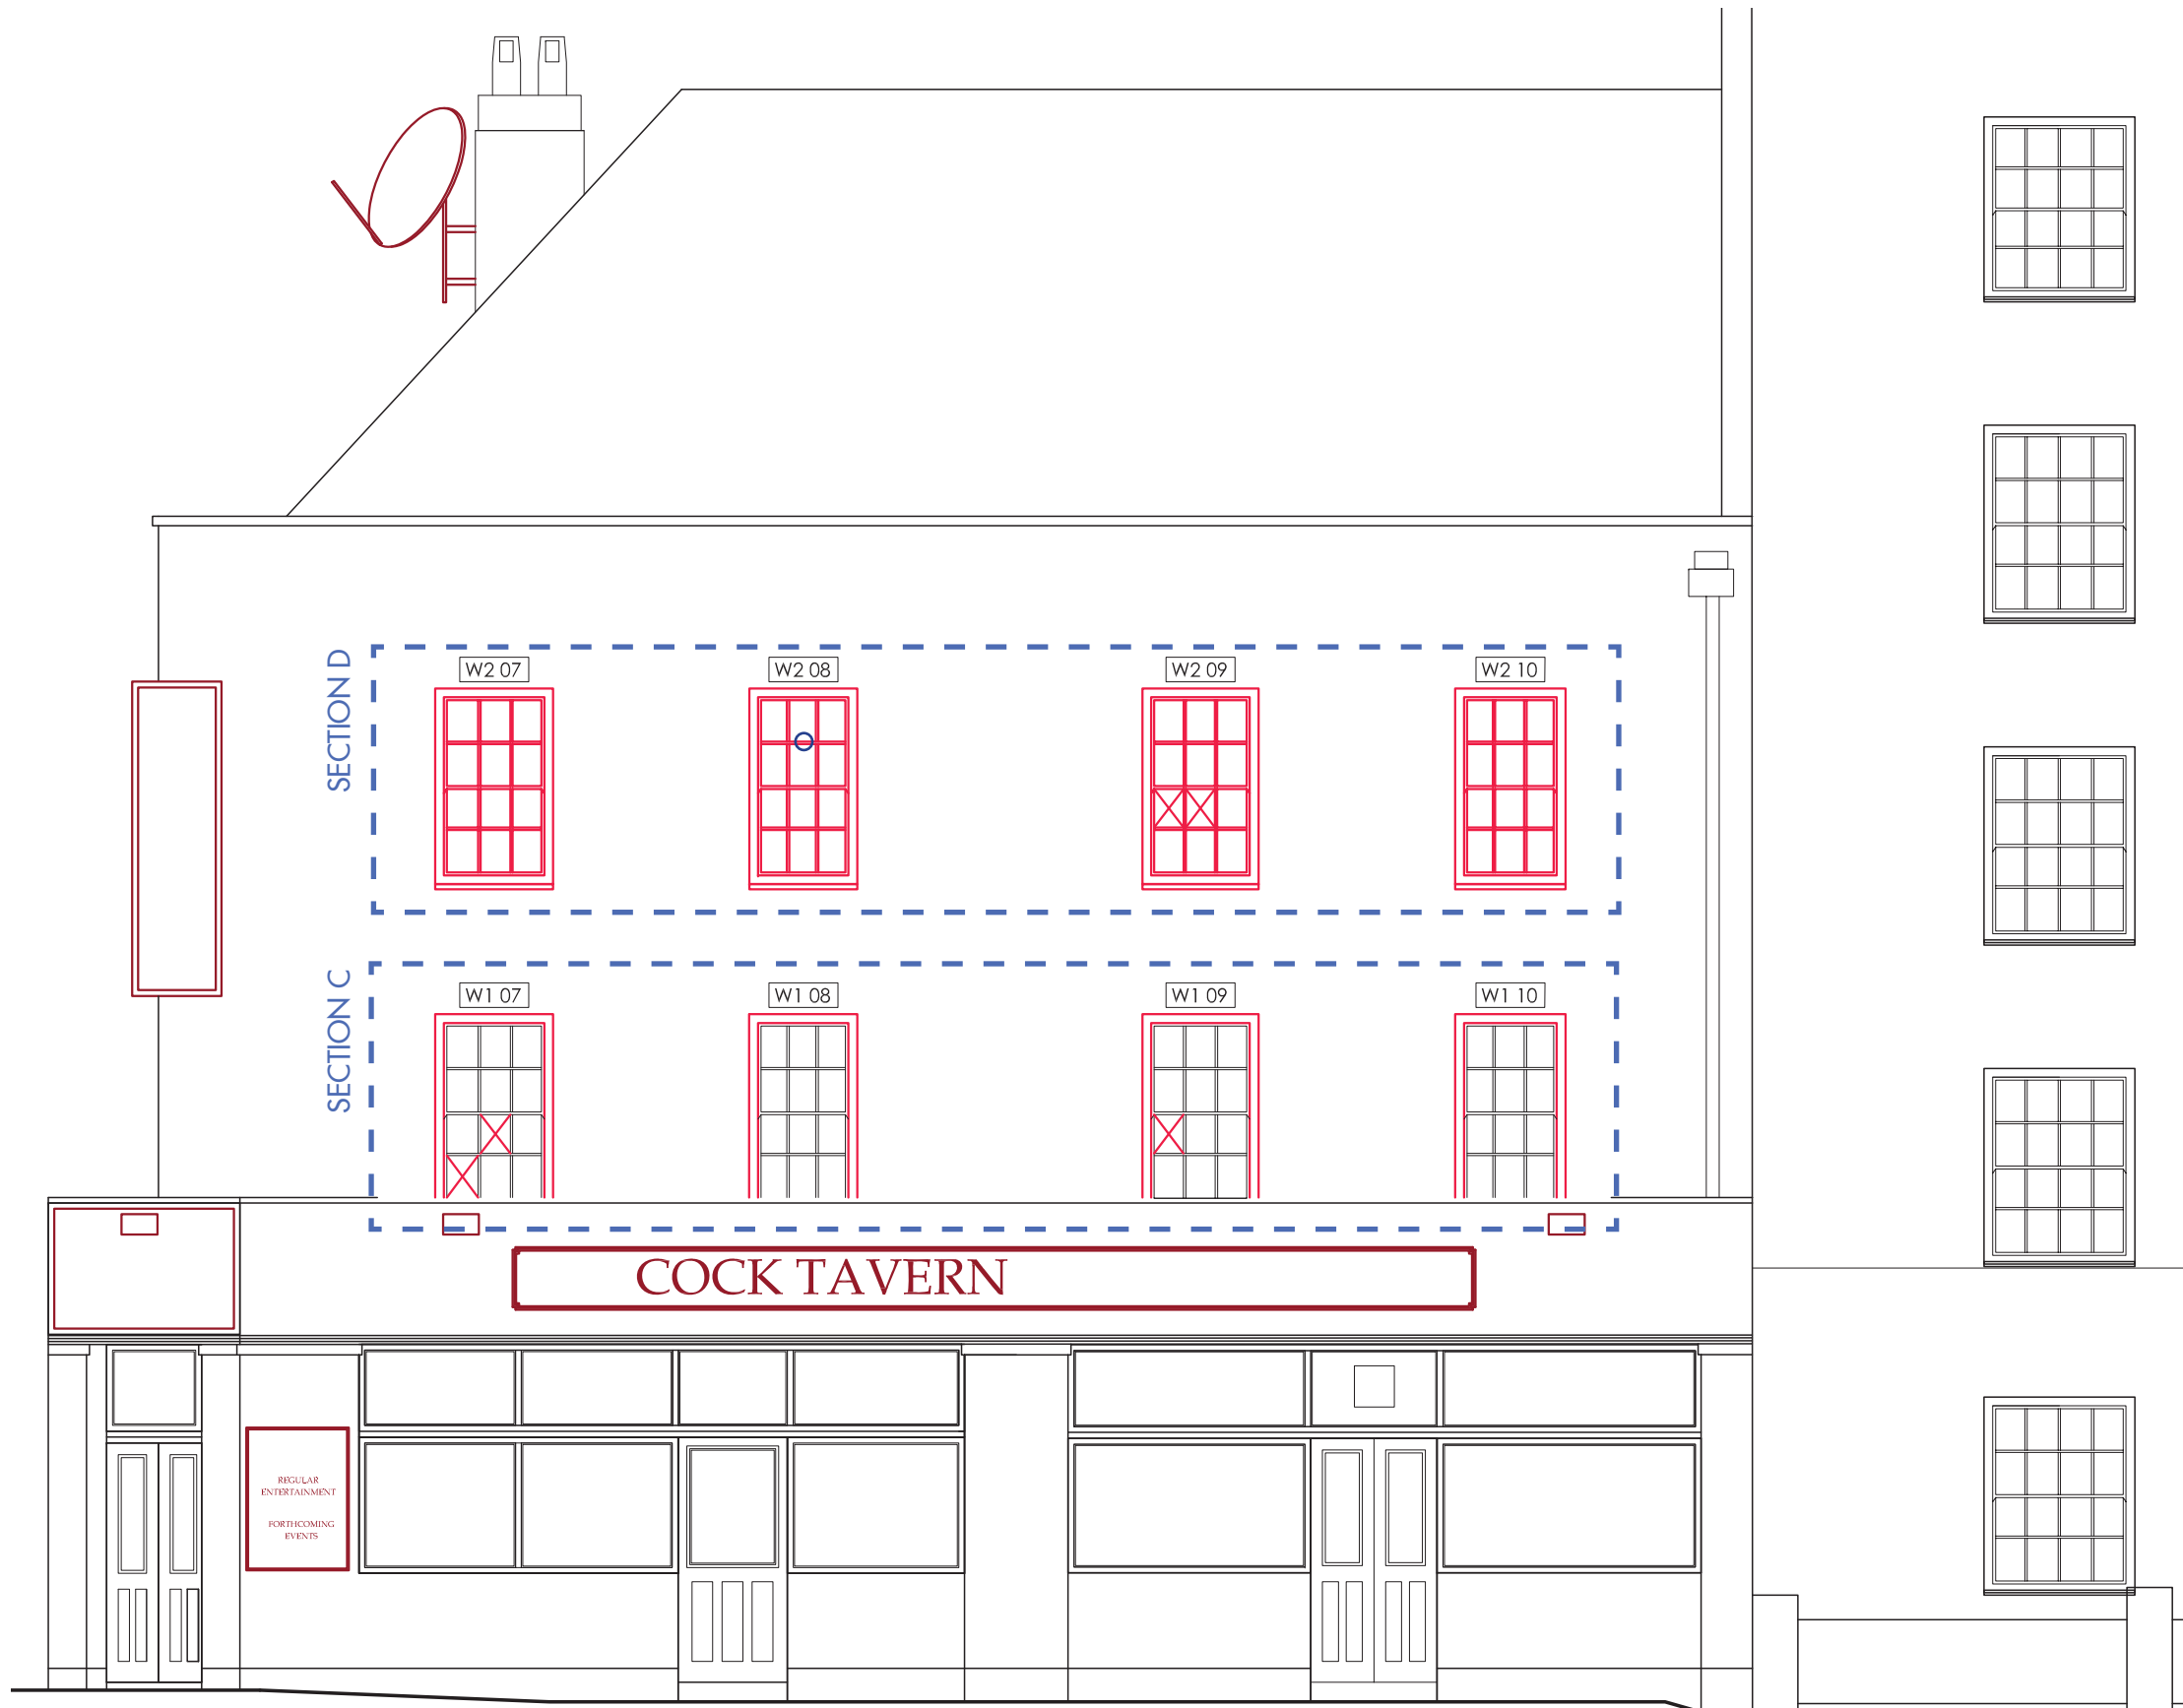
## 2.0 SOUTH EAST ELEVATION

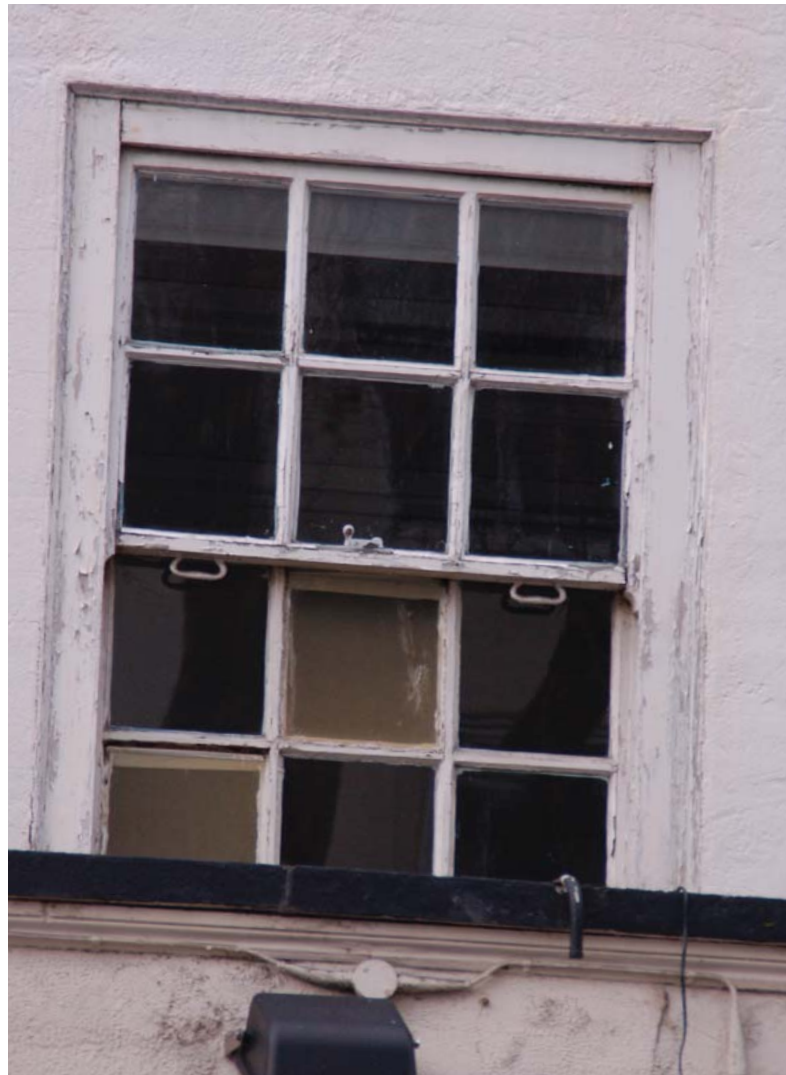
2.1 SOUTH EAST ELEVATION  
SECTION 'C'

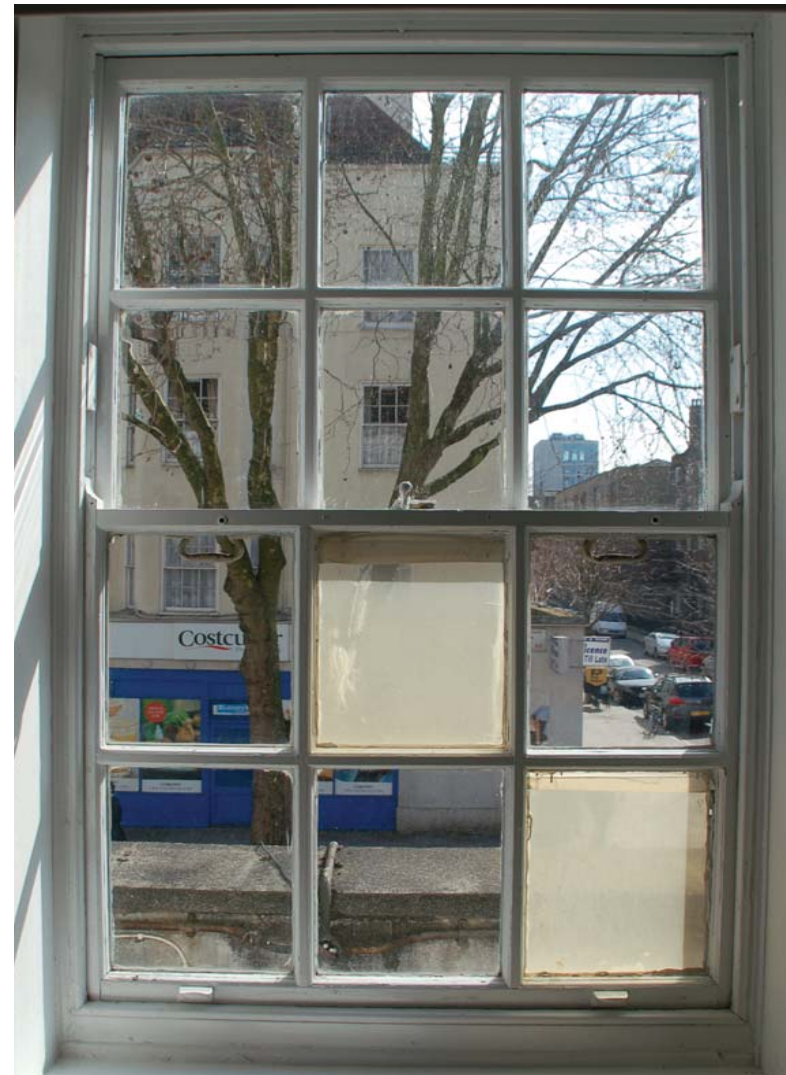
fig. 4 - Mismatching glass panels.

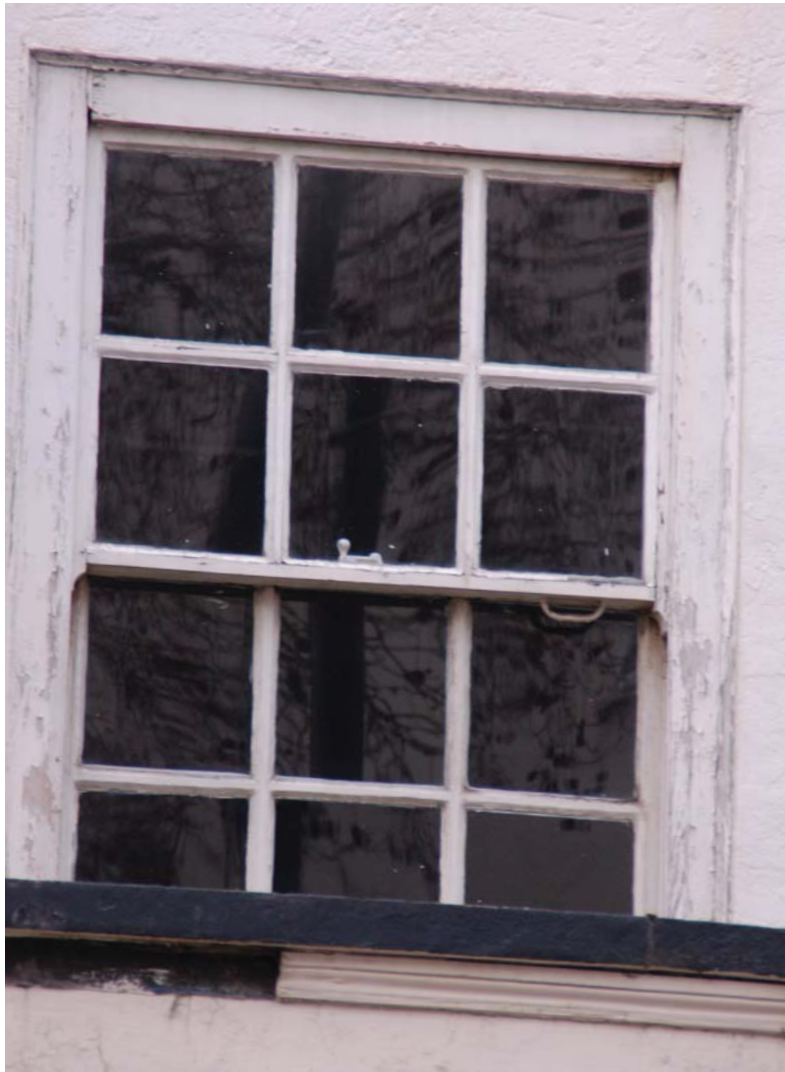
2.1 SOUTH EAST ELEVATION  
SECTION 'C'

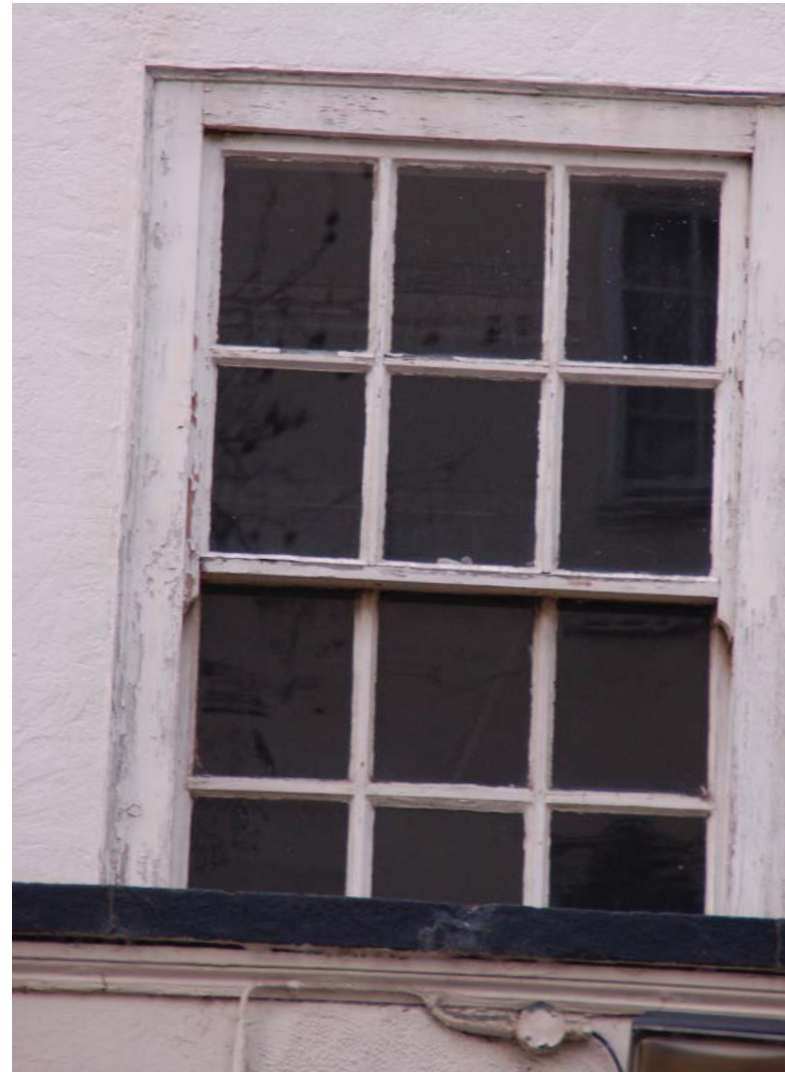
Rotten cill, beyond repair. Damaged runners. Rope for pulley damaged and window requires re-weighting. External sash handles need re-fitting. External box severely damaged beyond repair.
