THE COCK TAVERN, 23 PHOENIX ROAD, LONDON,  
NW1 1HB

WINDOW CONDITION SURVEY REV A

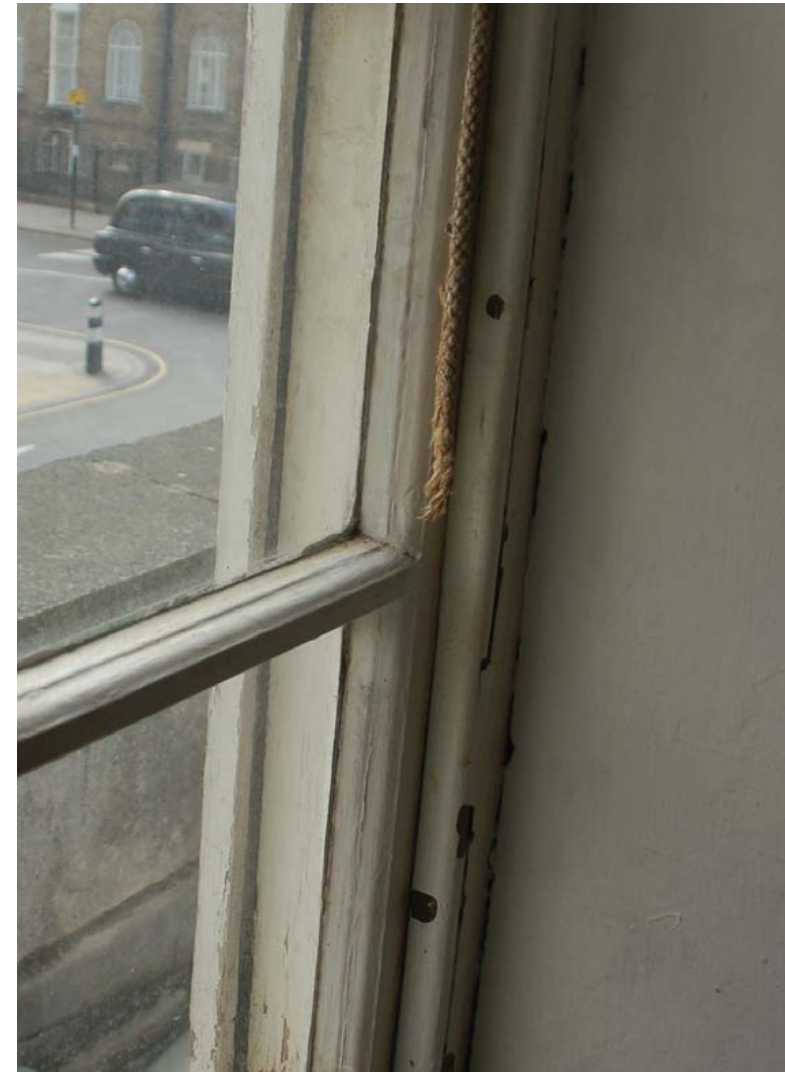
fig. 5 - Broken counter-weight rope.

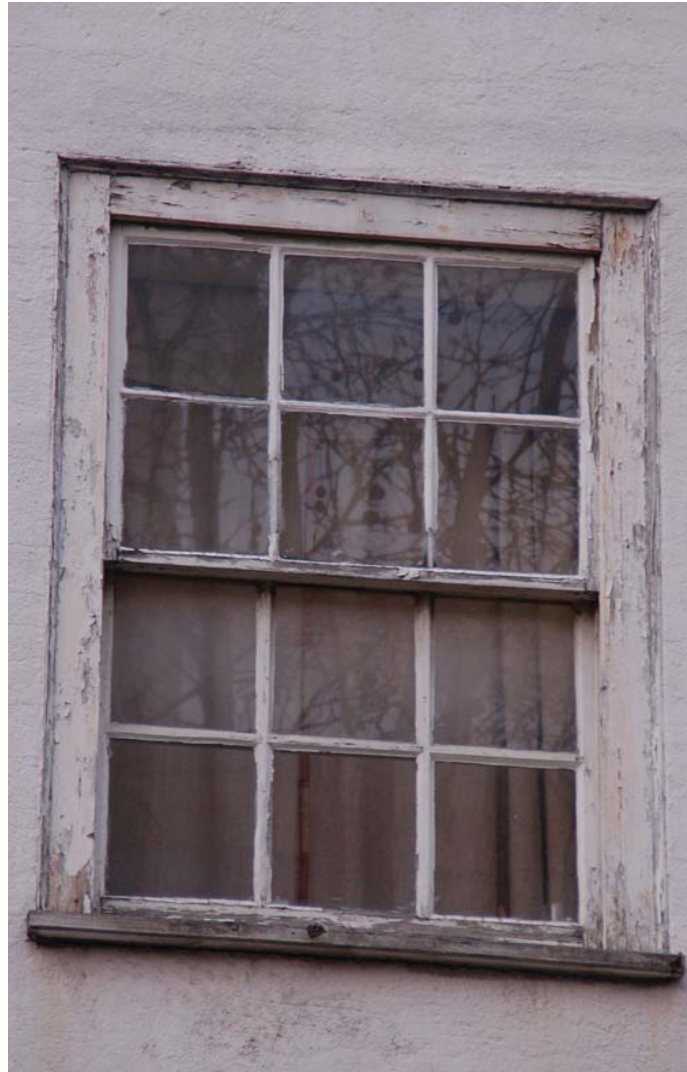
2.2 SOUTH EAST ELEVATION  
SECTION 'D'

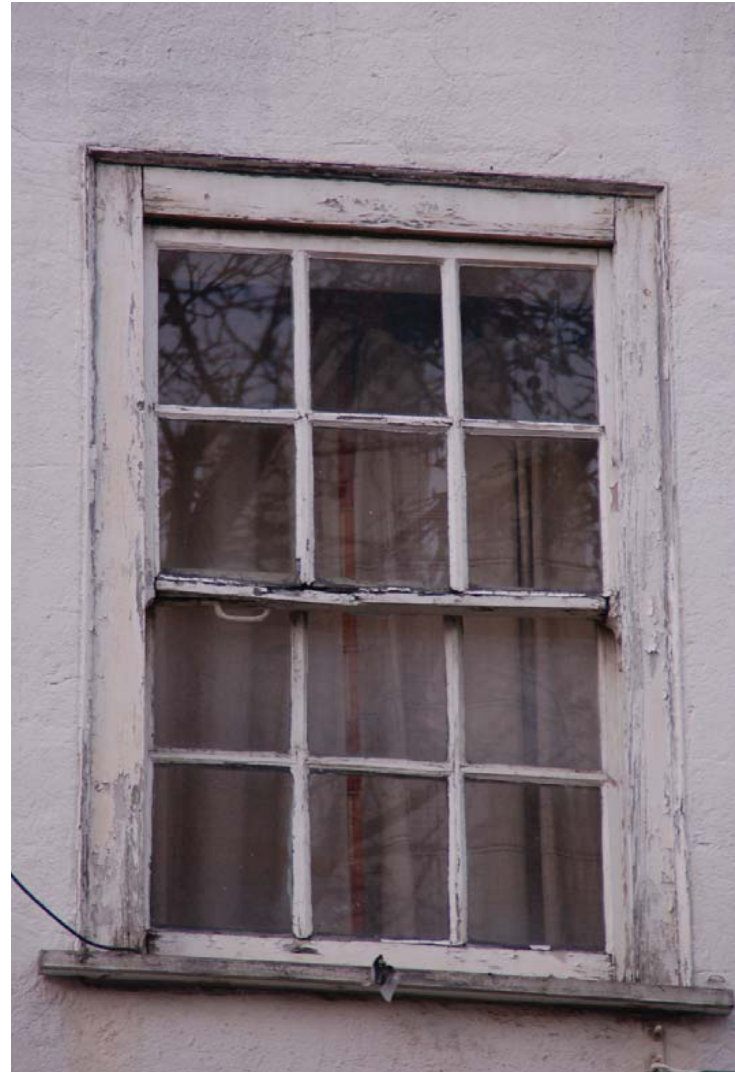
Rotten cill, beyond repair. Bottom rail to bottom sash rotten. Damaged runners and window lock. External sash handles need re-fitting. External box severely damaged beyond repair. Upper sash window has thinner mullions and does not match with other windows suggesting it is not original.

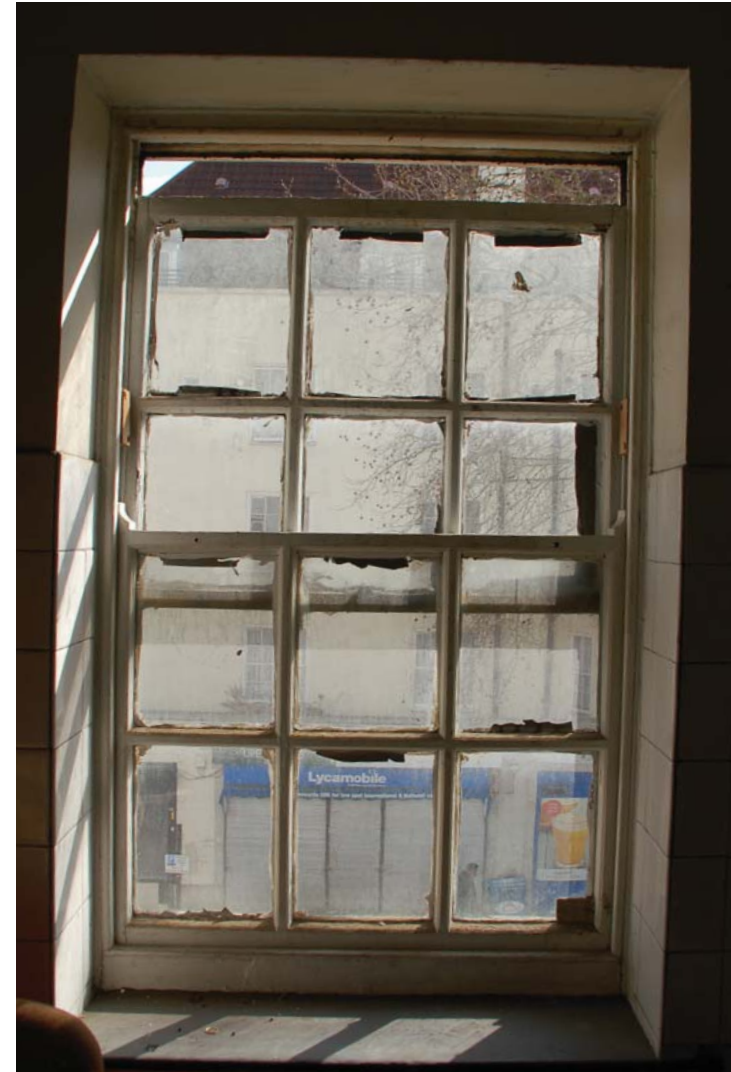
fig. 6 - Sash window interior condition. Damaged glass panels held in frame by old putty.

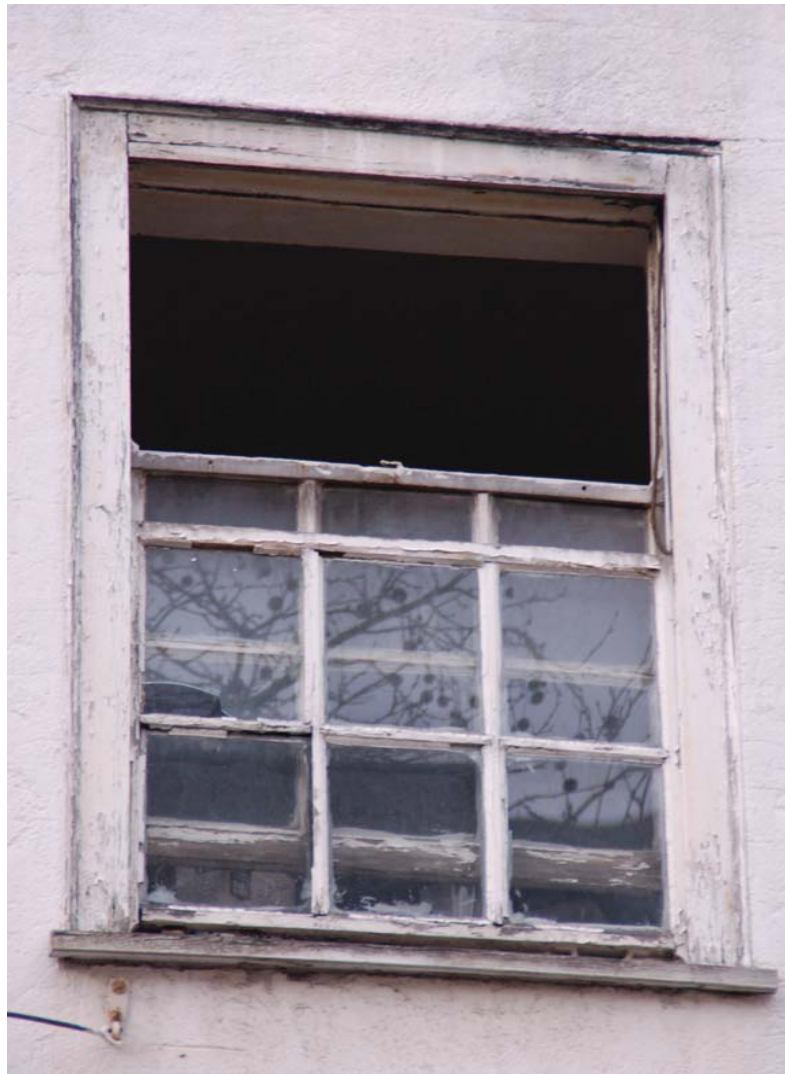
2.2 SOUTH EAST ELEVATION  
SECTION 'D'

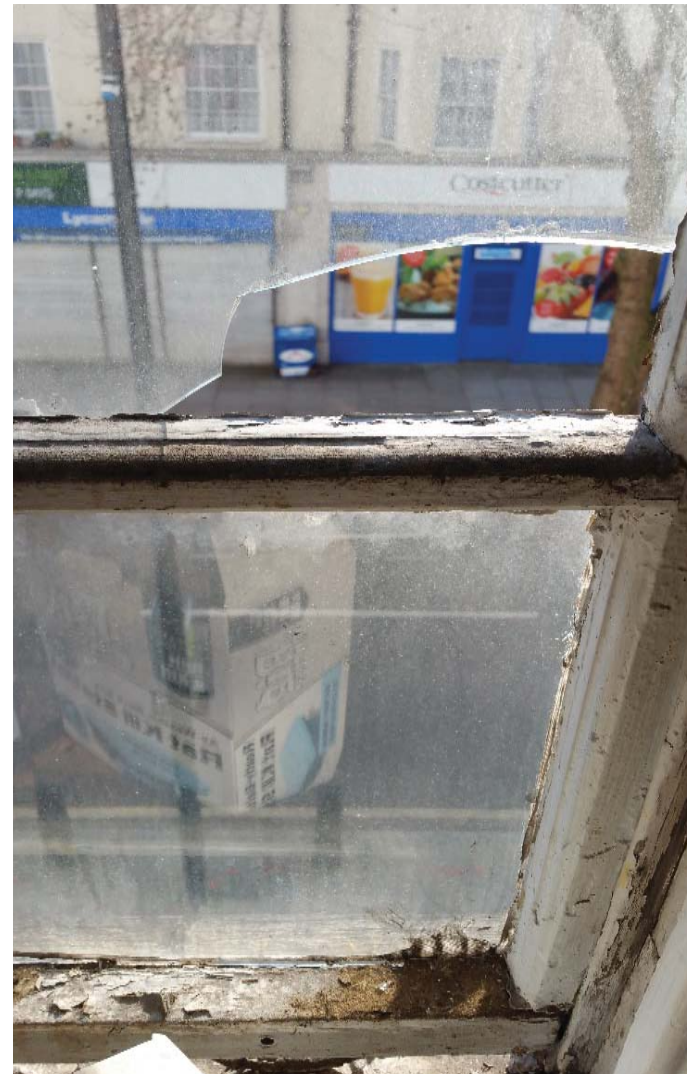
fig. 7 - Broken glass panel on lower sash.

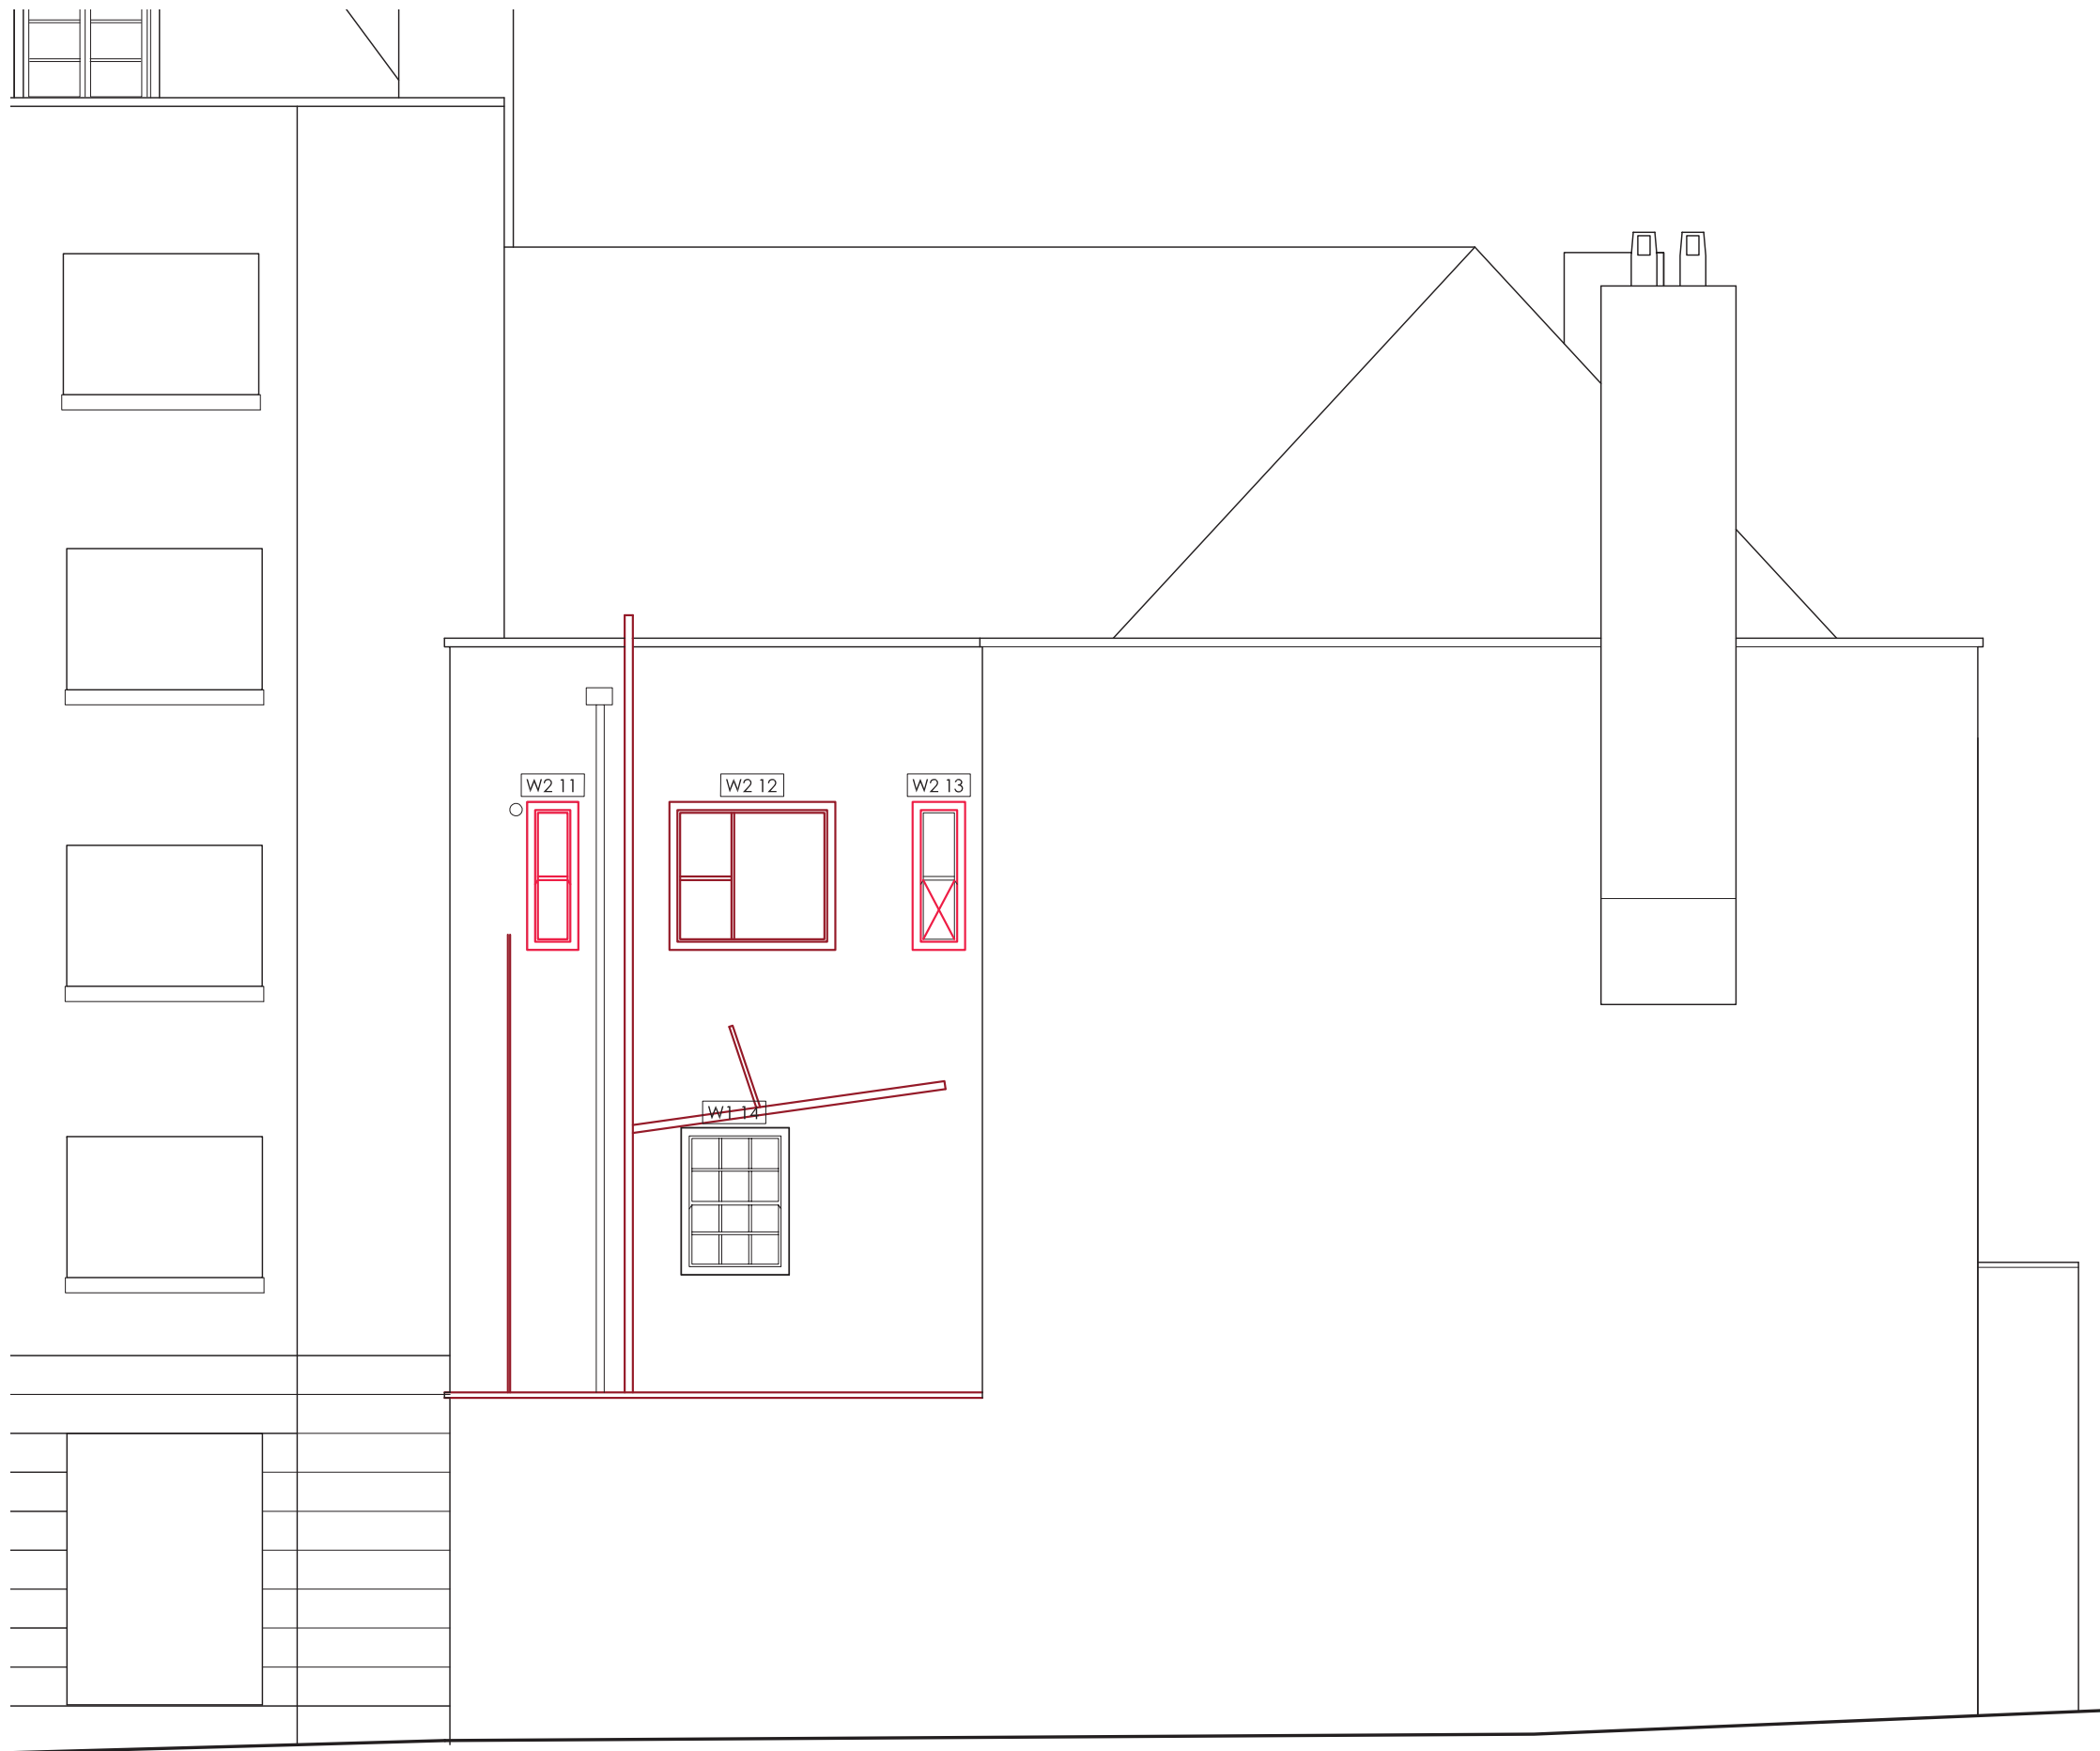
### 3.0 NORTH WEST ELEVATION

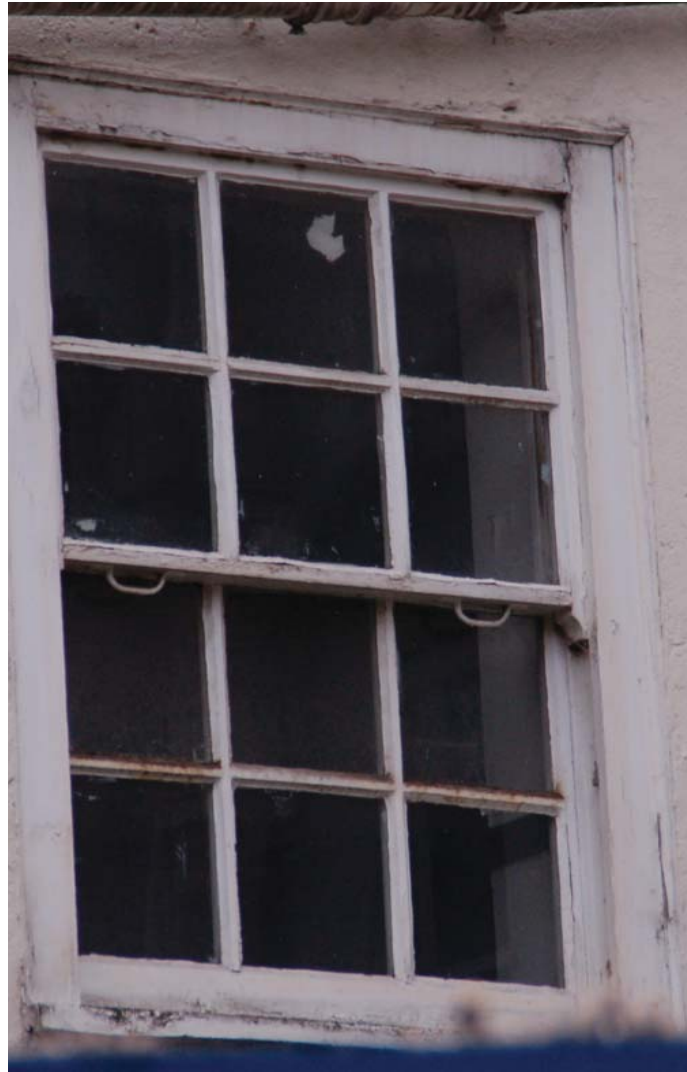
### 3.0 NORTH WEST ELEVATION

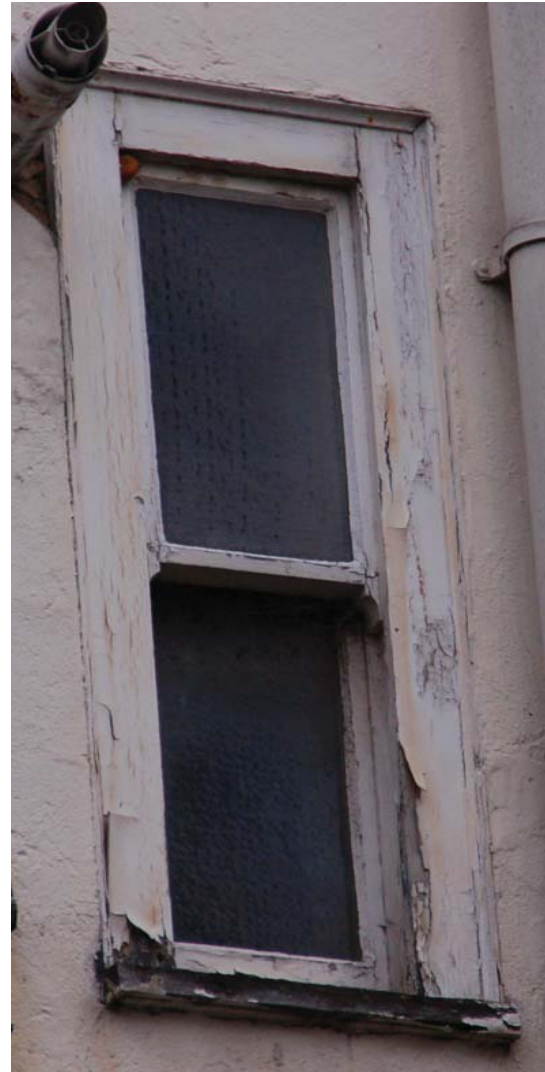
Rotten cill, beyond repair. Damaged runners and window lock. External sash handles need re-fitting. External box severely damaged beyond repair.

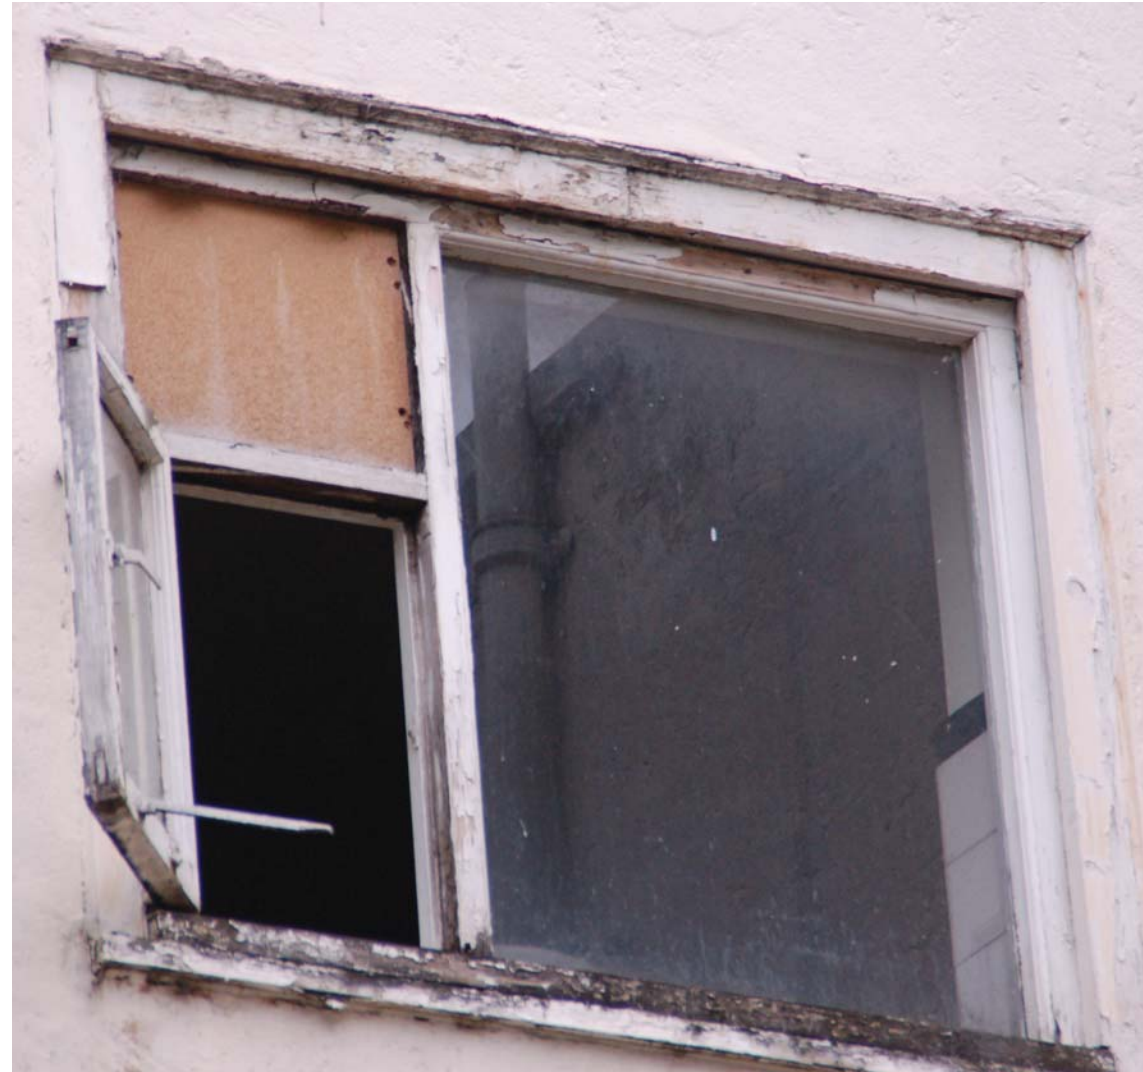
Rotten cill and frame, beyond repair. Damaged runners. Old, damaged putty holding glass panels in place. Top rail to top sash rotten, bottom rail to bottom sash rotten. External box severely damaged beyond repair.

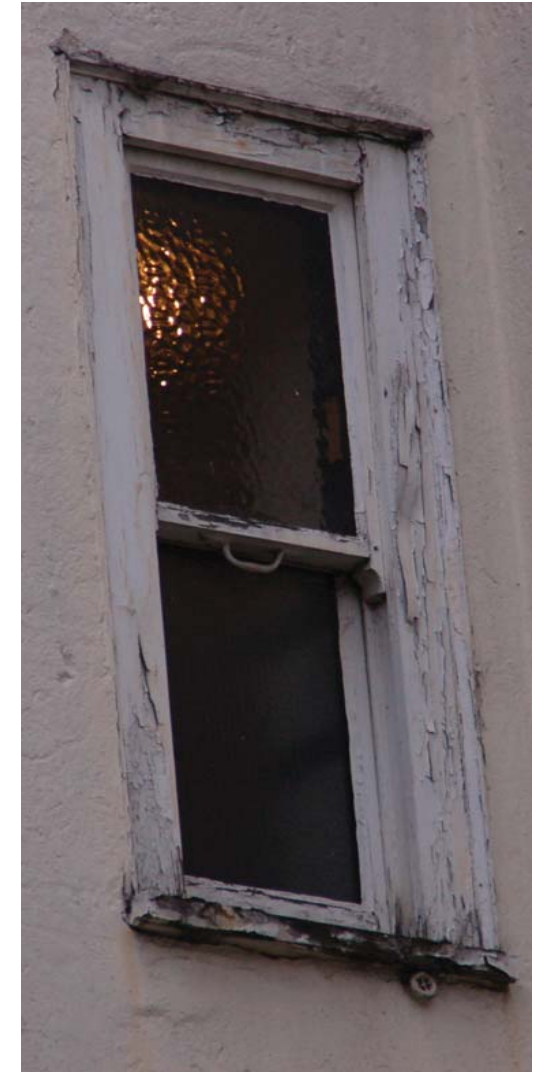
Non-original casement window to be demolished and replaced by new sash window. Broken and missing glass panel and rotten sill and frame. To be replaced with new sash window, with timber to match thickness and sightlines, keeping the external building fabric the same.

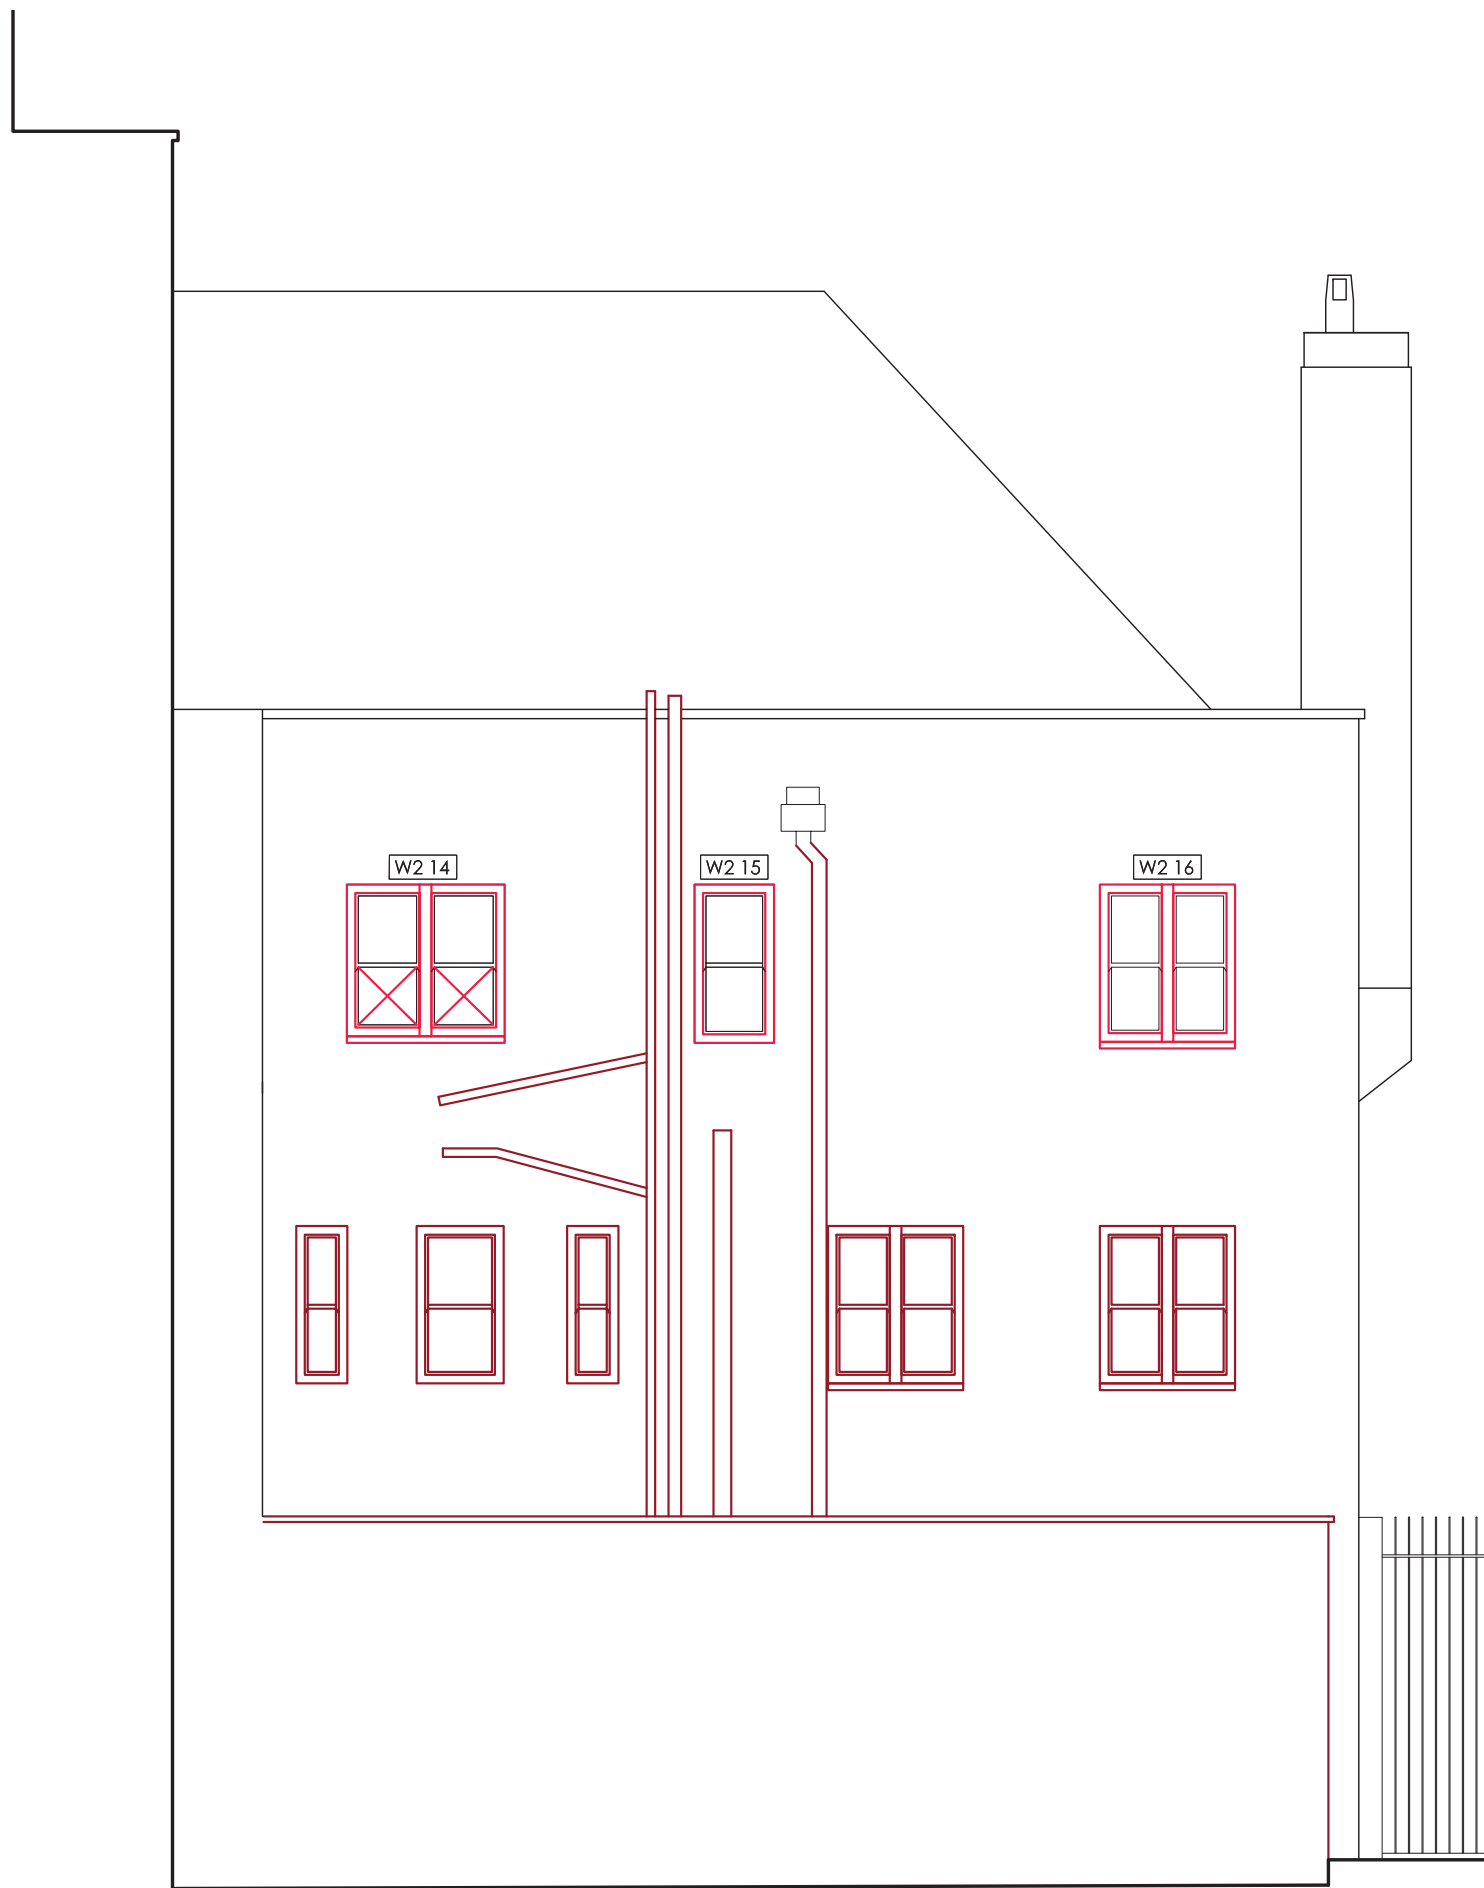
#### 4.0 NORTH EAST ELEVATION

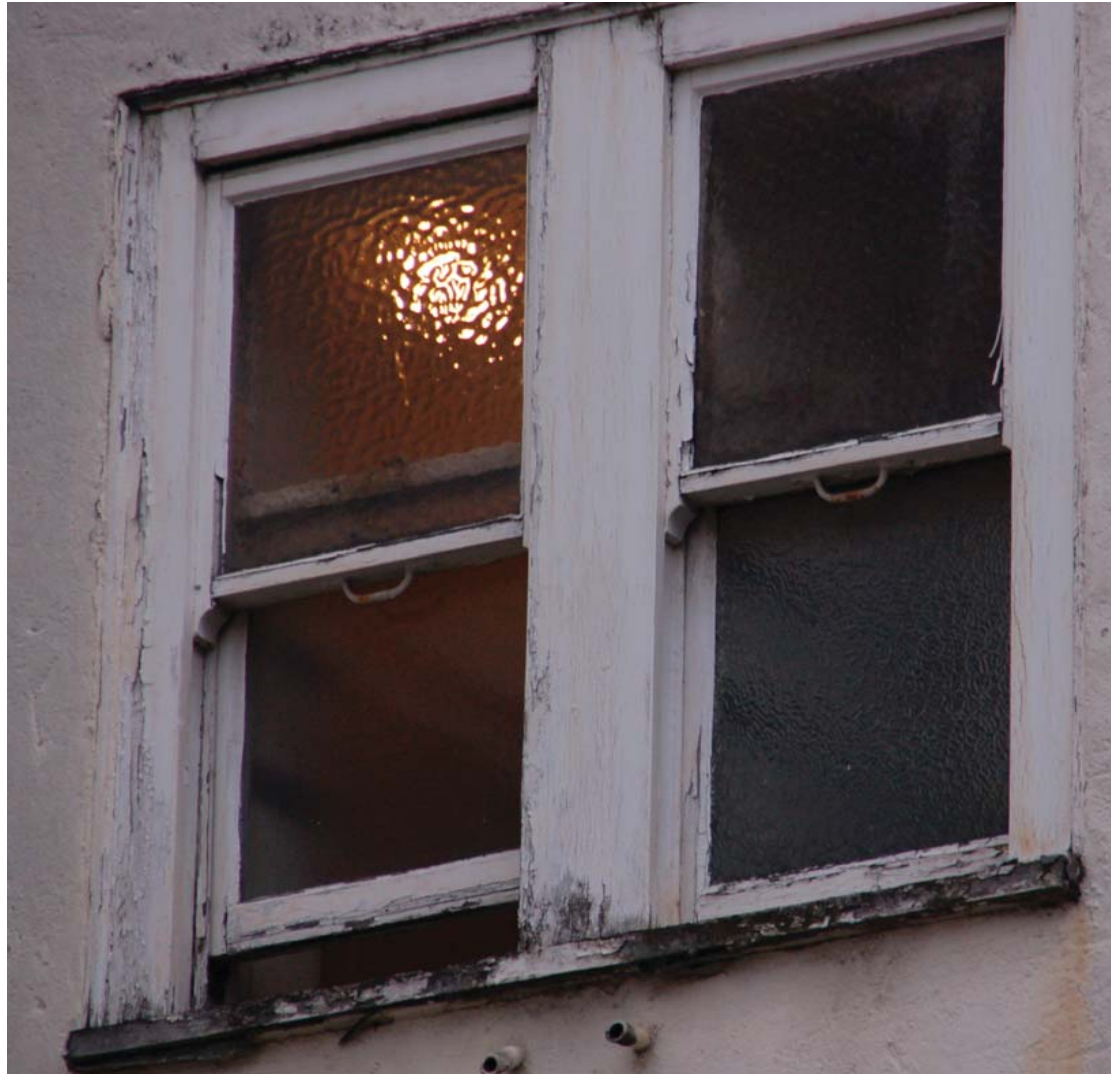
## 4.0 NORTH EAST ELEVATION

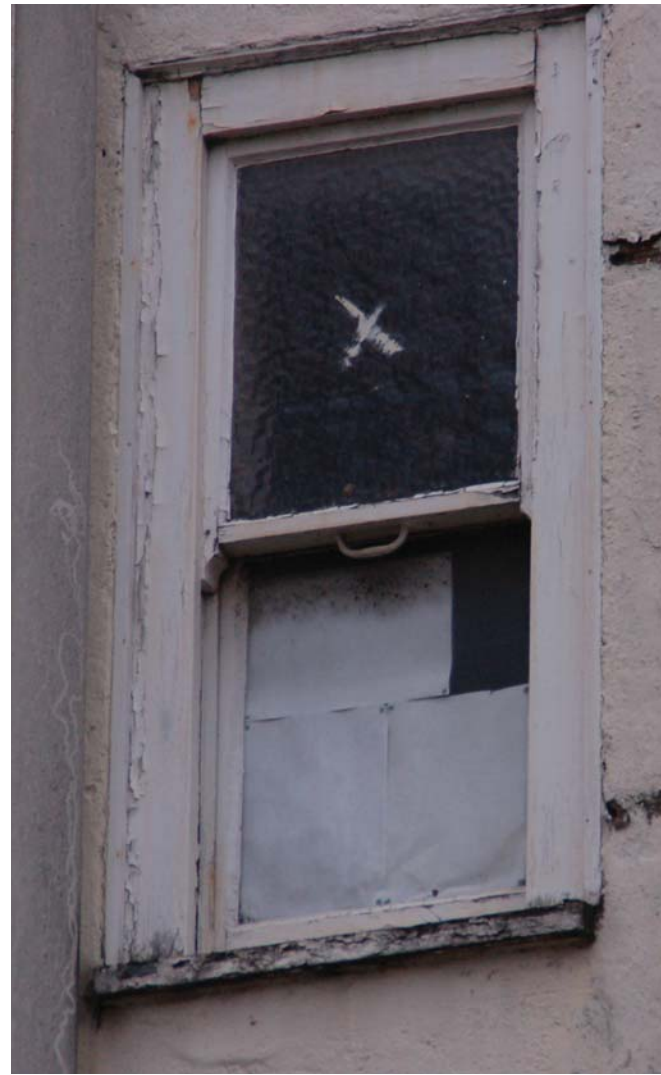
Rotten cill, beyond repair. Damaged runners. Old, damaged putty holding glass panels in place. Non-original obscured glazing to lower sash windows. External box severely damaged beyond repair.

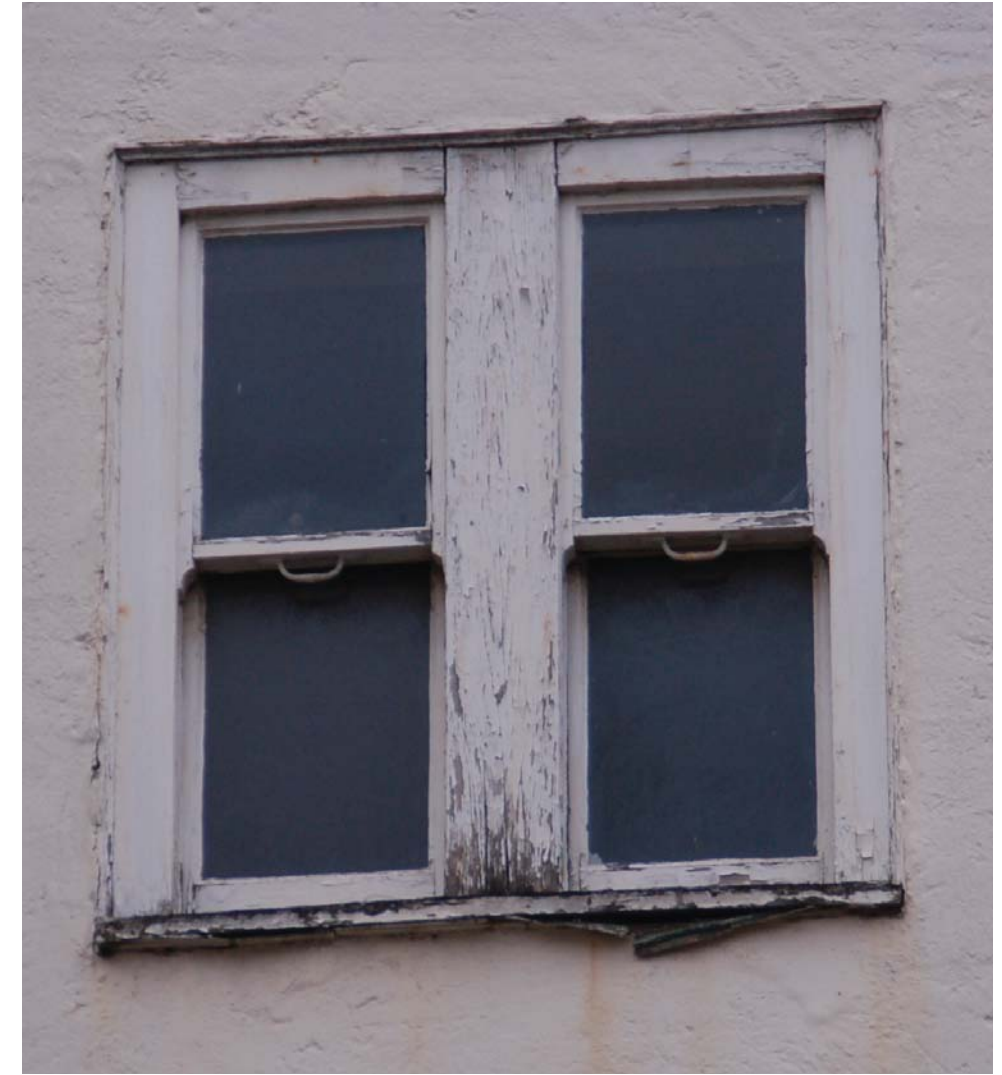
Rotten cill, beyond repair. Damaged runners. Old, damaged putty holding glass panels in place. External box severely damaged beyond repair.

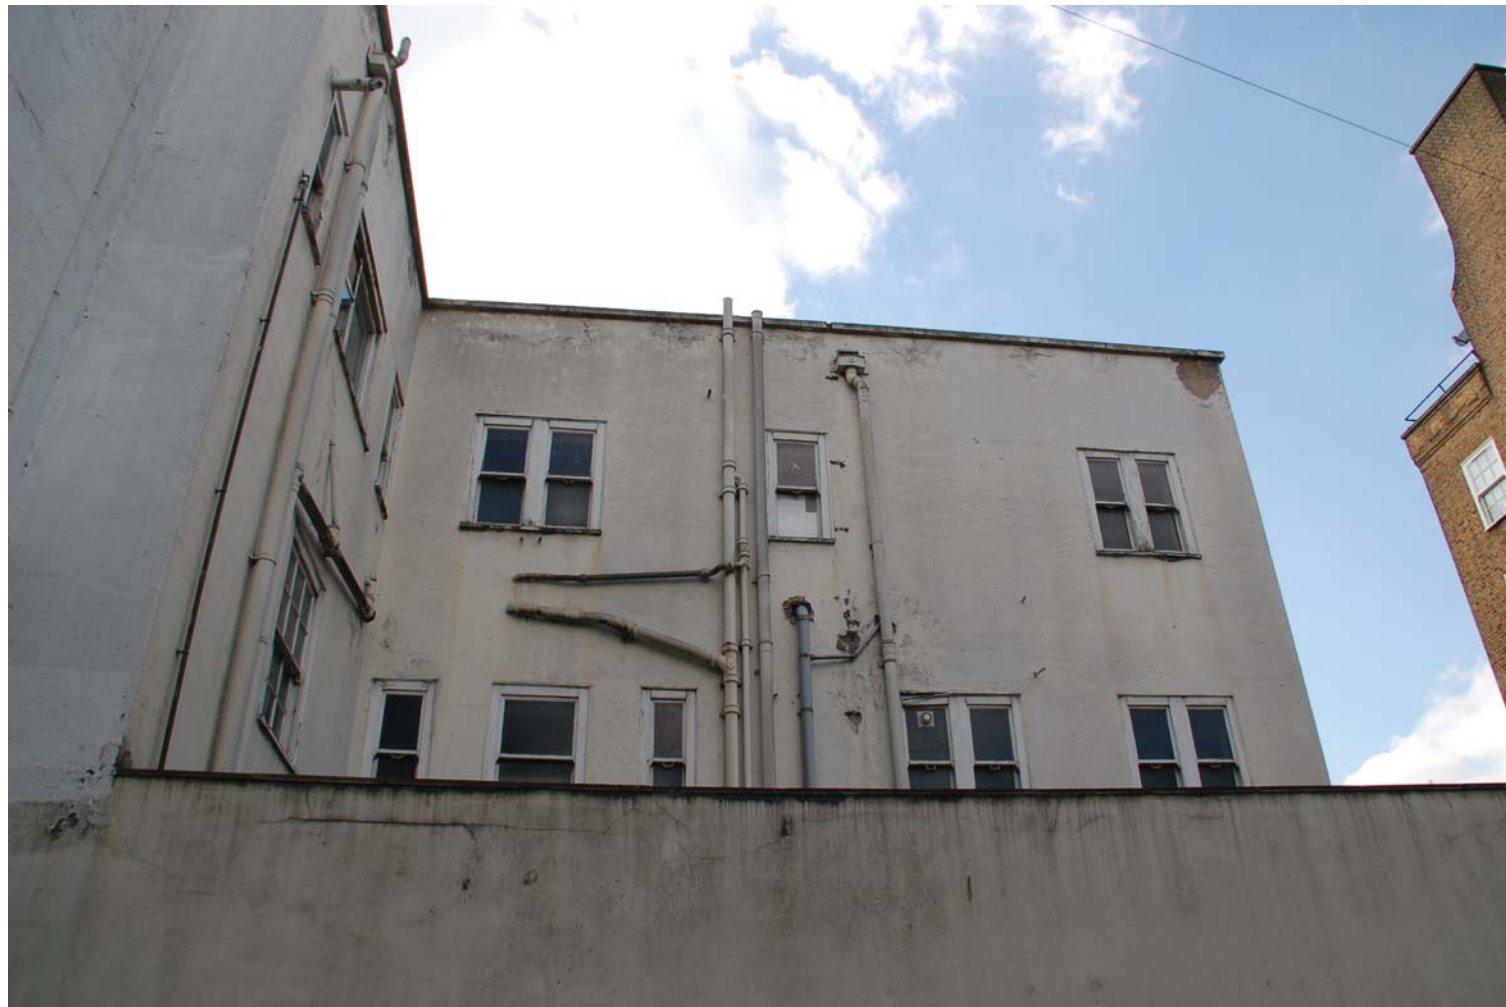
Rotten cill and box, beyond repair. Damaged runners and window lock. Old, damaged putty holding glass panels in place. External box severely damaged beyond repair.
