Your ref:
Our ref: 1-38-2779

3rd October 2016

Re: 20, Belsize Square, London, NW3 4HT

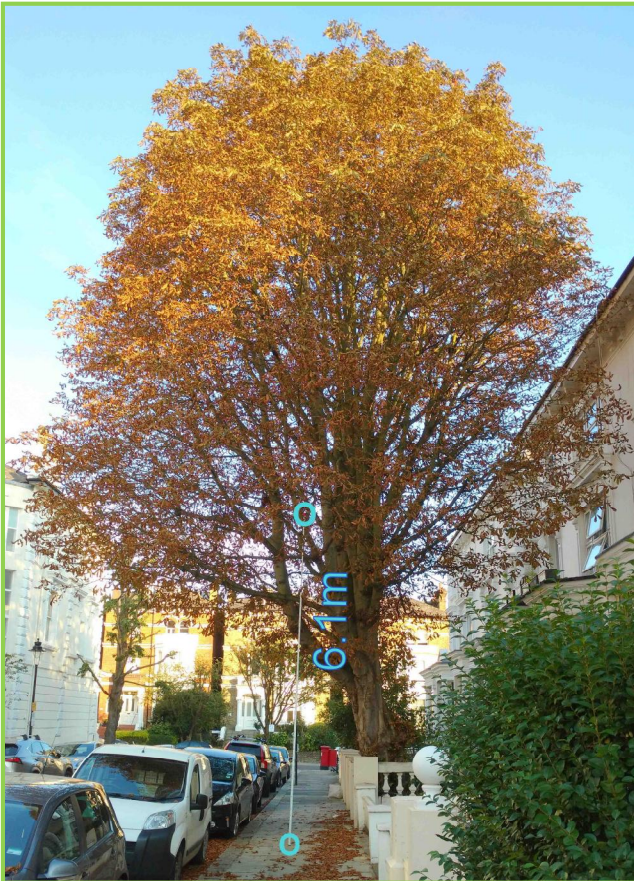
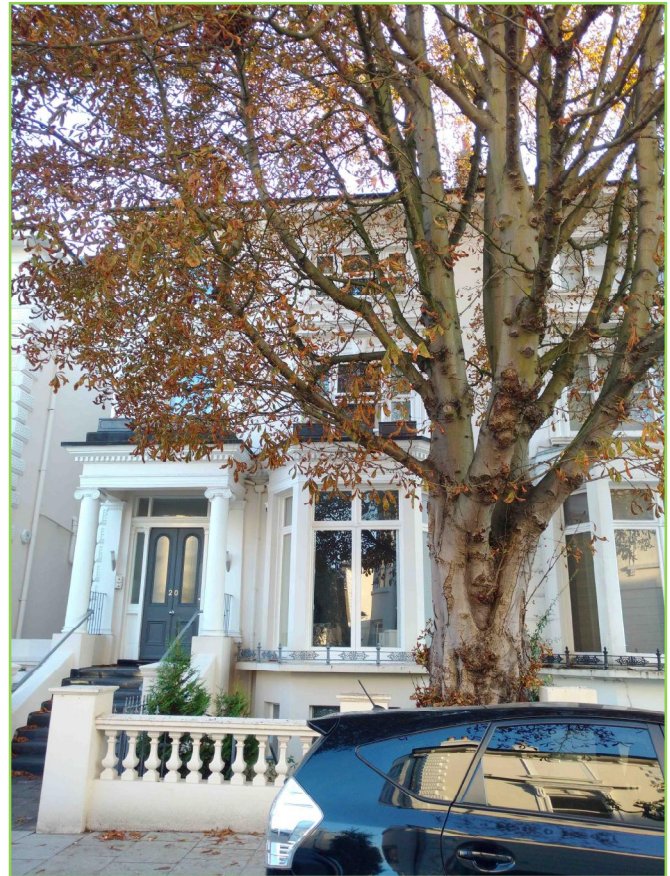
6) DISEASE The tree has now for several years been affected by *Cameraria ohridella* – this pest typically causes serious disfigurement and leaf damage in the late summer. There is currently no Forestry Commission-approved treatment for this disease. Please note the pictures do not show normal autumn colouring :

- and note the drifts of prematurely fallen leaves. Thus, on aesthetic grounds the tree is a 'net-detractor' by late summer; and during winter is of very poor form.

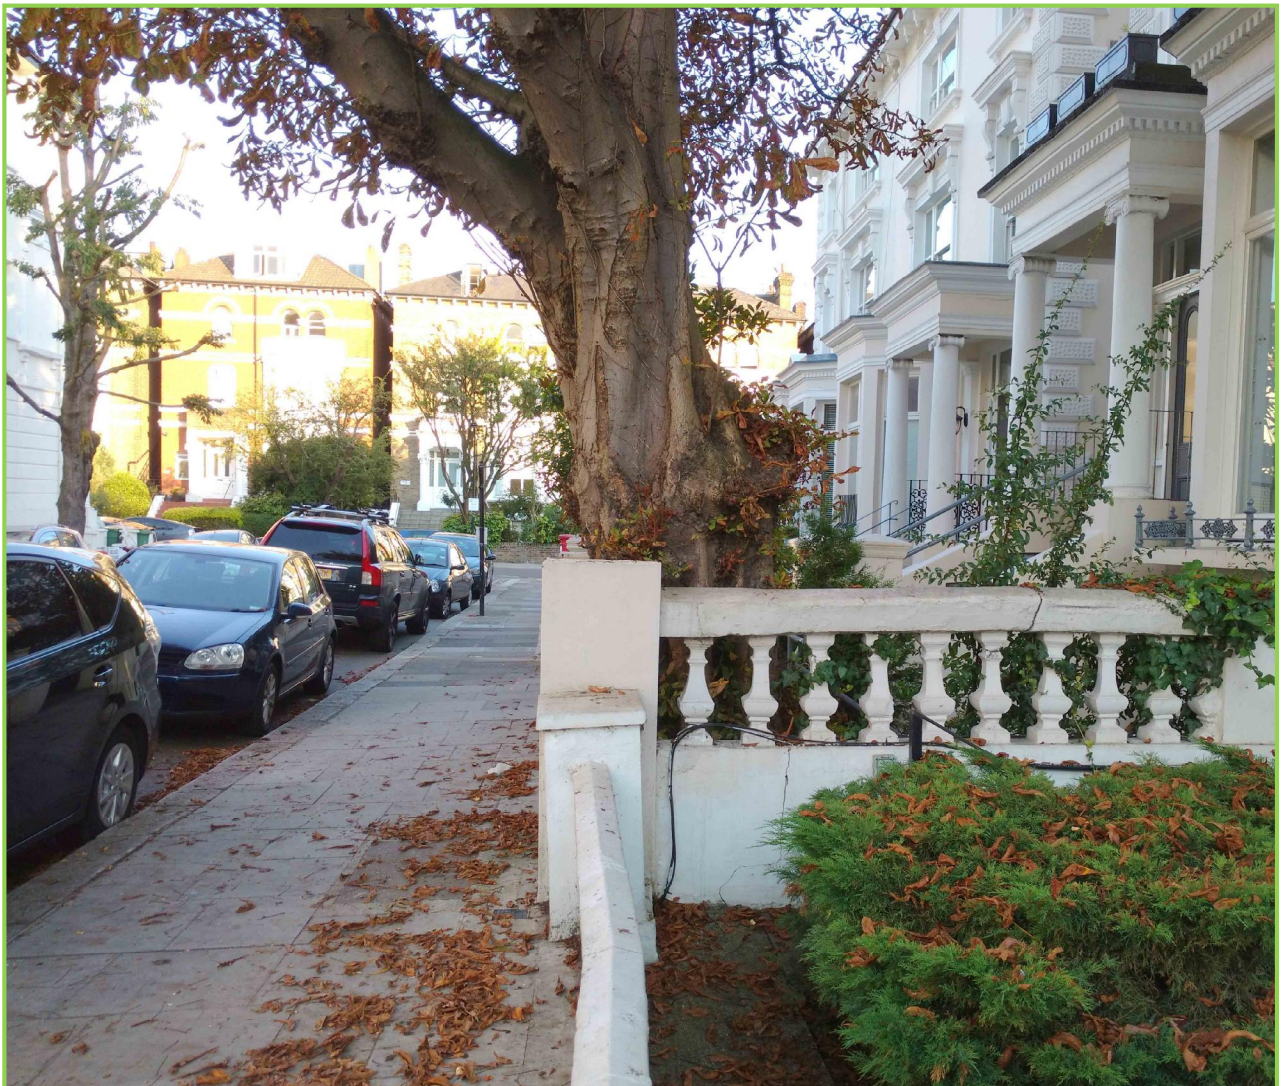
8) The tree is clearly causing massive disruption, via direct damage, to access steps to the basement as the photographs appended show. Disruption to the boundary street wall was also noted, the pillar being substantially out-of-true. Such damage

has worsened and will worsen further and require periodic repair. It will not be alleviated markedly by low pollarding. Please note that if the tree was suitable for the location I would be the first to be advocate an engineered solution, as you will recall was my position in defence of the fine London plane tree at Park Village West/ Albany Street.

FELL the tree and remove the stump.

REPLACE with an agreed tree.

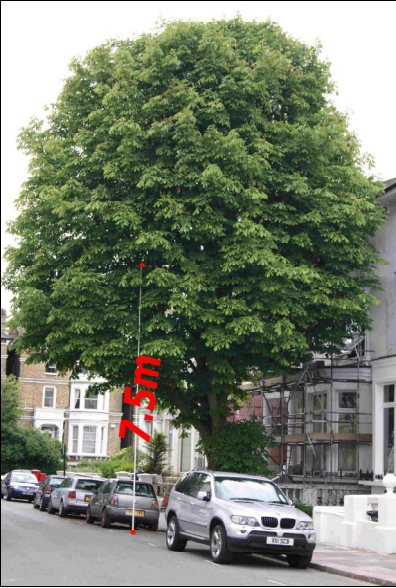
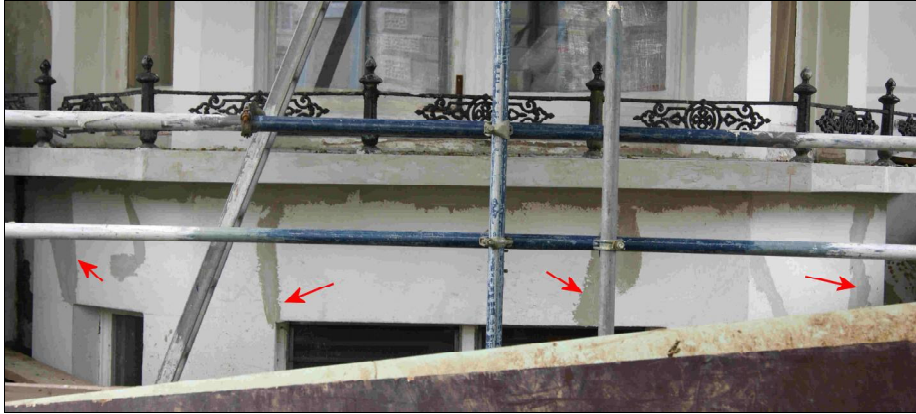
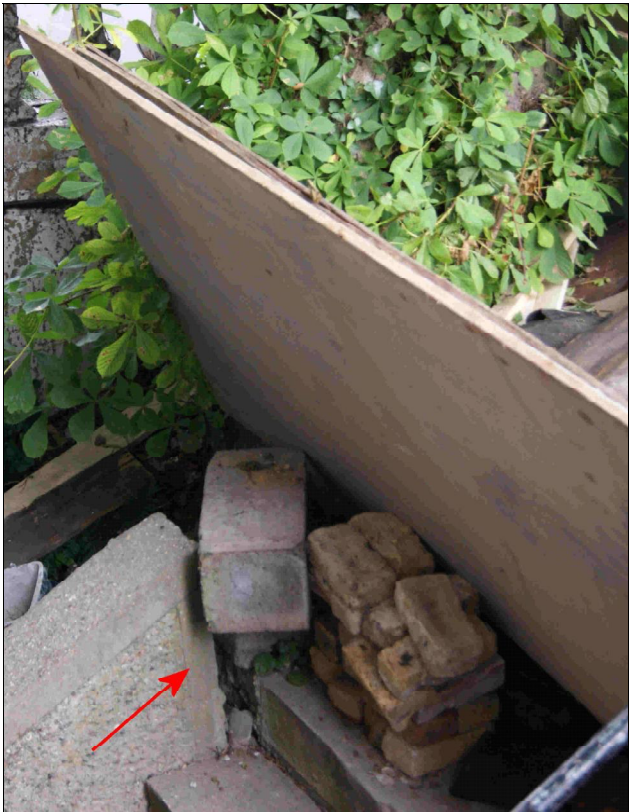
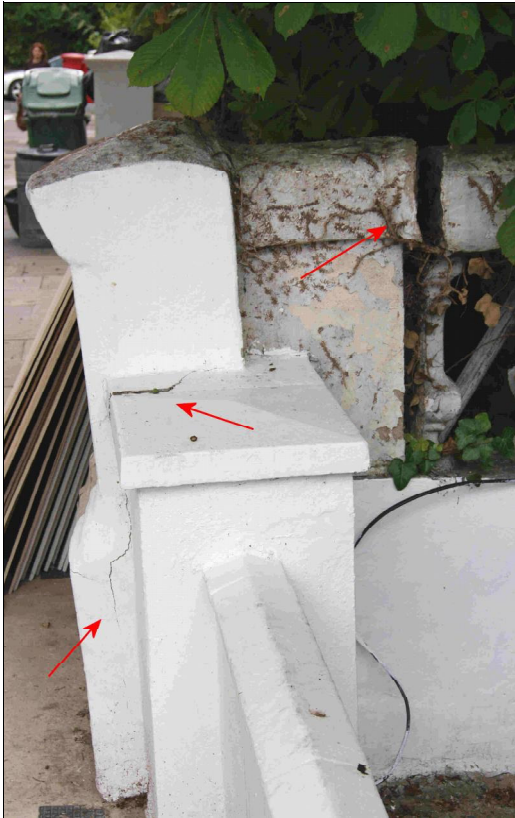
Photos—horse chestnut tree tree and damage
to no.20, Belsize Square, NW3
Ref: TC/1-38-2779/pho
June 2011

Damage arrowed red

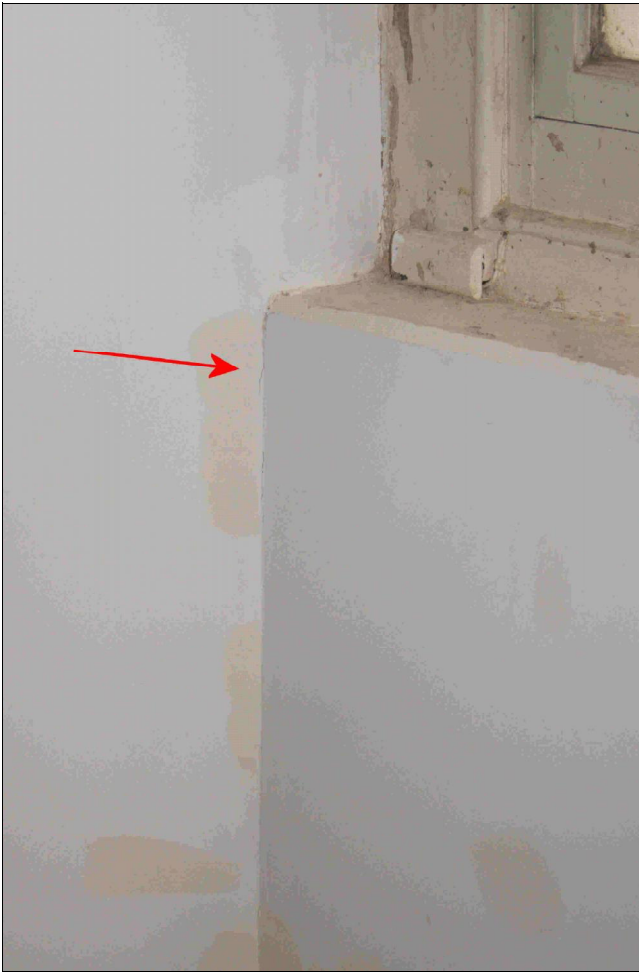
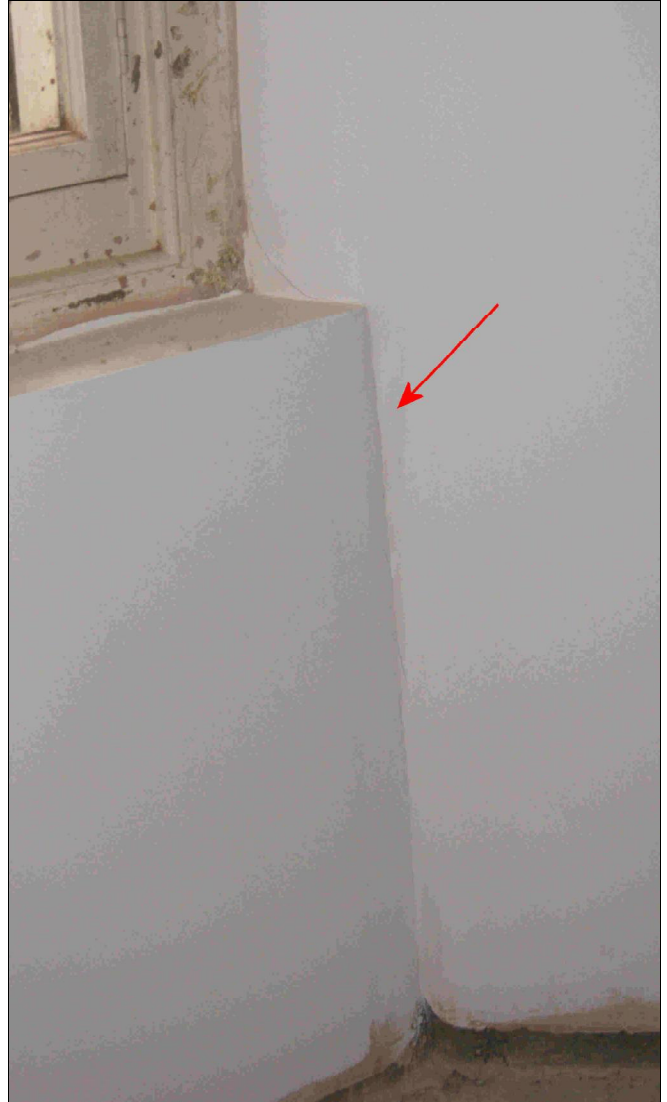
Photos—horse chestnut tree tree and damage
to no.20, Belsize Square, NW3
Ref: TC/1-38-2779/pho 2
June 2011

Cracks L and R side of access door to lower ground floor,
front elevation
June 2011
